**Inspection Photos 09/13/18**  
**Location: KP Kauffman Lauridson No. 1A & 2A Facility**  
**Well API # 123-07992 / 123-08372**

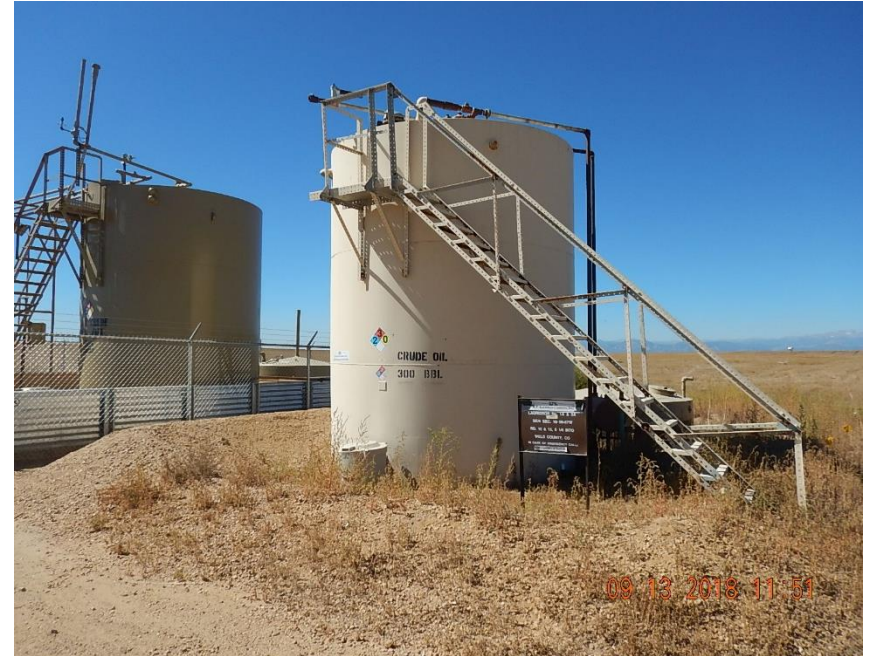
**Lauridson tank battery; excessive weed growth inside and around tank berms.**

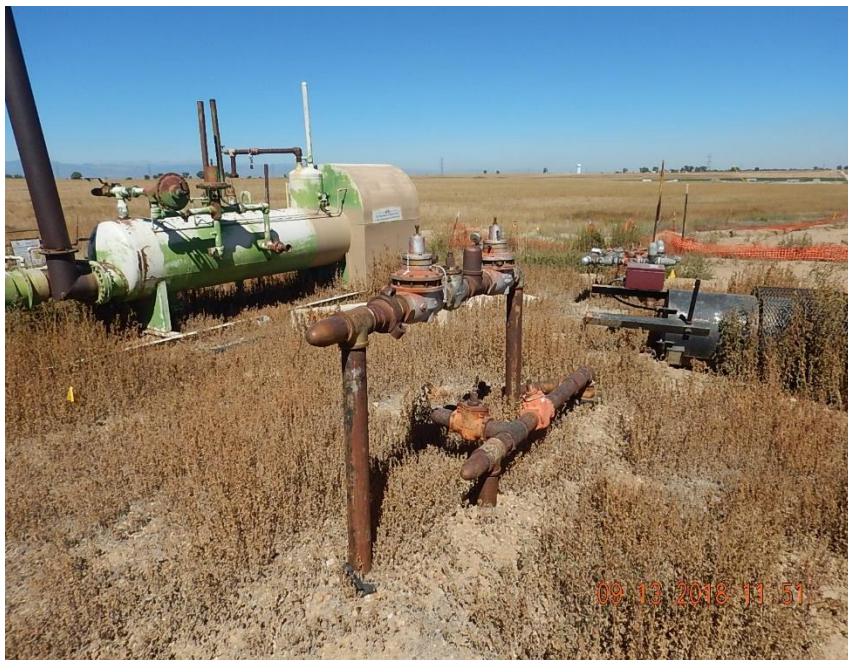
**Unused equipment; disconnected horizontal separator, unused ECD (vent stack) and unmarked flowline risers.**

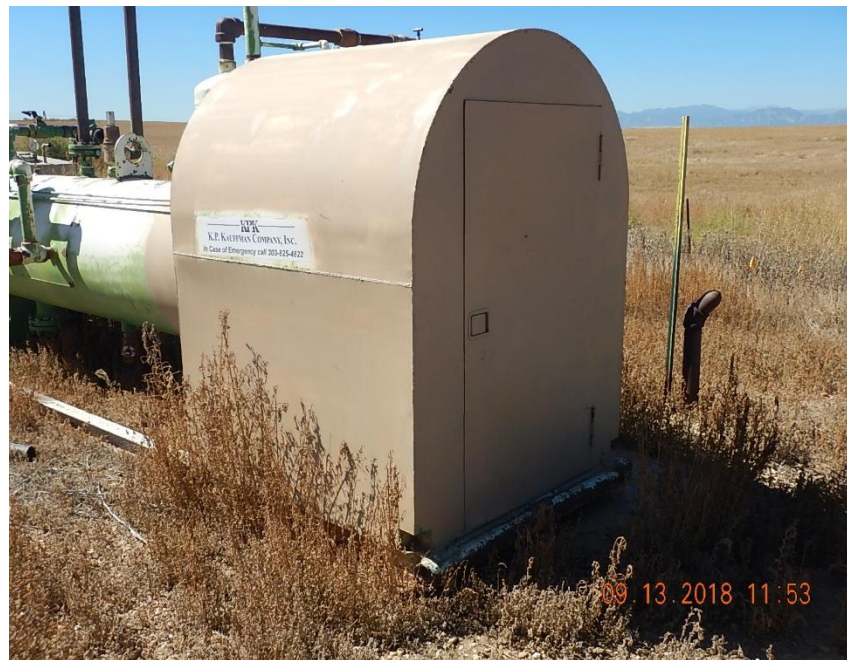
**Unused flowline riser near the NW corner of horizontal separator; not marked or locked/ tagged out.**

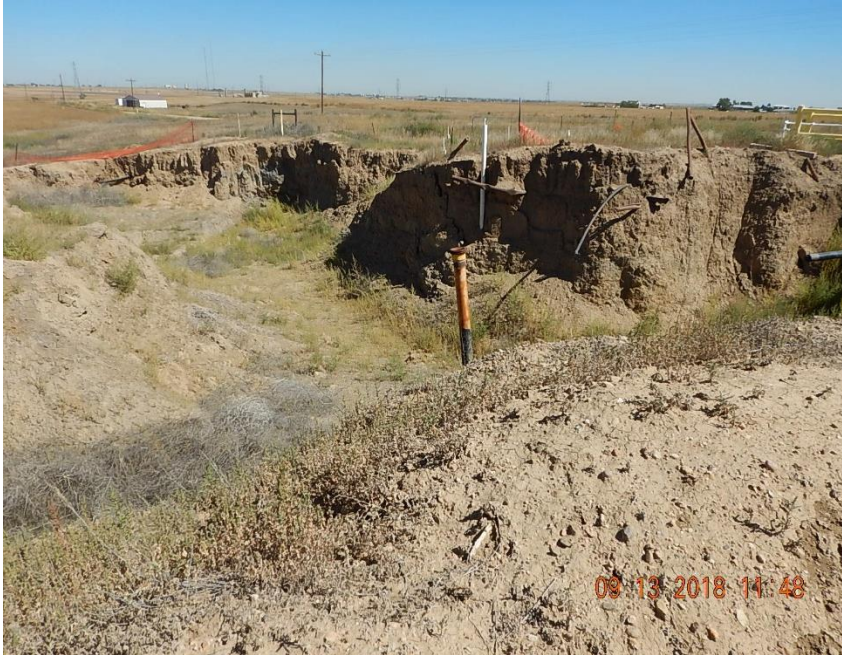
**View to north of excavation completed by KPK to remove a produced water vault (REM #9971); Inactive flowlines have been exposed in the excavation. The flowlines have been cut, segments removed. The ends (considered risers) have not been marked or sealed (capped or plugged).**

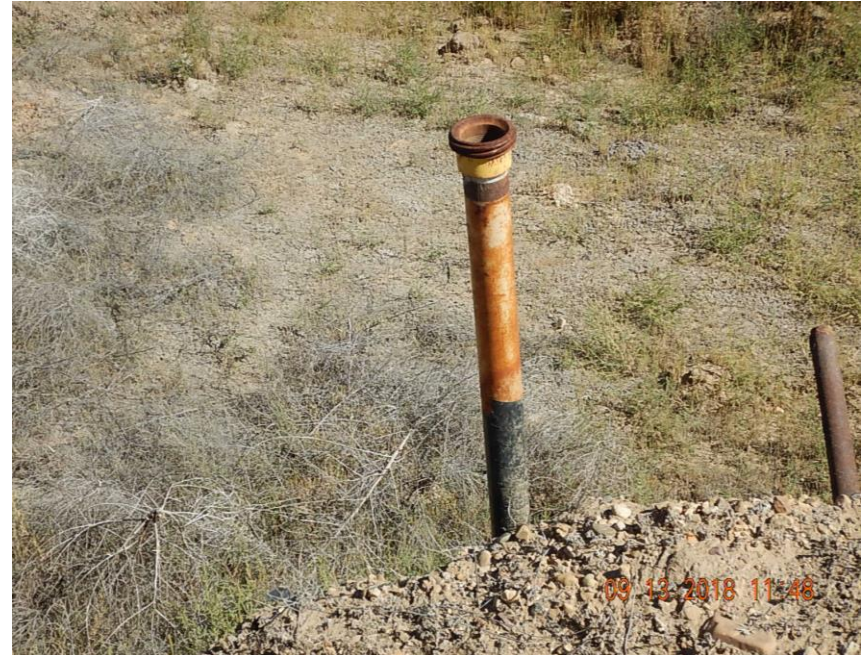
**Close up view of an unused and inactive flowline riser that previously tied into KPK equipment; and adjacent to the south side of the excavation. Riser end not marked or plugged (hammer union fitting) and LOTO.**

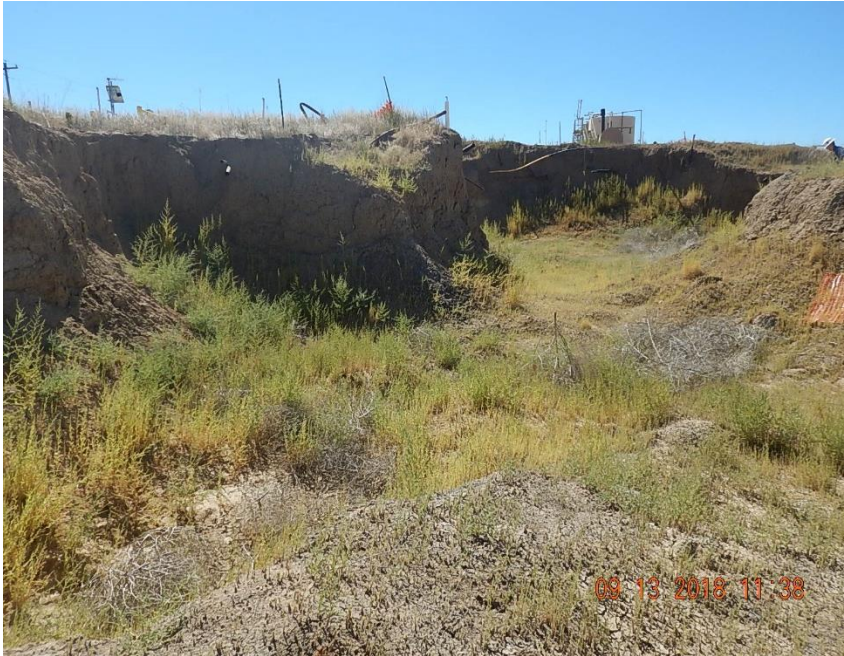
**View south toward battery of the excavation completed by KPK during the water vault removal. Excessive weed growth observed in the excavation. Inactive flowlines exposed.**

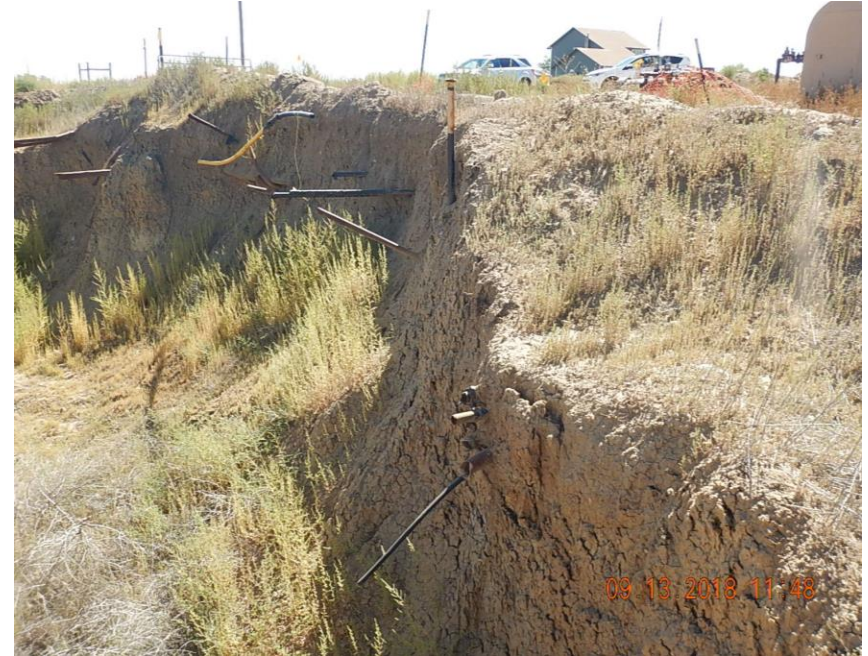
**View to east of the south wall of excavation; Numerous inactive flowlines are exposed. The flowlines exposed (open to surface as risers) are open ended and have not been abandoned in place per COGCC rule 1105.**

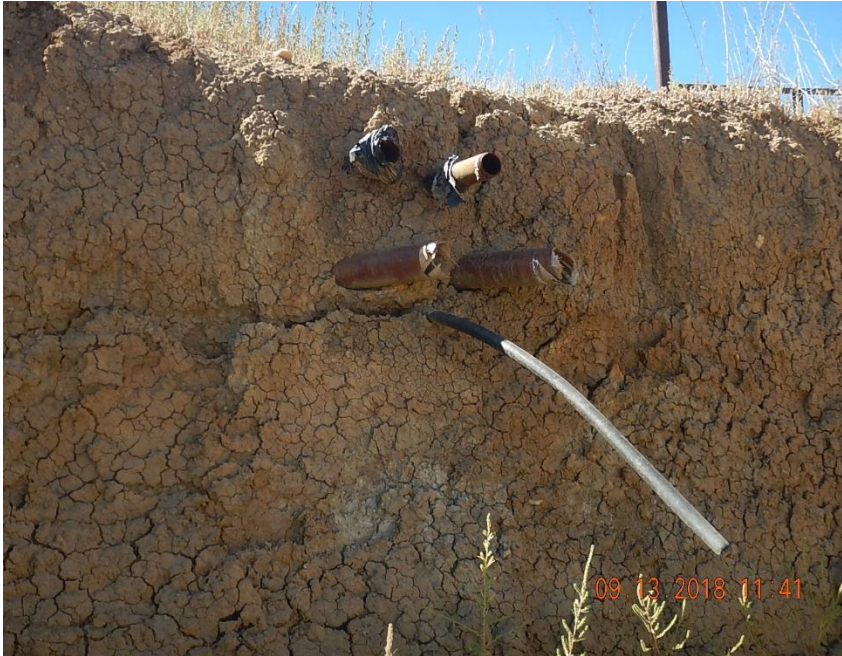
**Close up view of flowlines exposed in excavation; Fiberglass, carbon steel and poly flowlines of numerous sizes were encountered during excavation. Some cut ends have been covered with tape (not an acceptable means of sealing ends)**

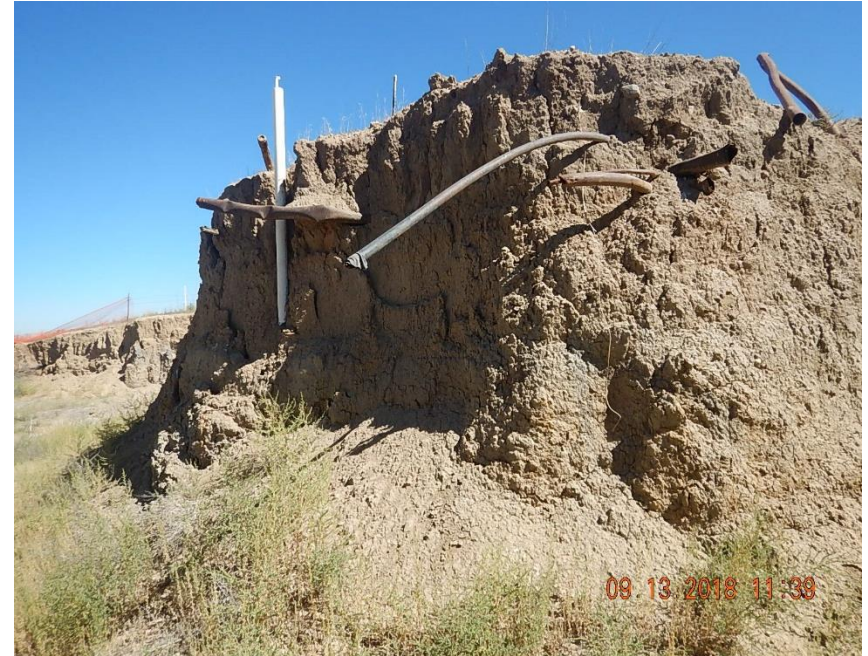
**View of inactive flowlines exposed along the north side of the excavation. Flowlines have not been located or marked on surface (adjacent to excavation). Flowlines (exposed to surface as risers) have not been abandoned per rule 1105.**
