# Inspection Photos

Operator: BP Production

API: 05-067-07486

Date: 9/13/2018

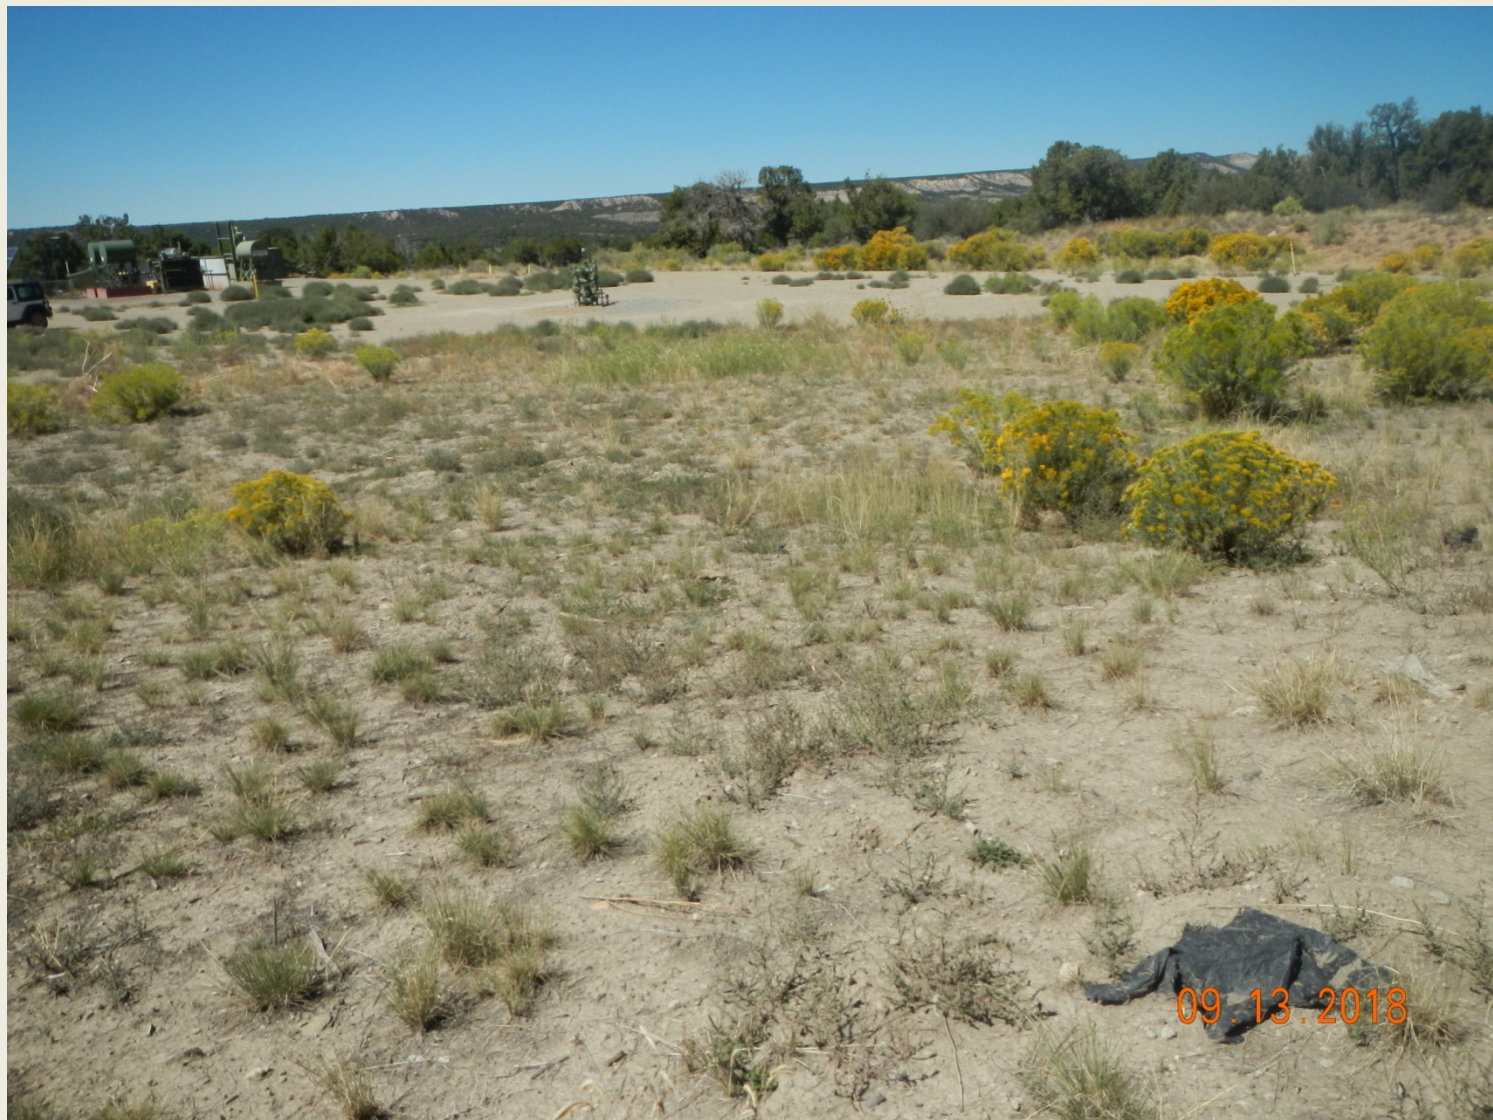
**Photo 1. View of the project area from the southeastern corner facing center. Black liner debris needs to be cleaned.**

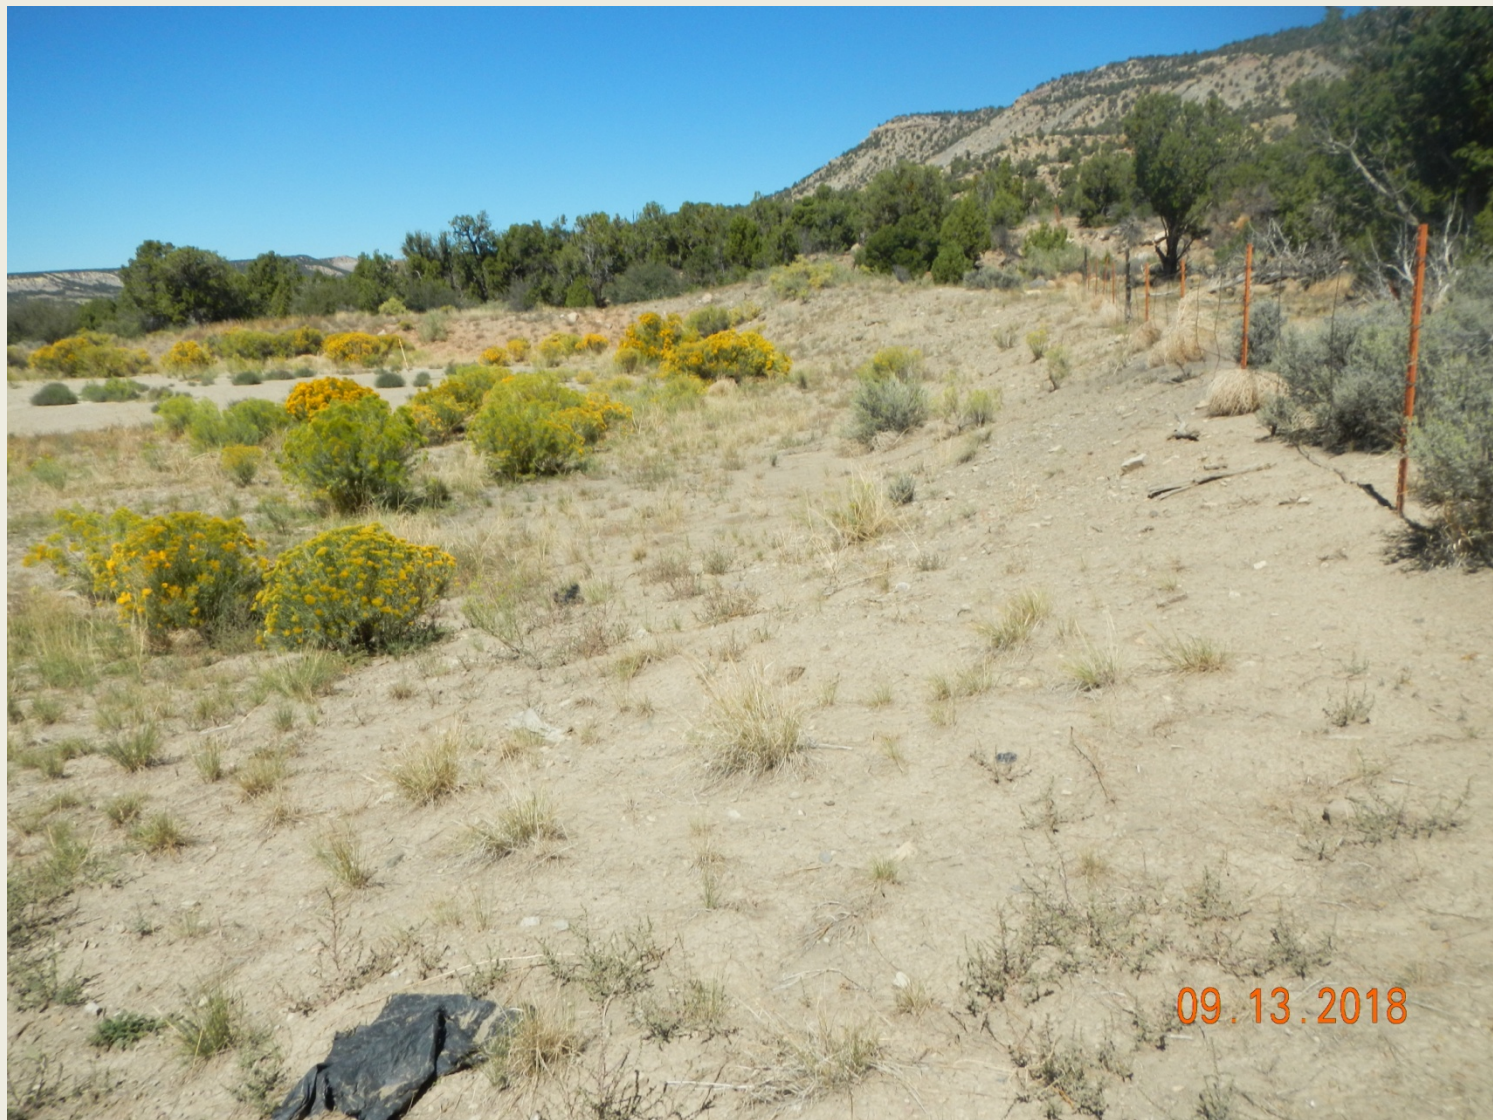
**Photo 2. View of the eastern project area from the southeastern corner facing northward.**

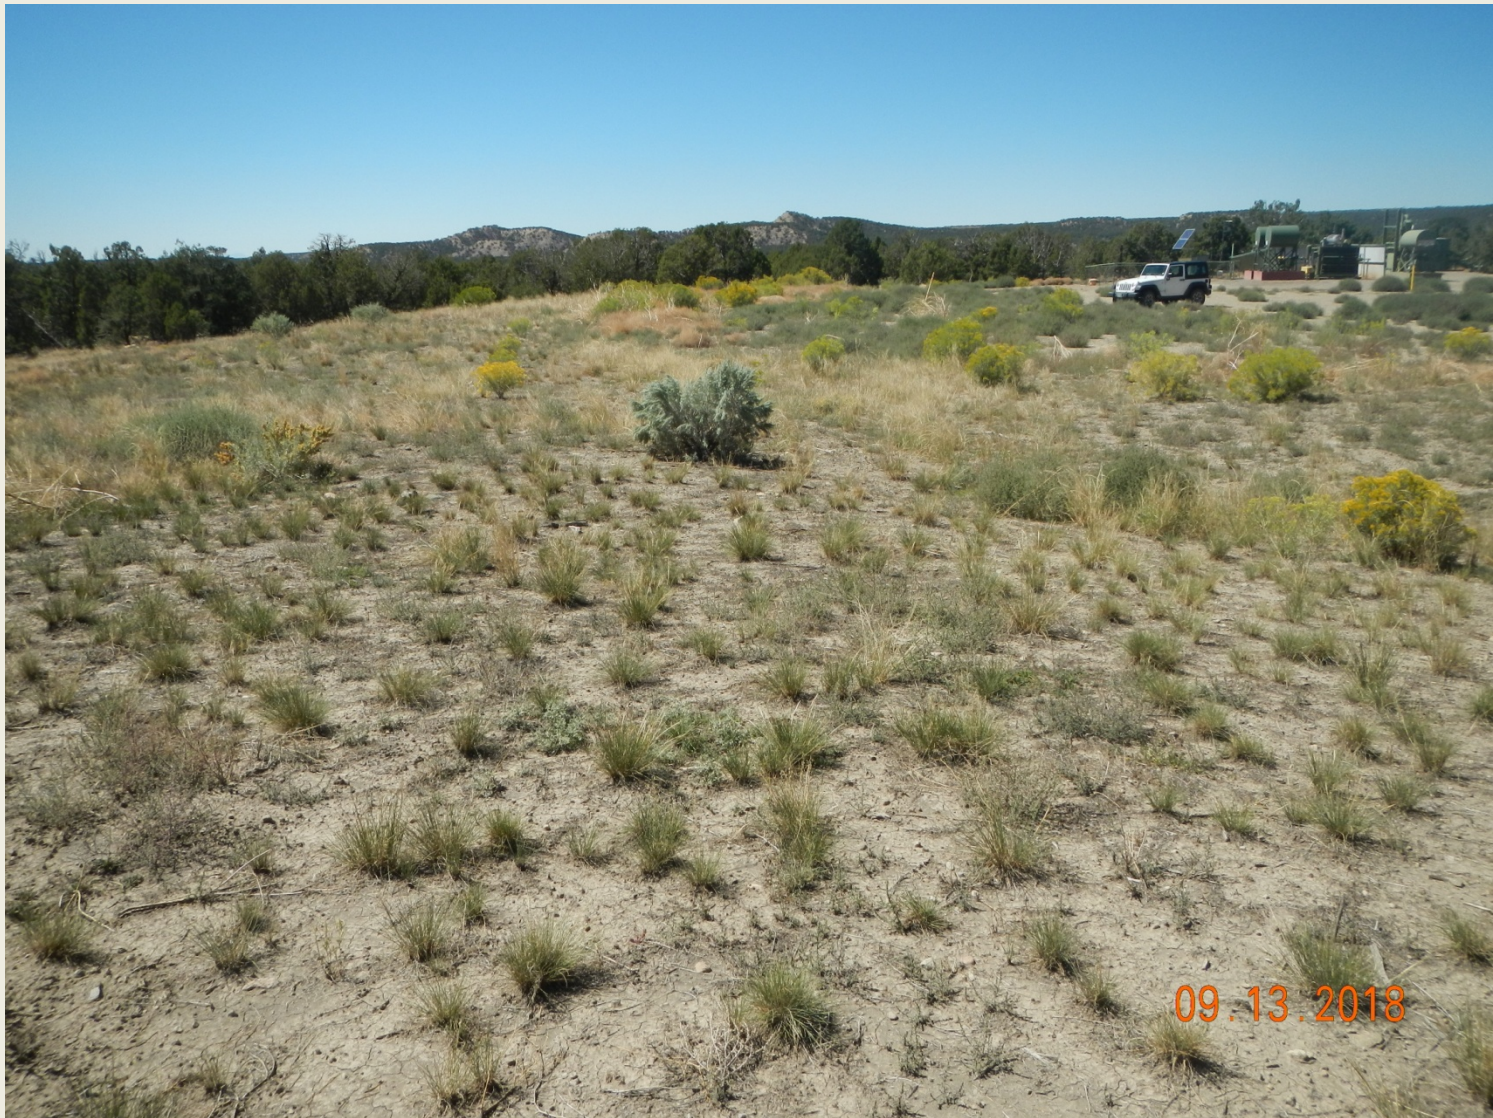
**Photo 3. View of the southern portion of the project area from the southeastern corner facing westward. Revegetation is largely comprised of grasses such as crested wheatgrass (*Agropyron cristatum*), Indian ricegrass (*Achnatherum hymenoides*), and sand dropseed (*Sporobolus cryptandrus*).**

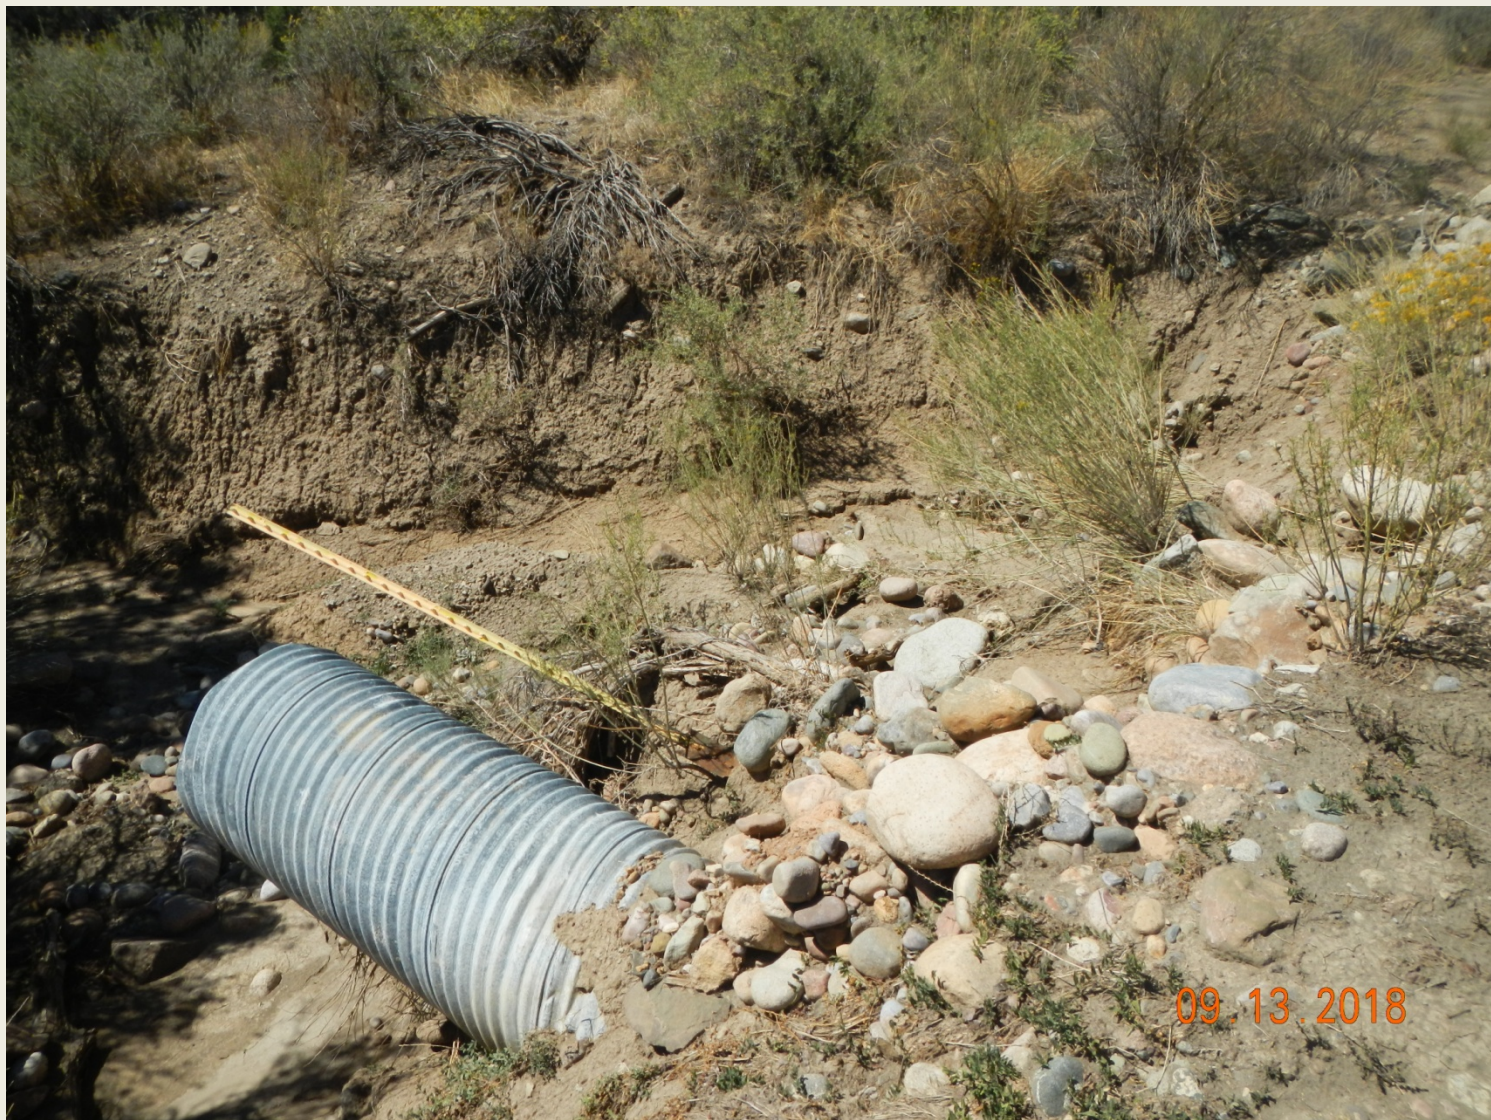
**Photo 4. View of erosion at culvert outlet where culvert is blocked on upstream side and stormwater flows over the road surface resulting in erosion on the road and where it flows into the drainage around the culvert.**

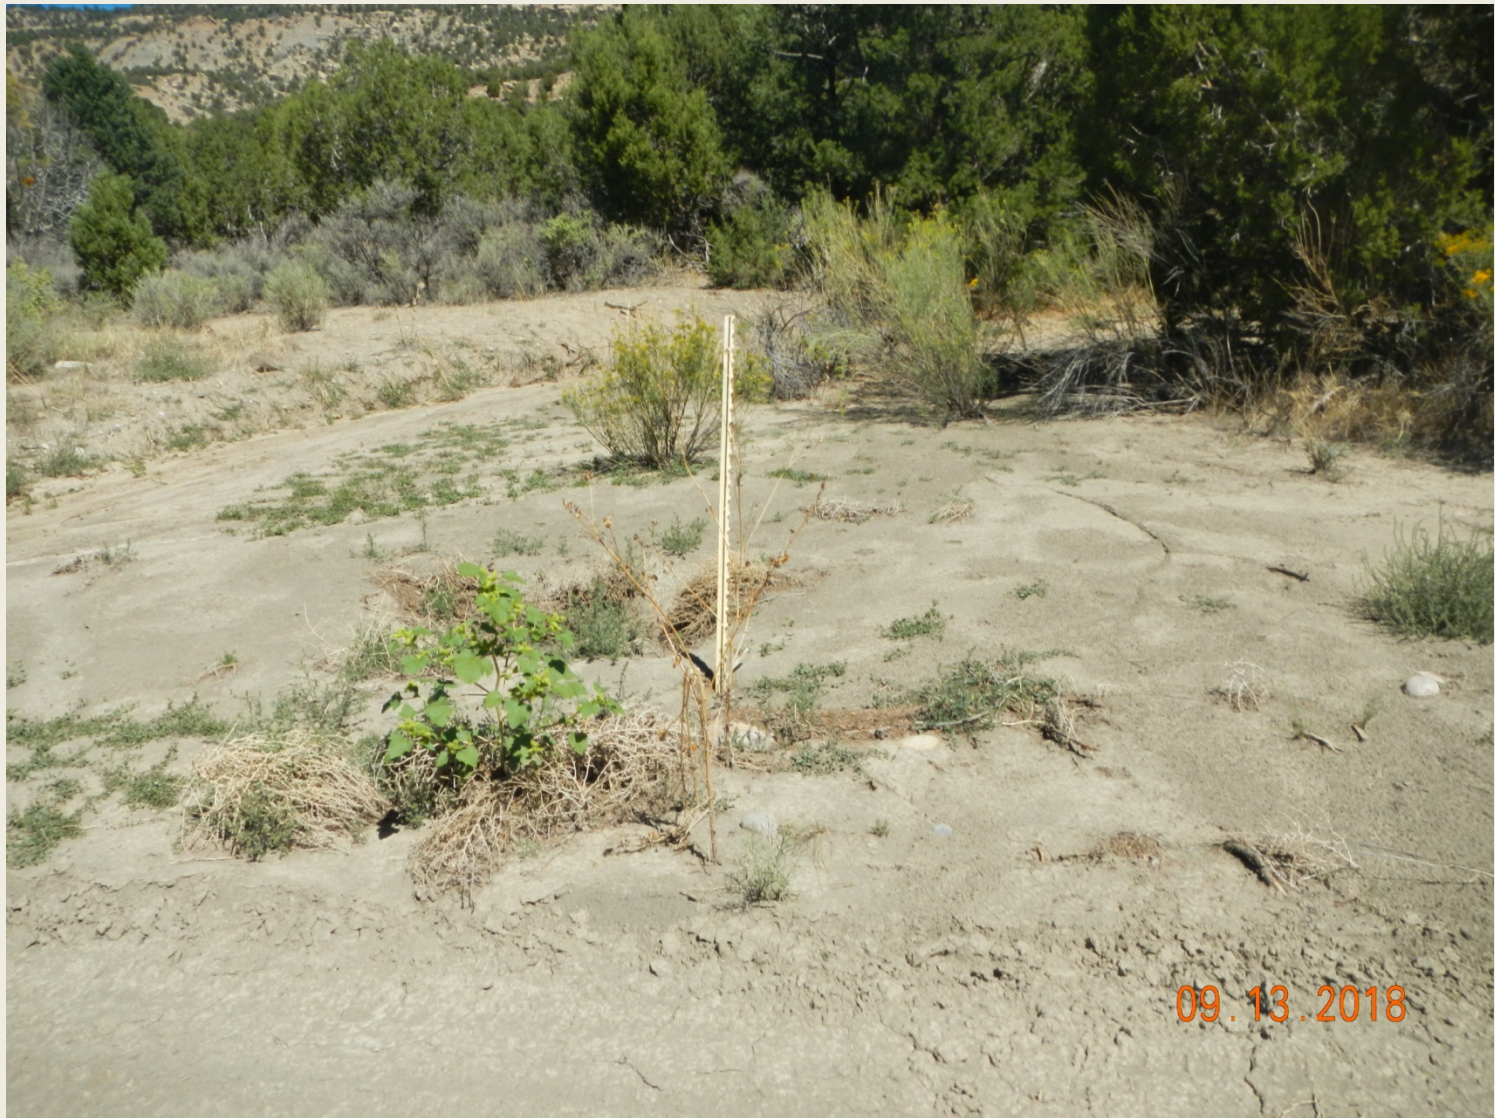
**Photo 5. View upstream from Photo 4, where sediment has filled culvert and stormwater flows onto the access road.**

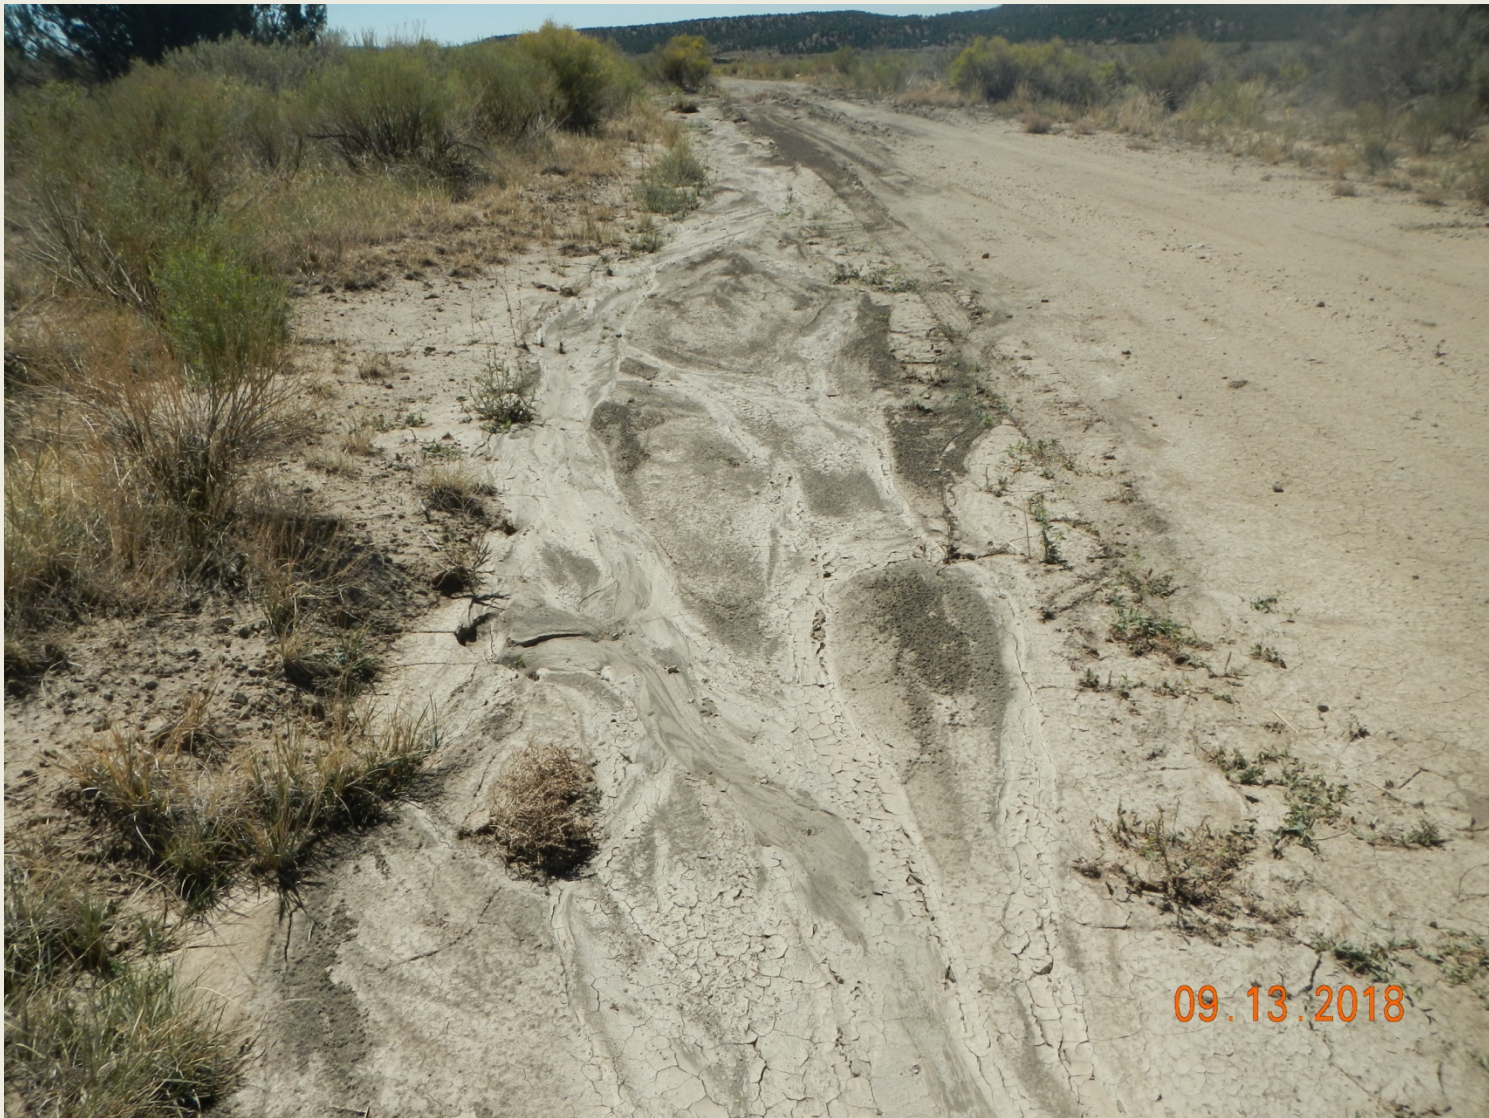
**Photo 6. View of area on the access road where roadside ditches are not present/functining and stormwater flows along the road eroding the road and depositing sediment.**

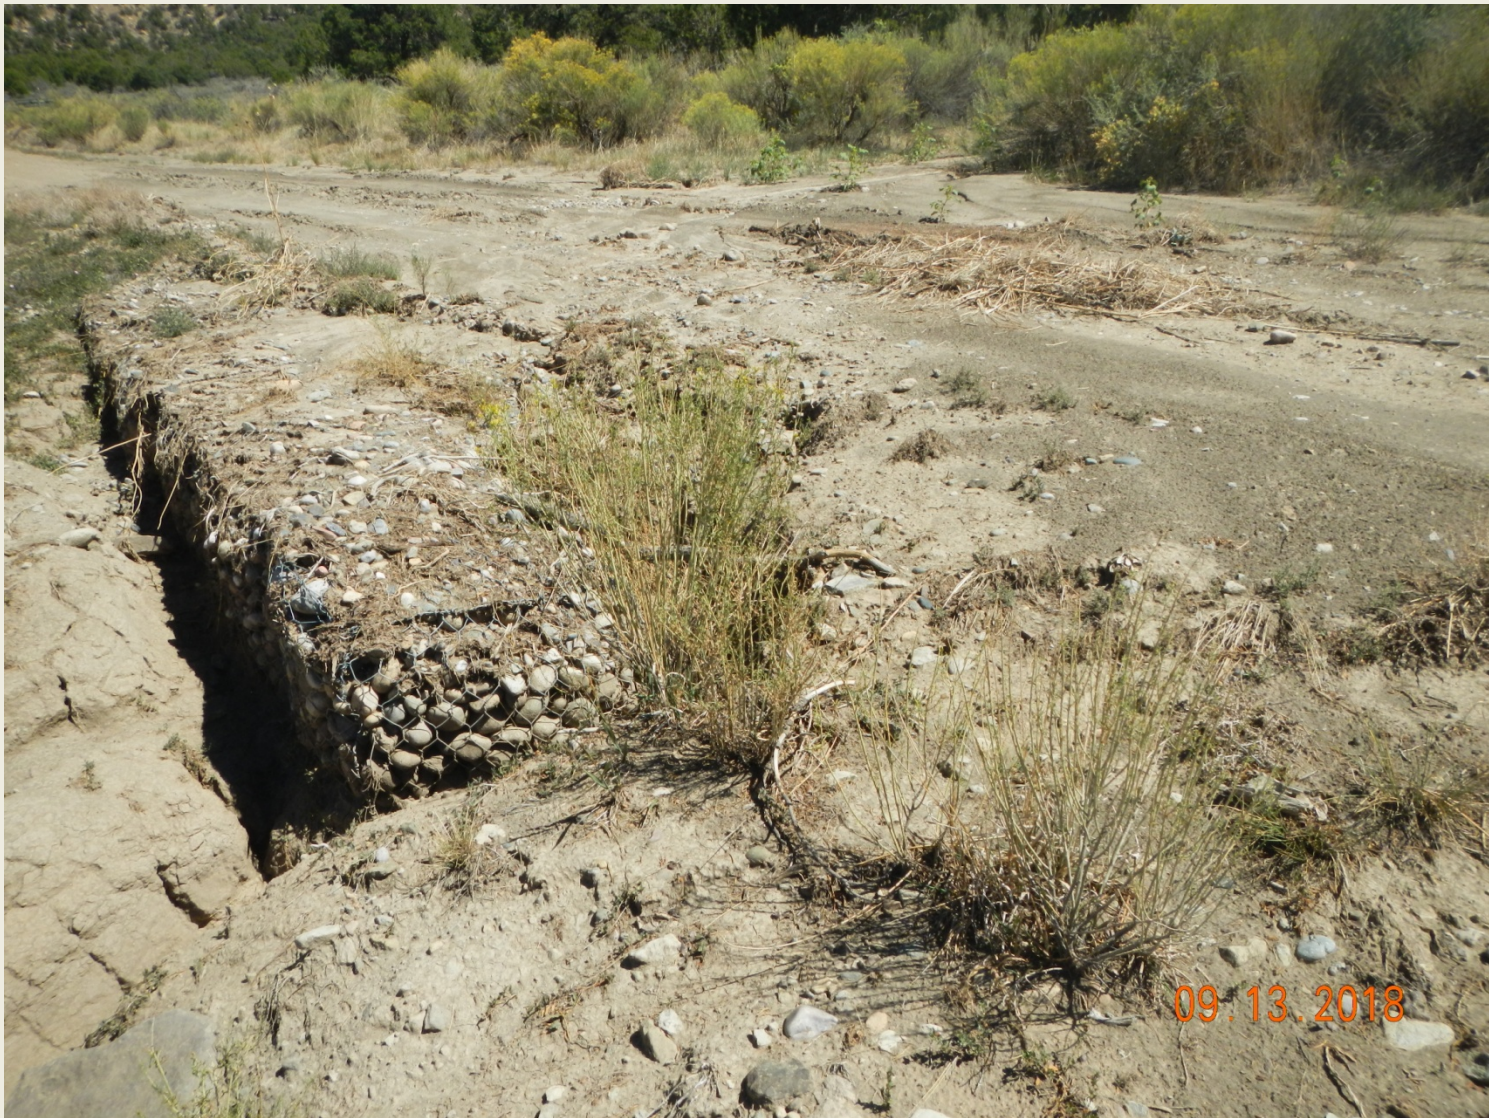
**Photo 7. View of area along the access road, downstream from photos 4-6, where drainage crosses the access further from the well pad. Stormwater flows over and erodes the access road and cut-banks. Upstream culvert inlet not observable.**

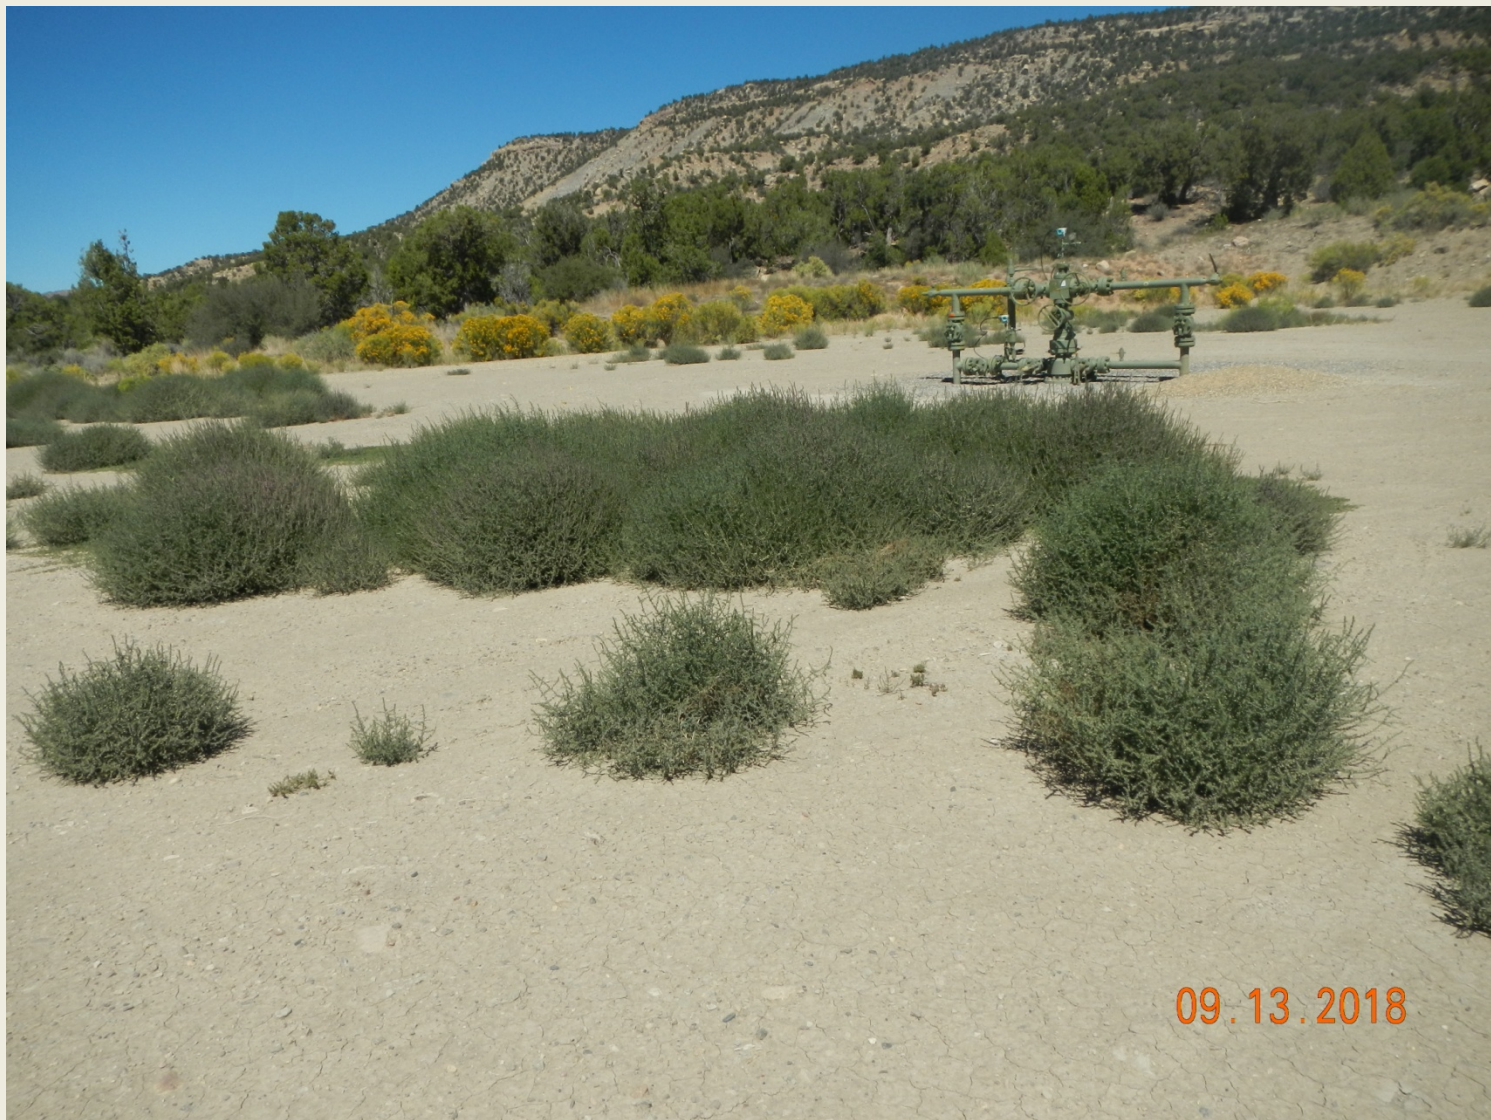
**Photo 8. View of Russian thistles (*Salsola tragus*) on the well pad growing up to 3 feet tall. These will break off and become debris.**

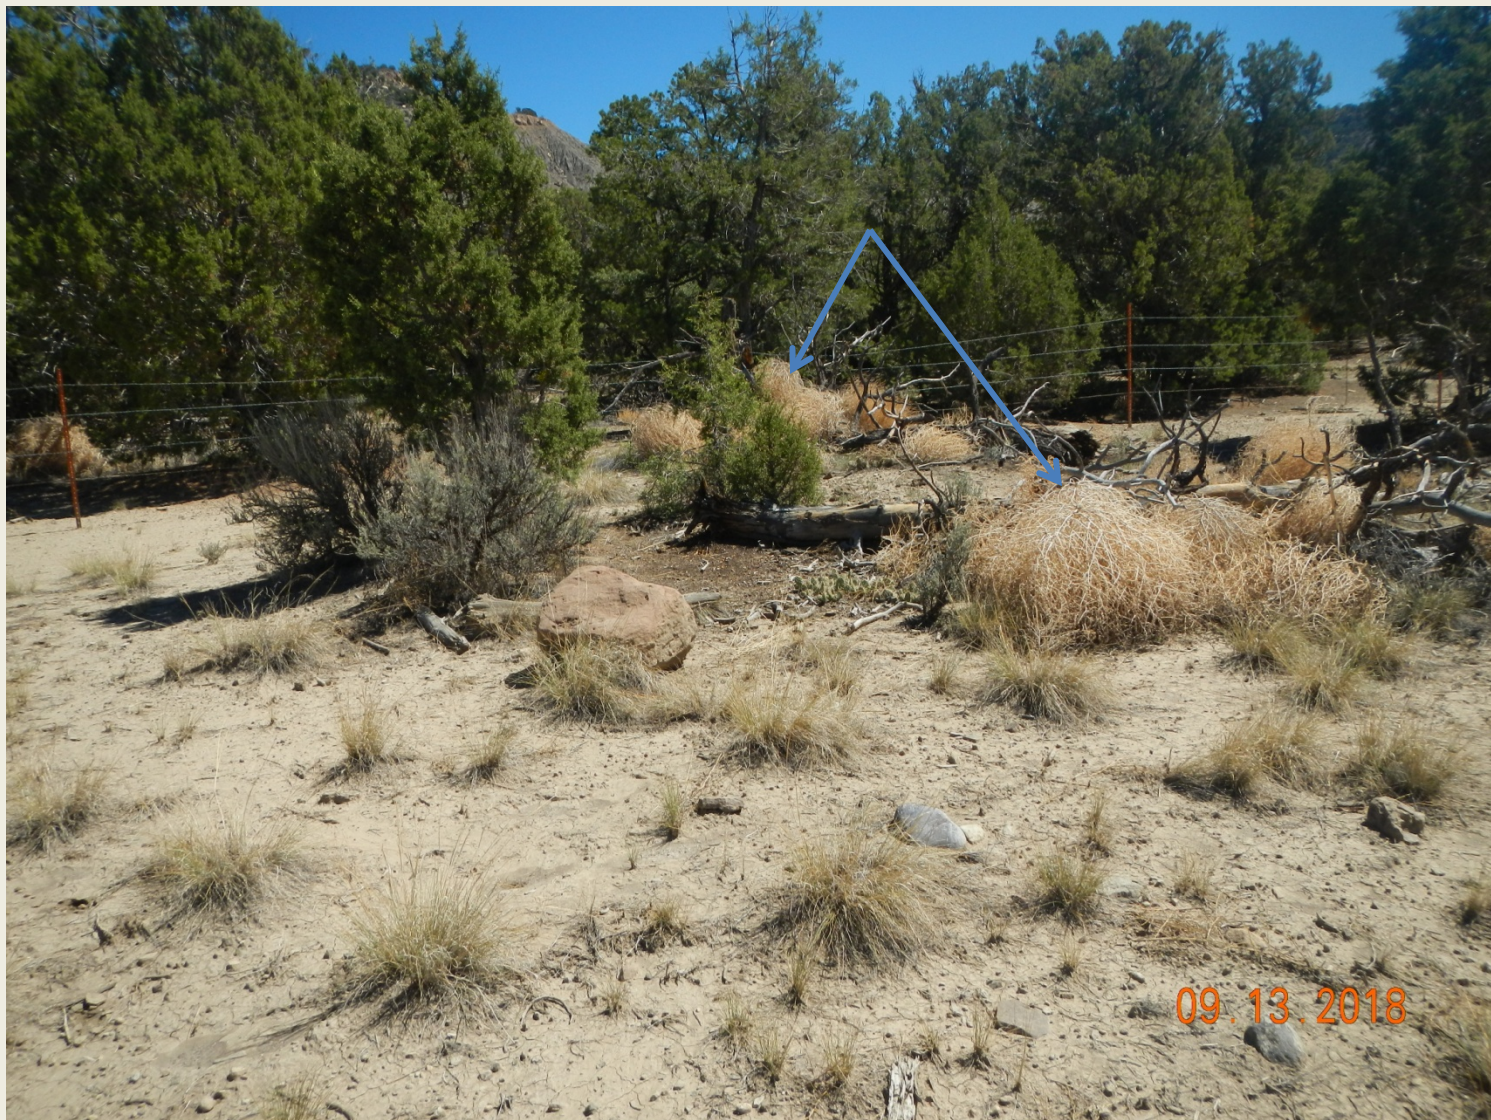
**Photo 9. View Russian thistle debris that has blown off of the project area, east of the well pad.**
