**Inspection Photos**  
**Location Name: EDKAM #2-23 corrective action**  
**API: 05-123-11885**

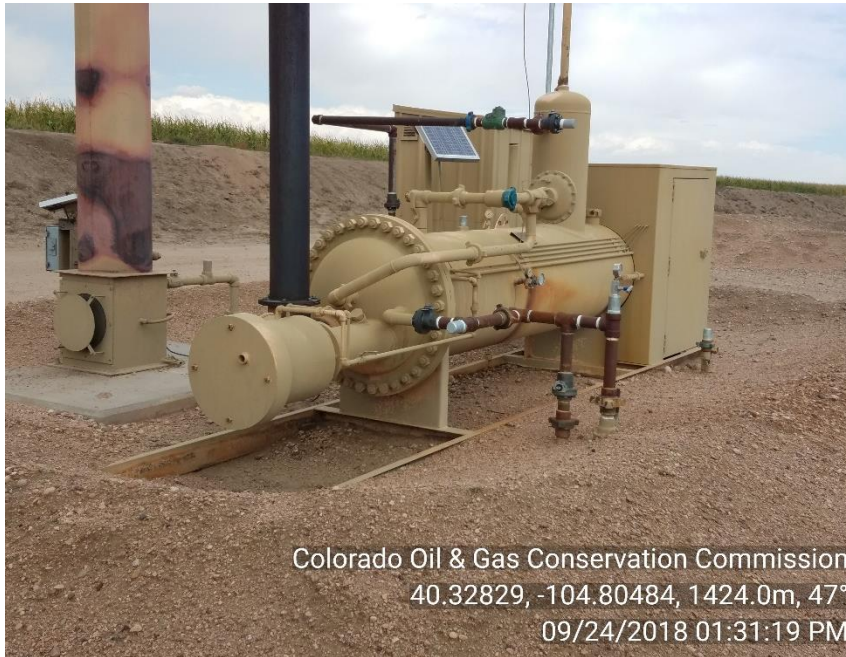
**Separator is not anchored.**

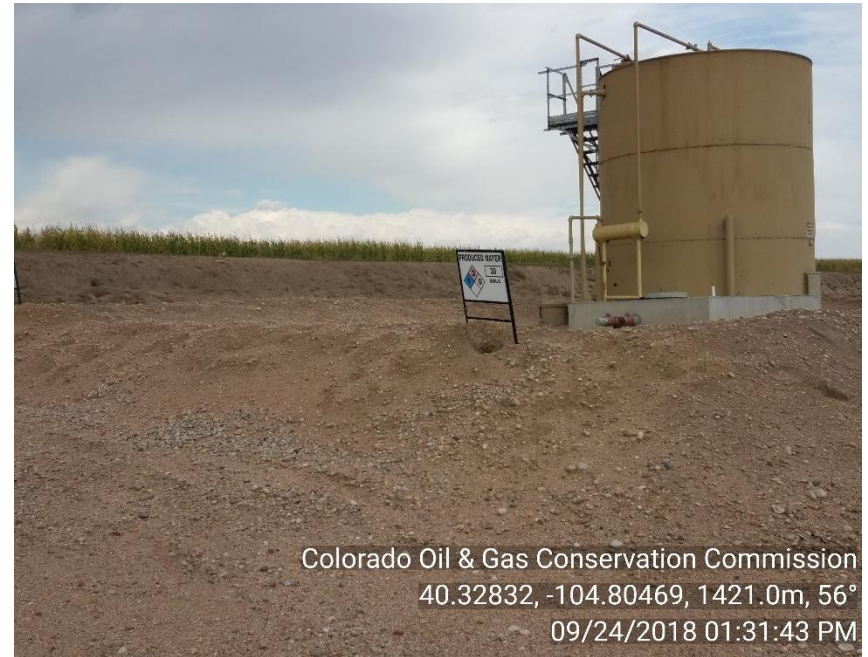
**Earth berm is inadequate.**
