Inspection Photos
Location Name: Smuggler /16-10-62
Location #: 418211

COLORADO
Oil & Gas Conservation
Commission
Department of Natural Resources

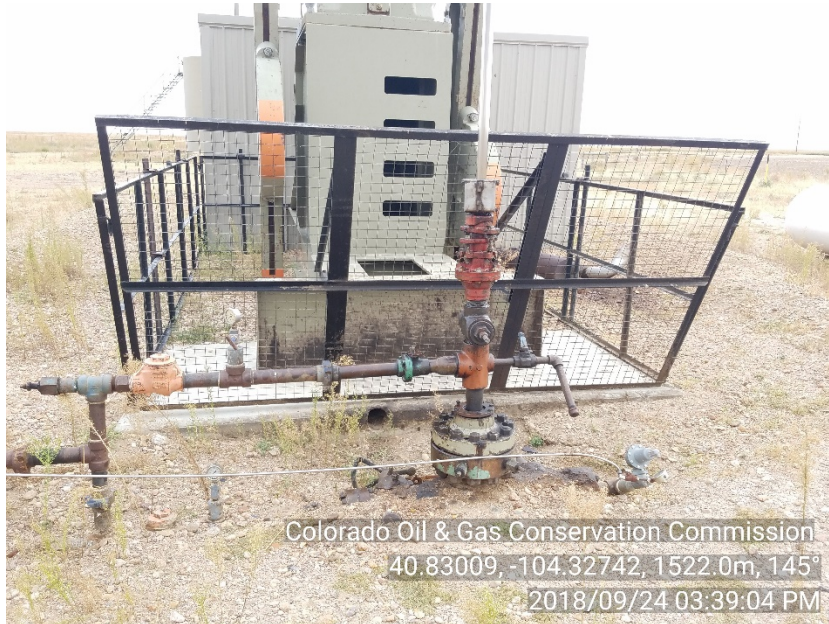
Photo #1

Smuggler 16-10-62 (API # 05-123-31853) wellhead

Stained soil, weeds

Bradenhead not plumbed to surface

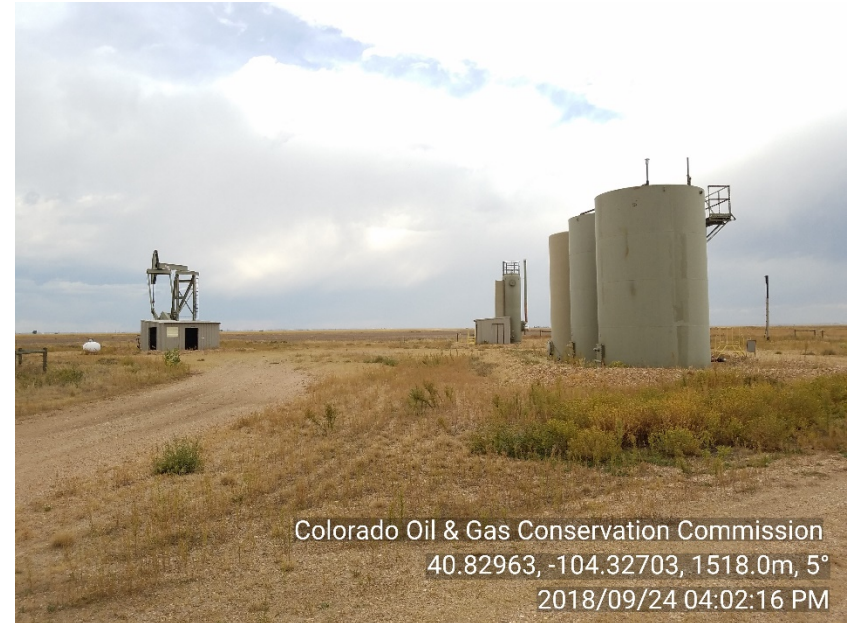
Photo #2

Smuggler 16-10-62 Battery

Weeds

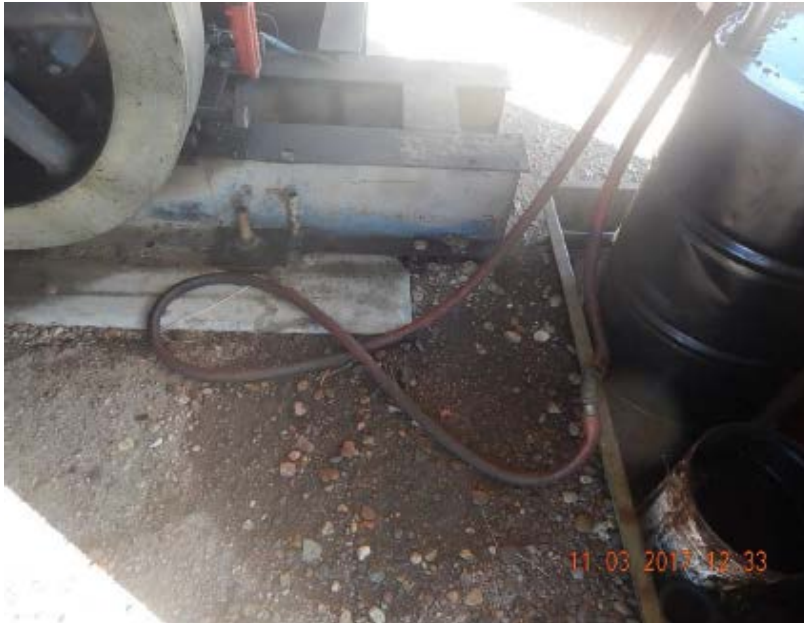
Photo #3
Smuggler 16-10-62 gas engine
Stained soil
From previous FIR

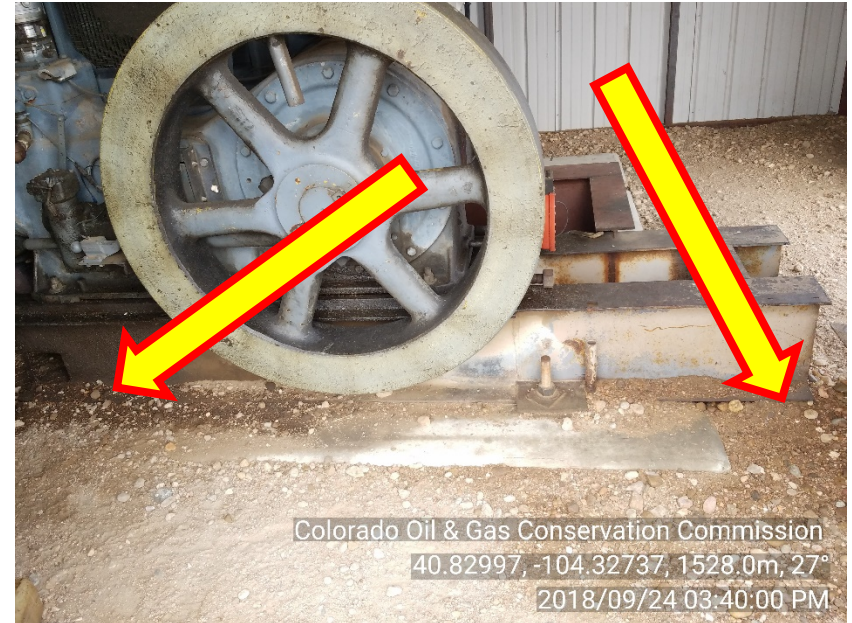
Photo #4
Smuggler 16-10-62 gas engine
Stained soil

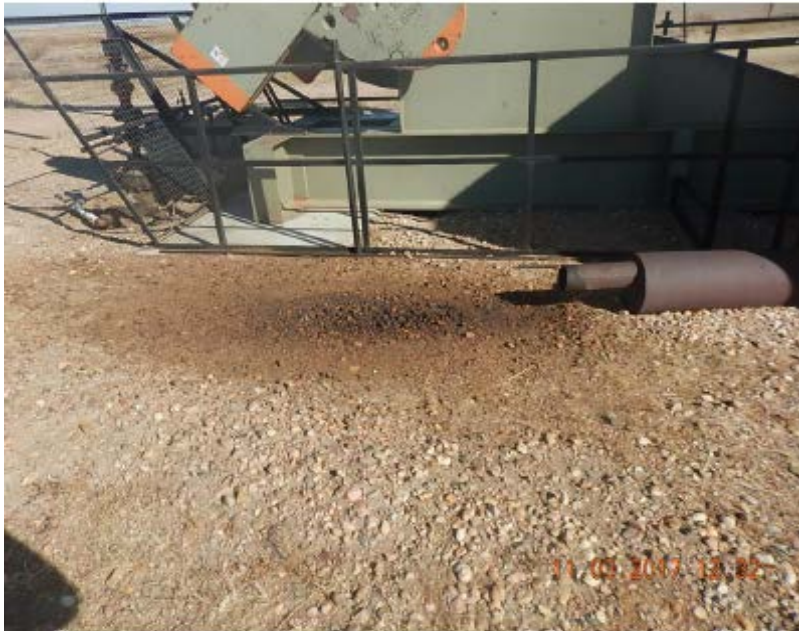
Photo #5
Smuggler 16-10-62 engine exhaust
Stained soil
From previous FIR

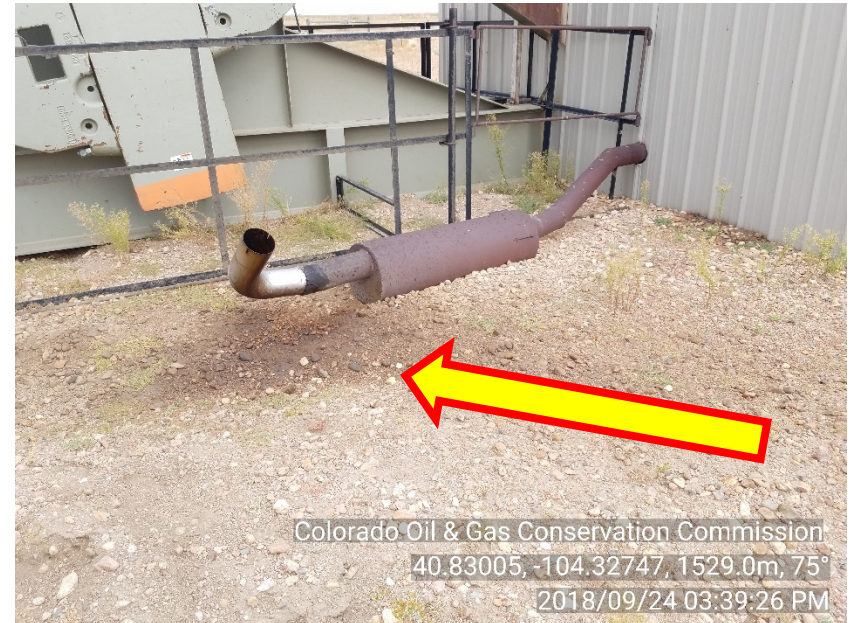
Photo #6
Smuggler 16-10-62 engine exhaust
Stained soil

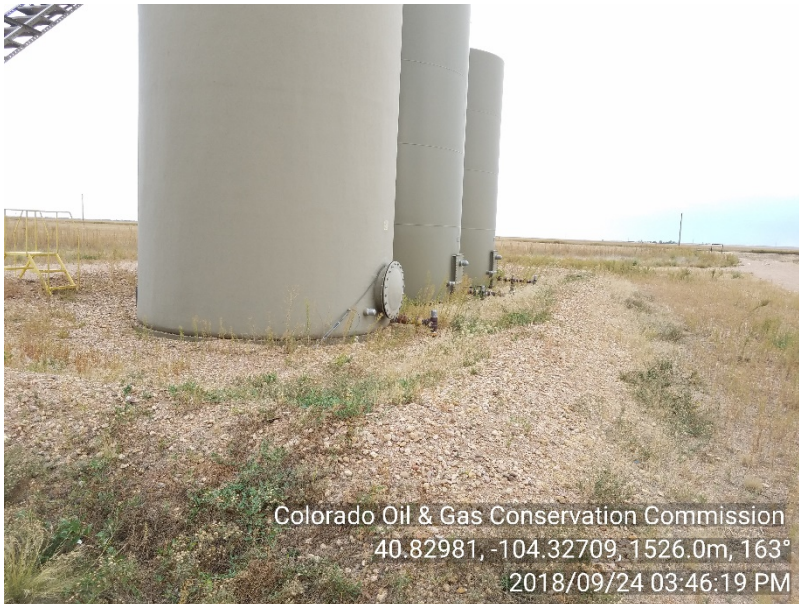
Photo #7
Smuggler 16-10-62 Tanks
Weeds

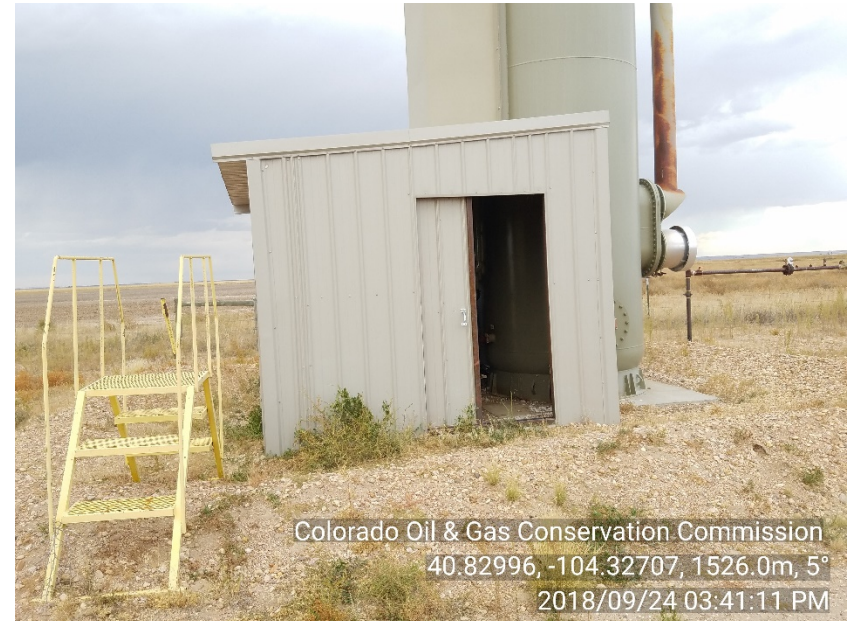
Photo #8
Smuggler 16-10-62 Treater
Weeds

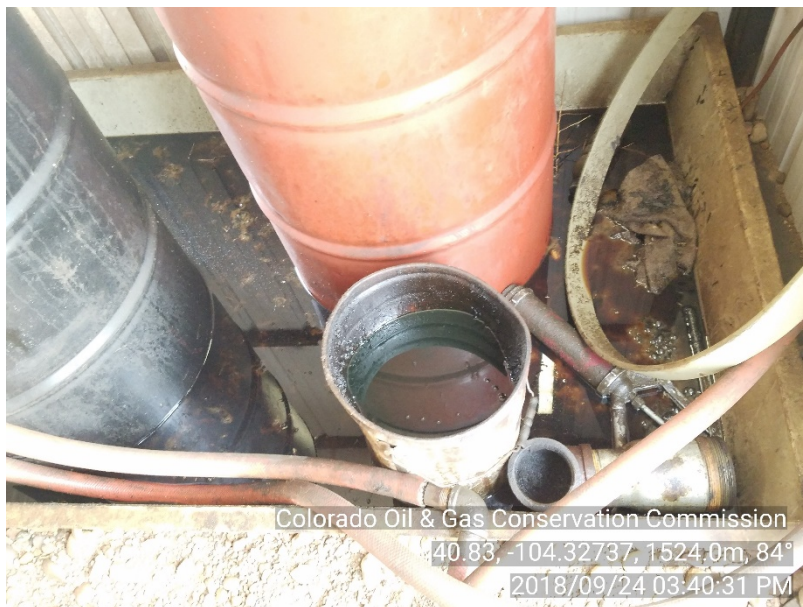
Photo #9
Smuggler 16-10-62 Engine House
Open bucket – Oily waste

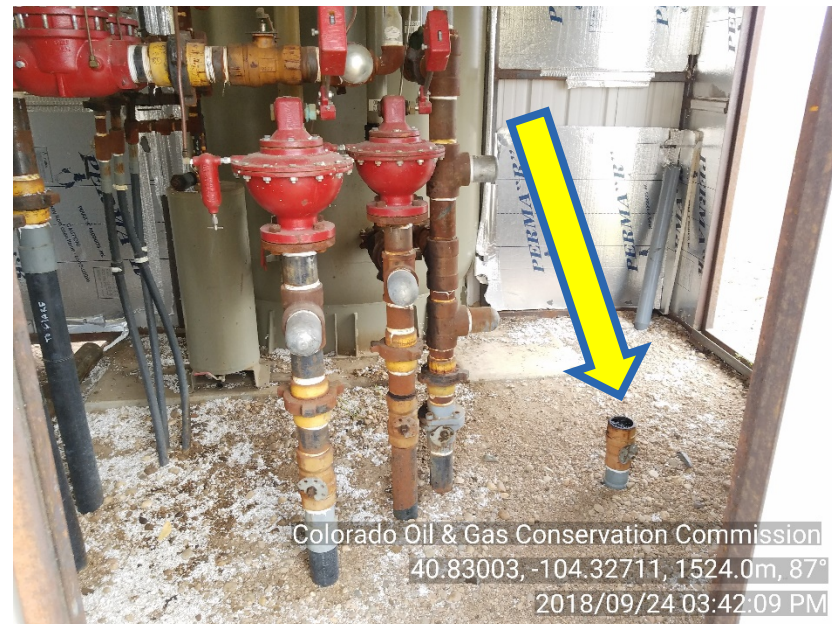
Photo #10
Smuggler 16-10-62 Treater house
Unmarked riser

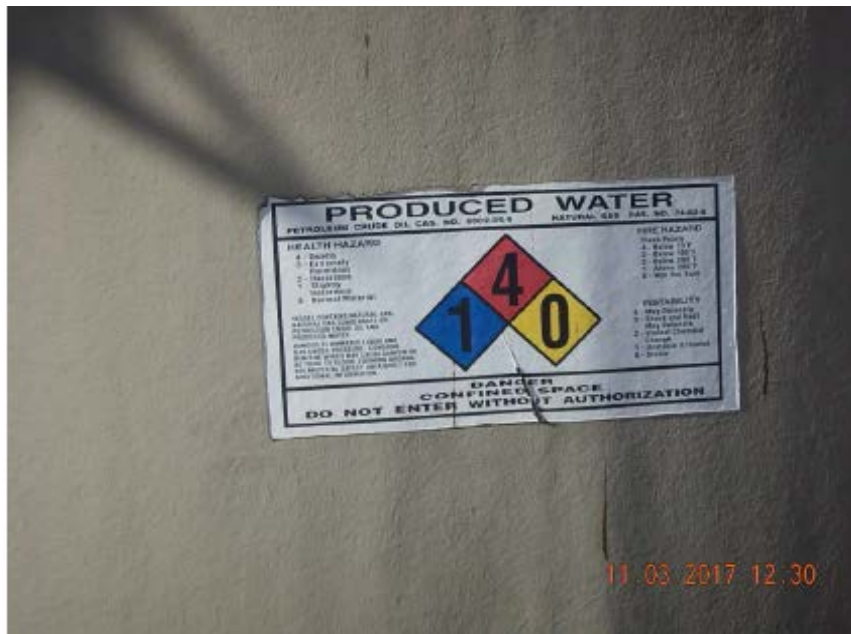
Photo #11

Smuggler 16-10-62 Produced H2O tank

No capacity posted

From previous FIR

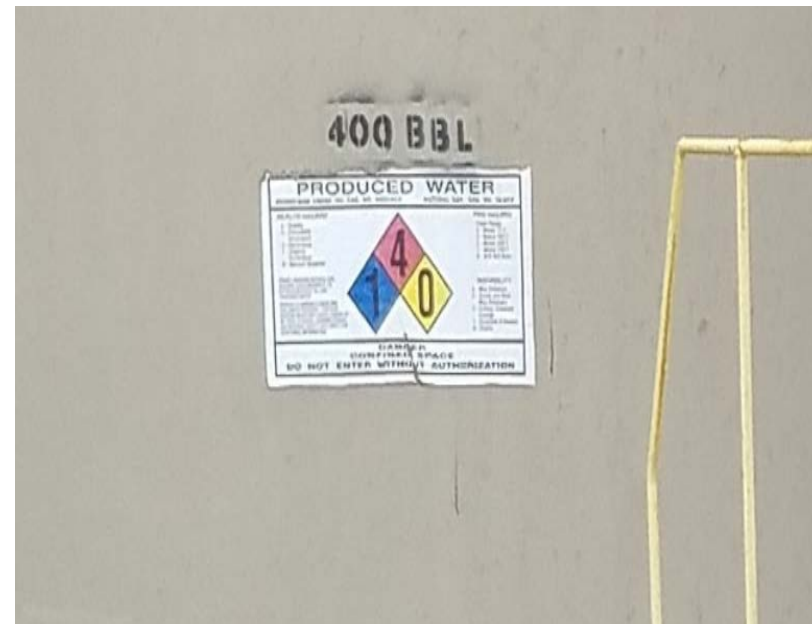
Photo #12

Smuggler 16-10-62 Produced H2O tank

Capacity posted

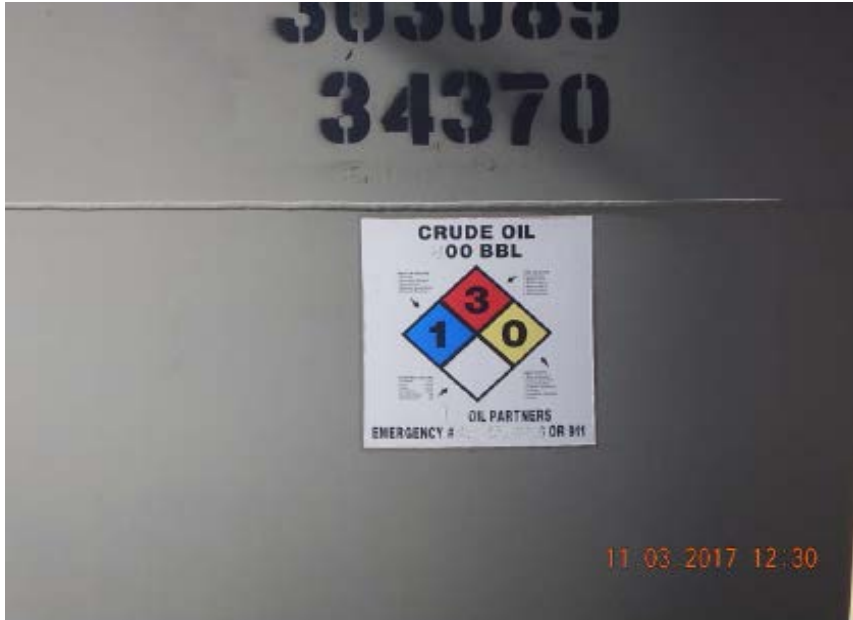
Photo #13

Smuggler 16-10-62 Crude oil tank

No capacity posted

From previous FIR

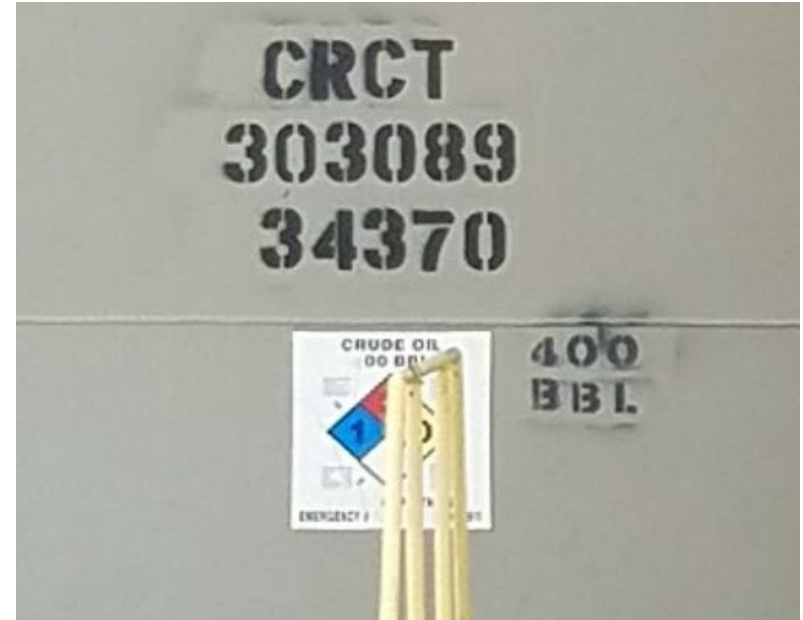
Photo #14

Smuggler 16-10-62 Crude oil tank

Capacity posted

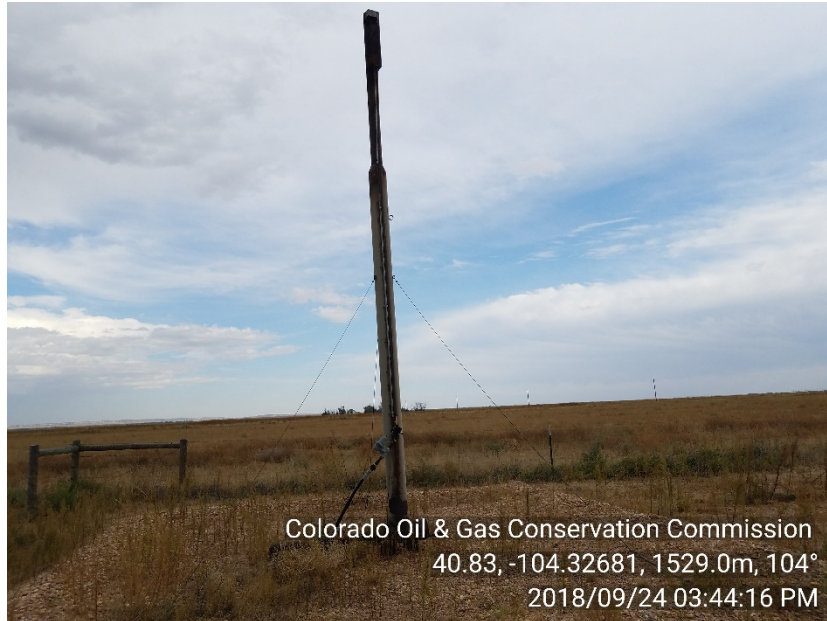
Photo #15
Smuggler 16-10-62 Candlestick Flare
Not in operation
Not flaring or venting

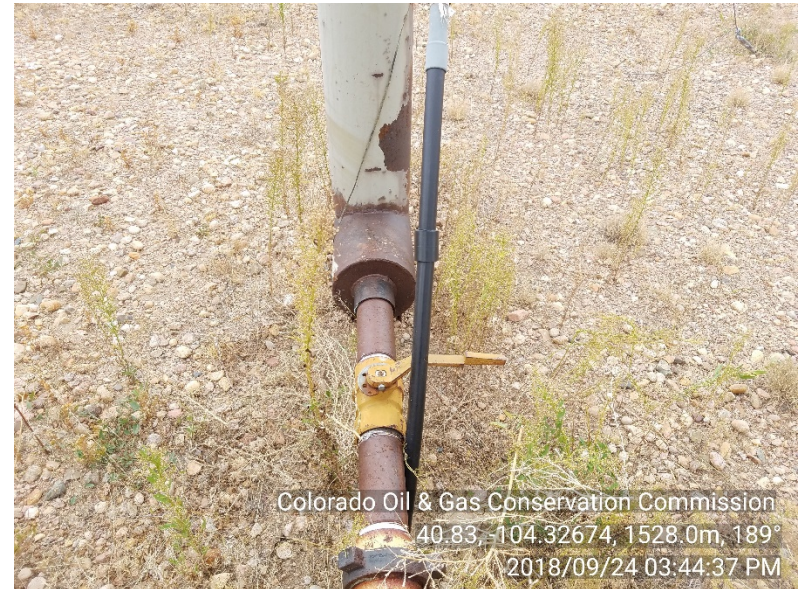
Photo #16
Smuggler 16-10-62 Candlestick Flare
Flare inlet - Closed
