Inspection Photos

Location Name: N. Parachute WF K22 596 Pad

Location ID: #335648

Inspection Date: September 21, 2018

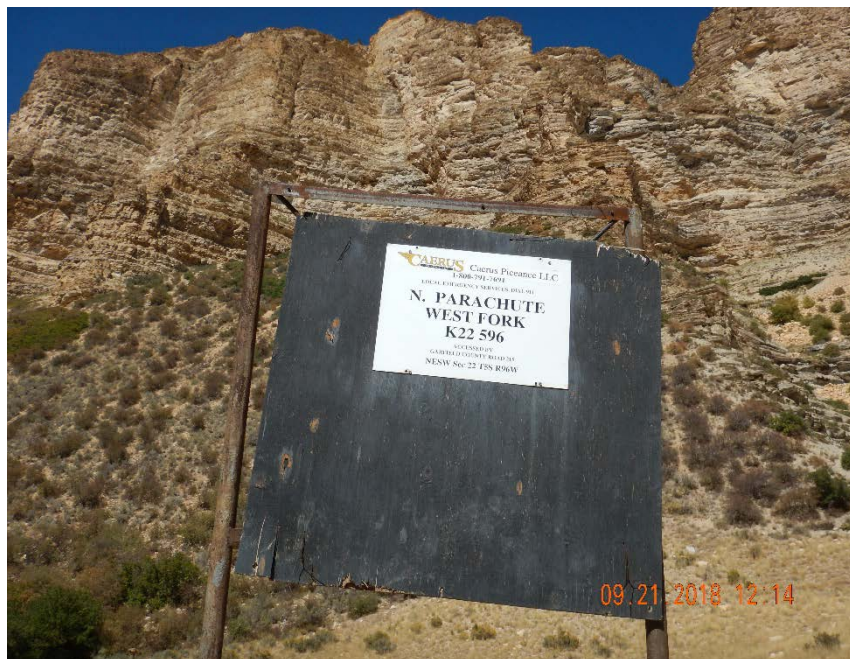
Photo #1 – Facility sign.

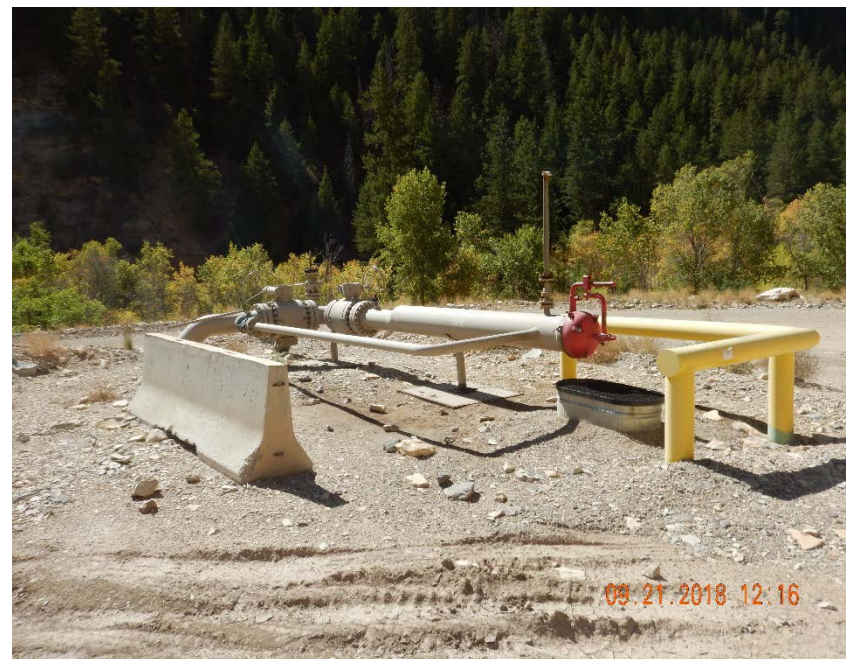
Photo #2 – Pig station located at entrance to pad.

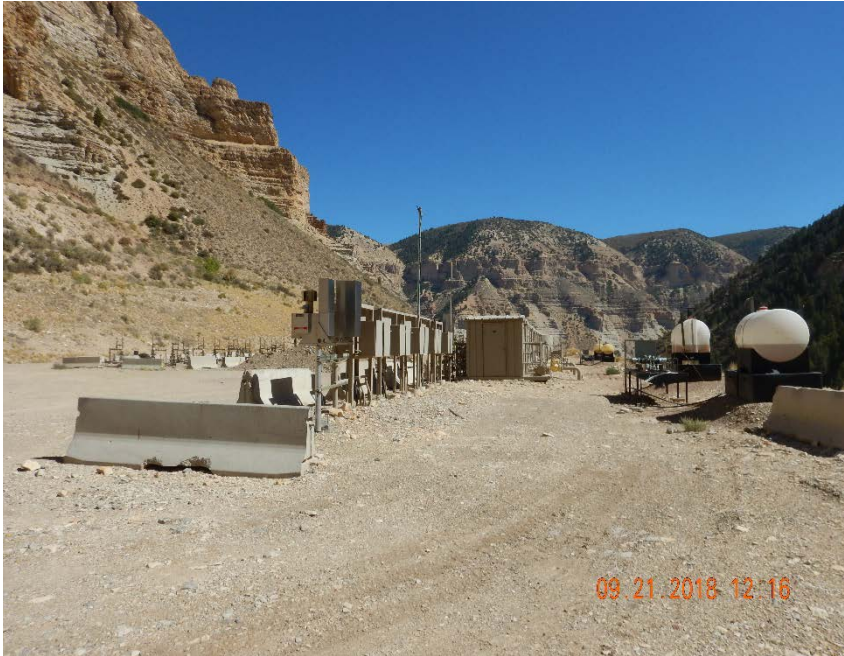
Photo #3 – Overview of meter sheds and chemical storage containers lining south side of pad, view from SW corner.

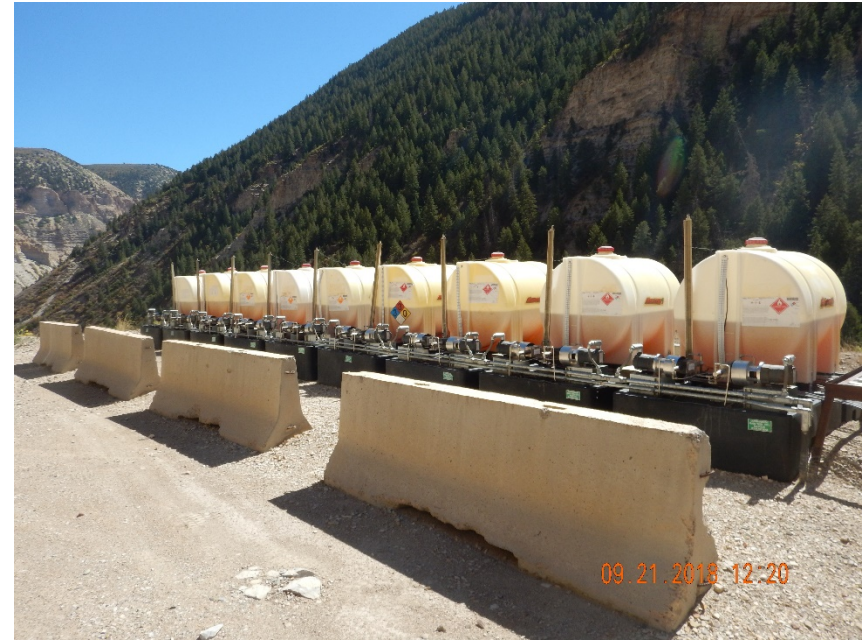
Photo #4 – Additional chemical storage containers at SE corner of pad.

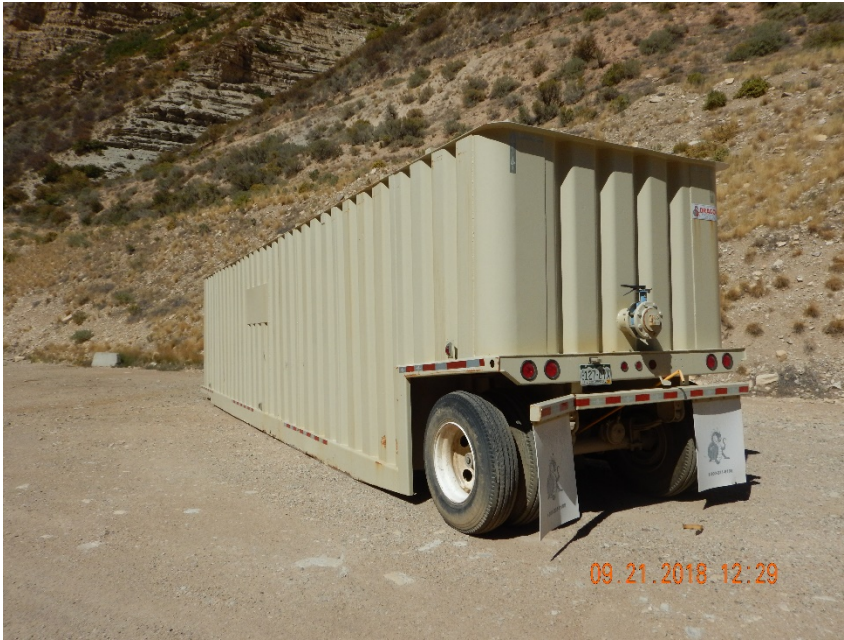
Photo #5 – Frac tank located at NE corner of pad.

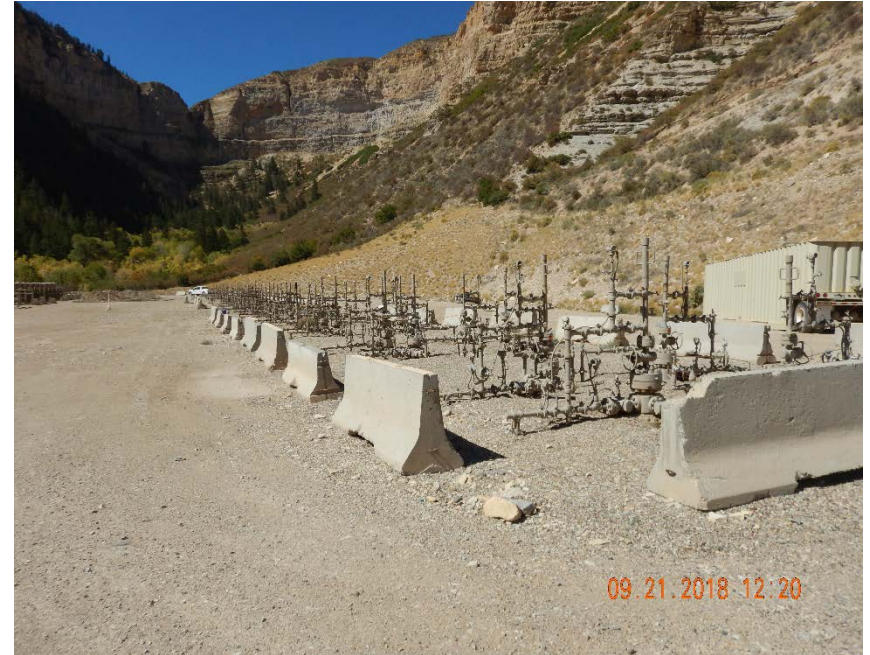
Photo #6 - View of wellheads from SE corner of pad.

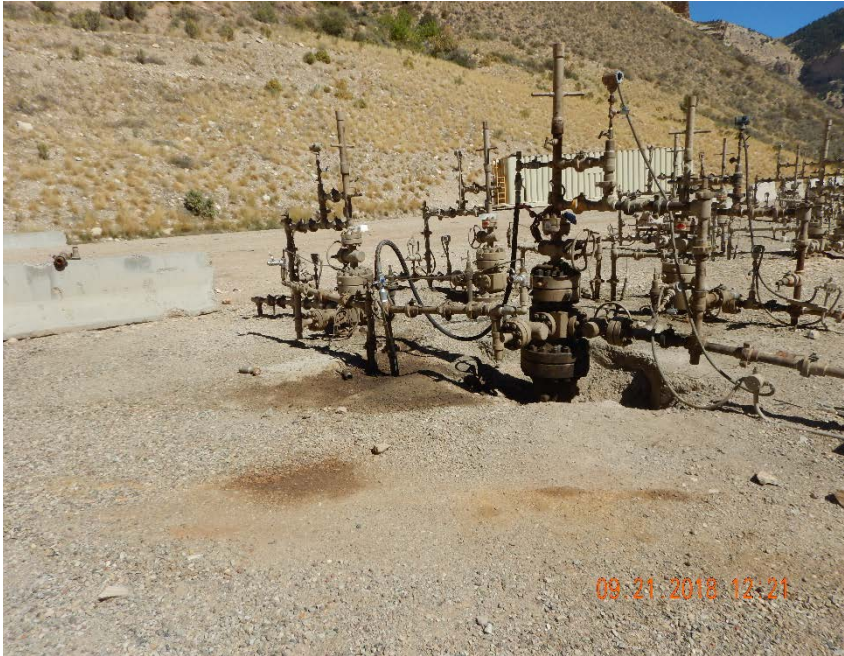
Photo #7 – Localized accumulation of oil-stained soil at WF 04B-27 K22 596 wellhead.

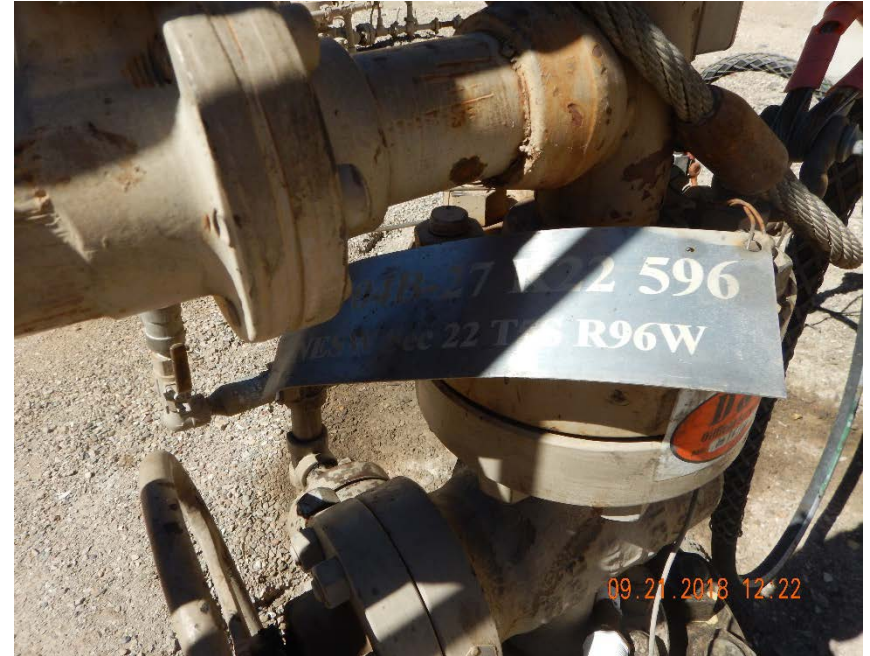
Photo #8 – Sign affixed to wellhead from previous photo.

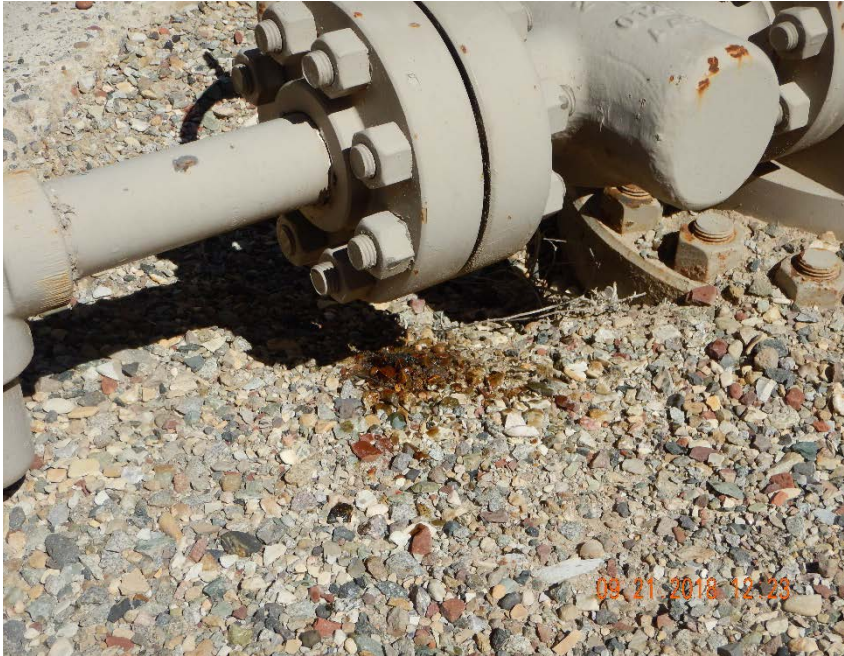
Photo #9 - Localized accumulation of oil-stained soil at K22 04A-27 WF04A-27 K22 596 wellhead.

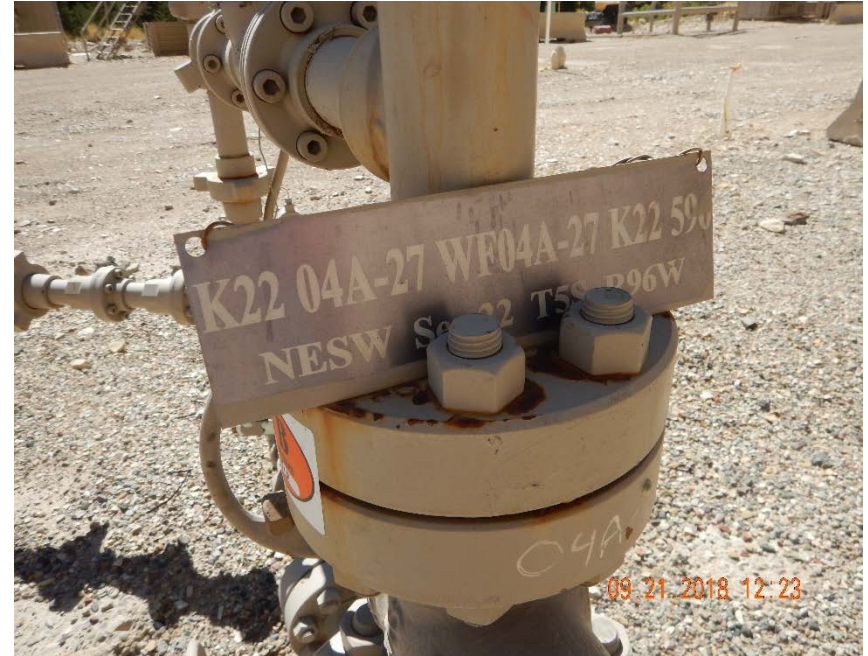
Photo #10 - Sign affixed to wellhead from previous photo.

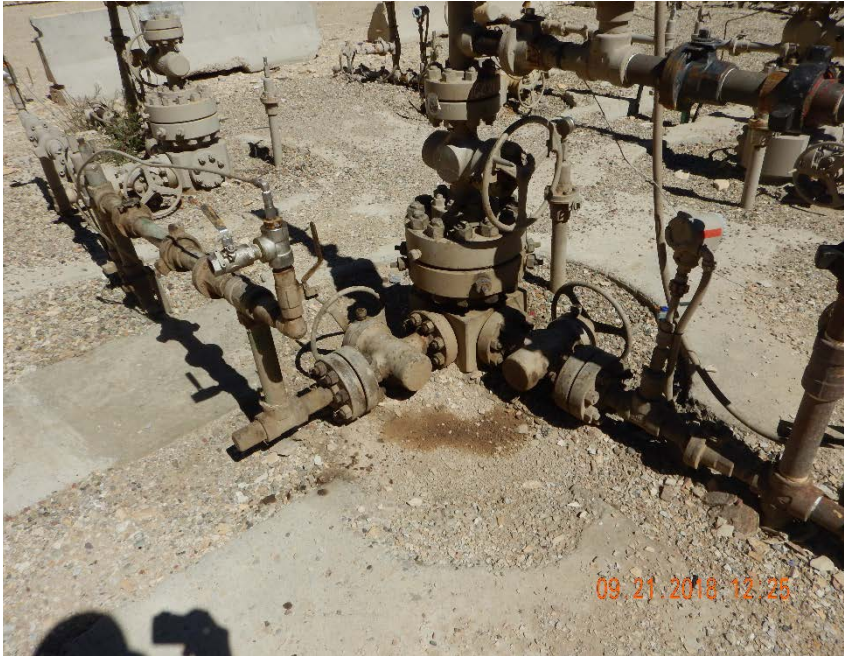
Photo #11 - Localized accumulation of oil-stained soil at wellhead. Note that this wellhead did not have a sign attached.

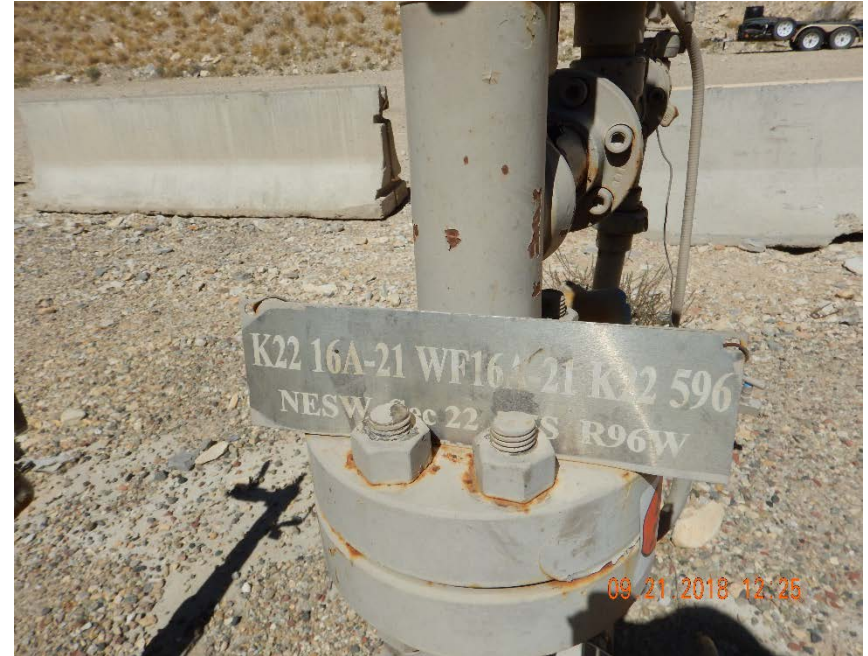
Photo #12 – The well in previous photo was located immediately south of K22 16A-27 WF16A-21 K22 596 wellhead.

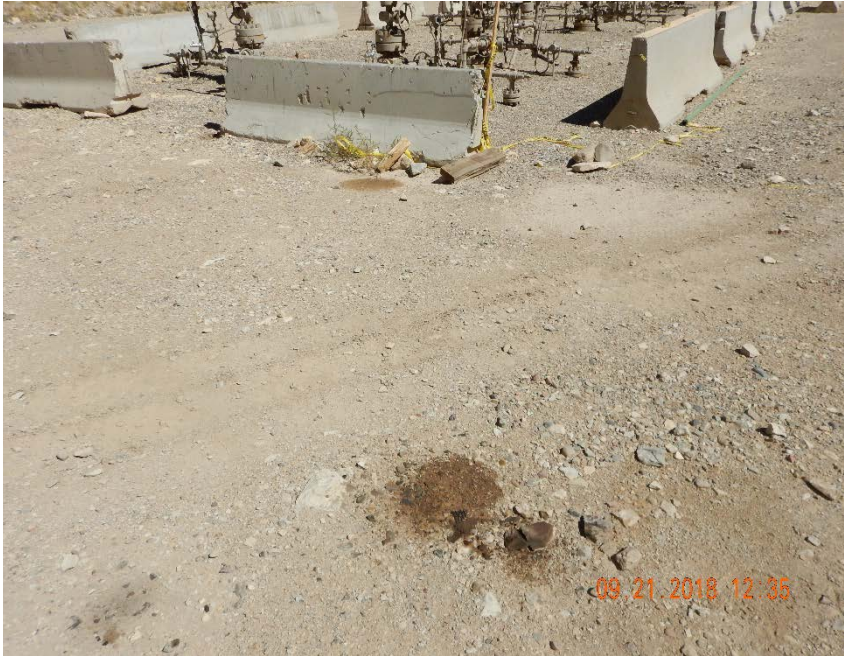
Photo #13 – Localized accumulations of oil-stained soil in two areas located SW of wellheads.

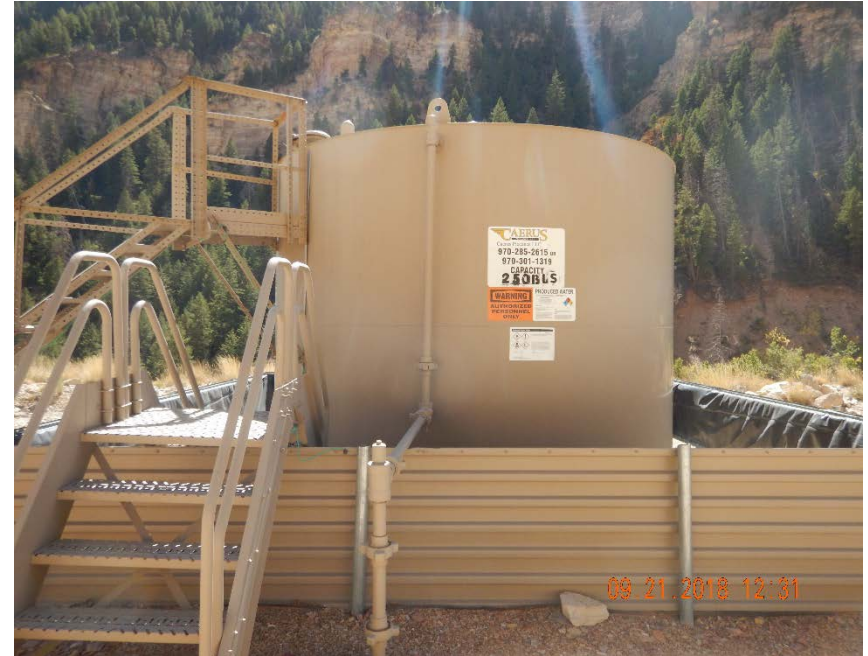
Photo #14 – 250 bbl produced water AST with lined, metal berm.

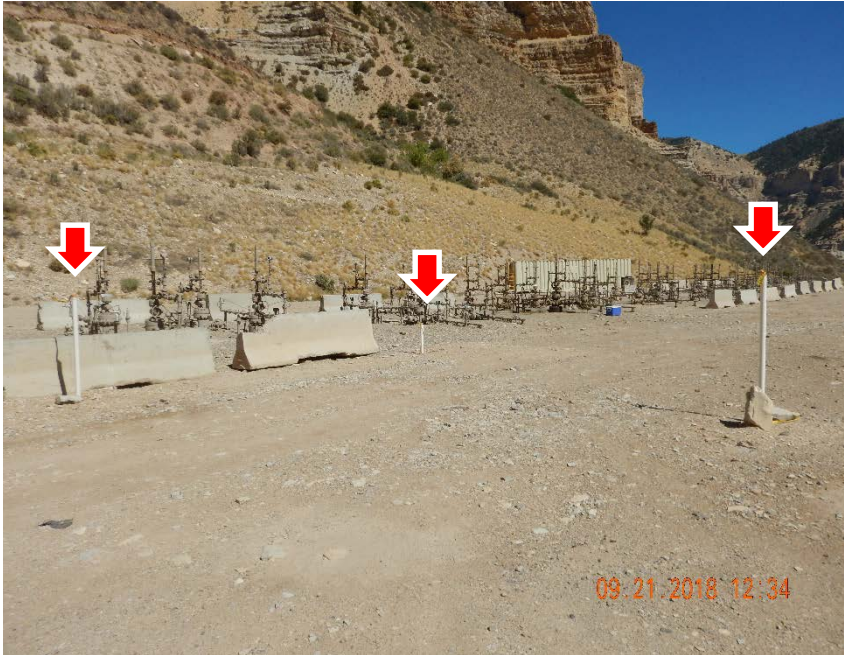
Photo #15 – 2” and 1” PVC risers located in center of pad appear to be temporary monitoring wells.

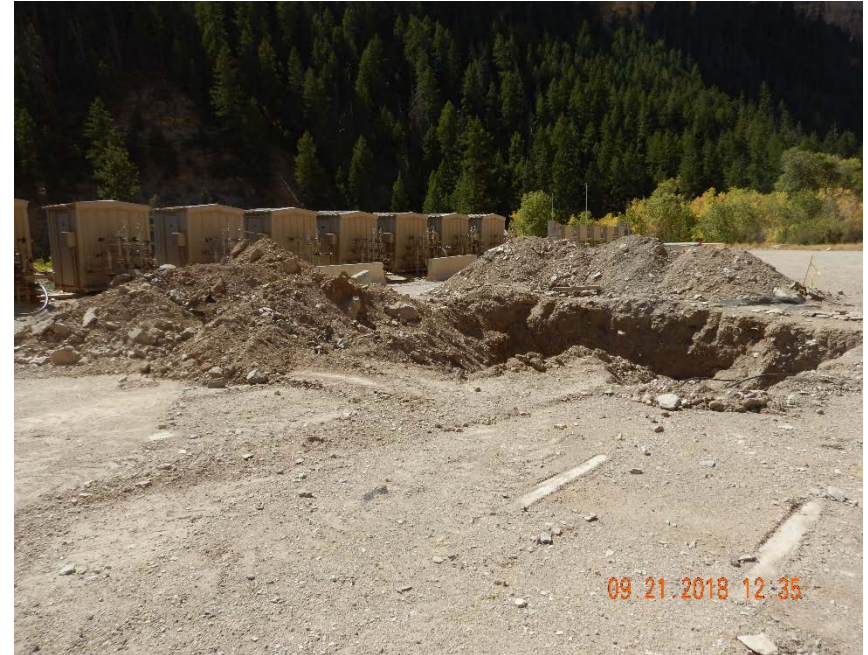
Photo #16 – View of soil stockpiles and open flowline excavation from NE. There was no visible liner beneath either soil stockpile on date of inspection.

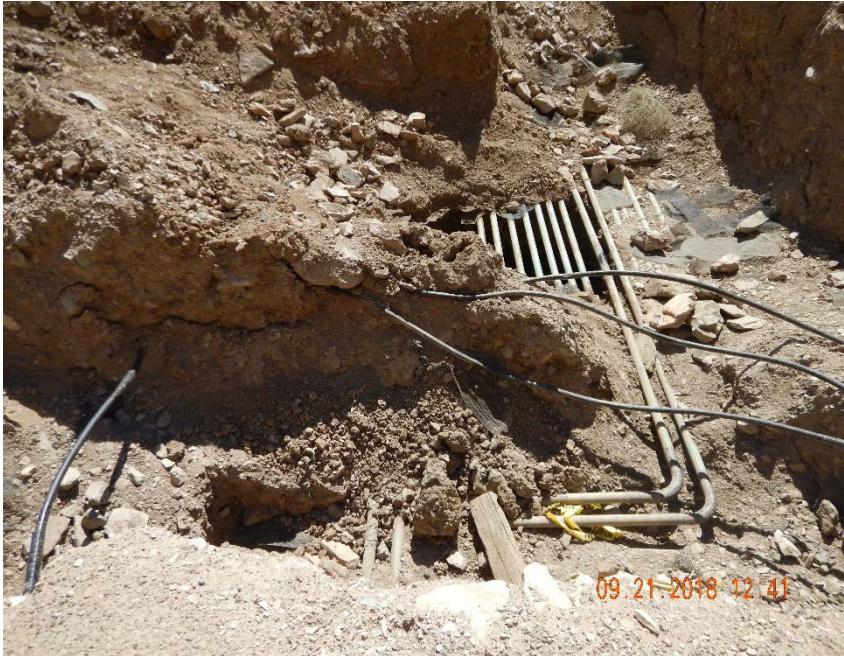
Photo #17 – Looking into open flowline excavation from north side. Note 2" flowlines and black electrical conduit inside of excavation.

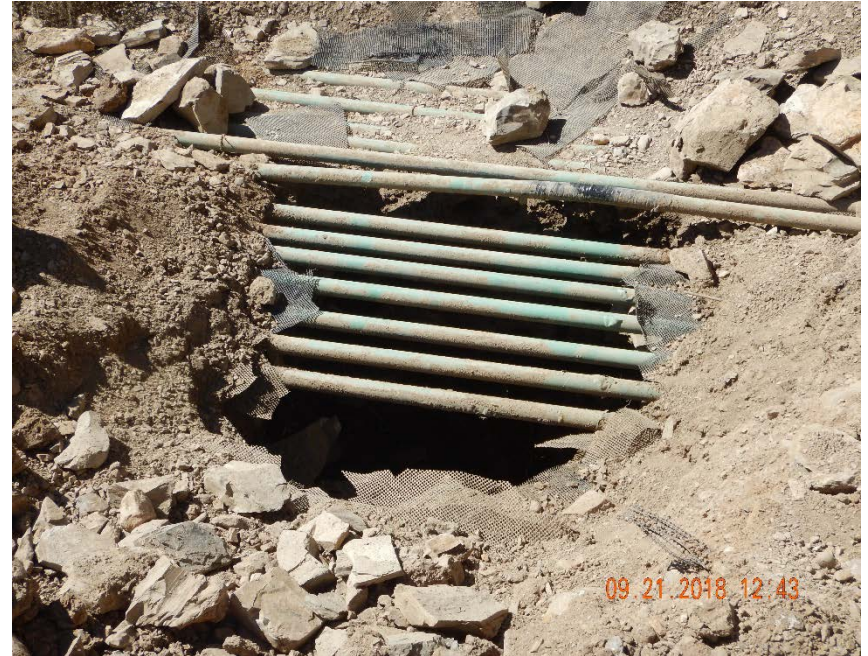
Photo #18 – View of flowlines from east side of excavation.
