Inspection Photos

Location Name: Homer Deep Unit 9-41

Location ID: #432260

Inspection Date: September 19, 2018

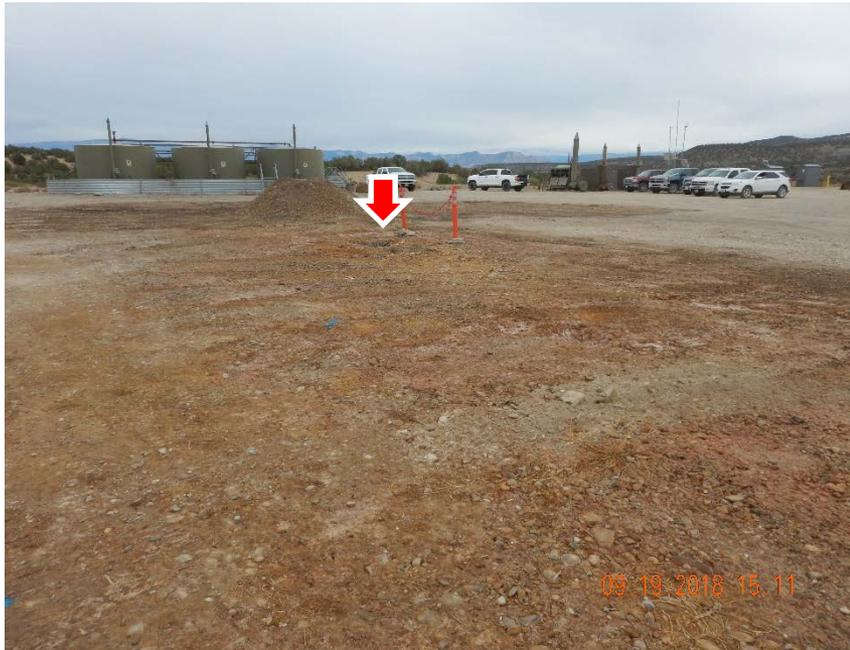
Photo #1 – Arrow depicts location of severed 10” poly line that was source of release to center of pad (assigned Spill/Release ID #457569).

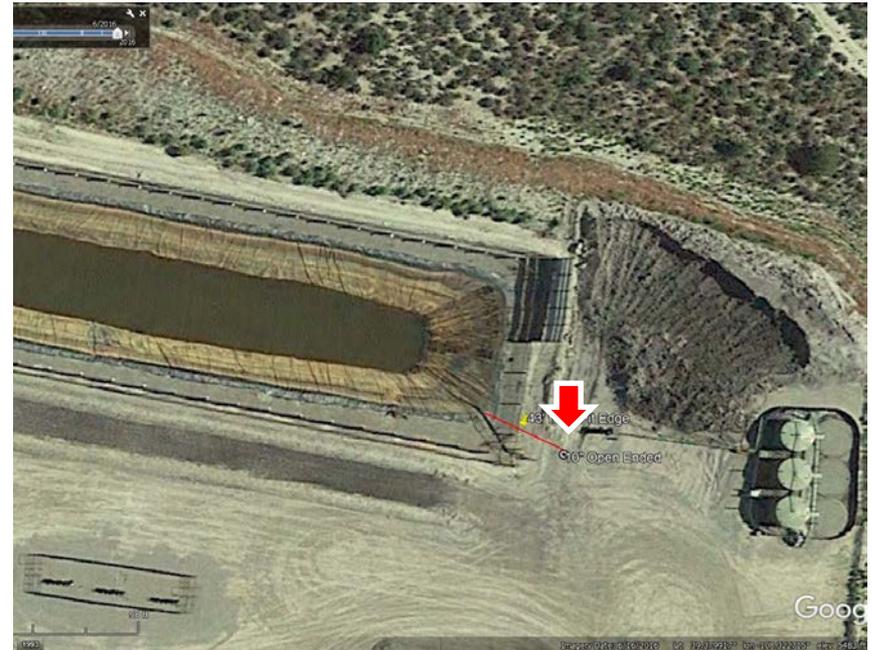
Photo #2 – Google Earth 2016 aerial photo provided by operator depicts location of severed 10” poly line in relation to historical Pit ID #432420. COGCC records indicate that pit was abandoned by previous operator in November 2017. See Remediation Project #10495 for additional information.

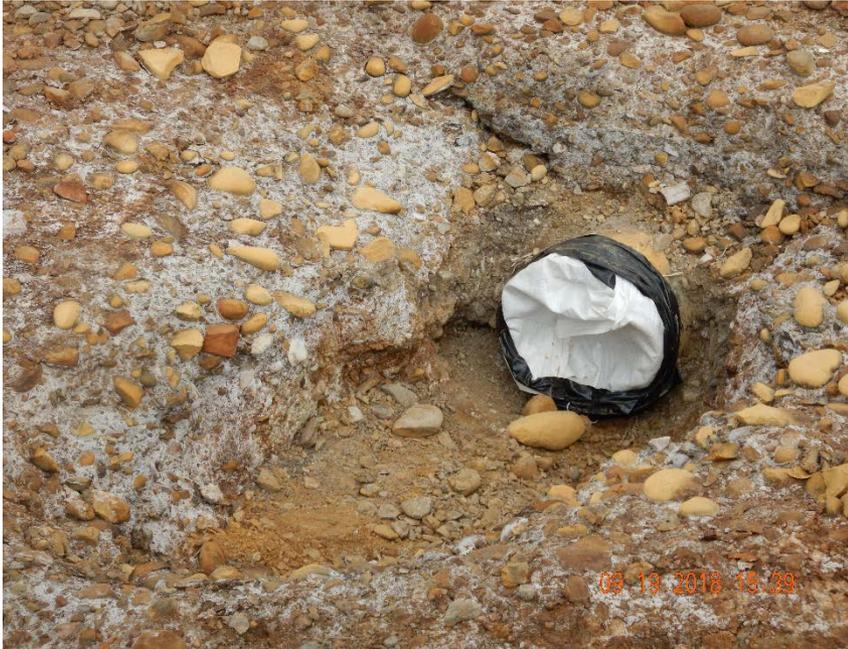
Photo #3 – View of exposed, severed 10” poly line that was source of Spill/Release ID #457569.

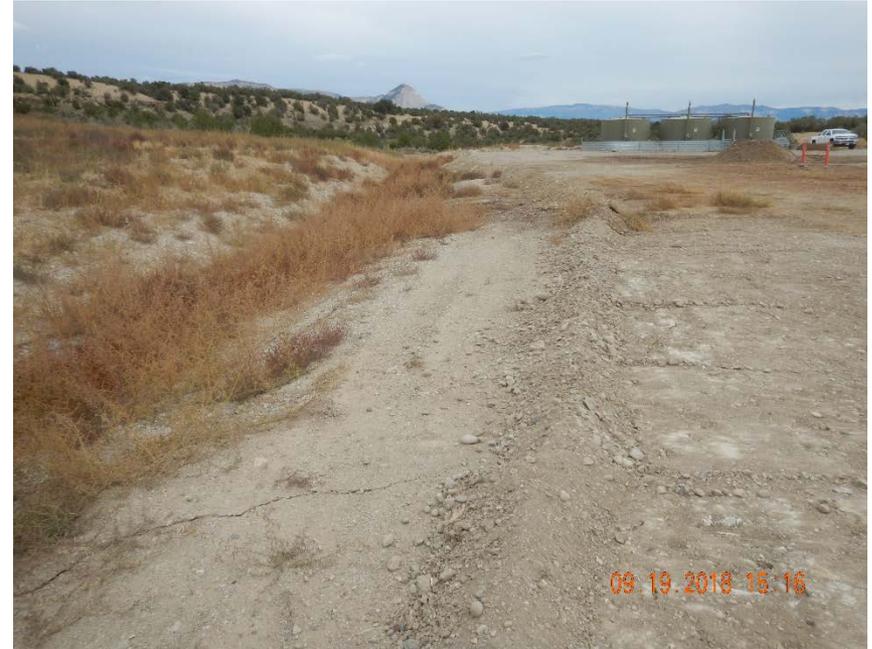
Photo #4 – Produced water released from 10” polyline flowed NW into stormwater ditch overlying former pit location. Operator constructed containment berm along ditch.

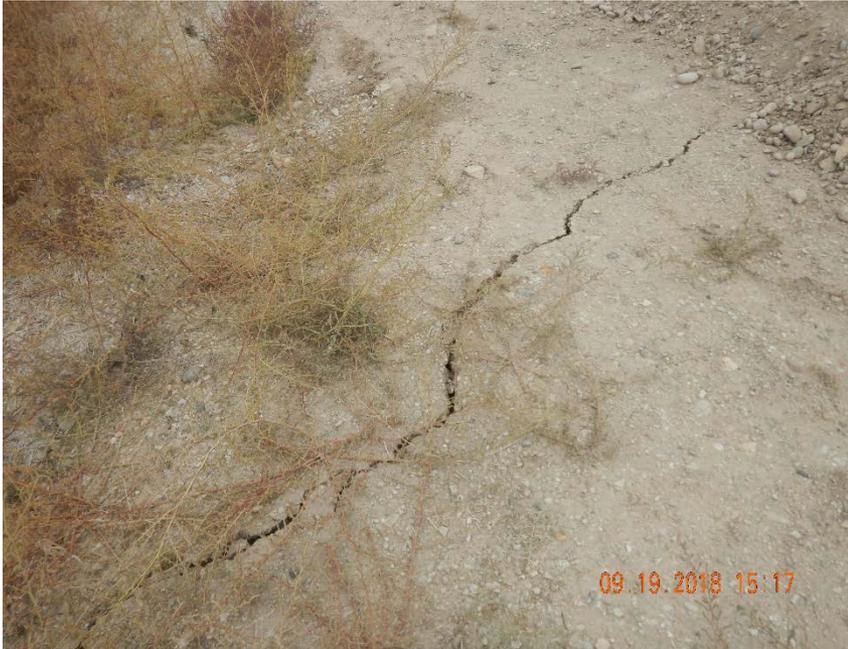
**Photo #5 – Subsidence observed along stormwater ditch/former pit area related to subsurface fluid migration.
(1)**

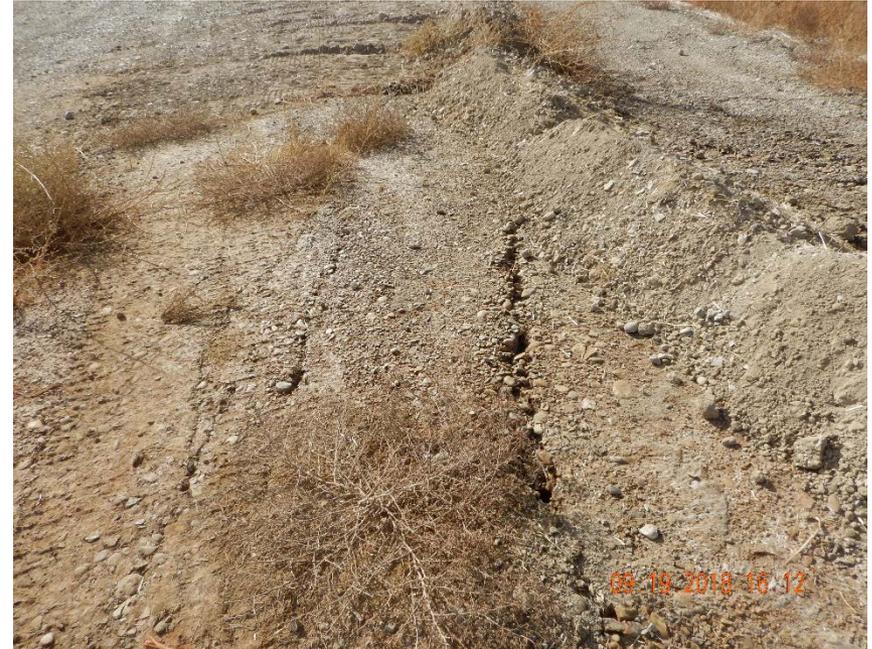
**Photo #6 - Subsidence observed along stormwater ditch/former pit area related to subsurface fluid migration.
(2)**

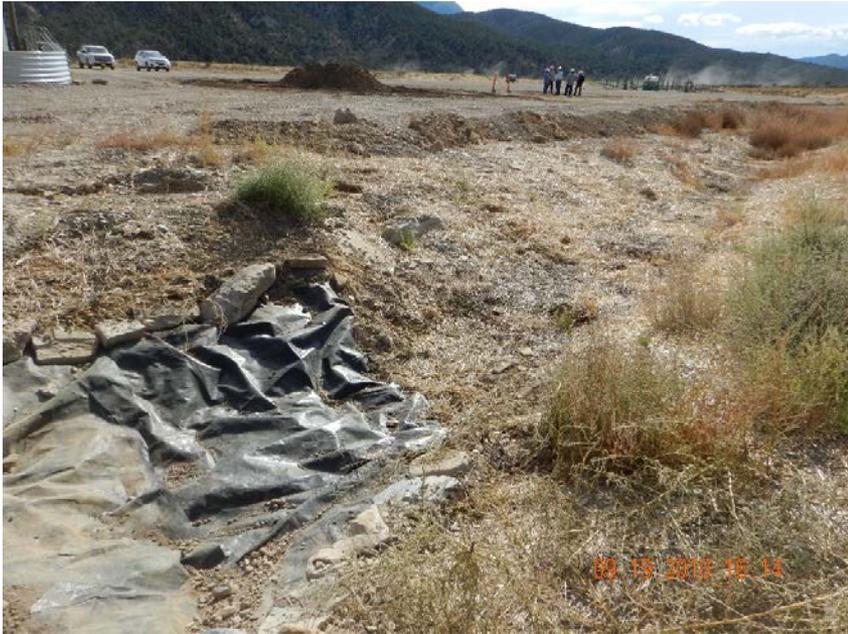
Photo #7 – Dam constructed by operator during initial response to release from severed 10” poly line is located at terminus of stormwater ditch.

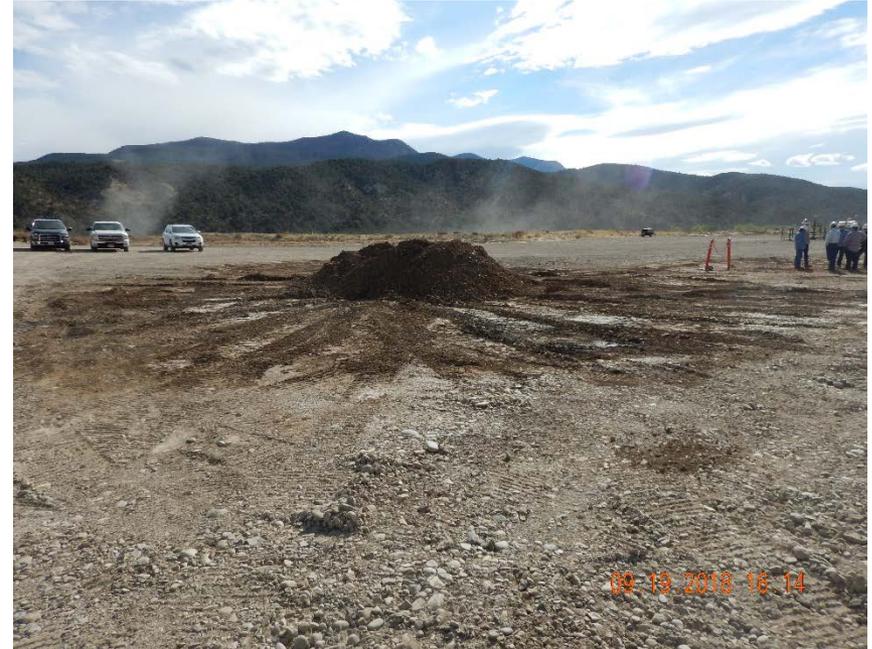
Photo #8 – Stockpile of impacted soil scraped from pad surface.

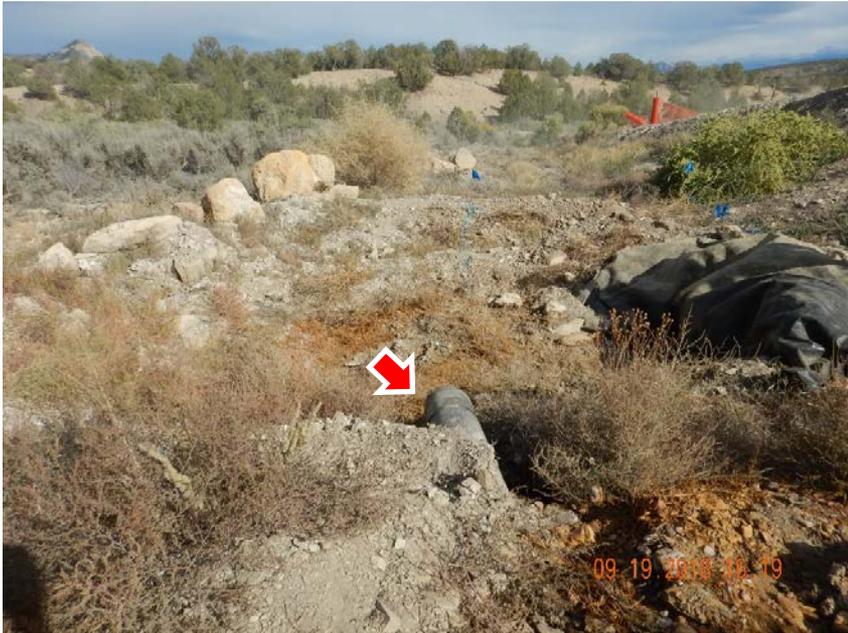
Photo #9 – Additional produced water impacts located ~130' SE of tank battery at distal end of severed 10" poly line (Spill/Release ID #457570). Note operator constructed berm of black liner material to prevent release from entering into stormwater culvert.

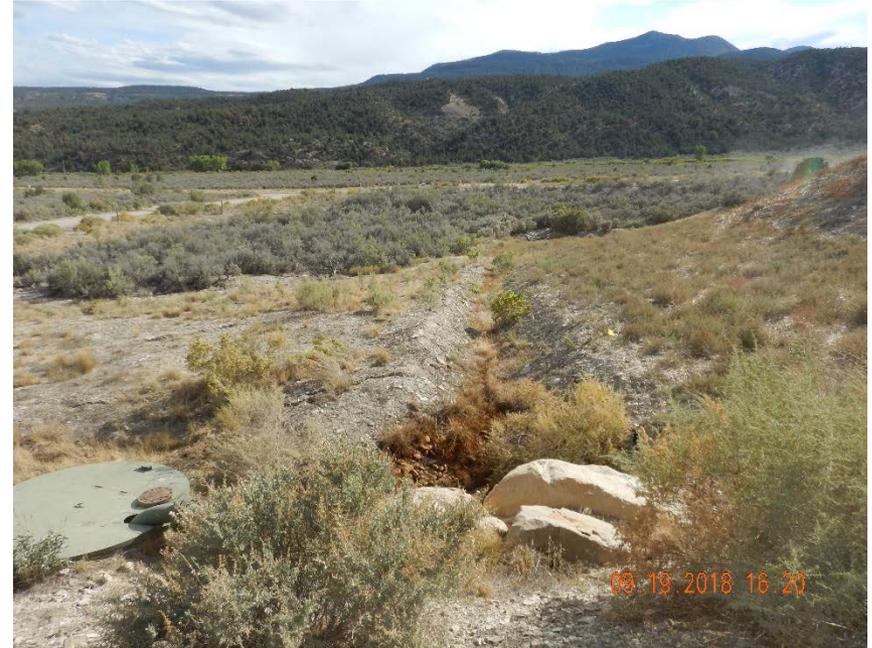
Photo #10 – 10" poly line from previous photo leads into stormwater ditch on south side of lease road through a culvert. Produced water impacts from Spill/Release ID #457570 extend into this ditch for approximately 200'.

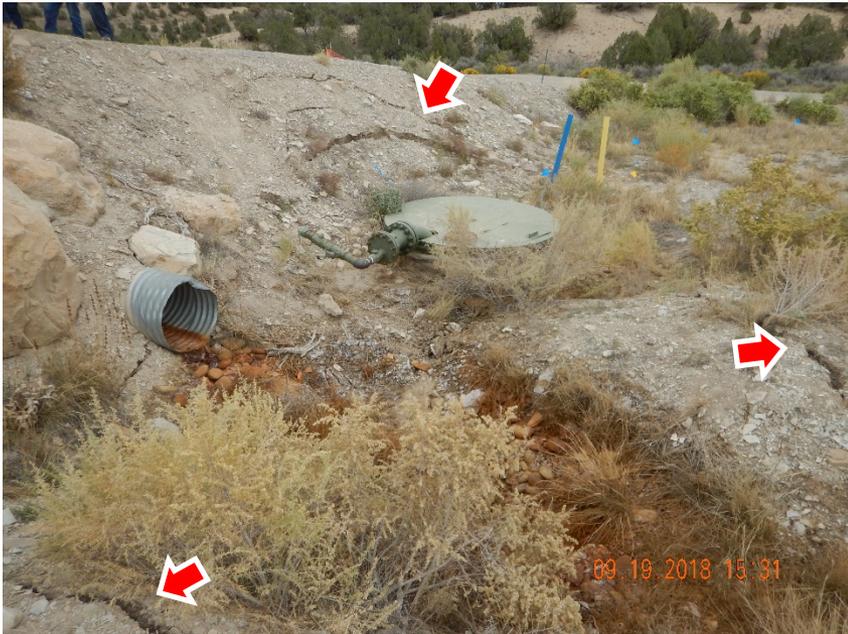
Photo #11 – Valve access vault on south side of lease road was impacted by produced water released during Spill/Release ID #457570. Note evidence of additional subsidence in this area.

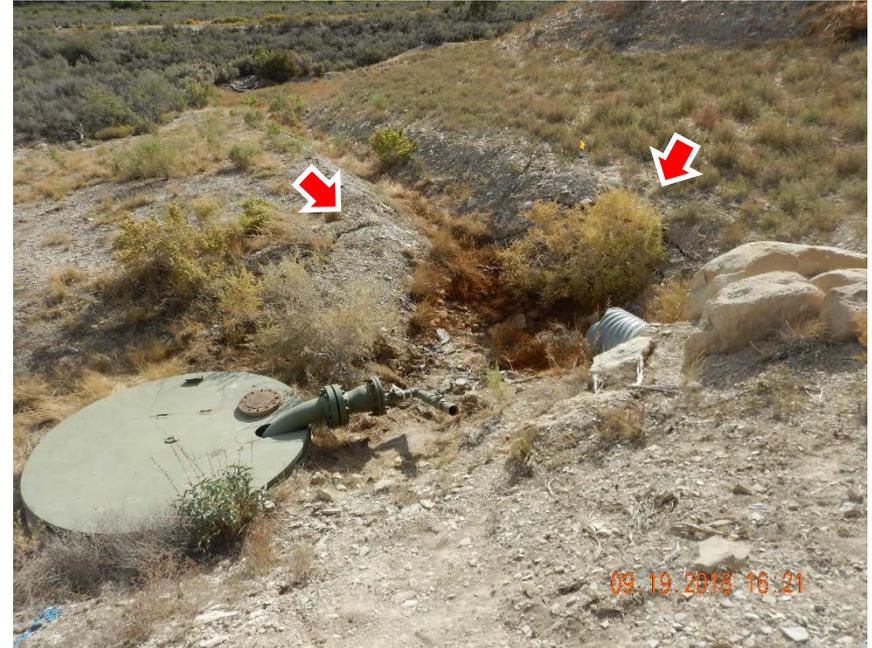
Photo #12 – Subsidence inside of stormwater ditch related to Spill/Release ID #457570.

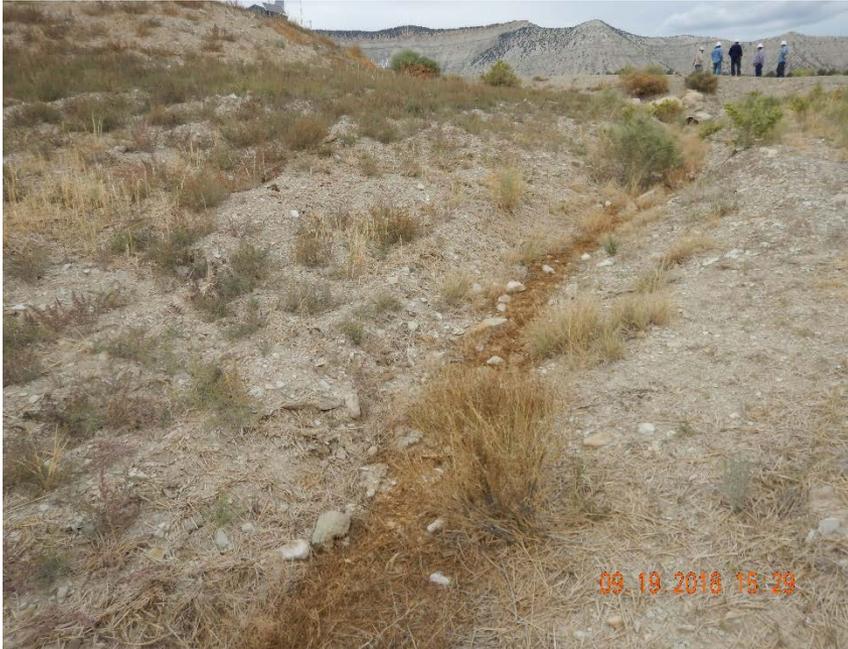
Photo #13 – Produced water released by Spill/Release ID #457570 flowed ~200' in stormwater ditch. View from inside of ditch, looking north.

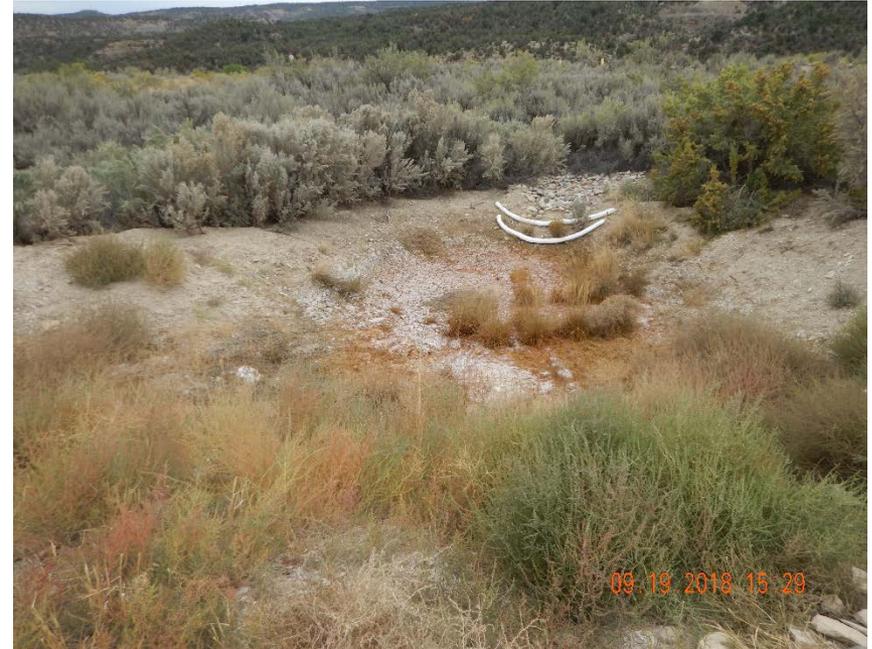
Photo #14 – Sediment trap located at terminus of stormwater ditch was also impacted by produced water released during Spill/Release ID #457570.
