Well Name : Navajo Lake 32-5 21-2

API # : 007-06308

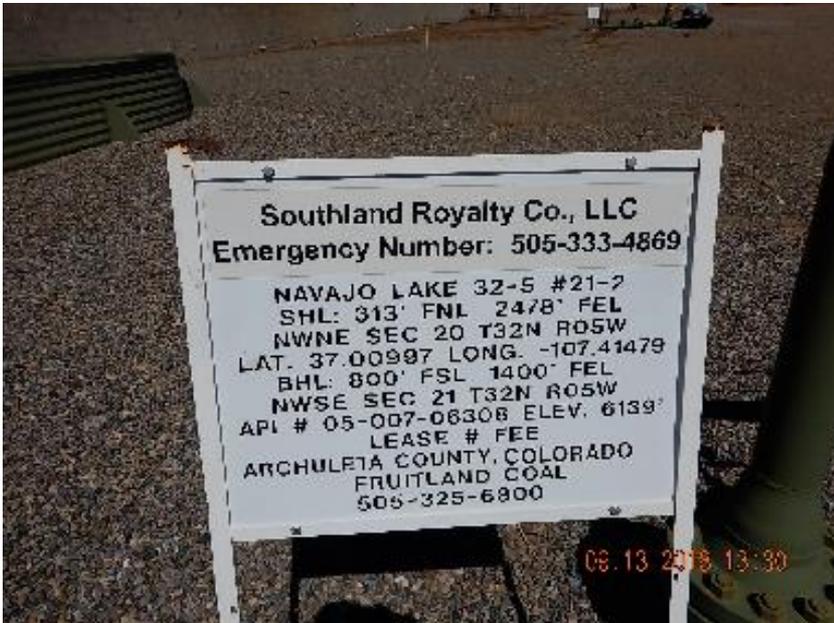
Photo 1: Wellhead sign.

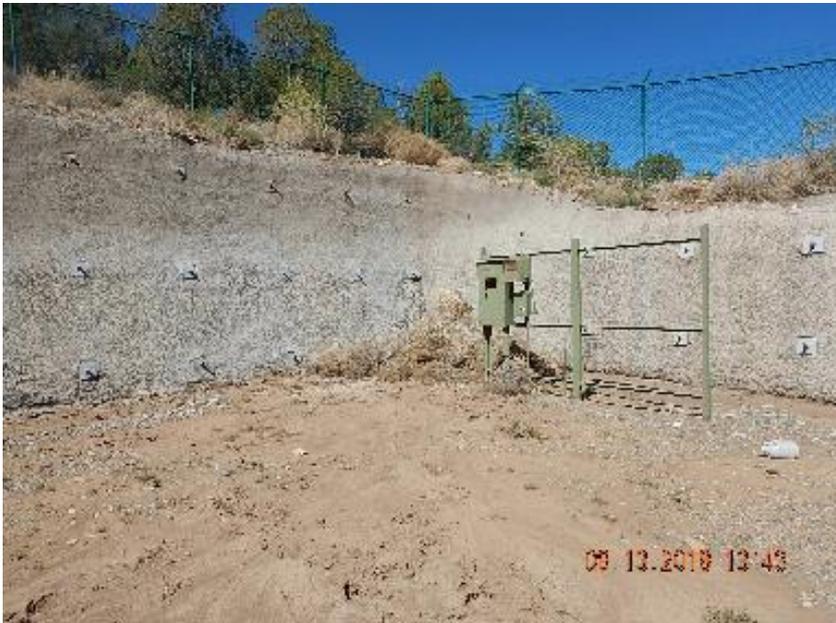
Photo 3: Trash and debris in corner of location.

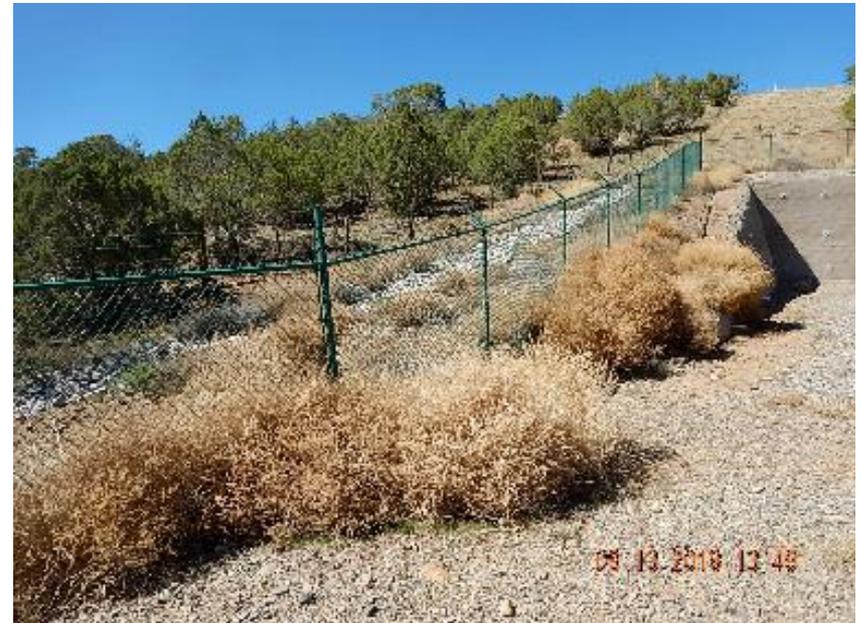
Photo 4: Dried Kochia debris along W perimeter fencing.

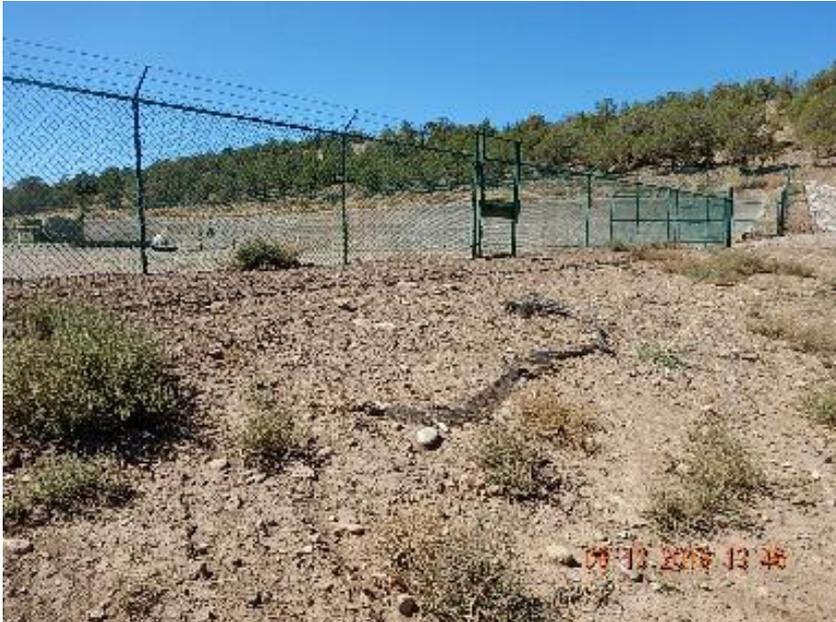
Photo 5: Waddle netting and wire debris outside fencing in E perimeter.

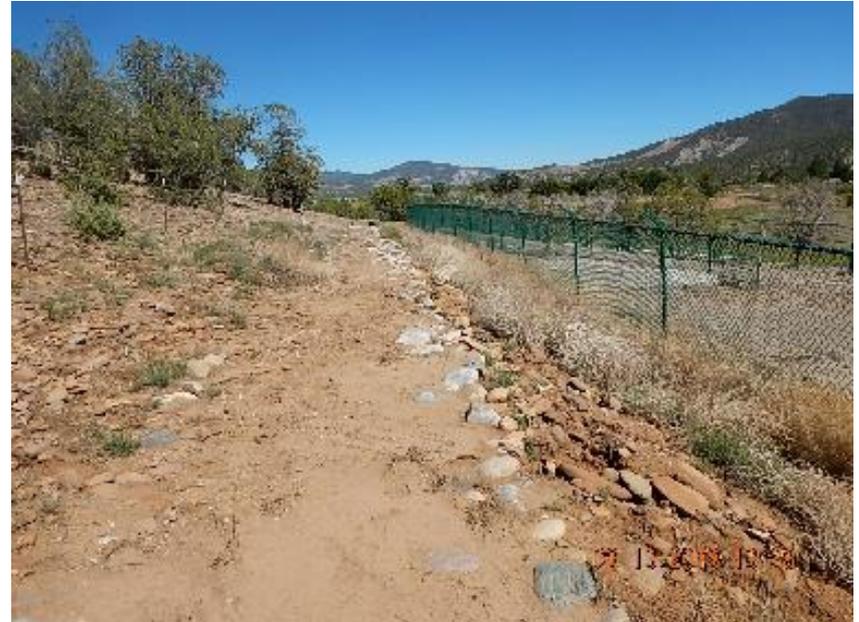
Photo 6: Dried Kochia debris at top of cut slope.

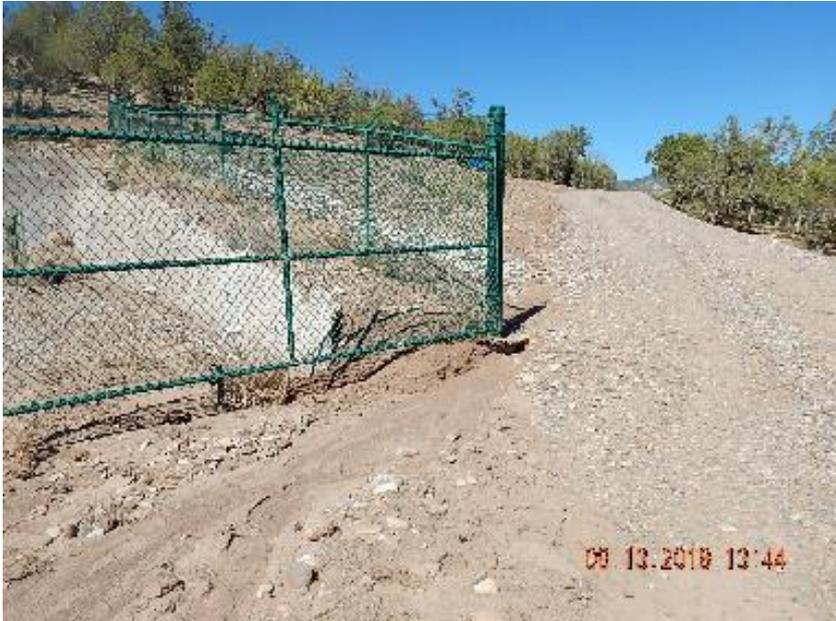
Photo 7: Sediment flow onto location from NE corner cobble run and erosion channel outside cobble.

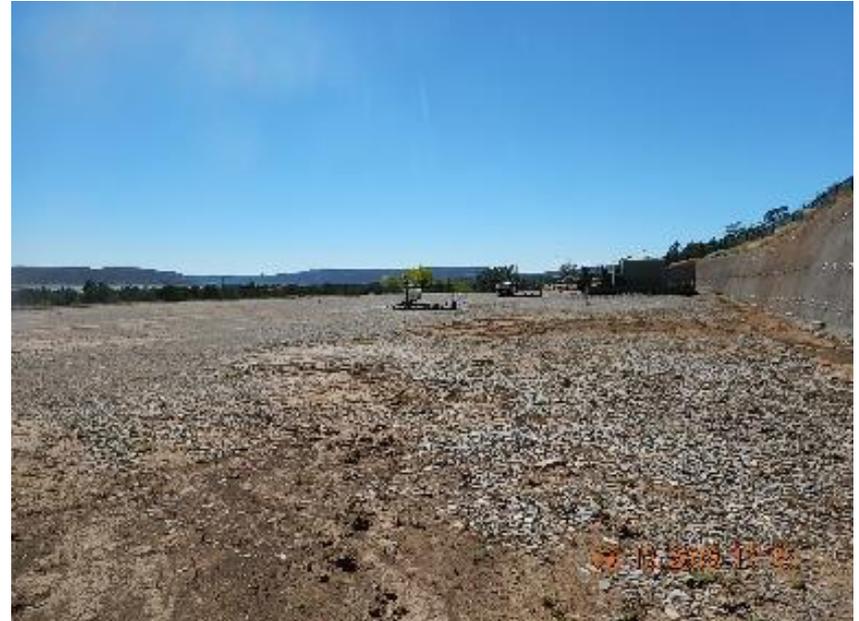
Photo 8: Sediment plume on location.

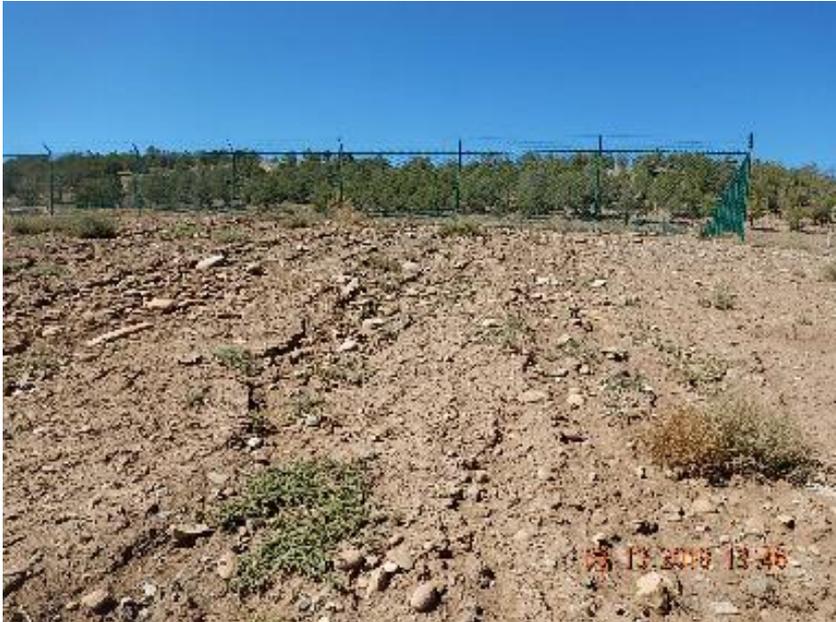
Photo 9: Rilling and erosion on S fill slope.

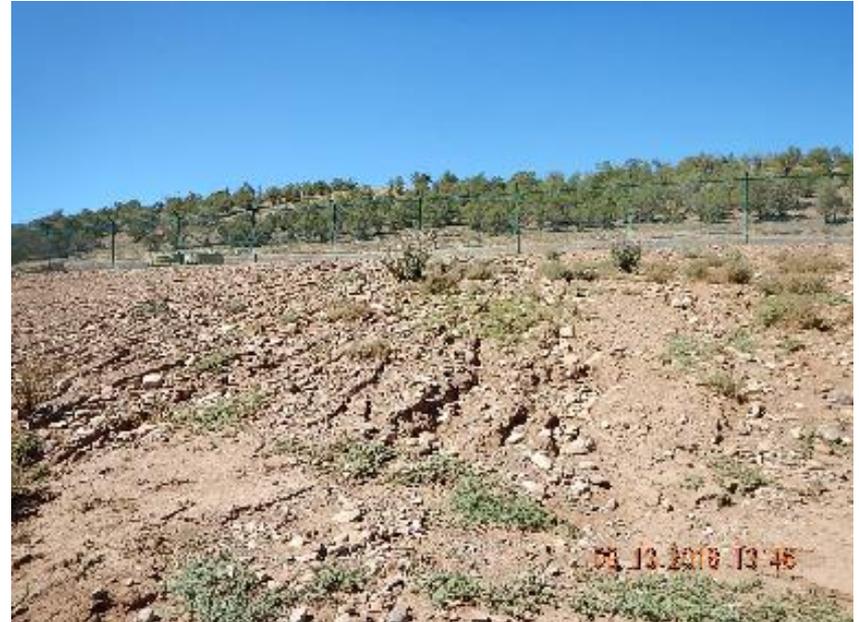
Photo 10: Rilling and erosion on S fill slope.

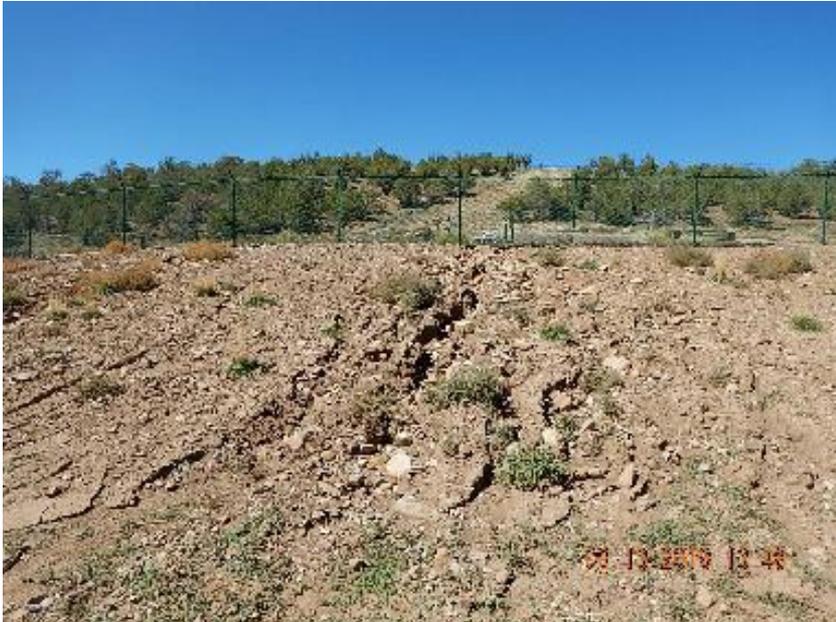
Photo 11: Erosion channel on S fill slope.

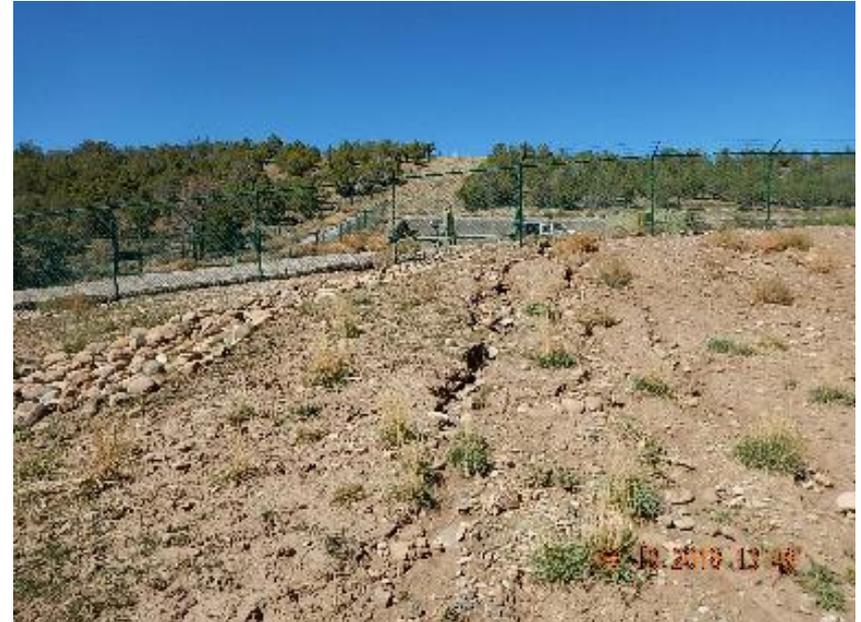
Photo 12: Erosion channel on S fill slope.
