Inspection Photos

Location Name: West Fork 3-Phase Line Spill

Spill/Release ID: #457694

Inspection Date: October 1, 2018

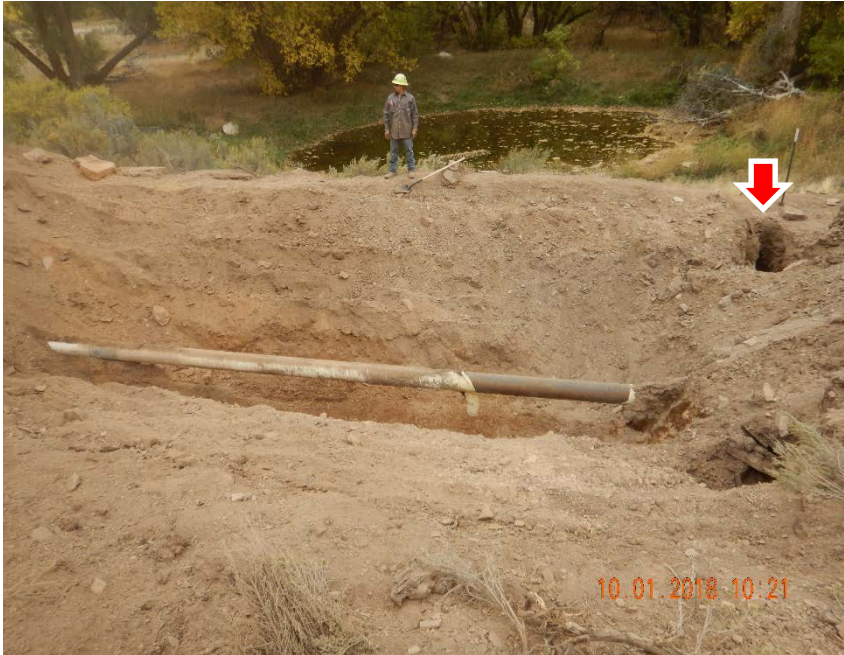
Photo #1 – View into flowline excavation from north side. Arrow indicates pothole location.

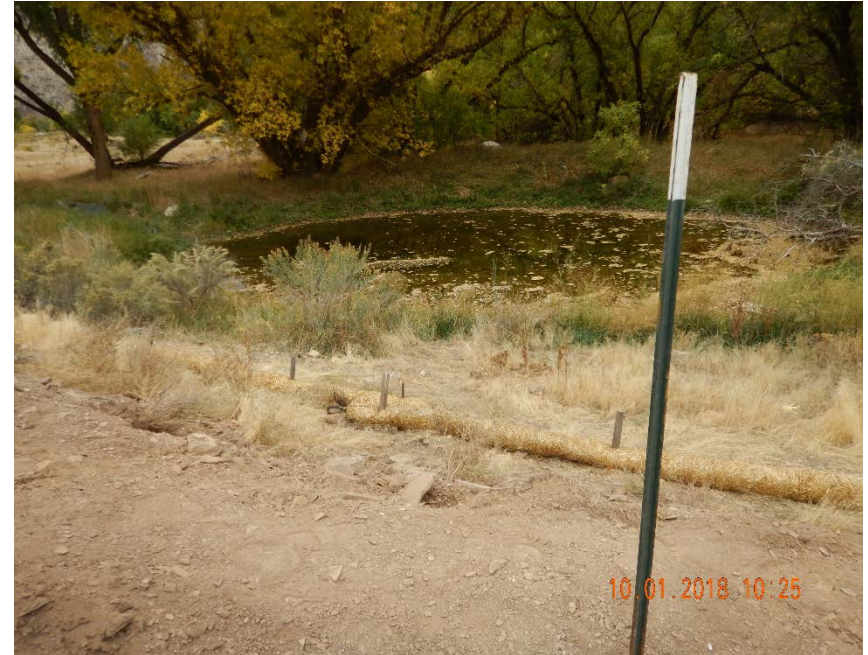
Photo #2 – View of irrigation pond and straw wattle immediately south of excavation. No surface expressions of released fluids were observed in area between excavation and pond. There was no visible sheen or odor observed at pond on inspection date.

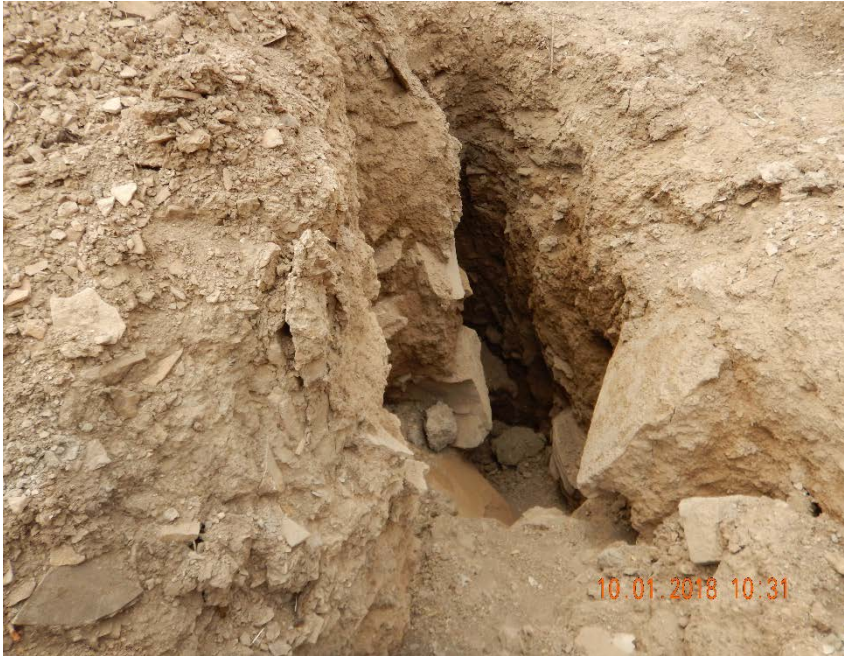
Photo #3 – View into pothole located at southwest corner of excavation. Impacted soil and hydrocarbon odor were observed inside of pothole on inspection date.

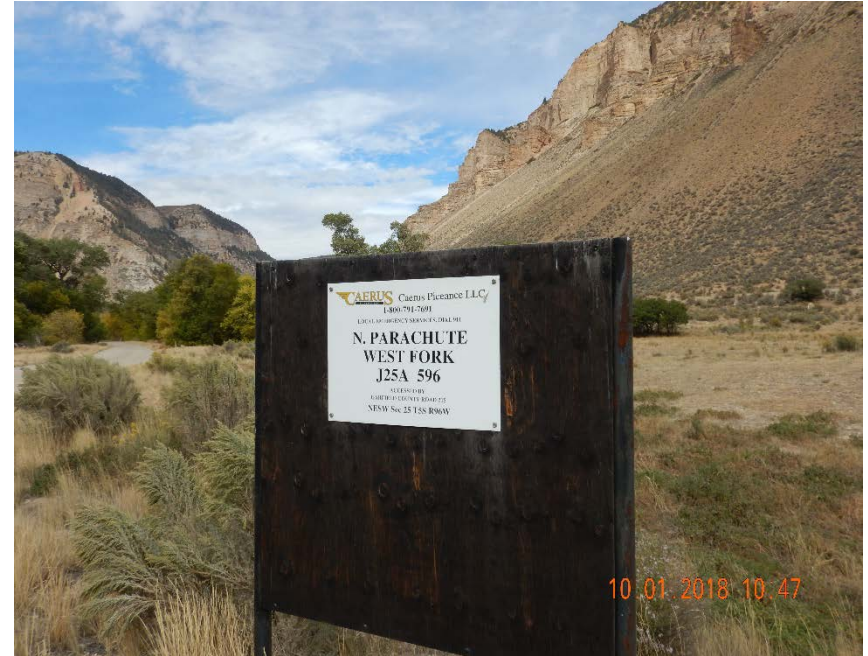
Photo #4 – Excavated soil was being hauled to lined stockpile at nearby N. Parachute West Fork J25A 596 pad.

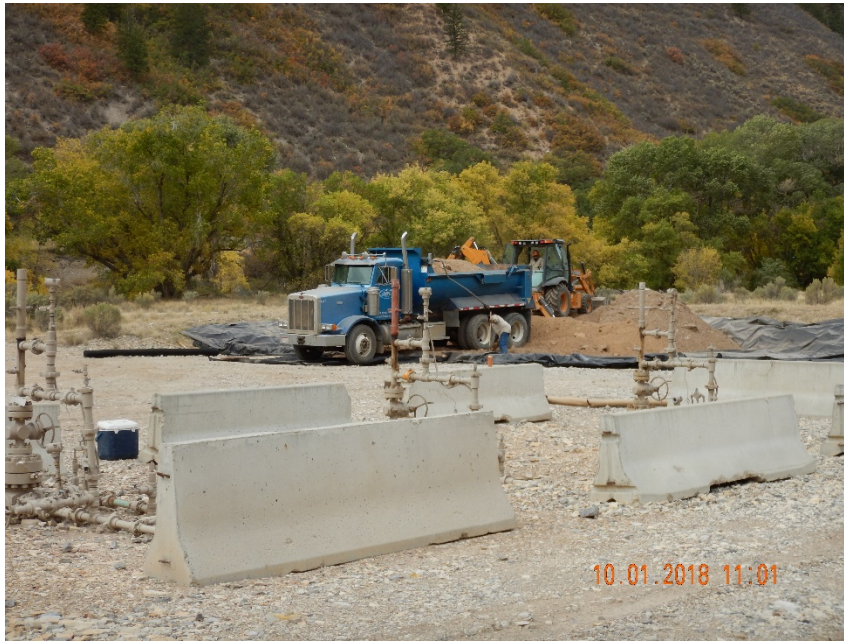
Photo #5 – Soil stockpile at nearby pad. Note that operator was not segregating clean overburden from impacted soil on inspection date.

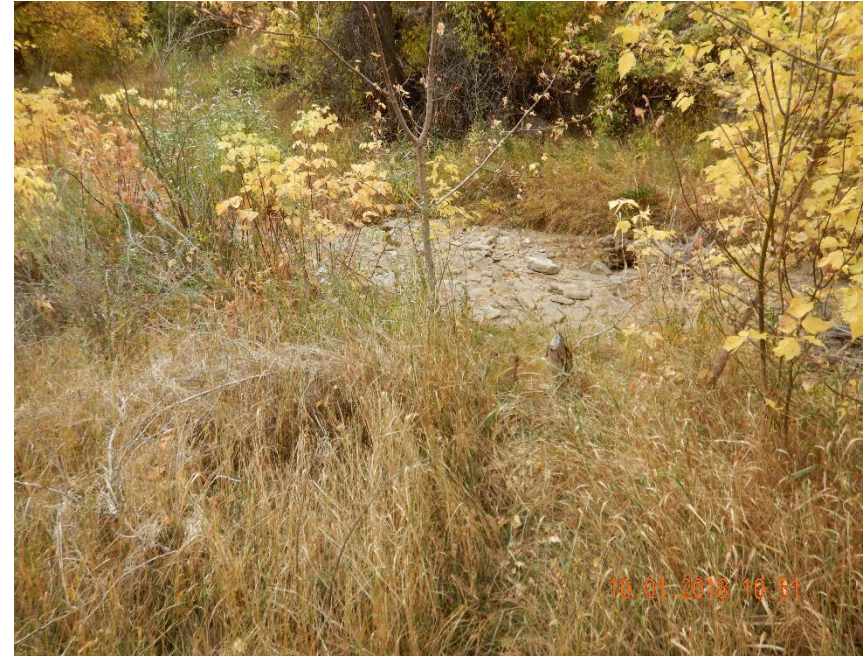
Photo #6 – COGCC inspectors walked a length of West Fork Parachute Creek on inspection date. Creek was dry with no visible impacts from subject release.
