Inspection Photos

Operator: BP America

API: 05-067-06778

Date: 9/25/2018

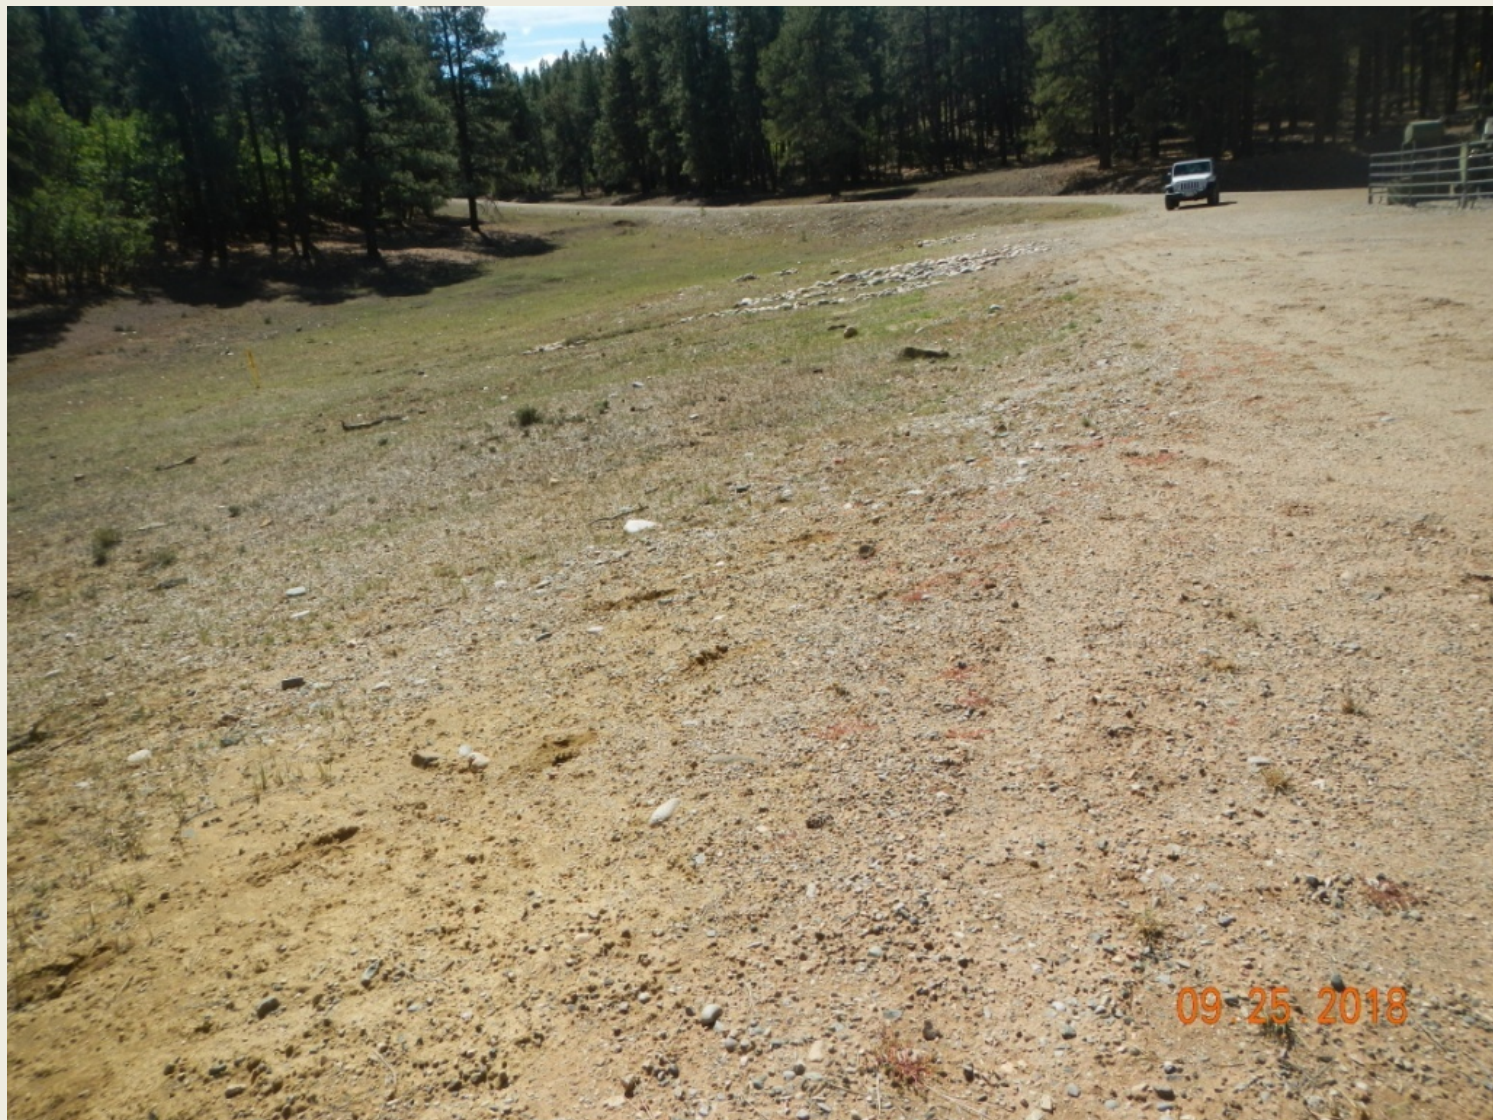
Photo 1. View of the eastern portion of the project area from the northeastern corner facing southward. Revegetation is grazed and largely comprised of grasses such as western wheatgrass (*Pascopyrum smithii*) and sand dropseed (*Sporobolus cryptandrus*).

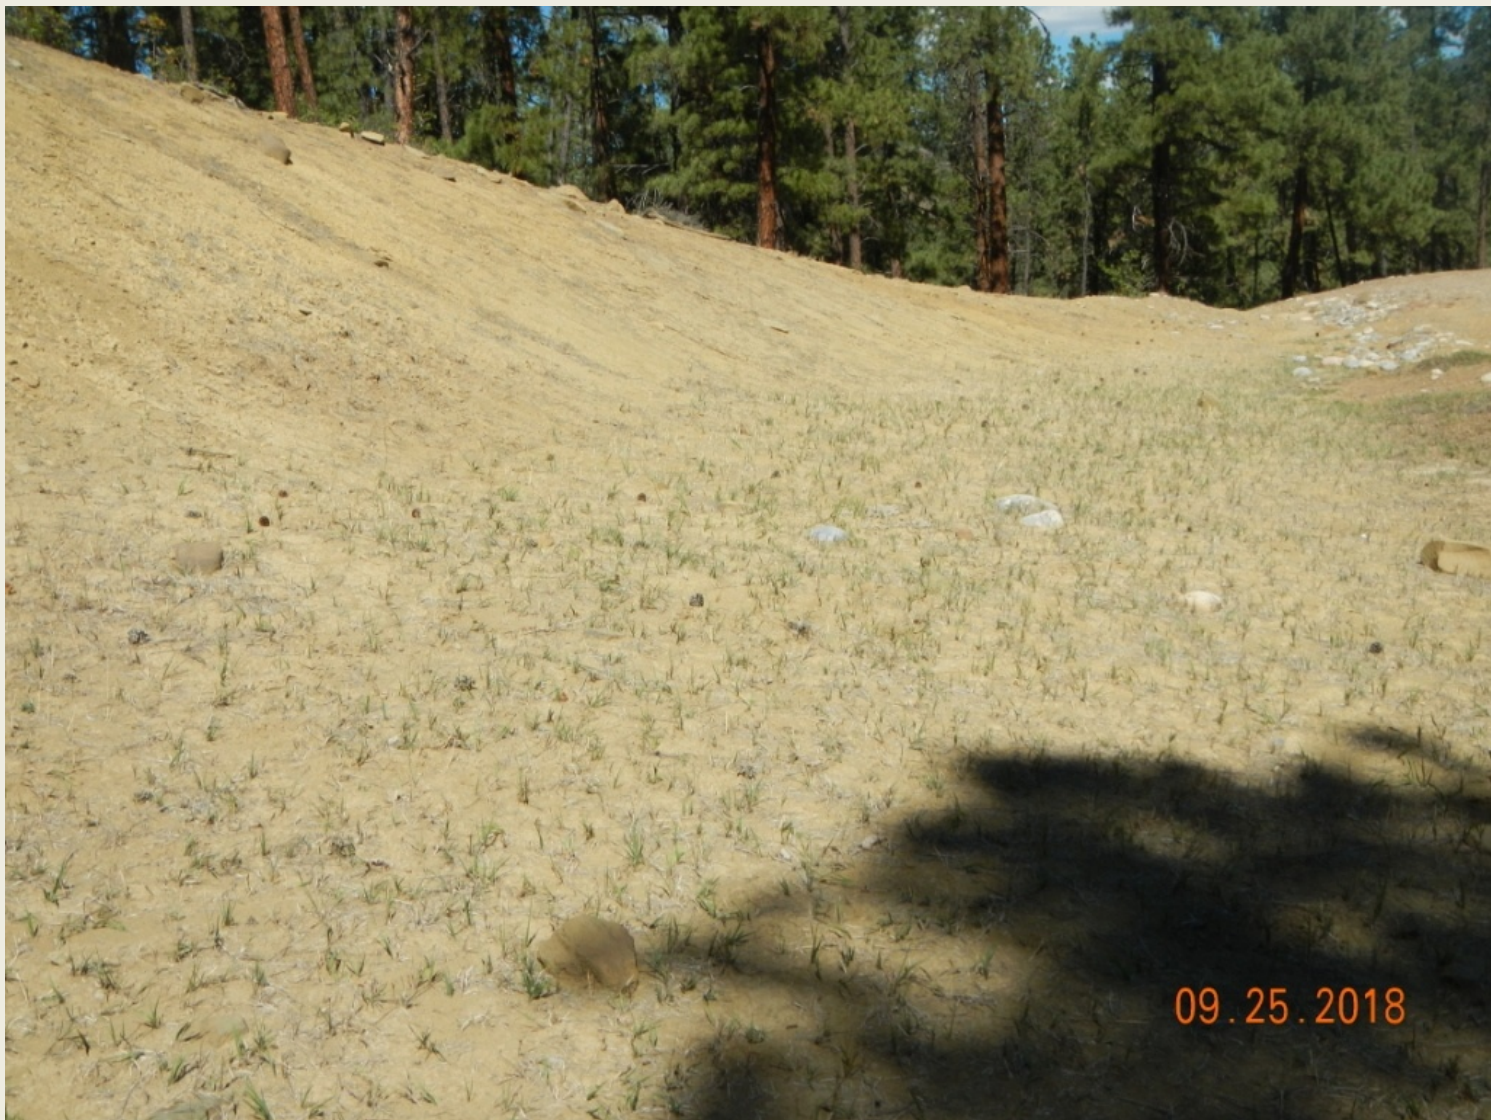
Photo 2. View of the western project area from the southwestern edge facing northward.

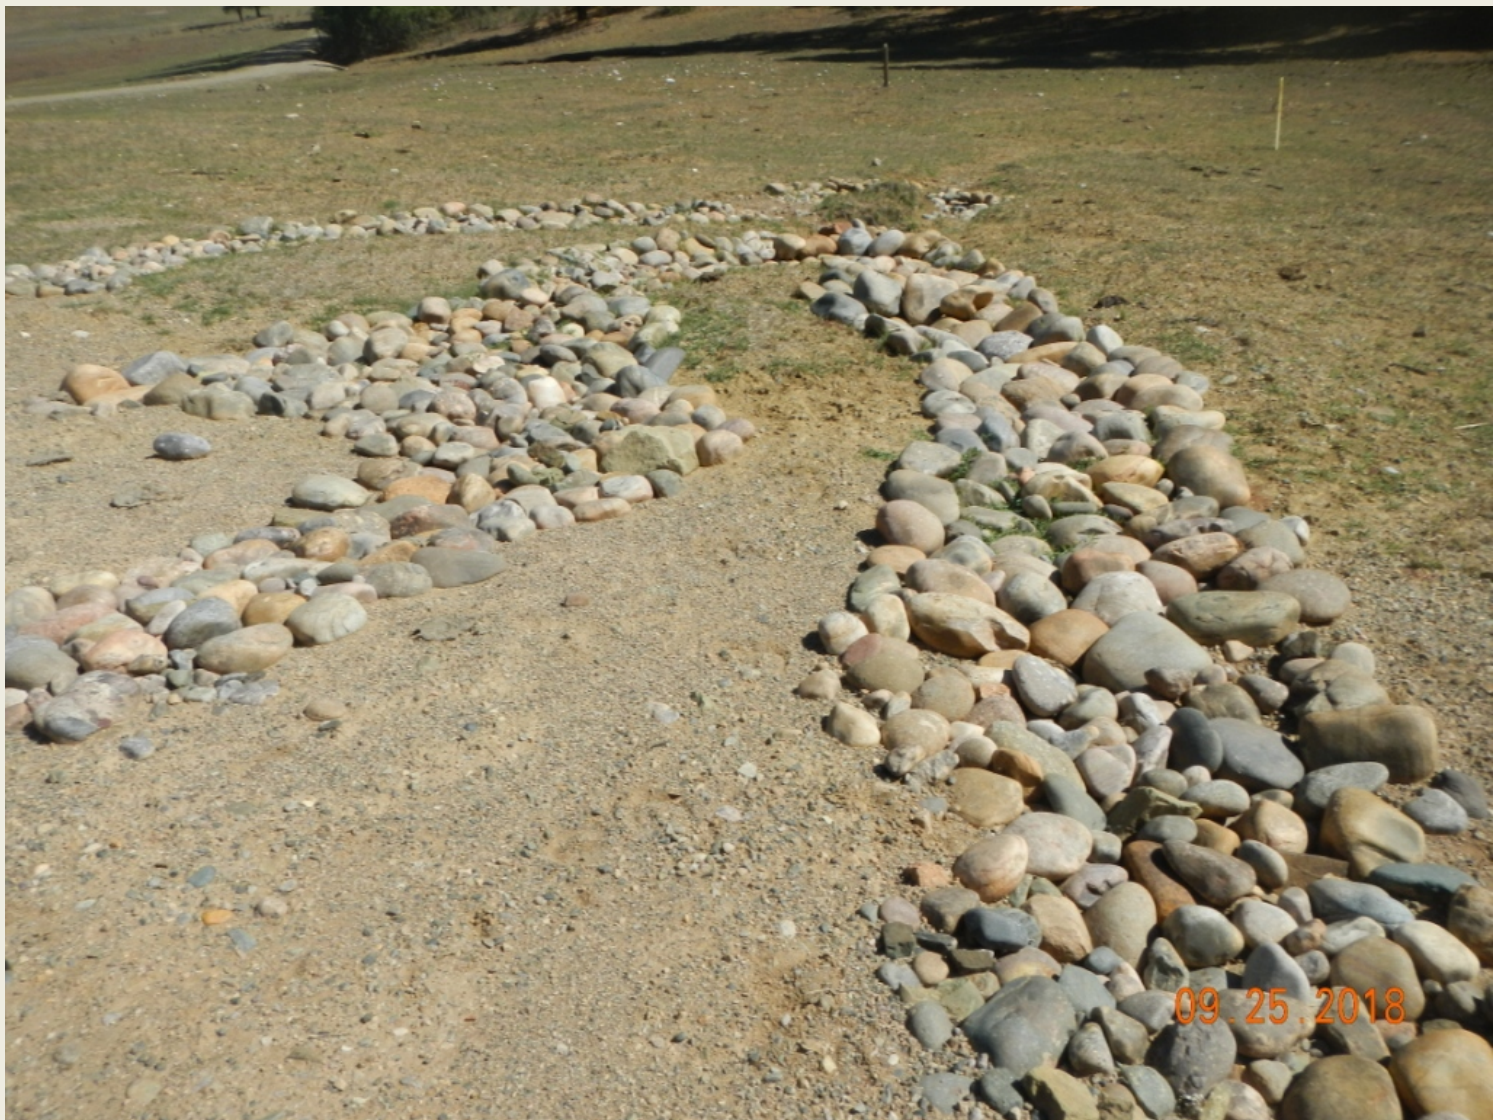
Photo 3. View of cobble run-downs in the eastern project area facing eastward.

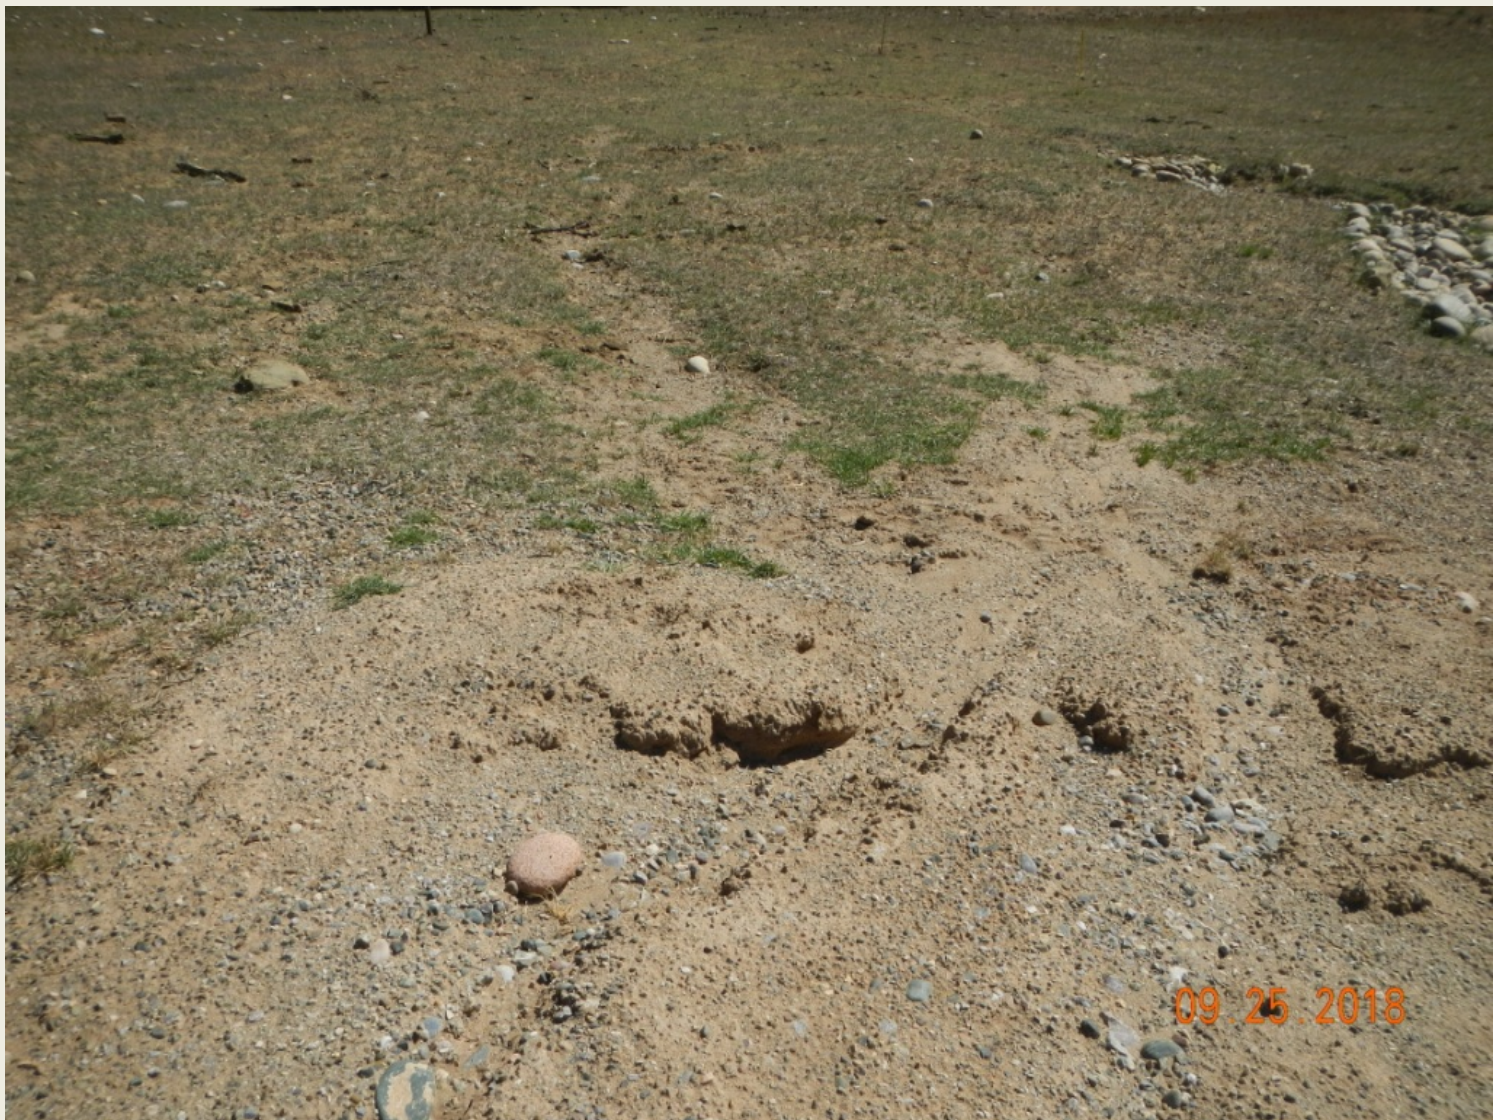
Photo 4. View of area along the eastern edge of the working area where scouring and erosional rilling is occurring.

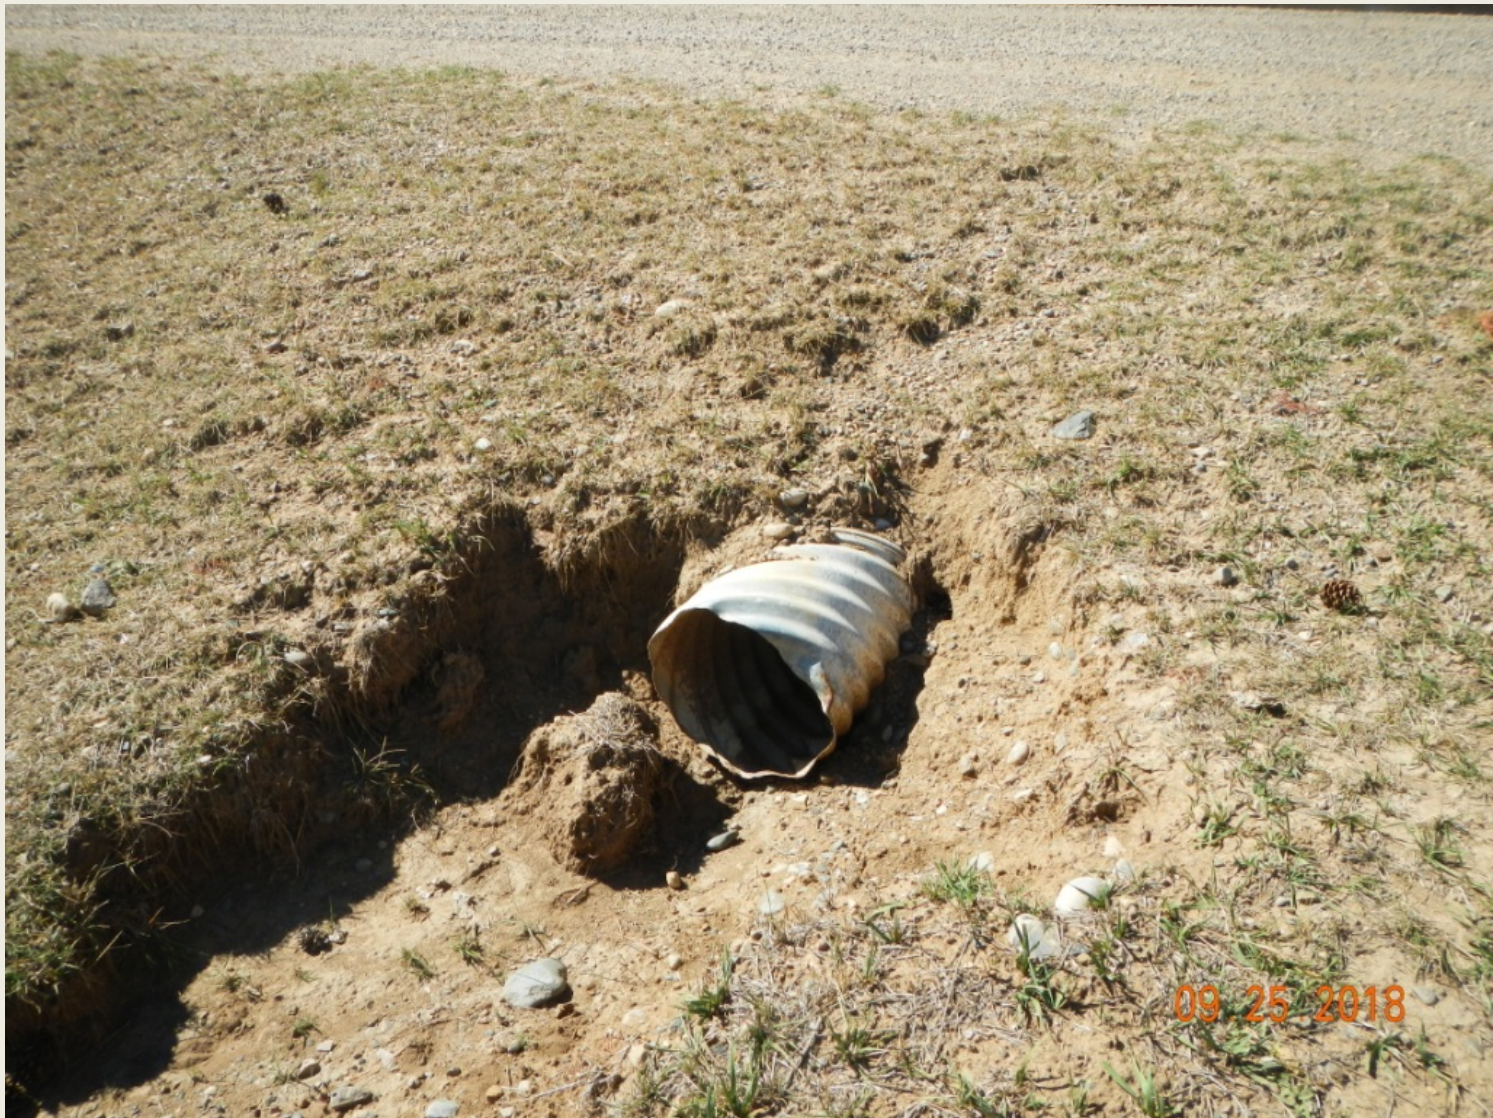
Photo 5. View of erosion at culvert outlet in southeastern project area.

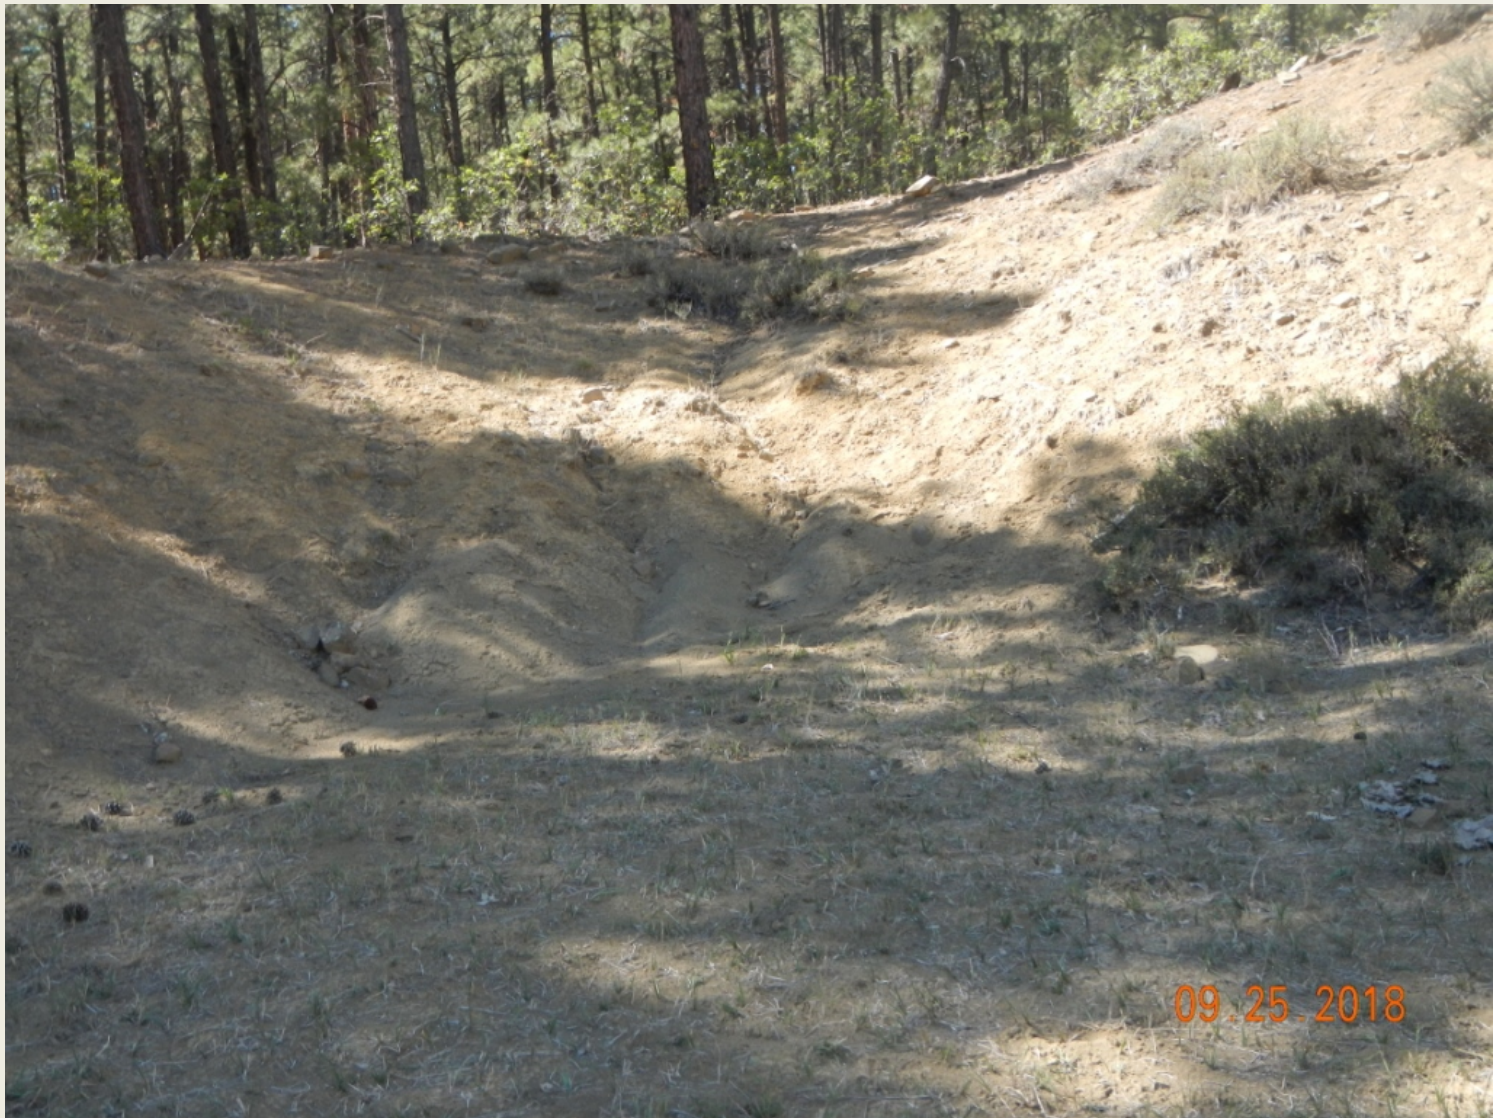
Photo 6. View of the southwestern corner of the project area where stormwater run-on is eroding the well pad cut-slope and depositing sediment down-slope.
