**Inspection Photos**  
**Location Name: Chavez #1**  
**API: 05-007-06120**

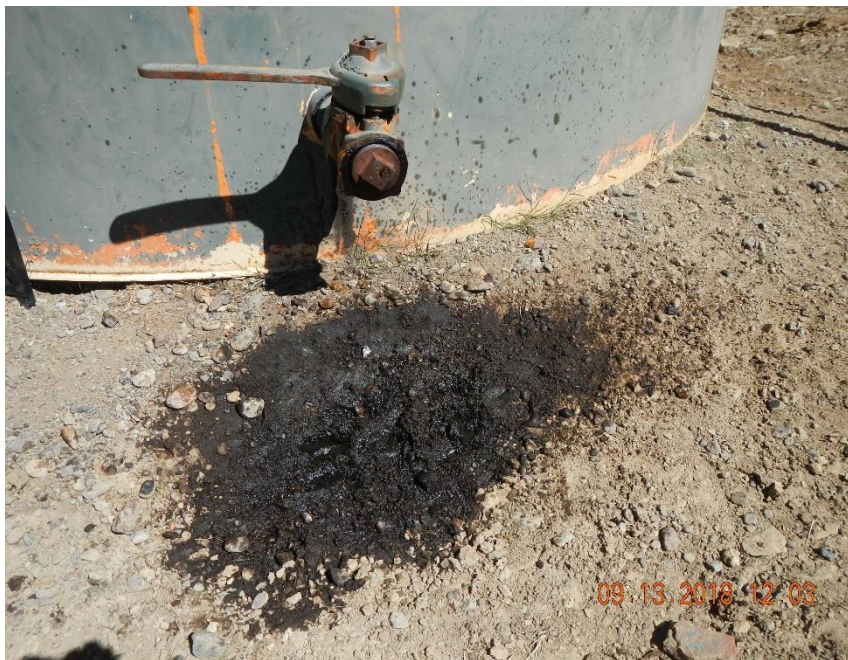
**Stained soil beneath truck load out valve on AST.**

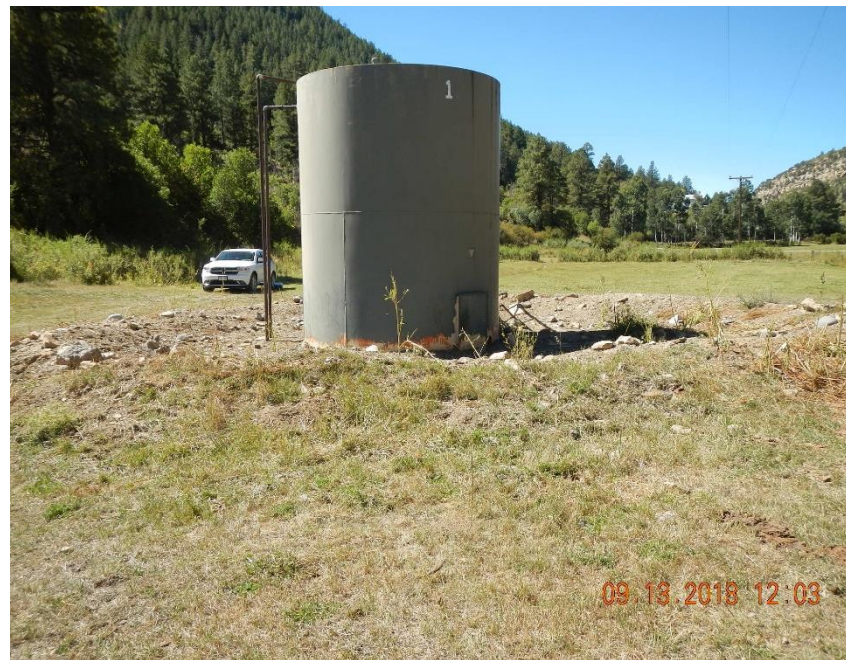
**Weeds have been removed from location.**

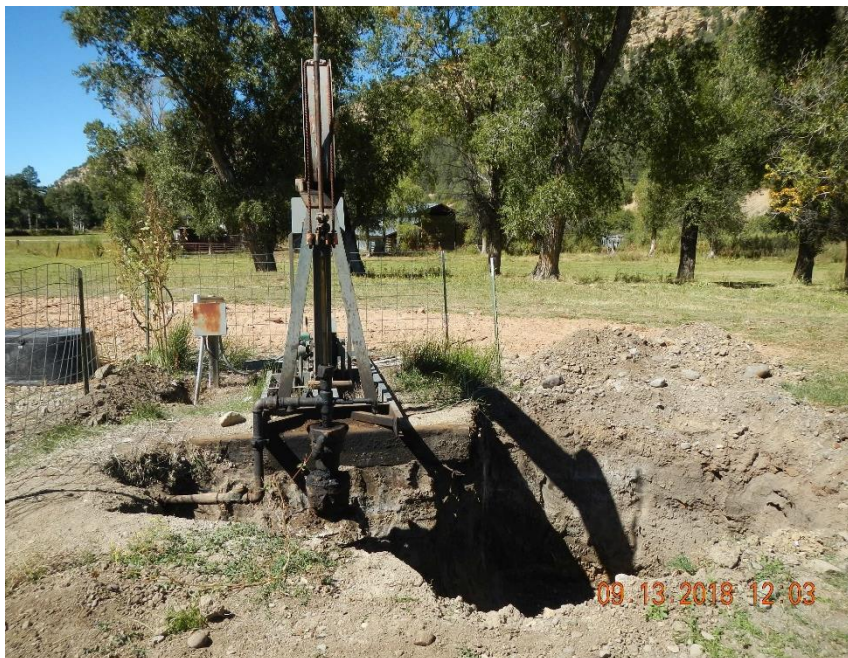
**Extent of excavation on arrival.**

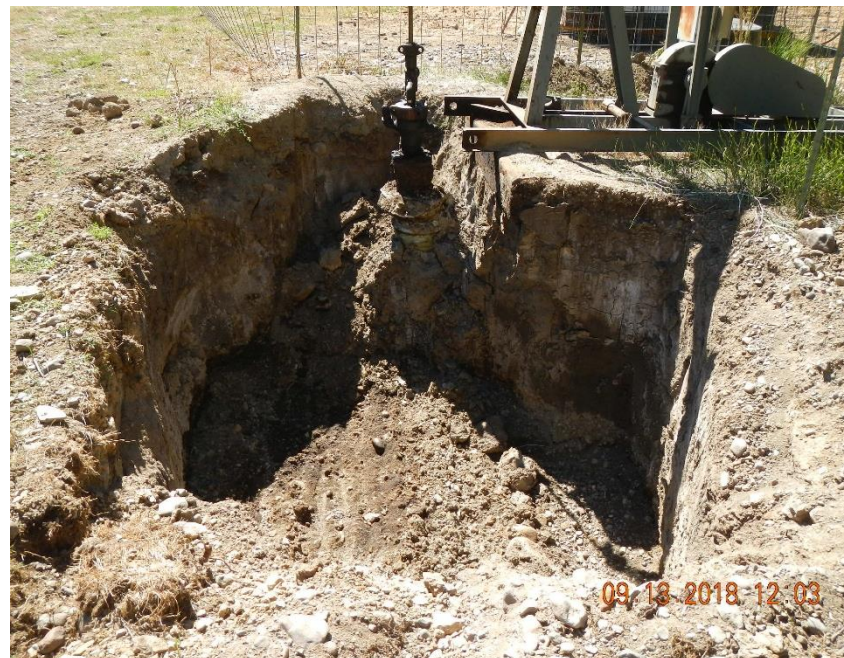
**Open excavation was dry at the time of this site visit.**

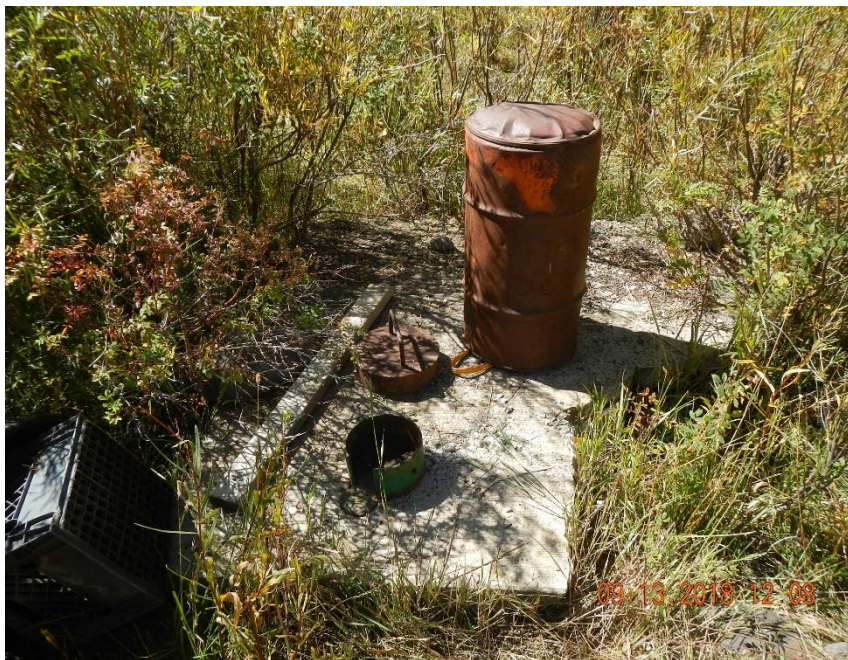
**Chavez water well with metal drum as cover.**

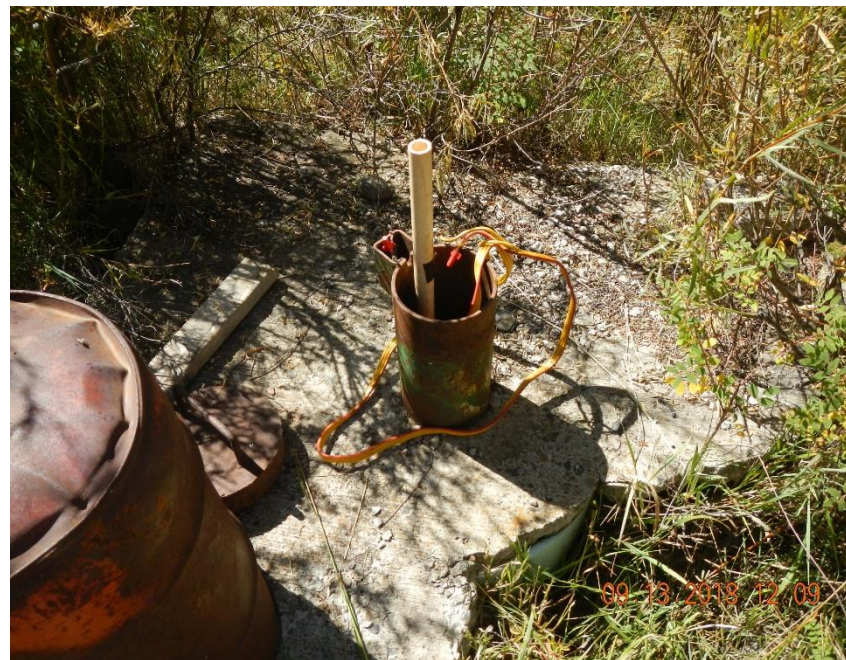
**Cover removed from Chavez water well.**
