APACHE CANYON 03-11 API# 05-071-09629 – TIMBER CREEK
OGCC OPERATOR NUMBER 10672 - DATE: OCTOBER 10, 2018
4 CORRECTIVE ACTIONS COMPLETED REGARDING COGCC FIR DOCUMENT # 682600545

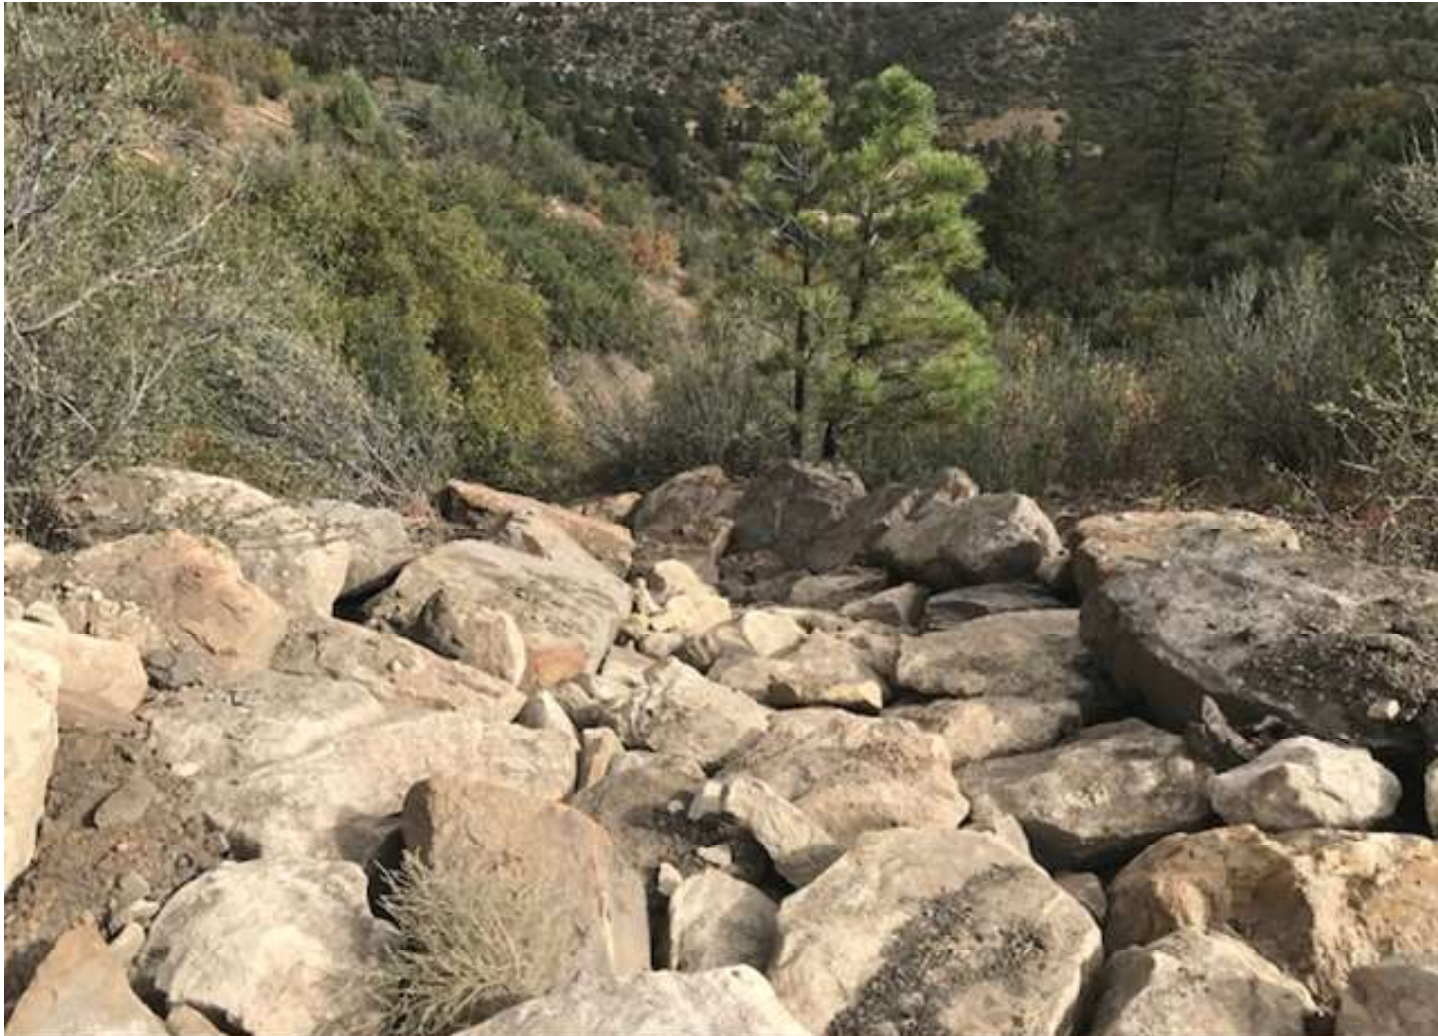
Stormwater run-off is directed to this armored outfall for erosion control.
