# TEP Rocky Mountain LLC Clough NR 22-3 Casing Integrity Report

## Casing Integrity Interpretation

TEP Rocky Mountain LLC  
 Clough NR 22-3  
 API # 05-045-23904  
 October 06, 2018

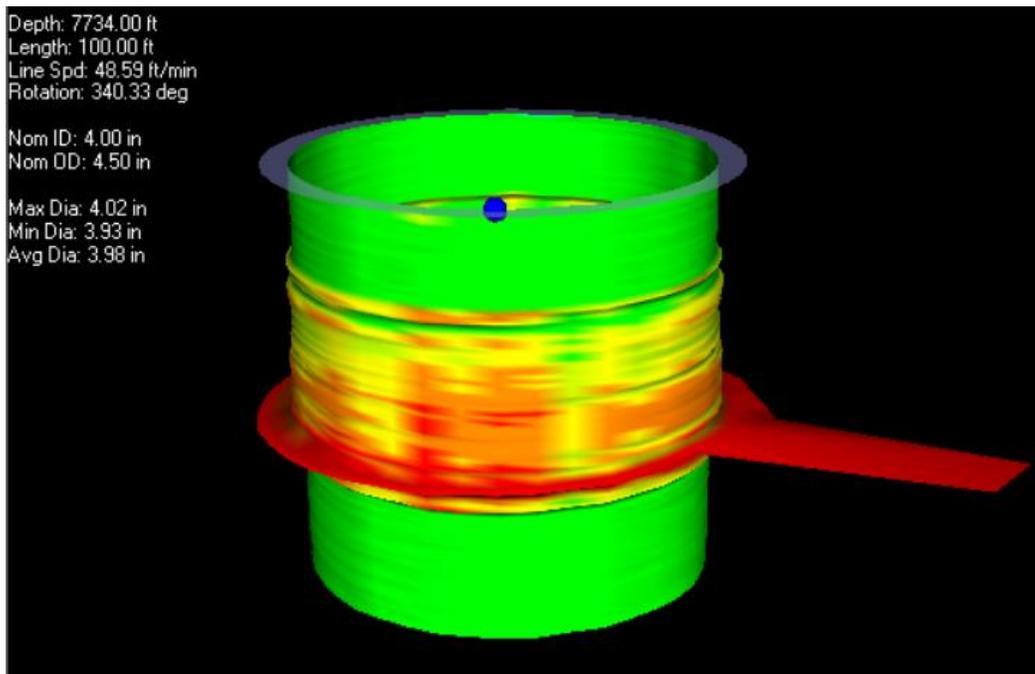
The largest anomaly in the well has a maximum penetration value of 100% at a depth of 7794.5 feet. This is a repeatable multi-finger anomaly and is classified as a possible hole. A “possible hole” is any anomaly with a penetration value larger than 80%. Even though only the largest anomaly for this joint is listed in the report, it’s important to note that the ID of the entire joint is very inconsistent with average ID values, ranging from 3.98 – 4.21 inches (not including the hole). In fact, approximately half of the joint has ID values greater than 4.11 inches. The log data showing this anomaly is shown in Figure 1, the cross section is shown in Figure 2, and 3D images of this anomaly are shown in Figure 3 and Figure 4.

Figure 4. 3D image of the anomaly at 7794.5 feet.
