Inspection Photos

Operator: Hilcorp Energy Co.

API: 05-067-08229

Date: 10/03/2018

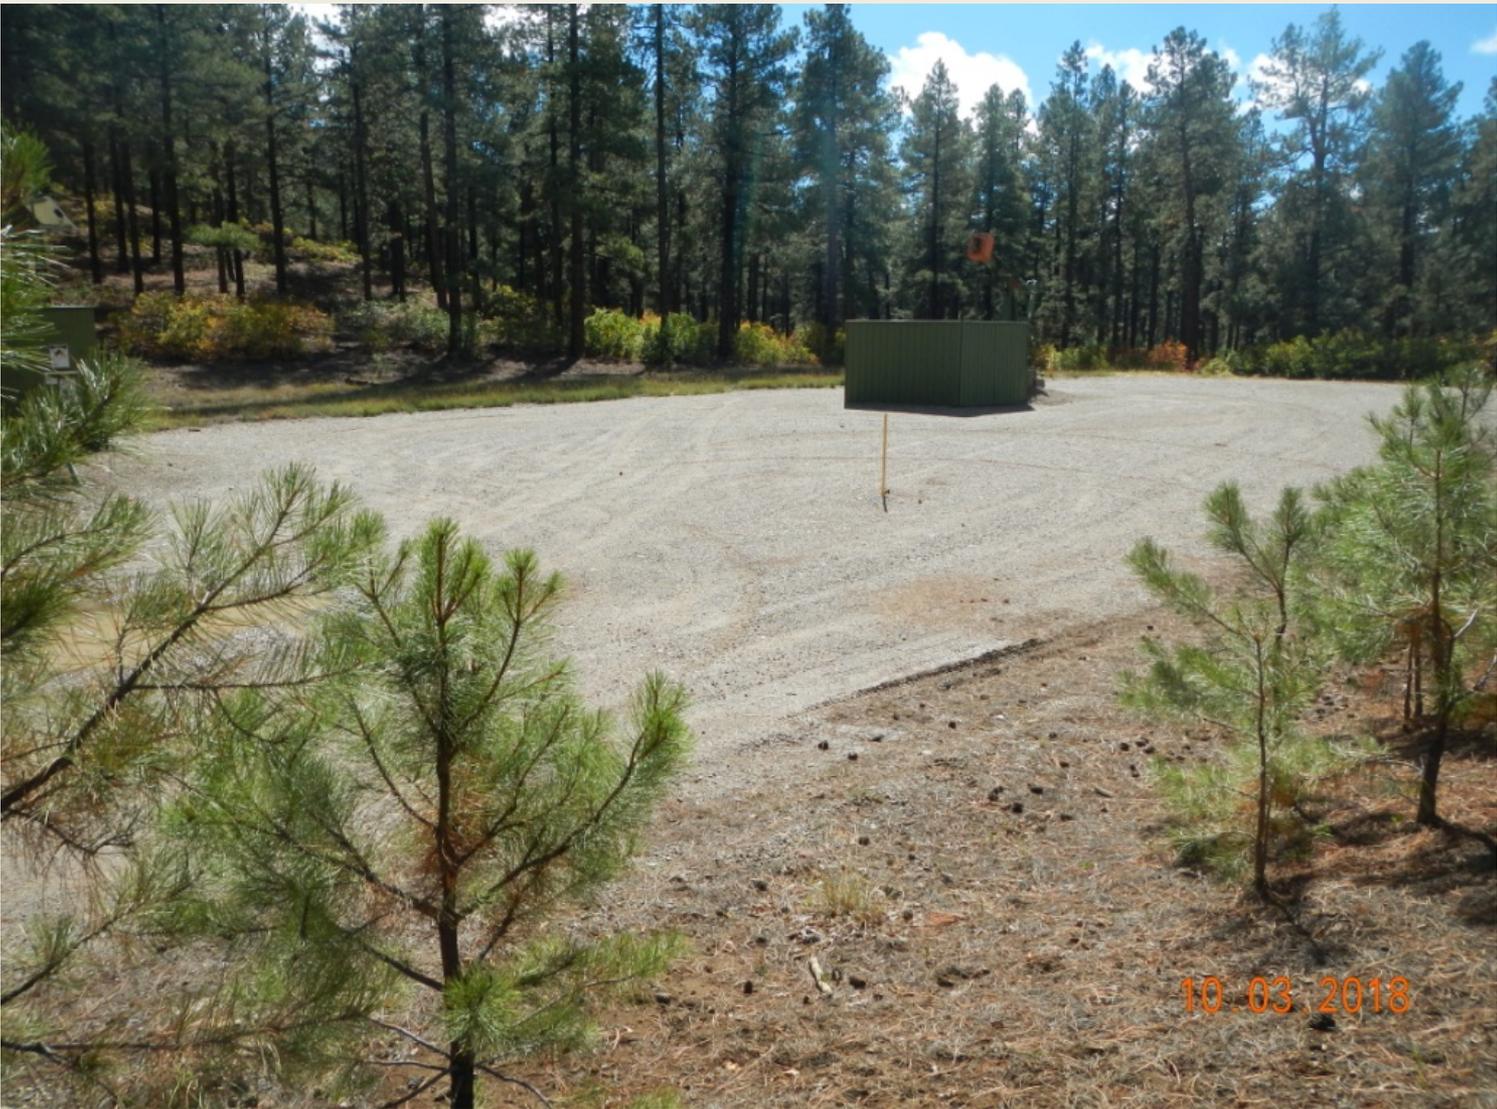
Photo 1. View of the project area from the northwestern corner facing center.

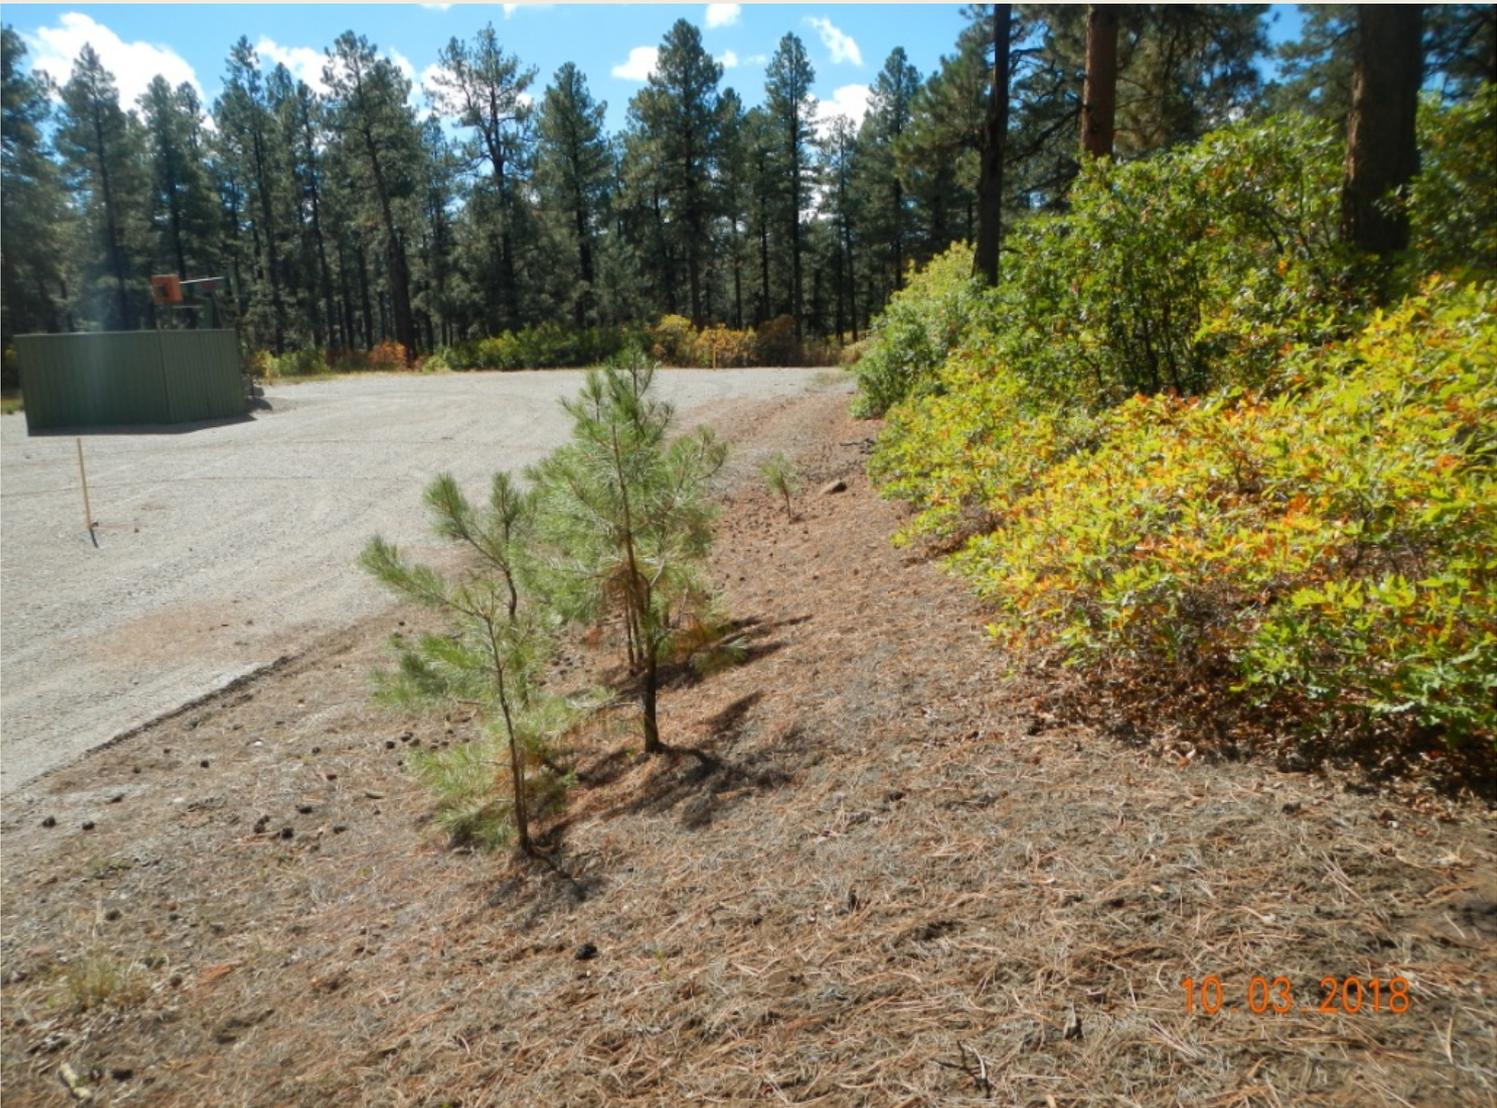
Photo 2. View of the western project area from the northwestern corner facing southward. Vegetation is well established in this portion of the interim reclamation area and comprised of grasses such as smooth brome (*Bromus inermis*), sand dropseed (*Sporobolus airoides*), and ponderosa pine trees (*Pinus ponderosa*).

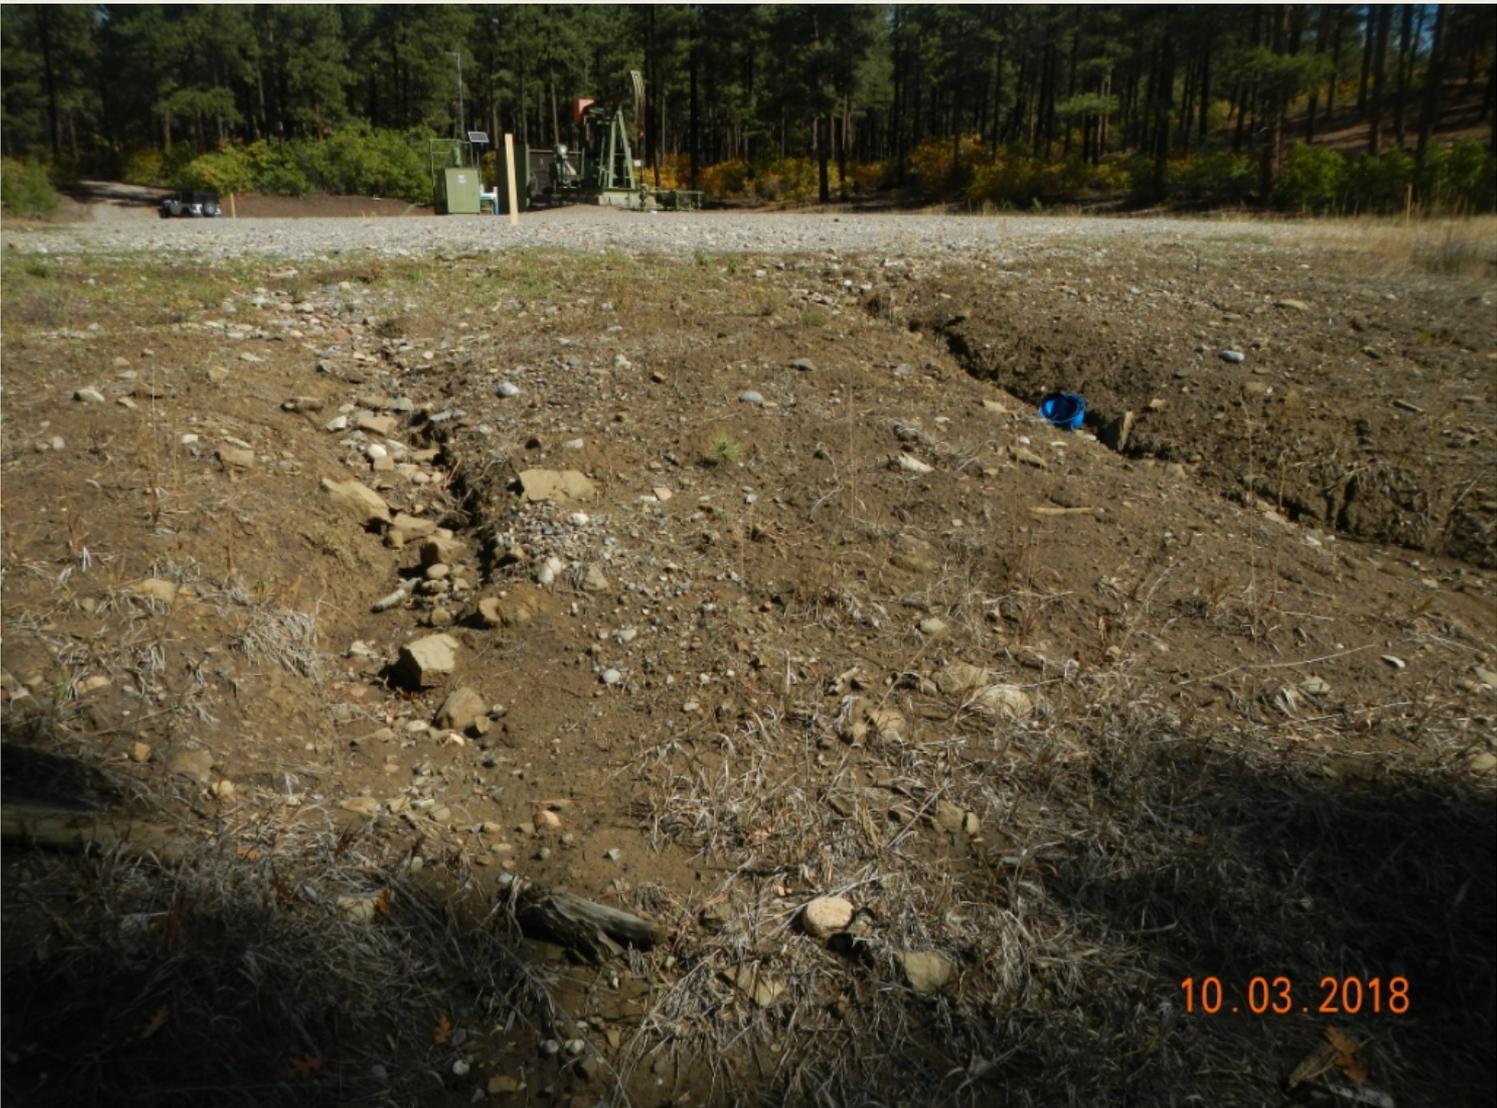
Photo 3. View of erosional channels up to 1.5 feet wide and deep in the southern project area, as well as sparse vegetative cover.

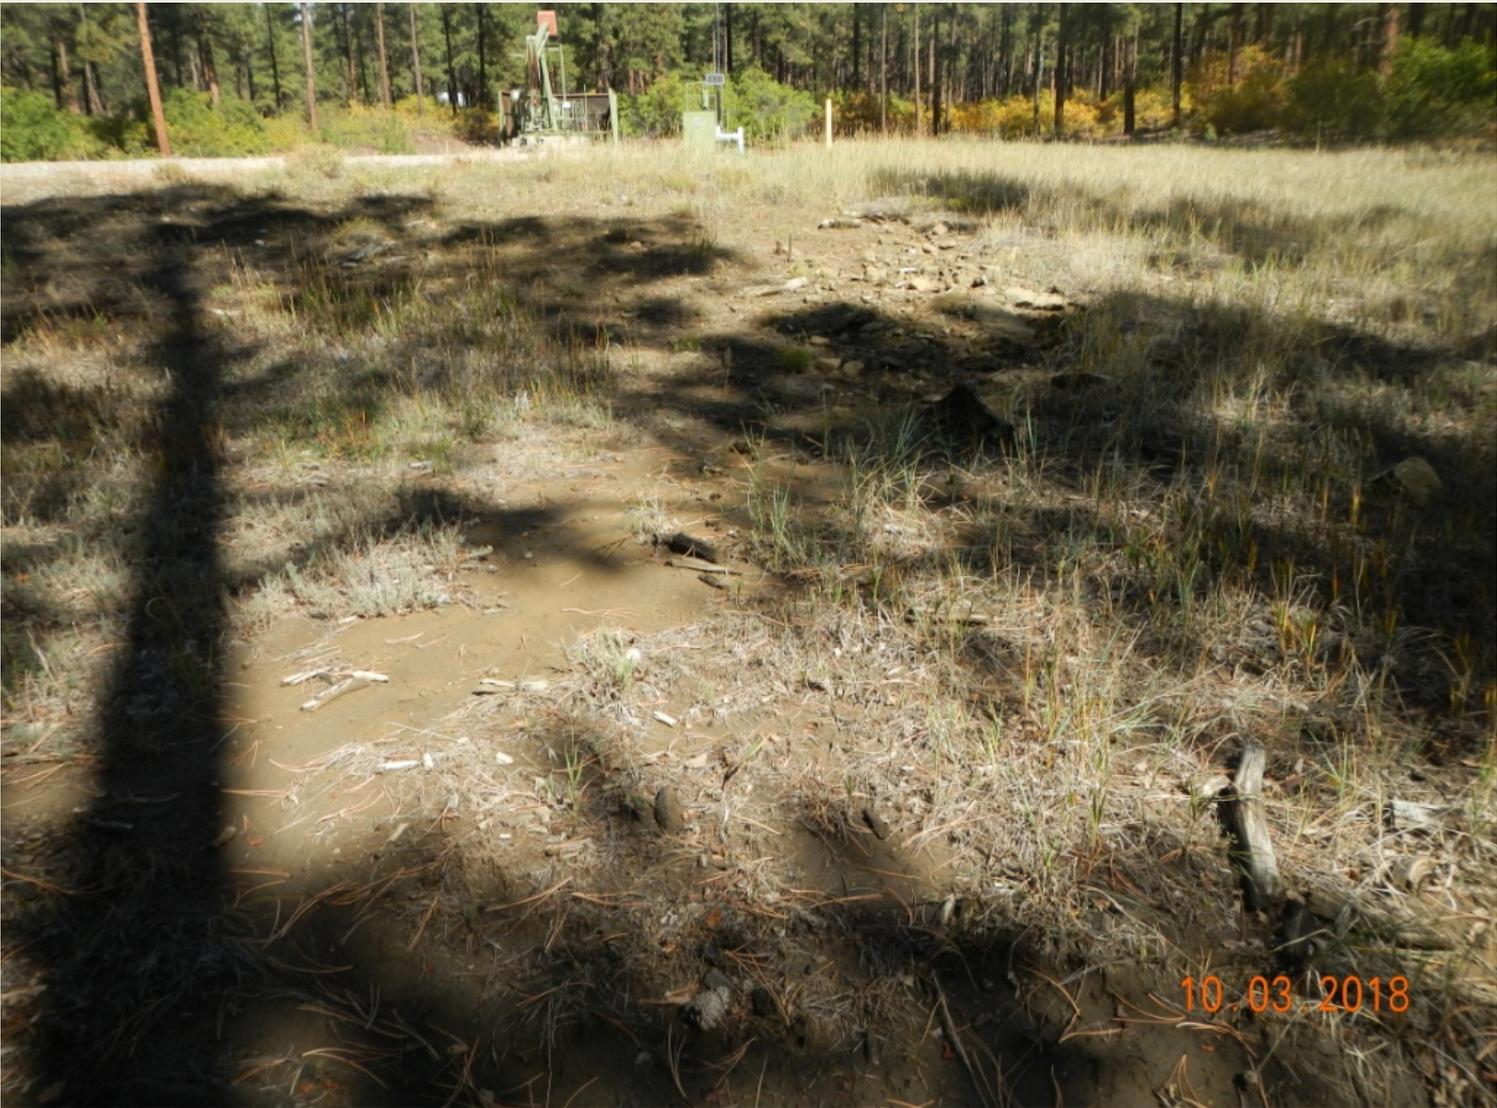
Photo 4. View of diversion in the southeastern project area where concentrated stormwater is diverted off of the southwestern corner of the project area and sediment deposition is occurring outside of the project area.
