Inspection Photos

Operator: Hilcorp Energy Co.

API: 05-067-07799

Date: 10/03/2018

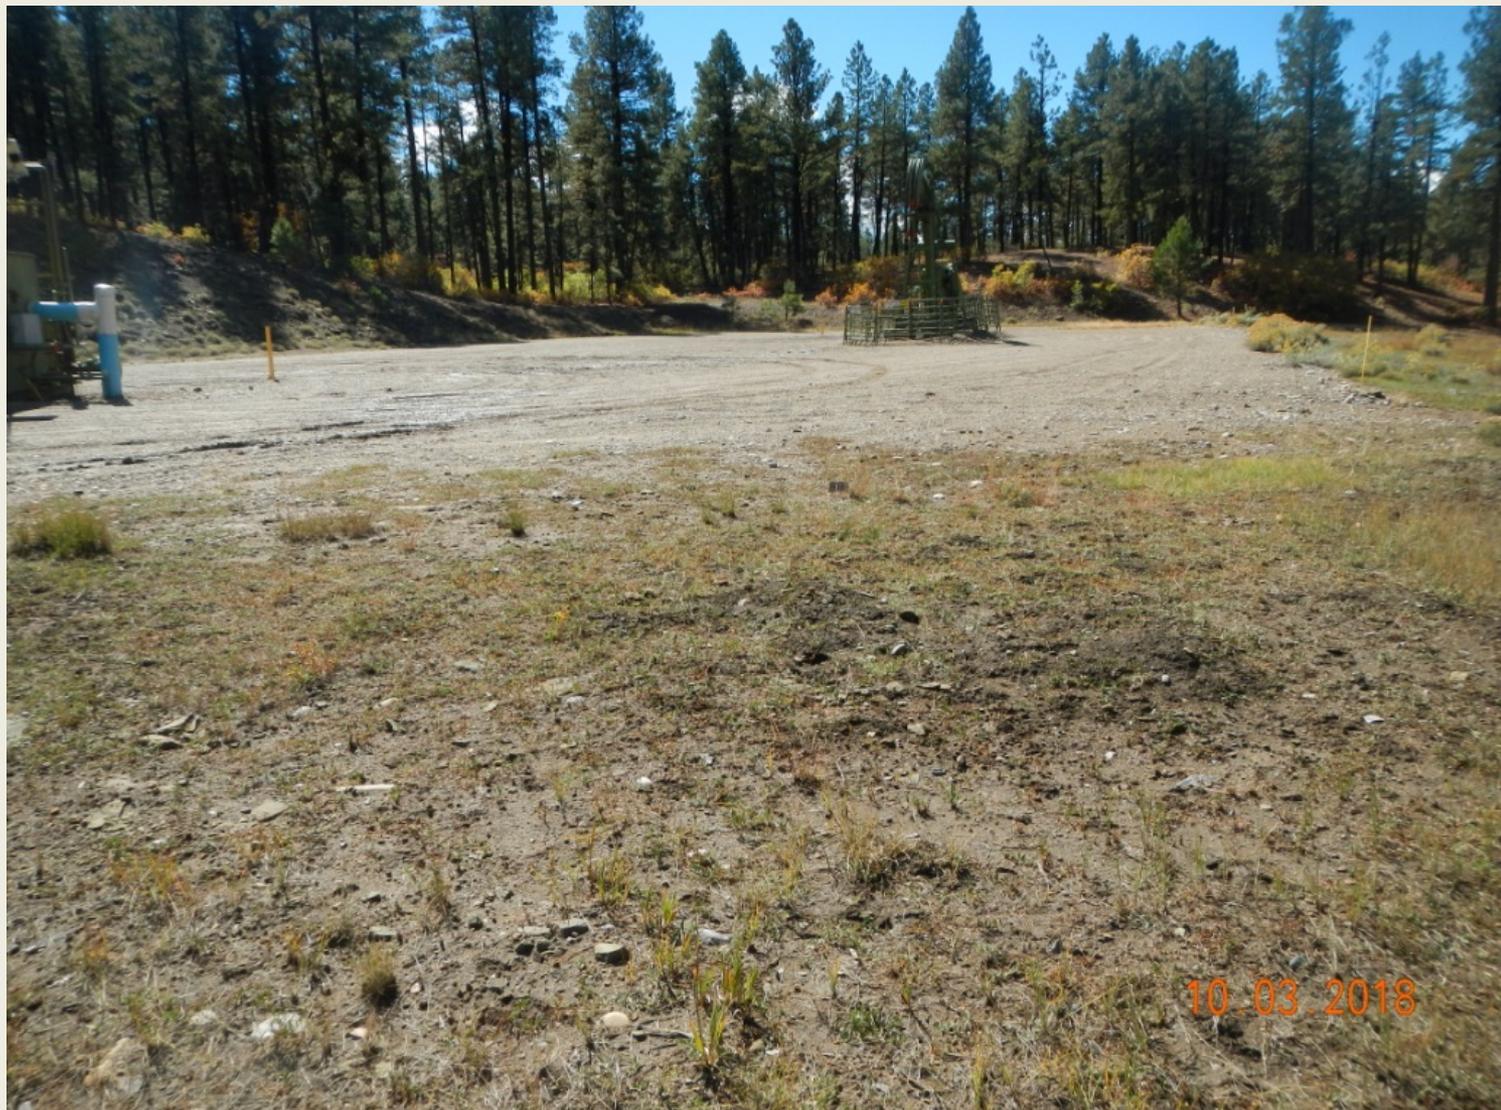
Photo 1. View of the project area from the northwestern corner facing center.

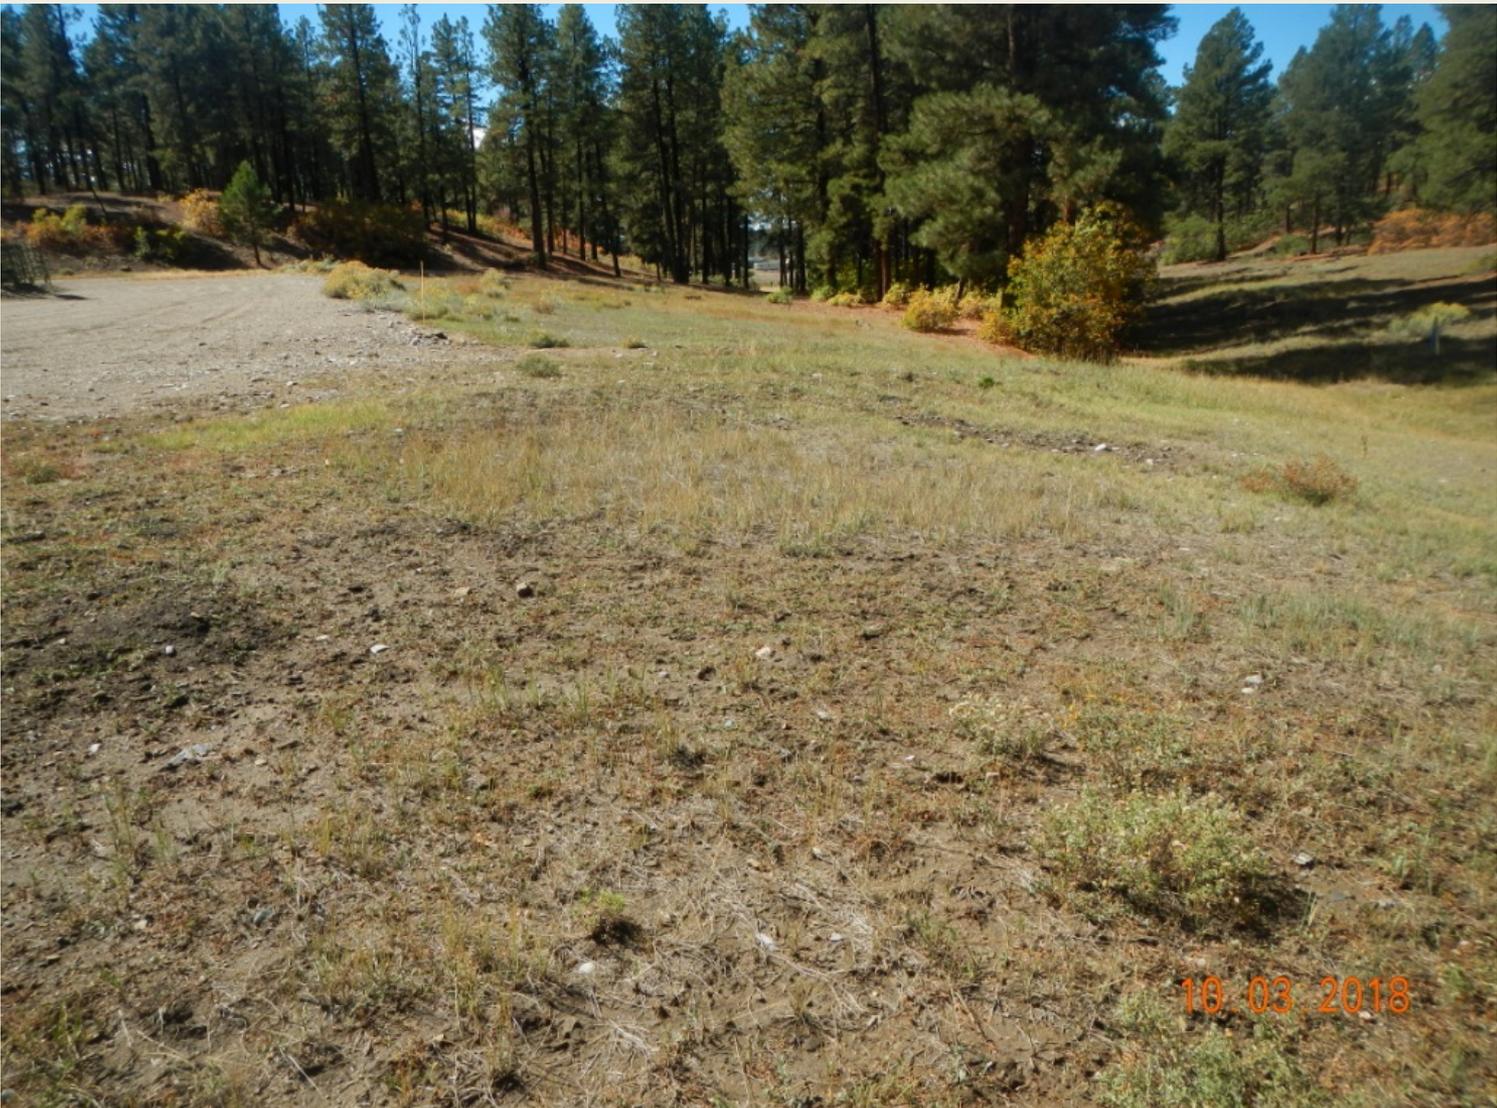
Photo 2. View of the western project area from the northwestern corner facing southward. Vegetation is becoming established with grasses such as western wheatgrass (*Pascopyrum smithii*) and forbs such as hairy goldenaster (*Heterotheca villosa*).

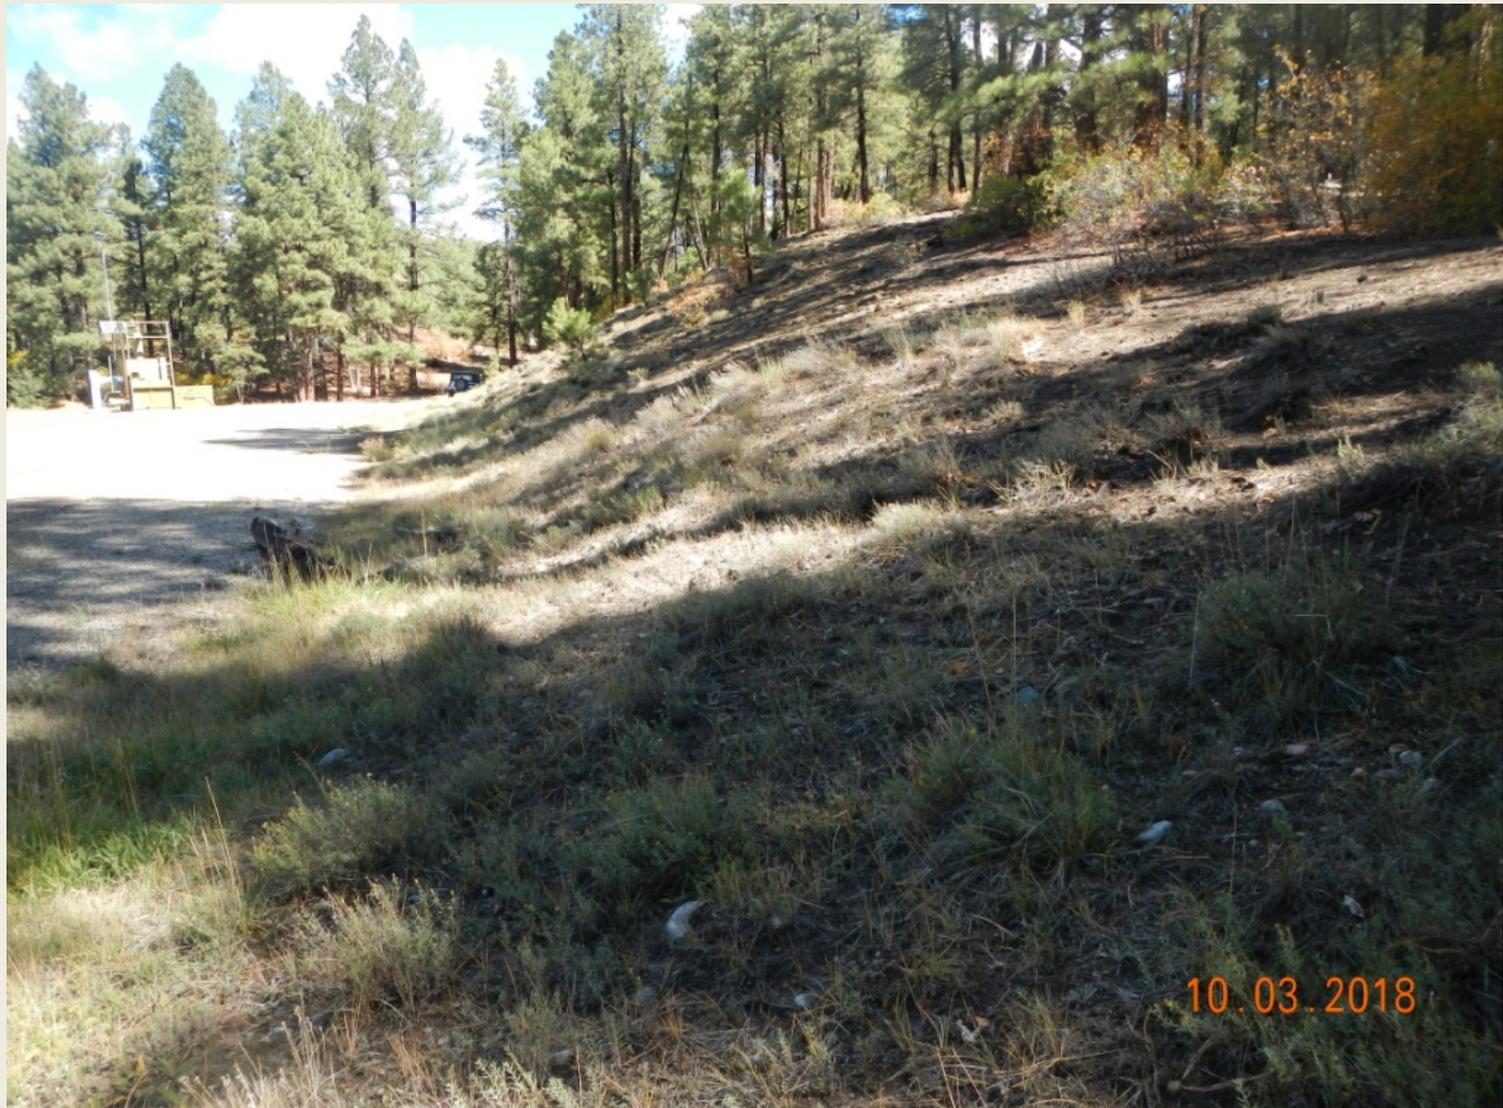
Photo 2. View of the eastern project area from the southeastern corner facing northward.

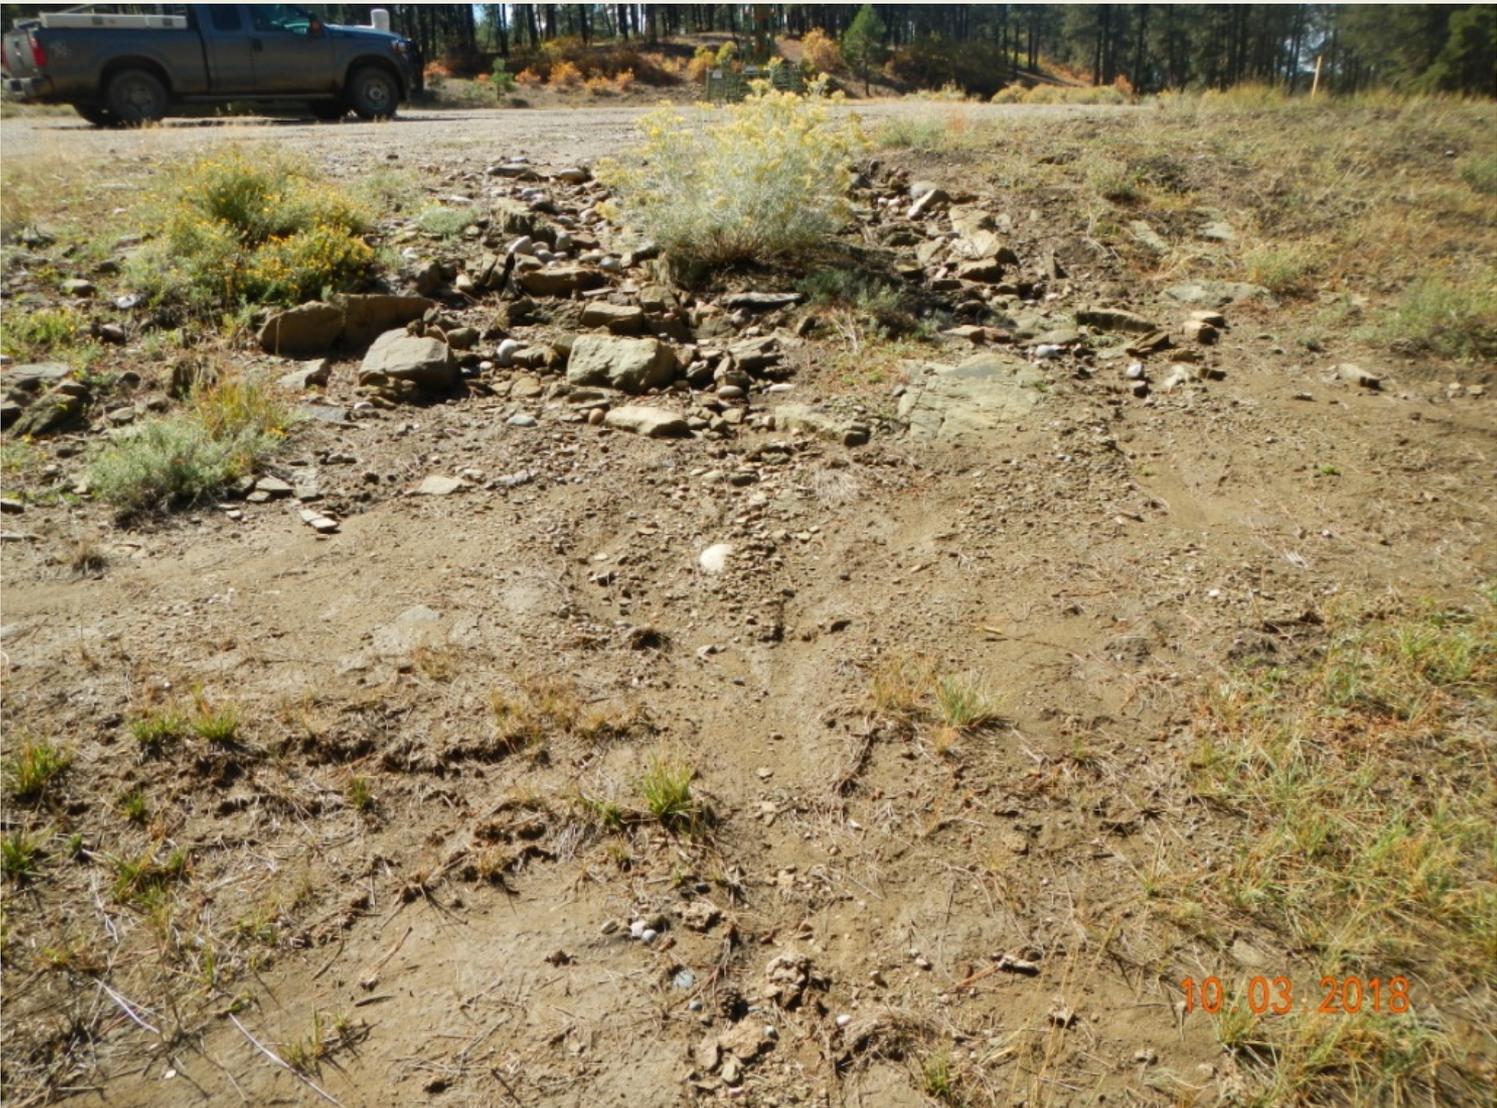
Photo 3. View of area in the northwestern project area where stormwater flows off of the well pad, scouring the rocky upper portions, and depositing sediment down-slope.

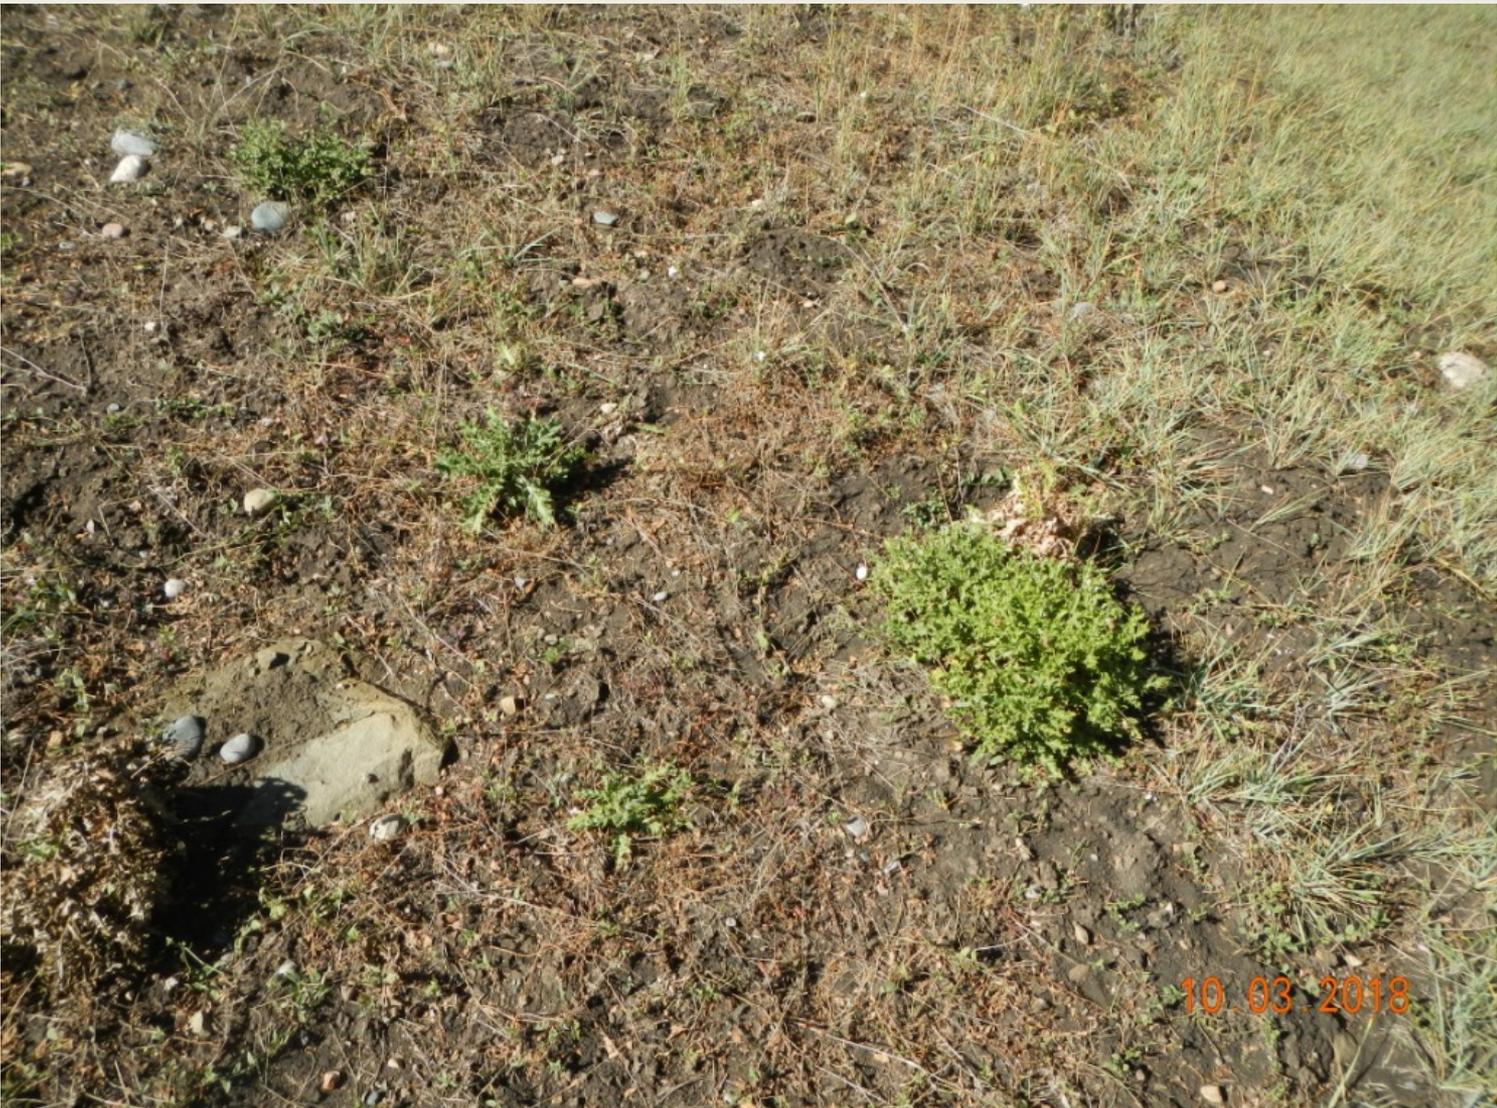
Photo 4. View of Canada thistles (*Cirsium arvense*), some treated and some alive, in the western project area. Approximately 15 individuals observed.
