Inspection Photos
Location Name: Robbins 24 -11A
Location ID: 319995

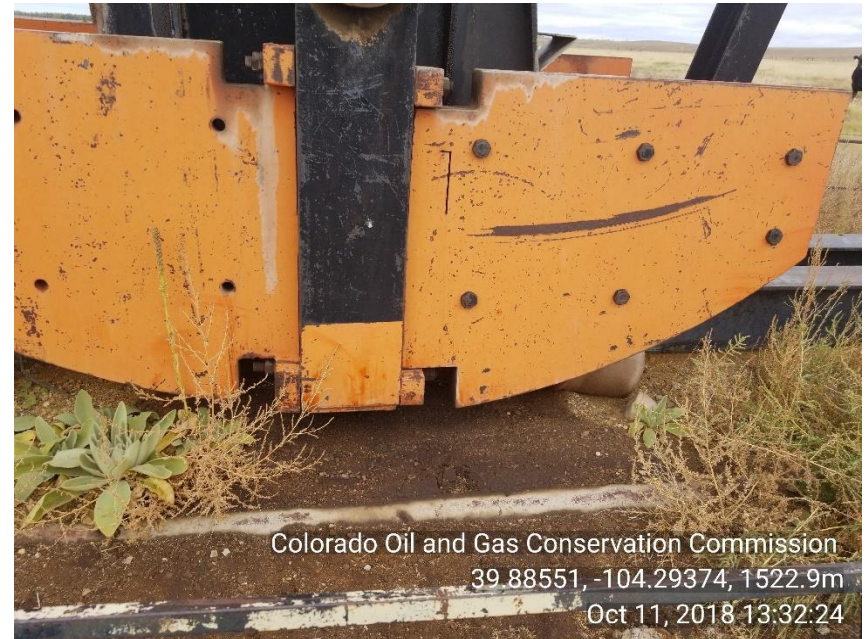
Photo 4 Stained soil PU

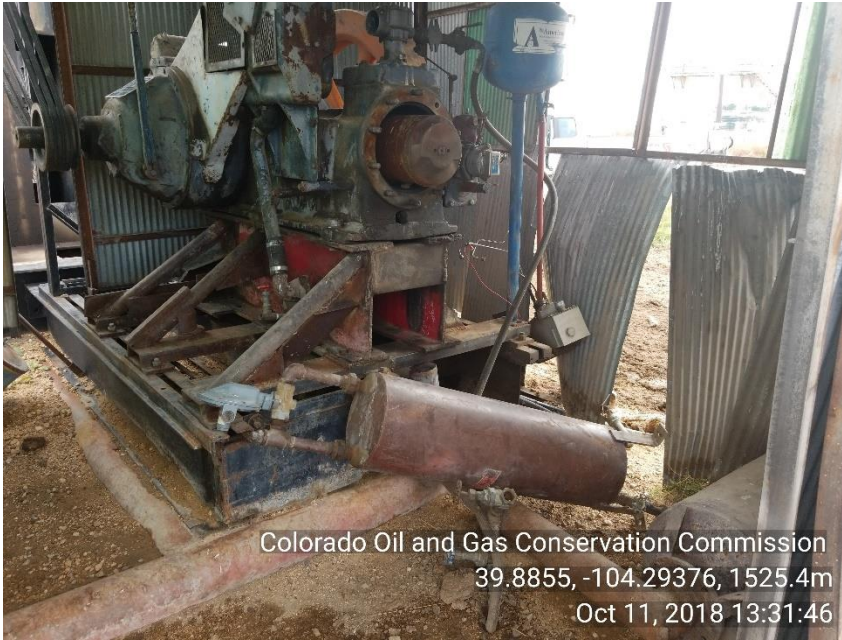
Photo 5 PU house caved in wall and knocked over fuel pot

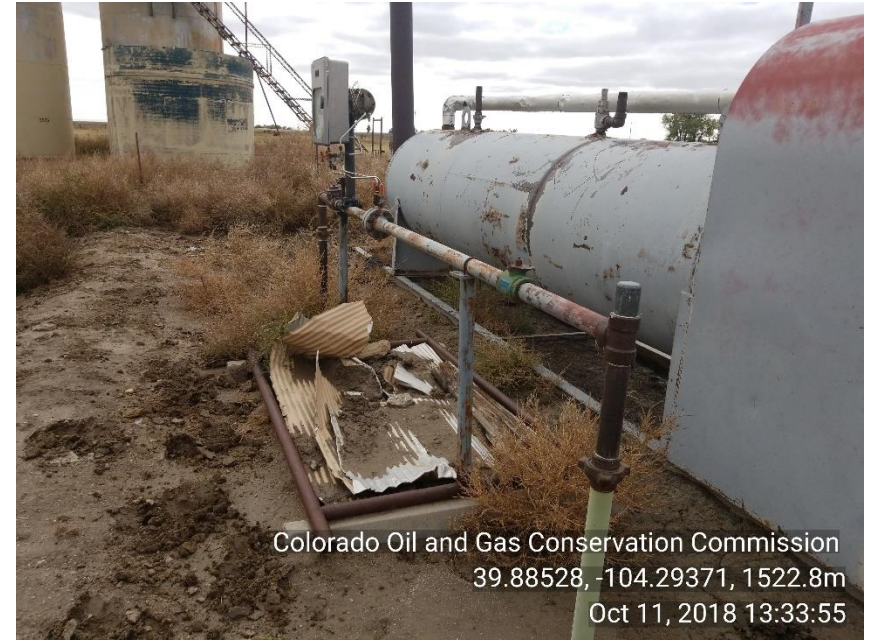
Photo 6 Trash along side of Sep

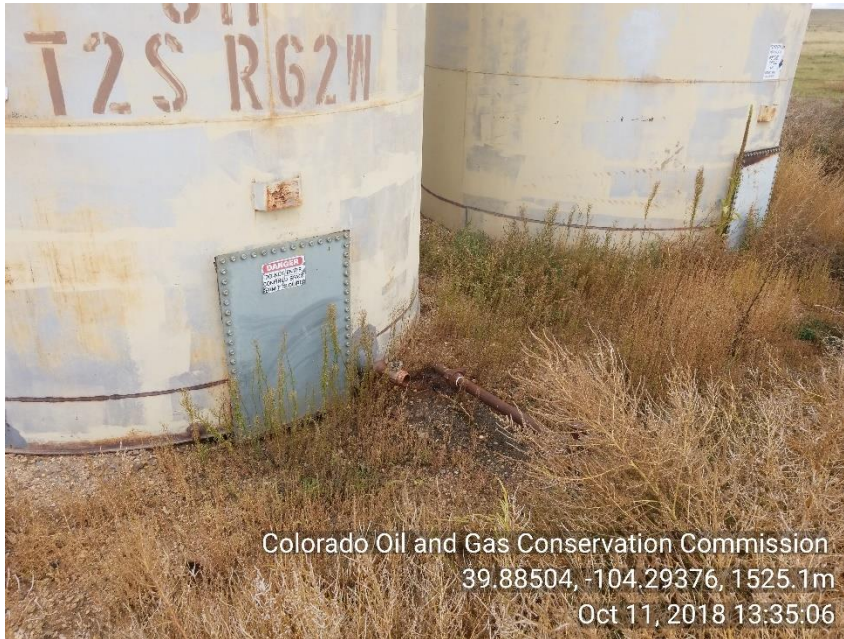
Photo 7 Leaking 2" inlet pipe to crude oil tank not connected
