Inspection Photos
Location Name: McIntyre Flowback Pits #3 and #4
Facility ID #421066

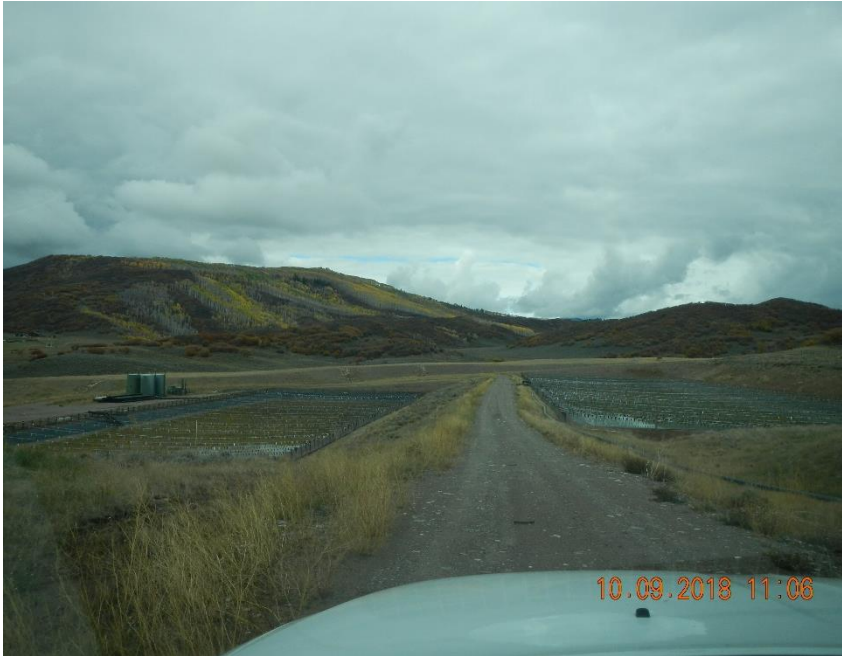
Pit Facility ID #421066 location photo.

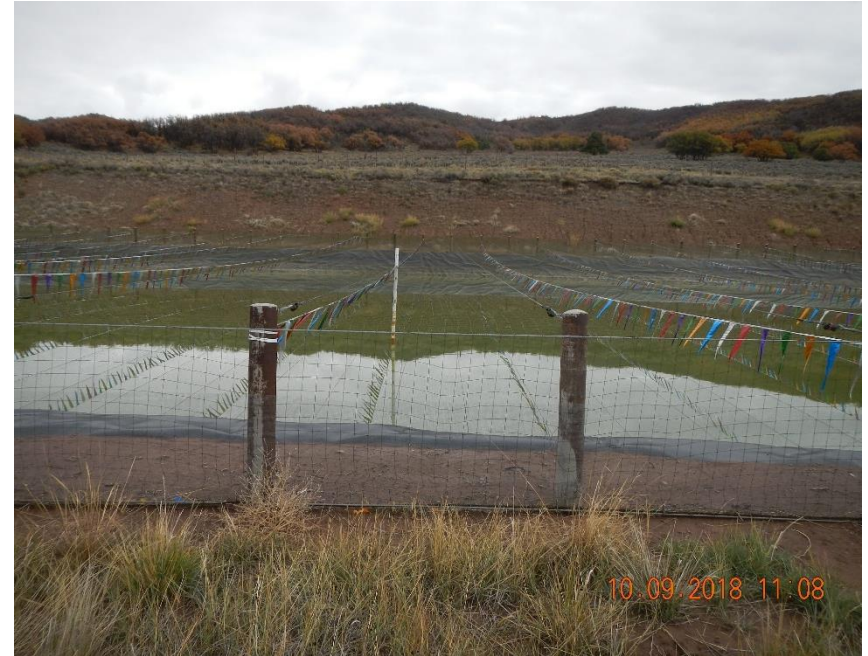
Gauge stick in pit #4 read approximately 9.5'.

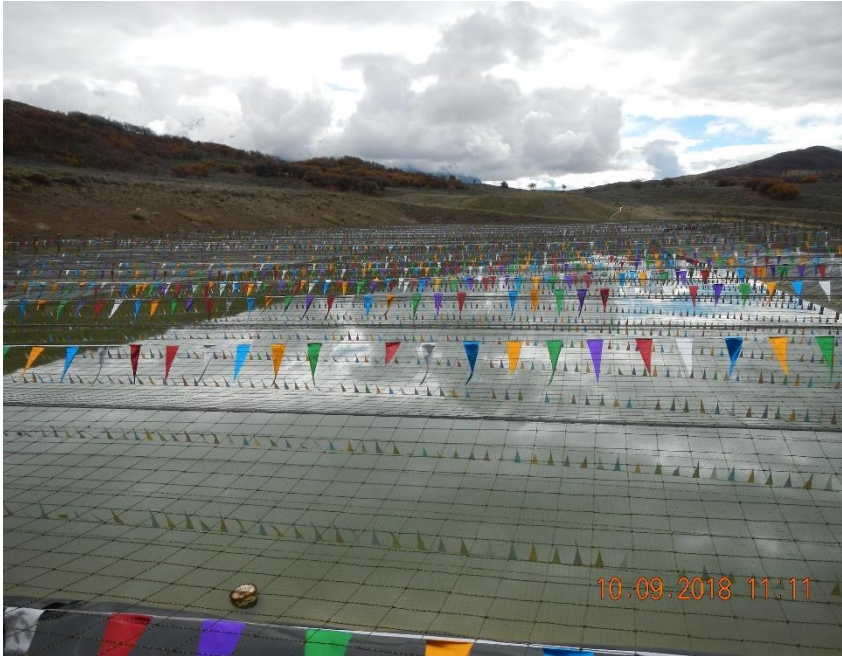
Upper Pit (#4), Facility ID #418790. Fence and netting are in good condition.

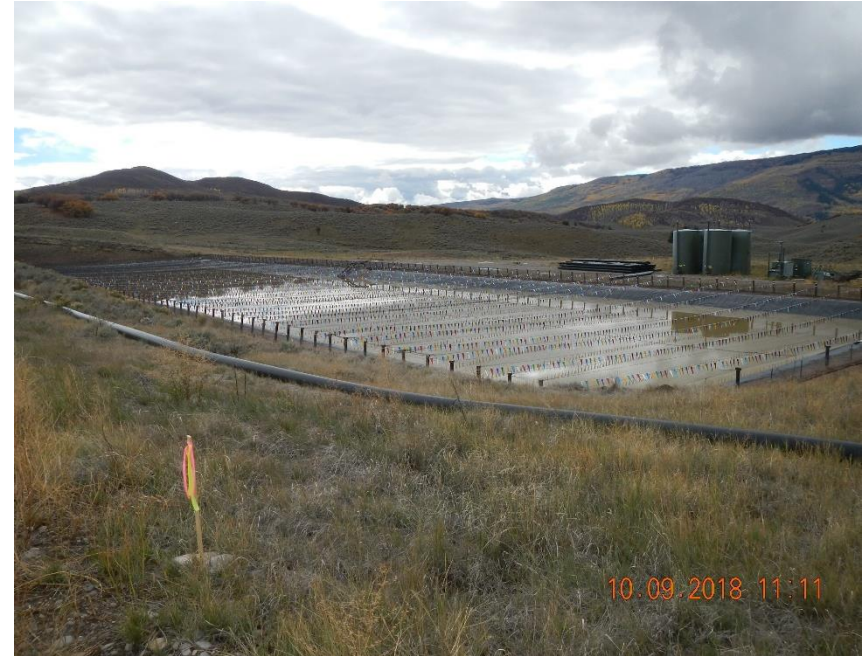
Lower Pit (#3), Facility ID #418791. Fence and netting are in good condition.

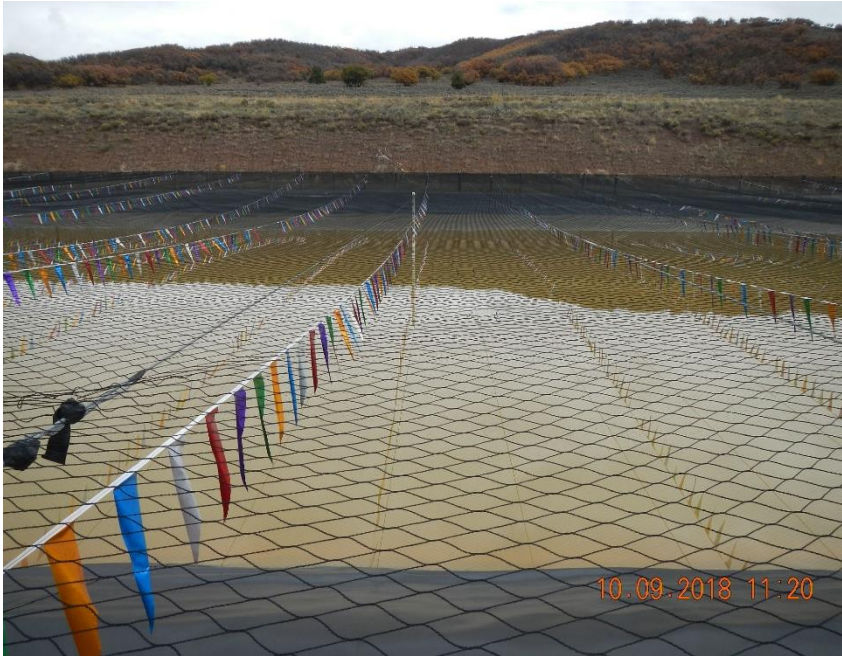
Gauge stick in Pit #3 read approximately 9'. No hydrotest pit level indicator marks were observed during this inspection.

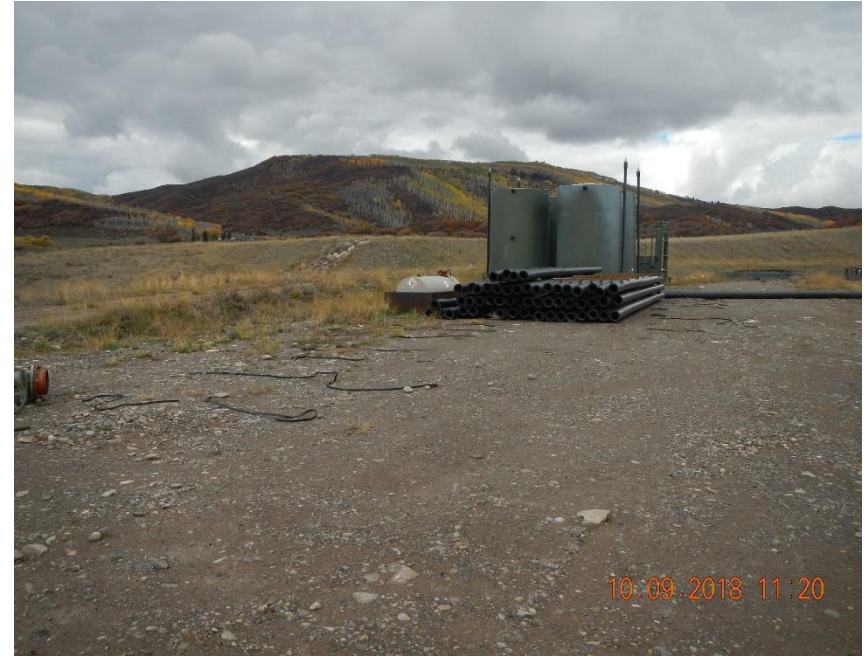
Poly water transfer pipe, being prepared for transport during last inspection, remains on site.

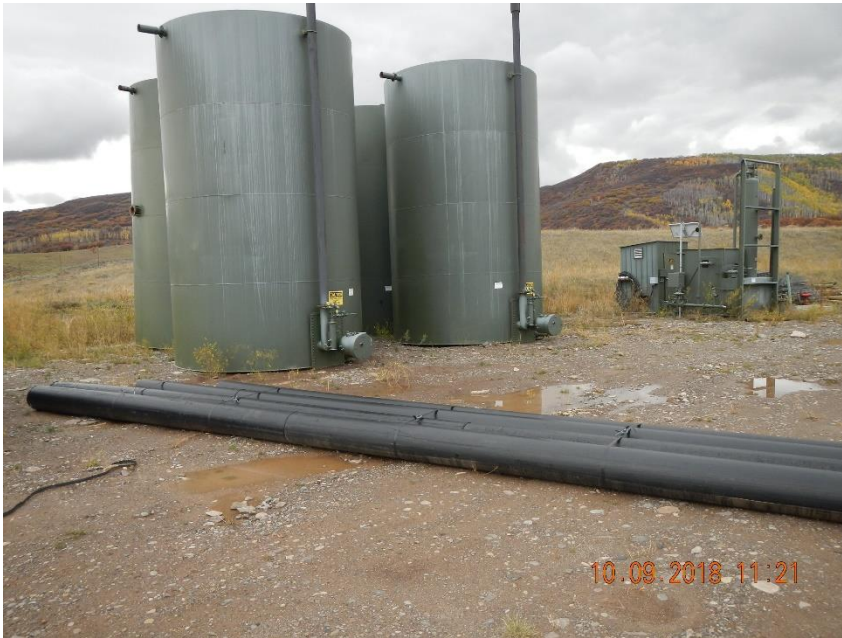
Poly water transfer pipe stored on location near SW corner of location.

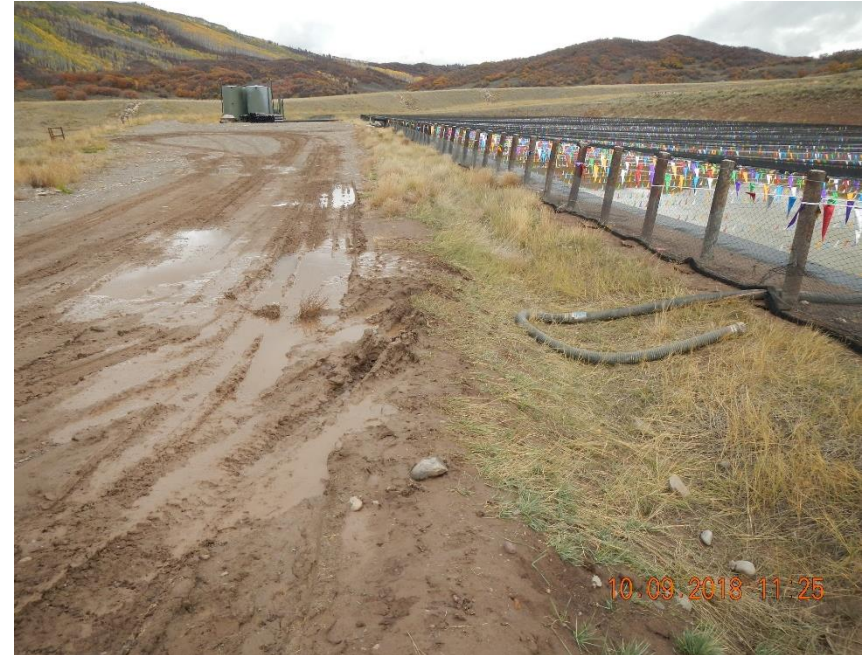
Area used by water trucks for water transfer operations. Ensure adequate spill prevention during transfers.
