**Inspection Photo
GMU 22-6
API # 045-18326
Inspection # 689302124**

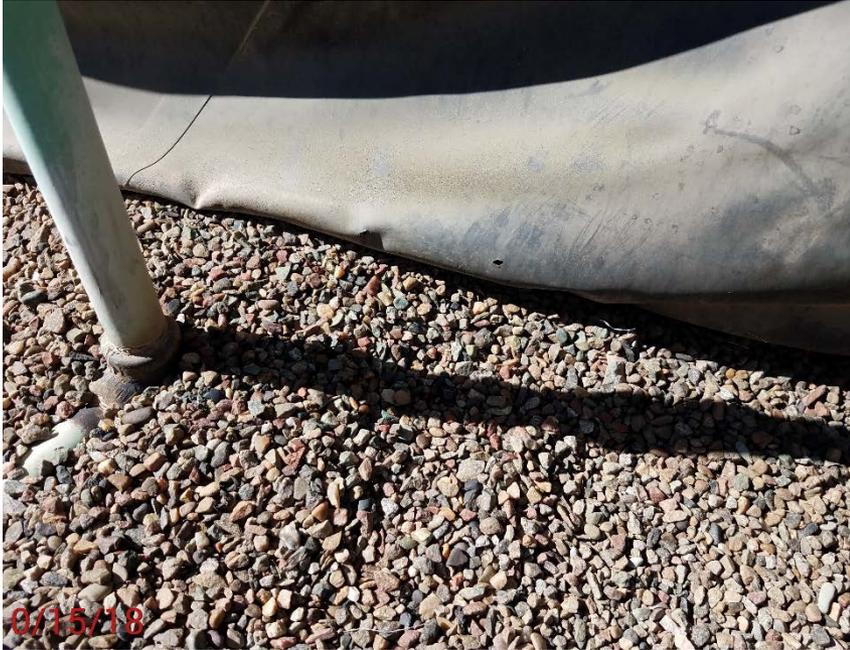
Location Photo #3, holes in secondary containment

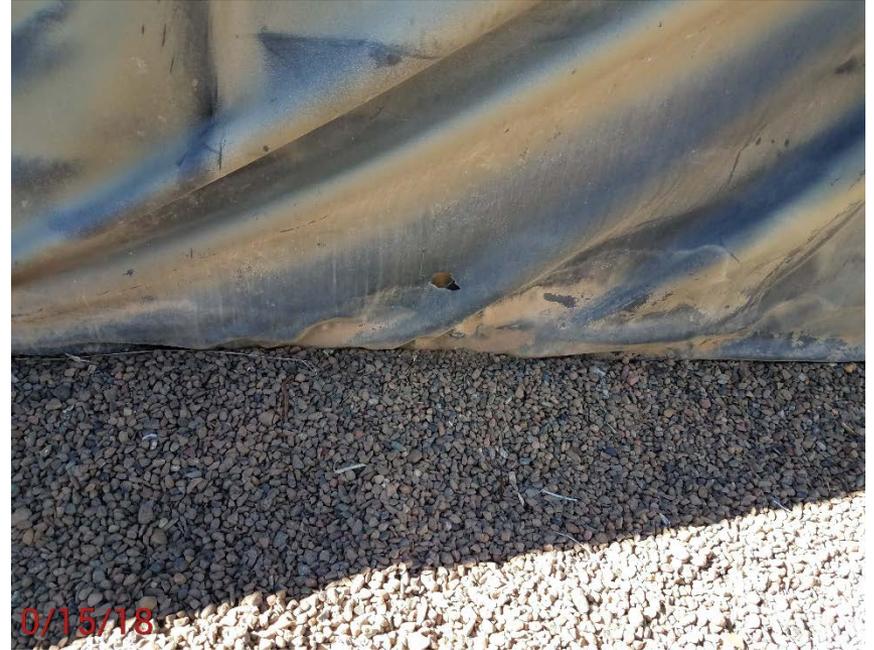
Location Photo #4, holes in secondary containment

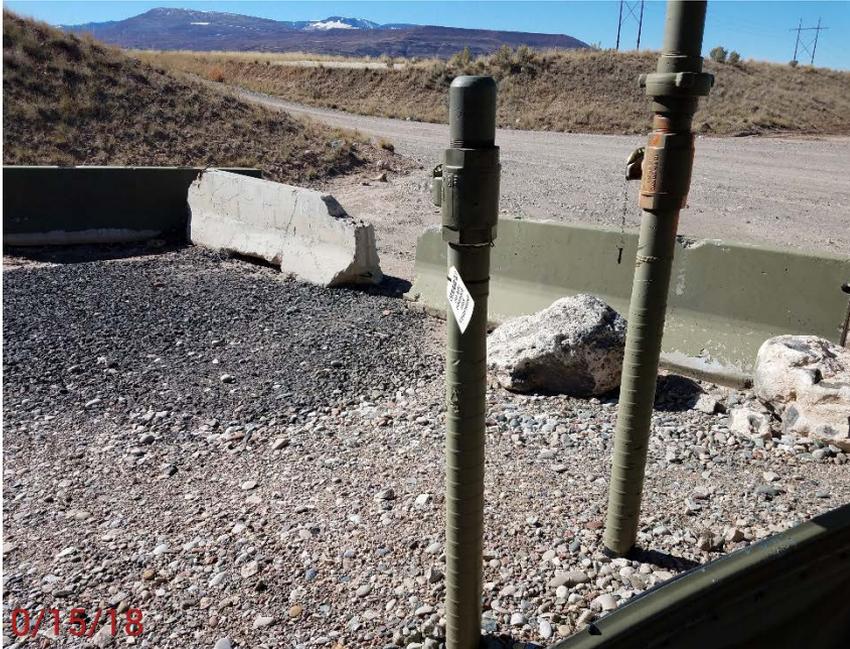
Location Photo #5, unused flow line riser

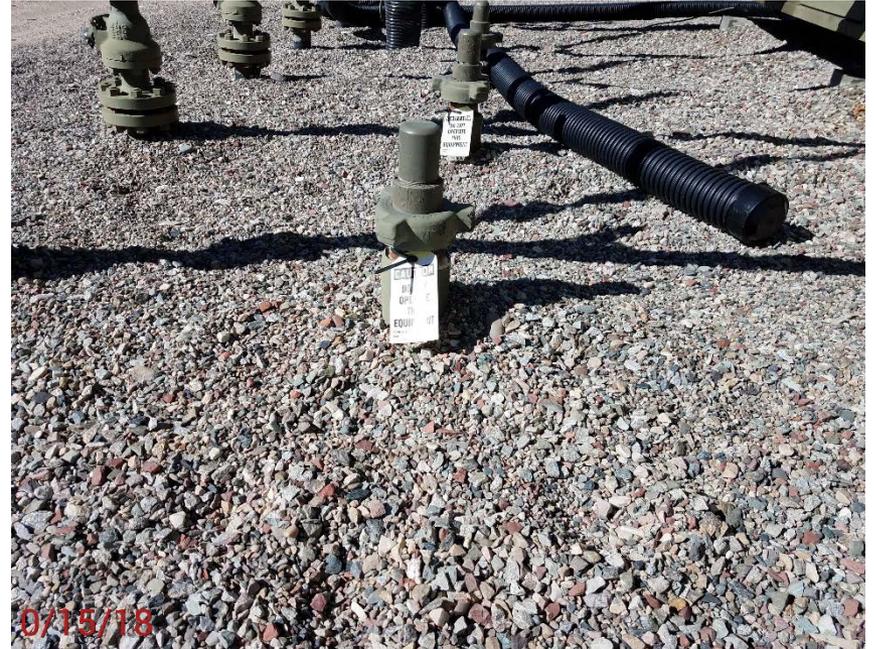
Location Photo #6, 4 unused flow line risers

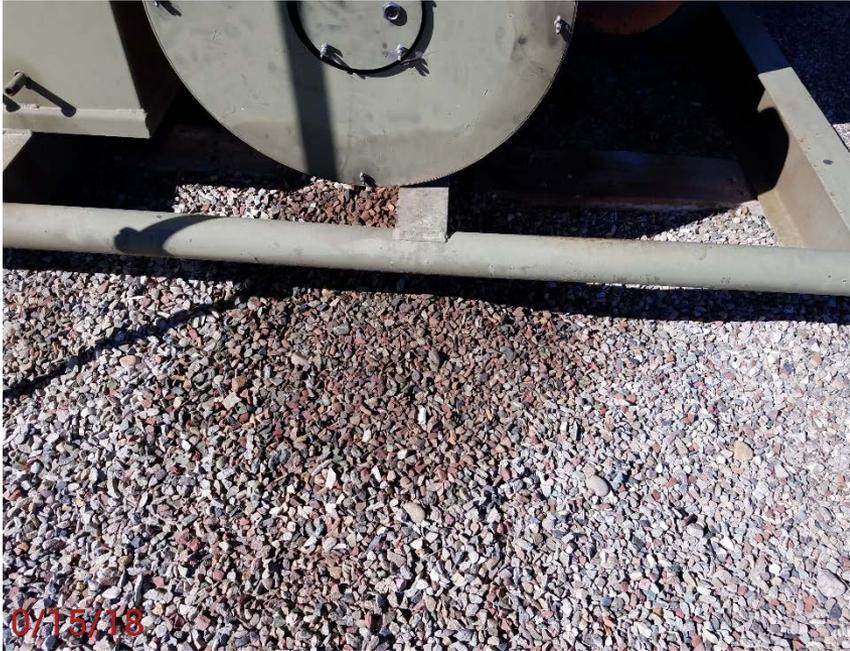
Location Photo #7, stained rock by separator

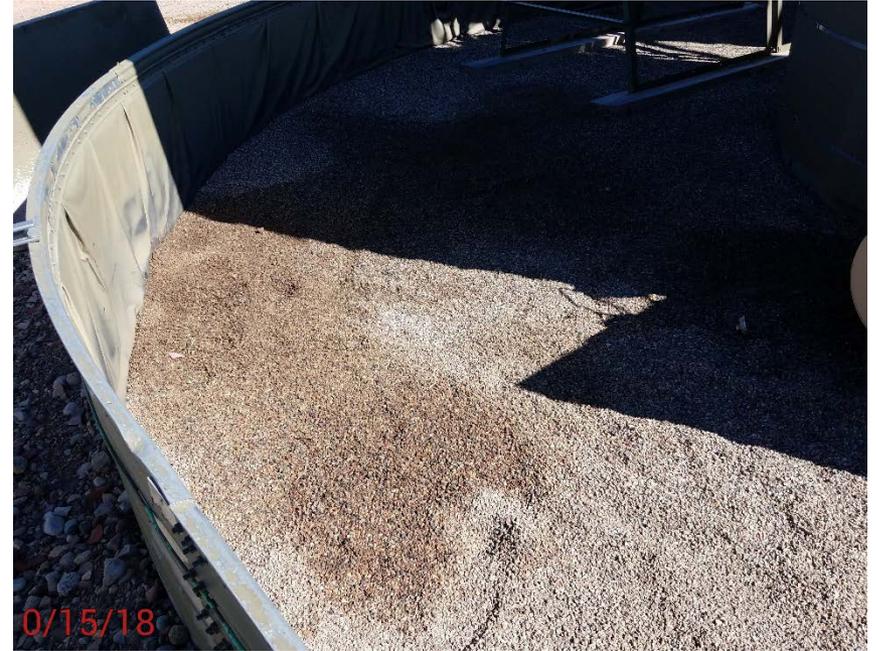
Location Photo #8, Stained rock in battery containment.

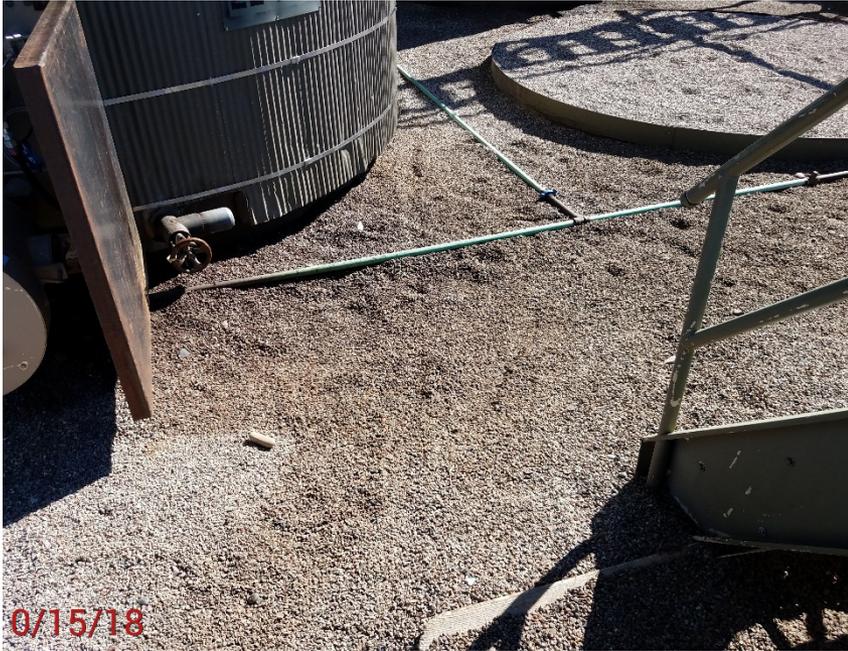
Location Photo #9, Stained rock in battery containment.

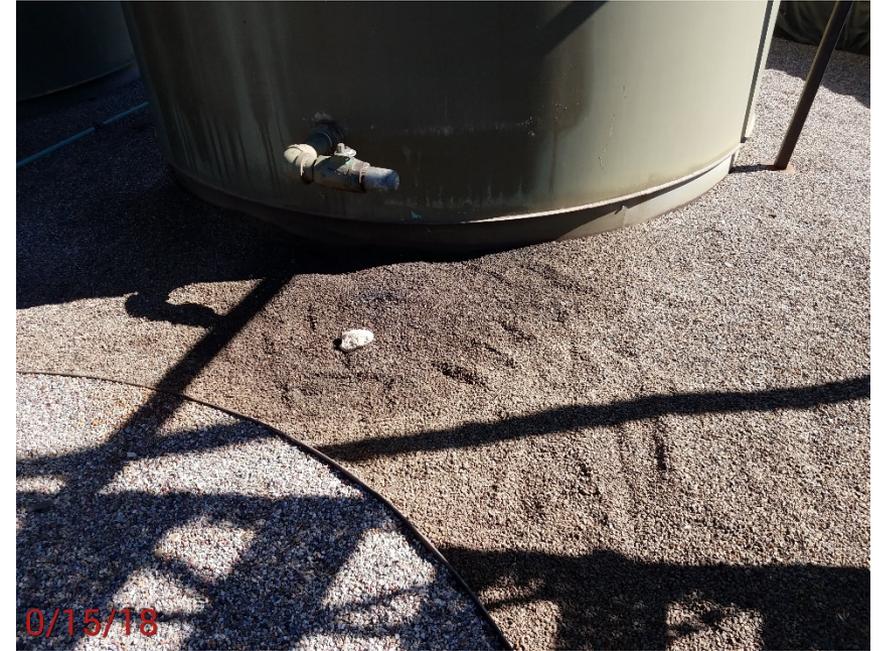
Location Photo #10, Stained rock in battery containment.

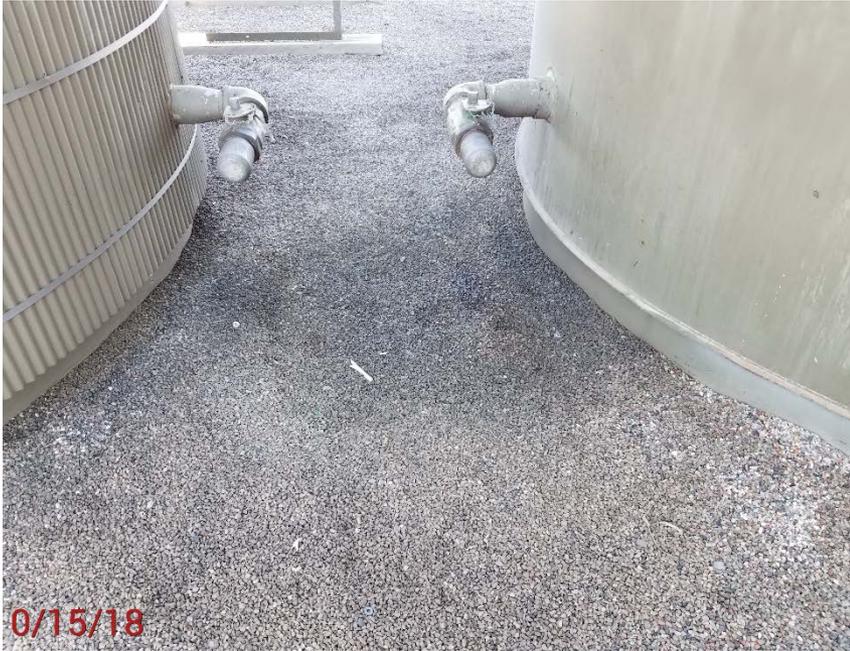
Location Photo #11, Stained rock in battery containment.

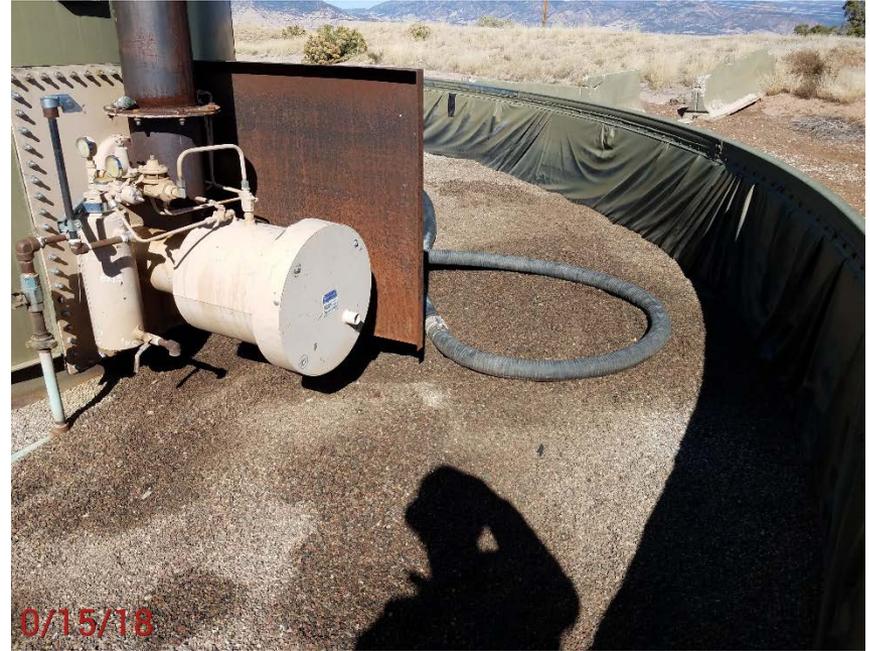
Location Photo #12, , Stained rock in battery containment.

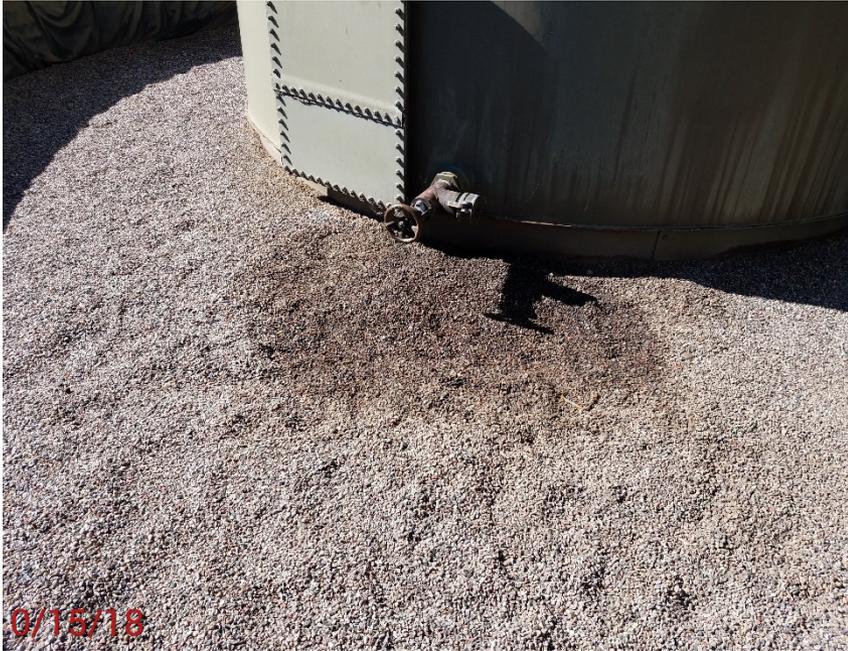
Location Photo #13, Stained rock in battery containment.
