Inspection Photos  
Location Name: Spicer 3-32H  
API: 05-057-06469

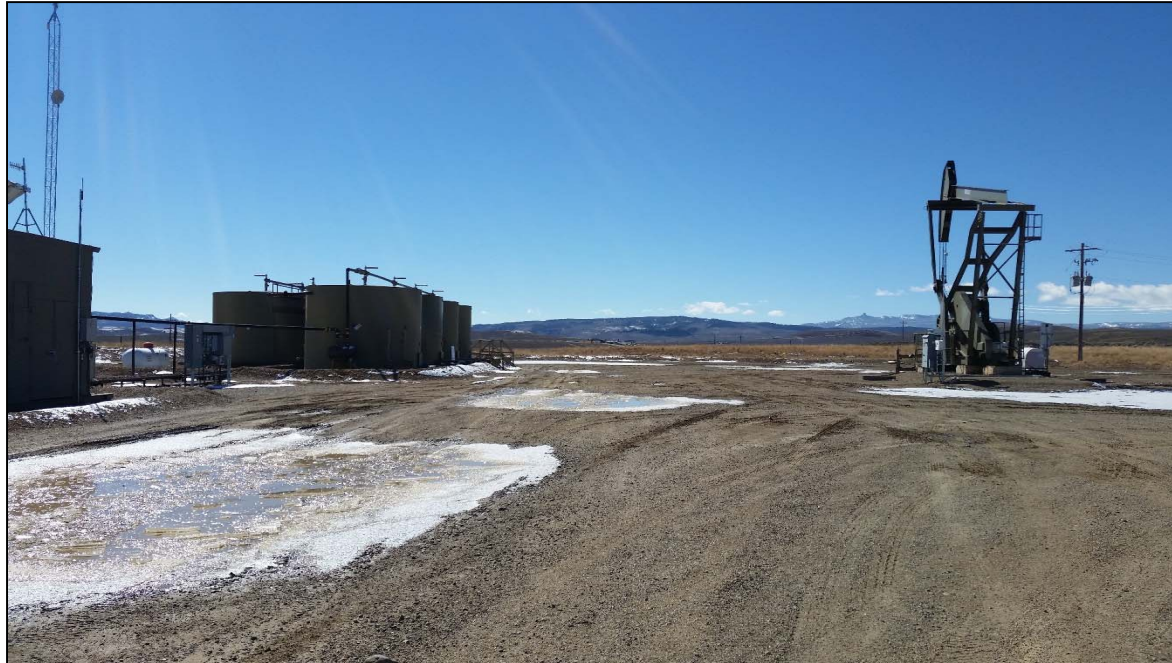
**Photo 1. Overview of location taken at entrance facing south.**

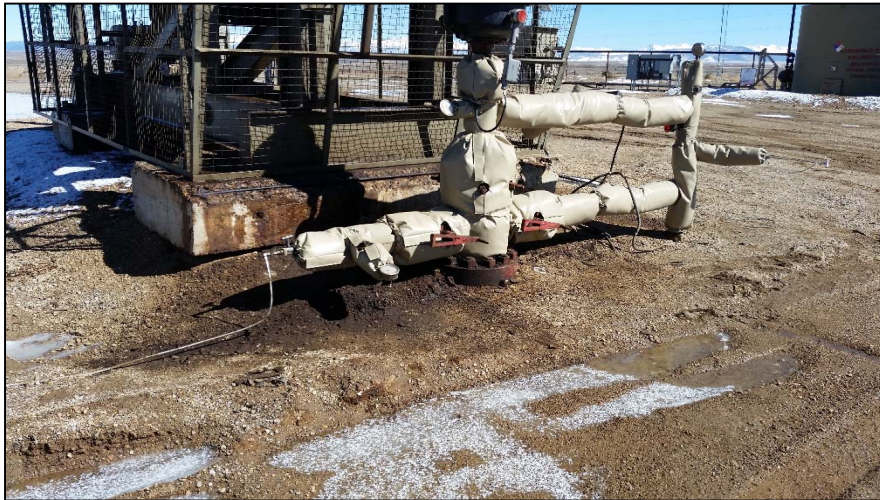
**Photo 2. Stained soil at wellhead.**

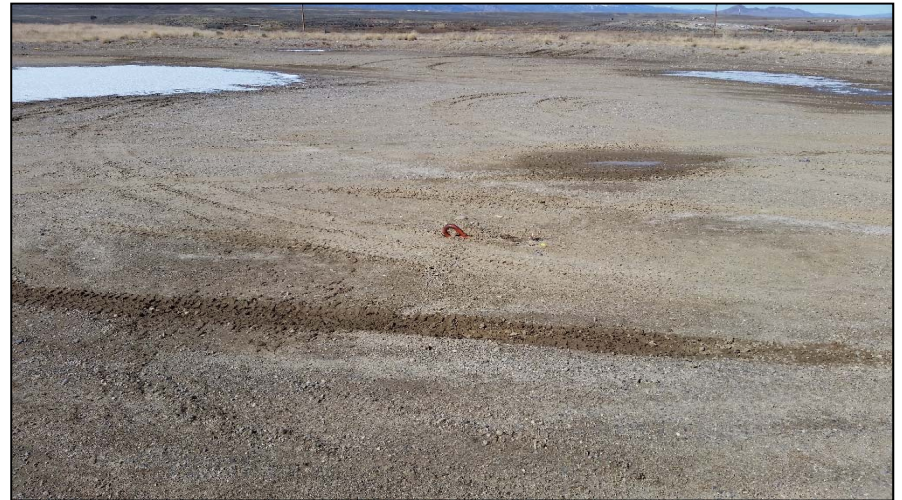
**Photo 3. Unmarked guy line anchor.**
