GM 14-27
Api# 05-045-07713
Inspection # 689701913

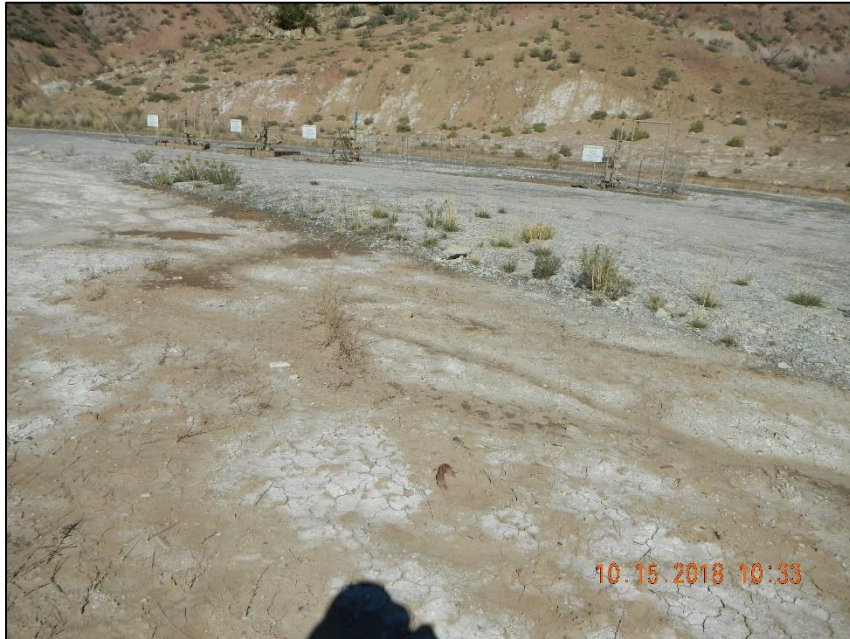
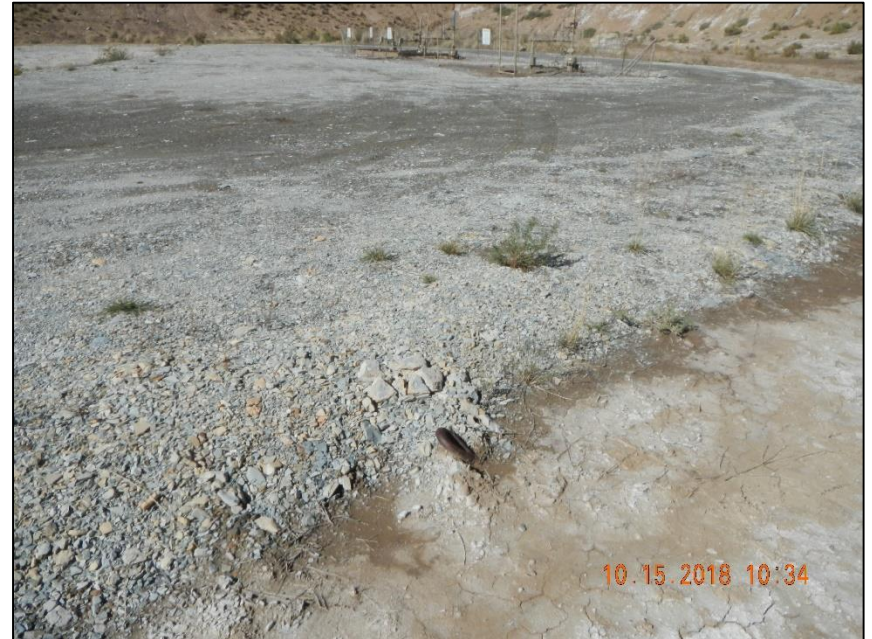
Unmarked deadmen

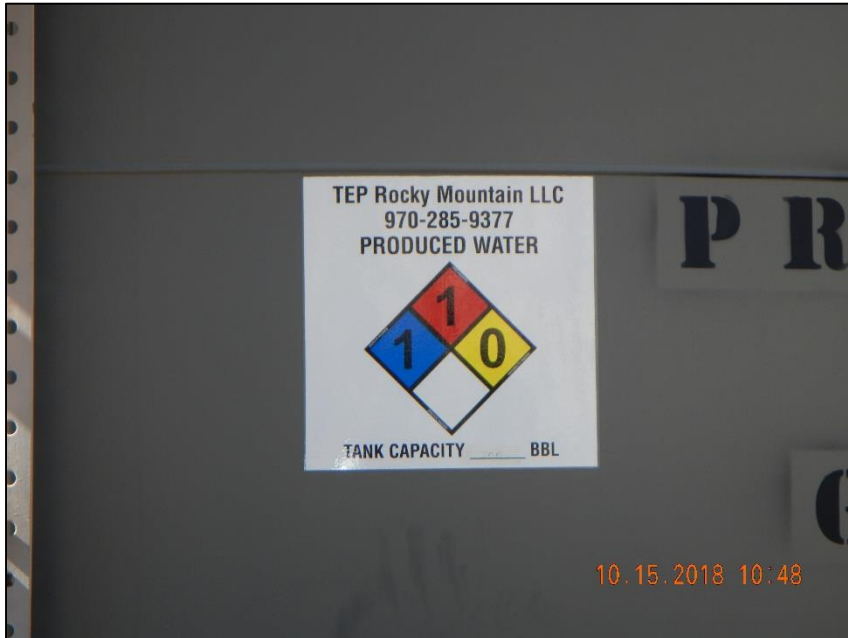
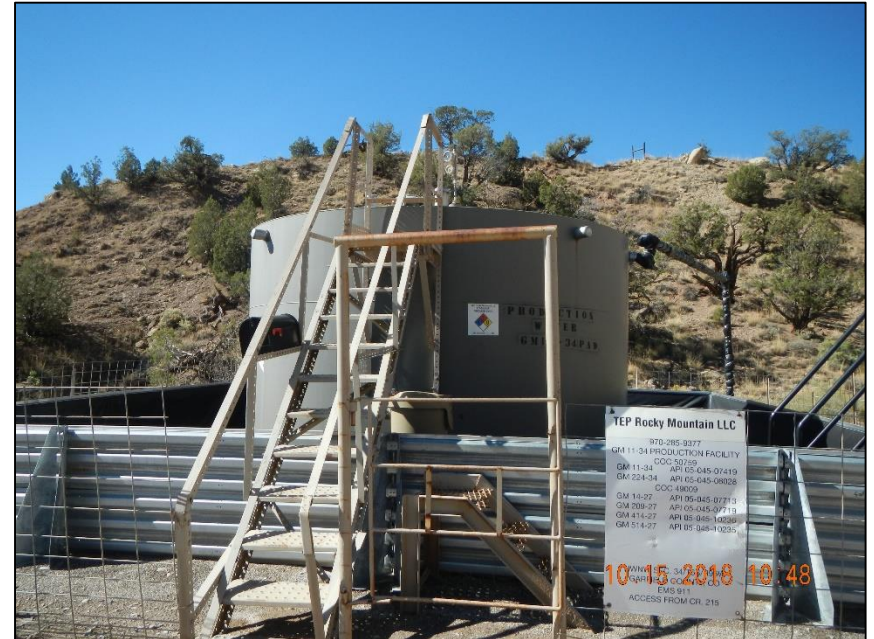
Faded capacity

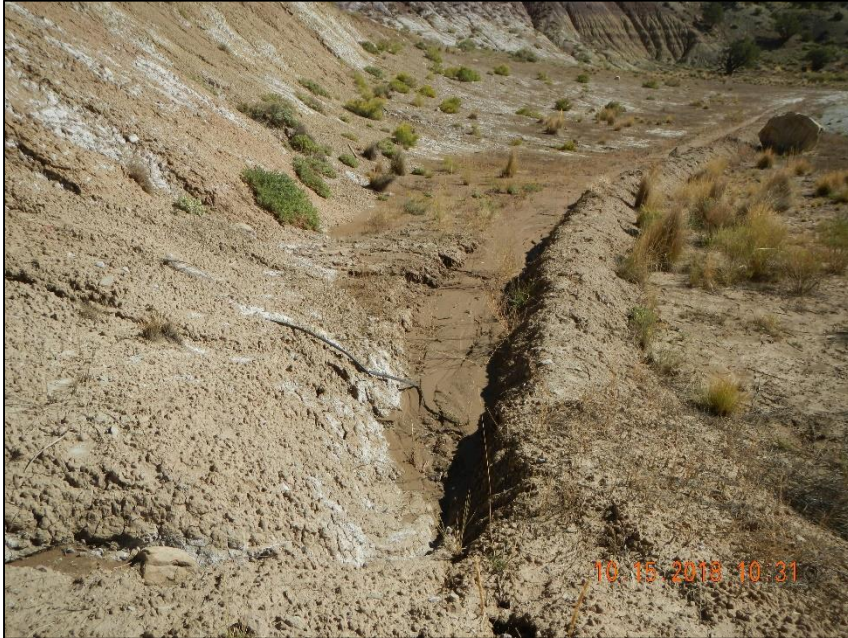
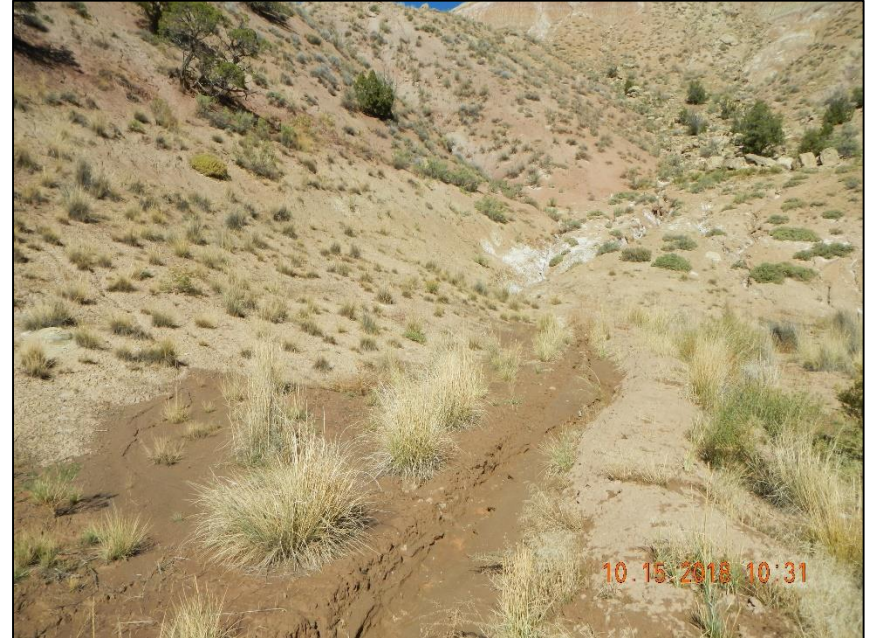
Erosion of slope and sediment build up north west of wells.

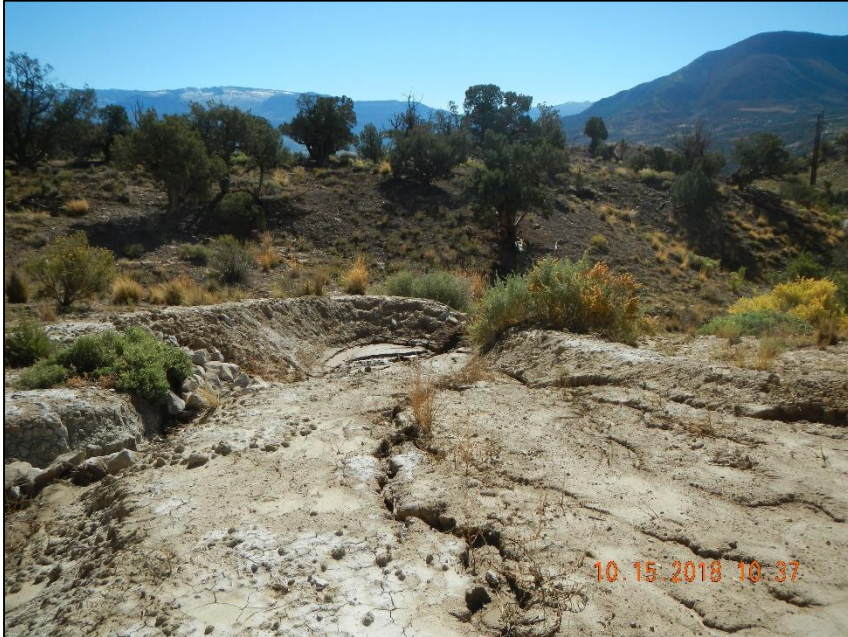
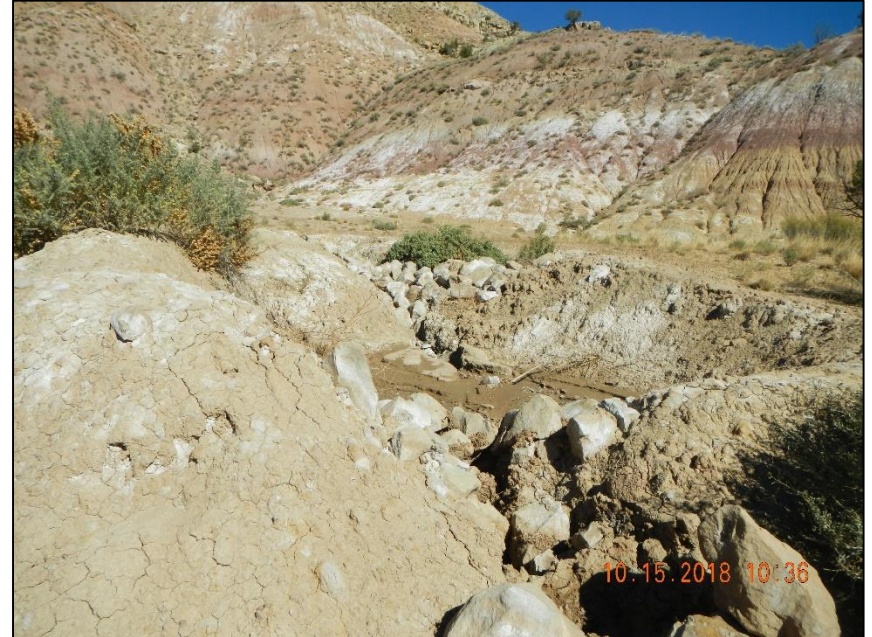
Erosion and damage of check east of wells.

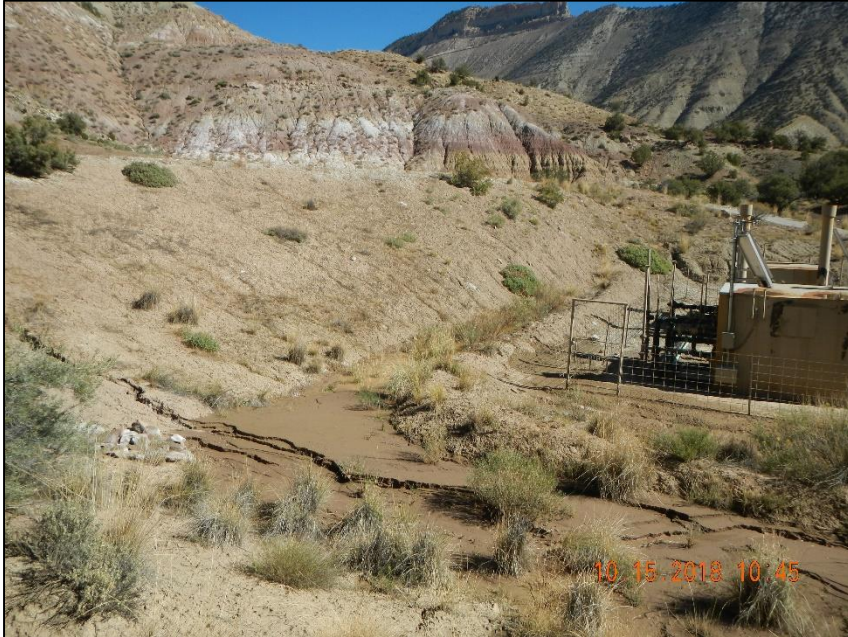
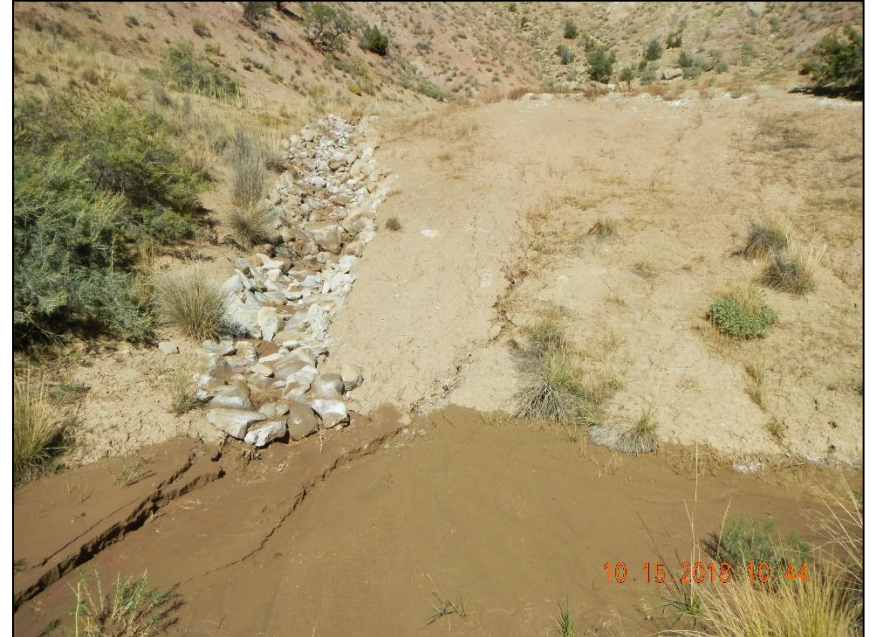
Riling of slope and sediment build up in ditch.

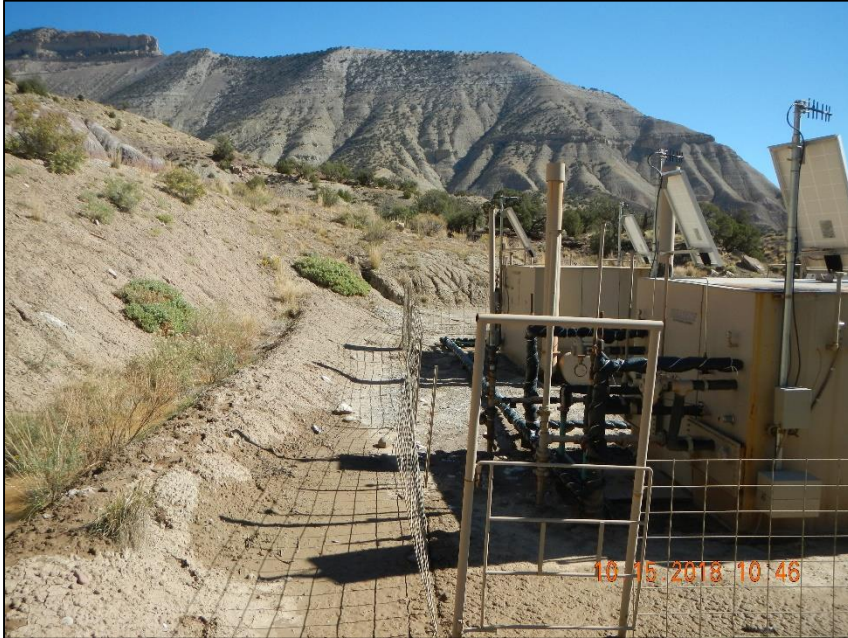
Erosion of slope east of separators

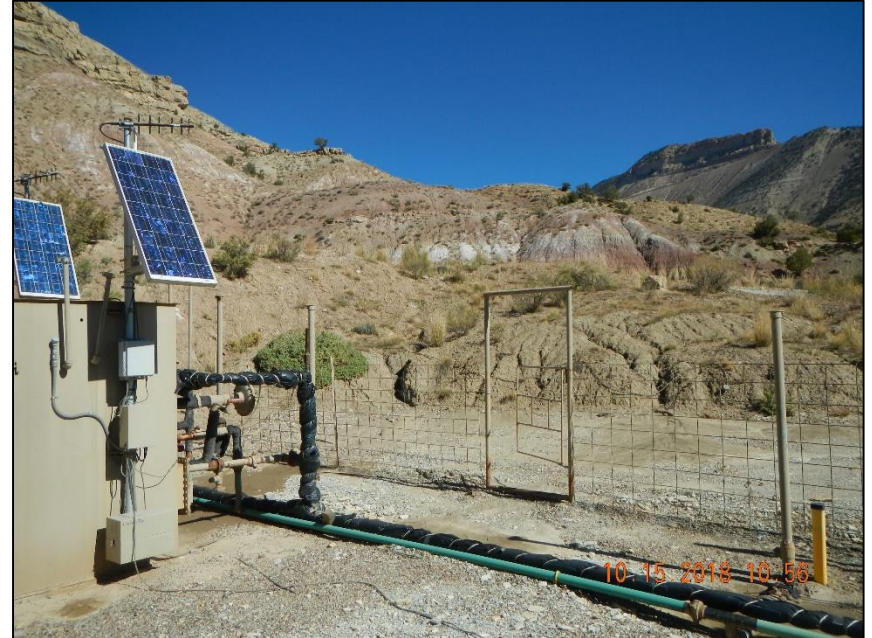
Erosion of slope east of separators

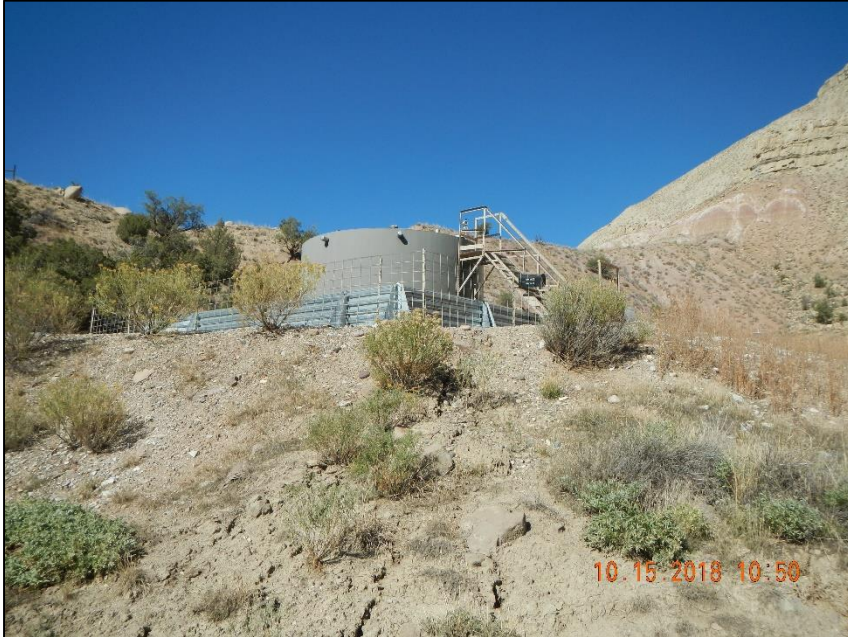
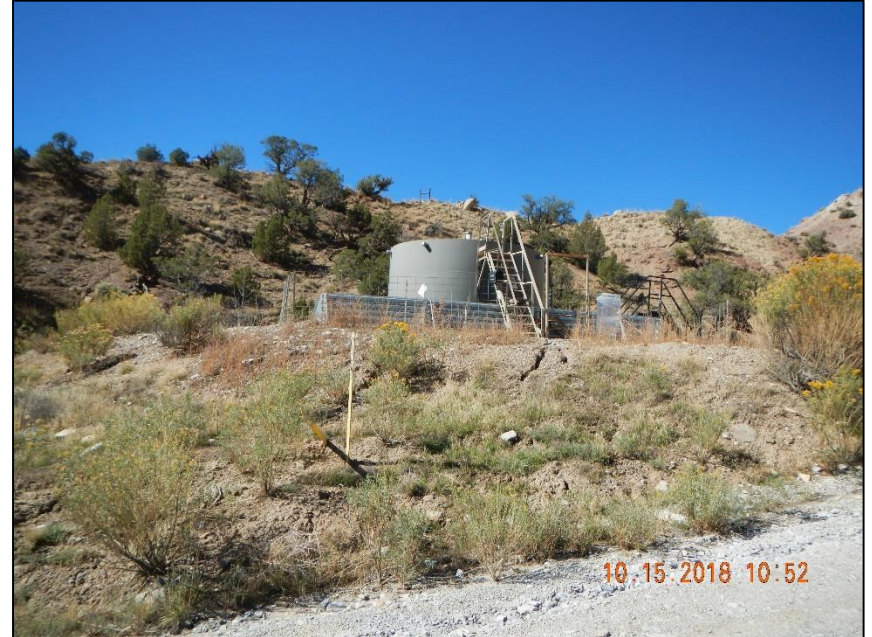
Washing rills at tank battery.
