# Inspection Photos

Operator: BP Production

API: 05-067-08745

Date: 10/05/2018

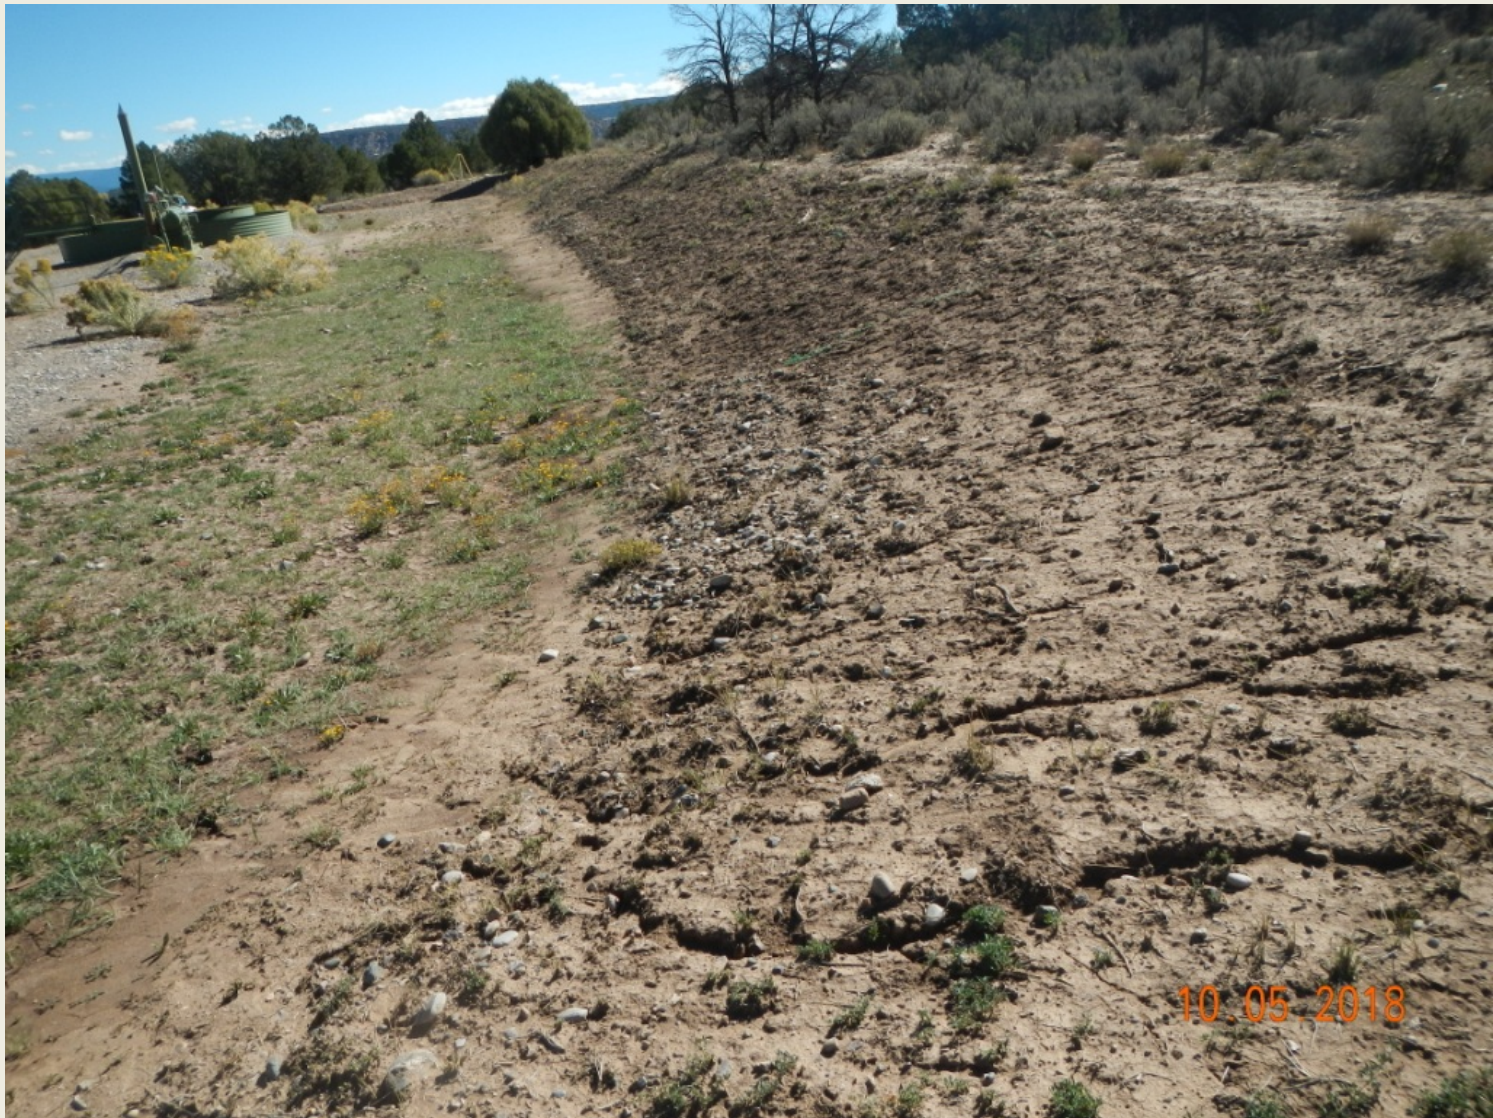
**Photo 1. View of the southern portion of the project area from the southwestern corner facing eastward. Revegetation on well pad cut and fill slopes is sparse and appears to be drought stressed. This needs to be monitored and re-vegetation efforts conducted if vegetation is not increasing during the 2019 growing season. Rilling is occurring on the cut-slope.**

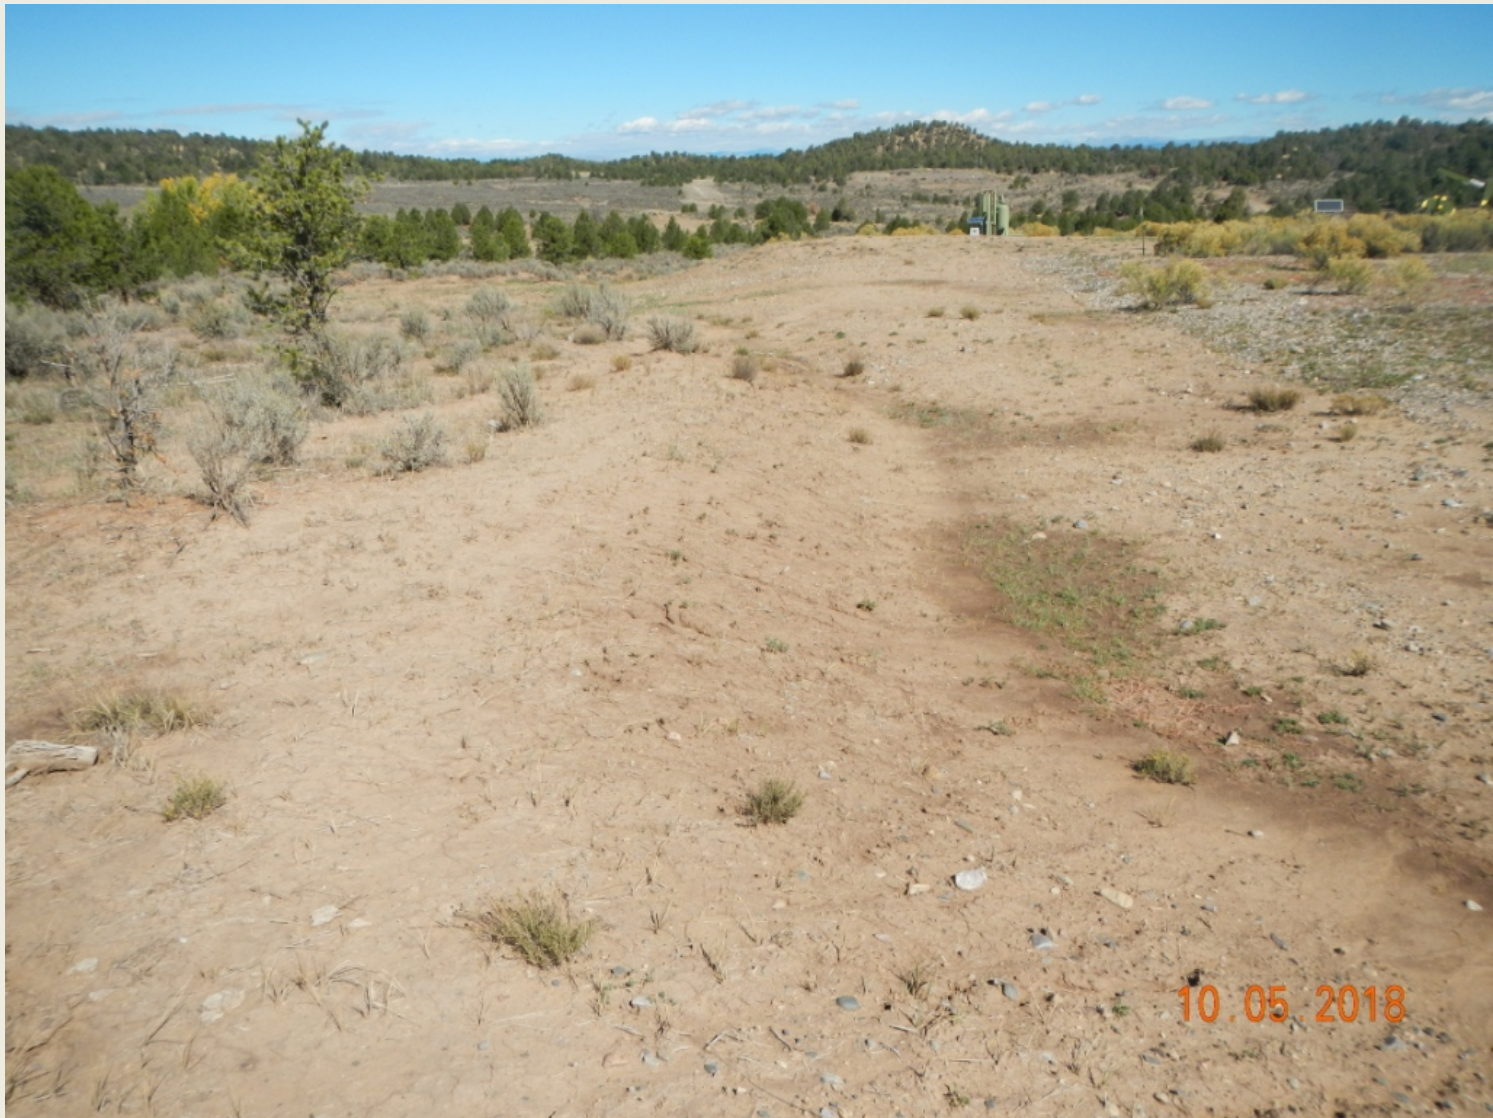
**Photo 2. View of the southwestern portion of the project area from the southwestern corner facing northward. Revegetation is also sparse here.**

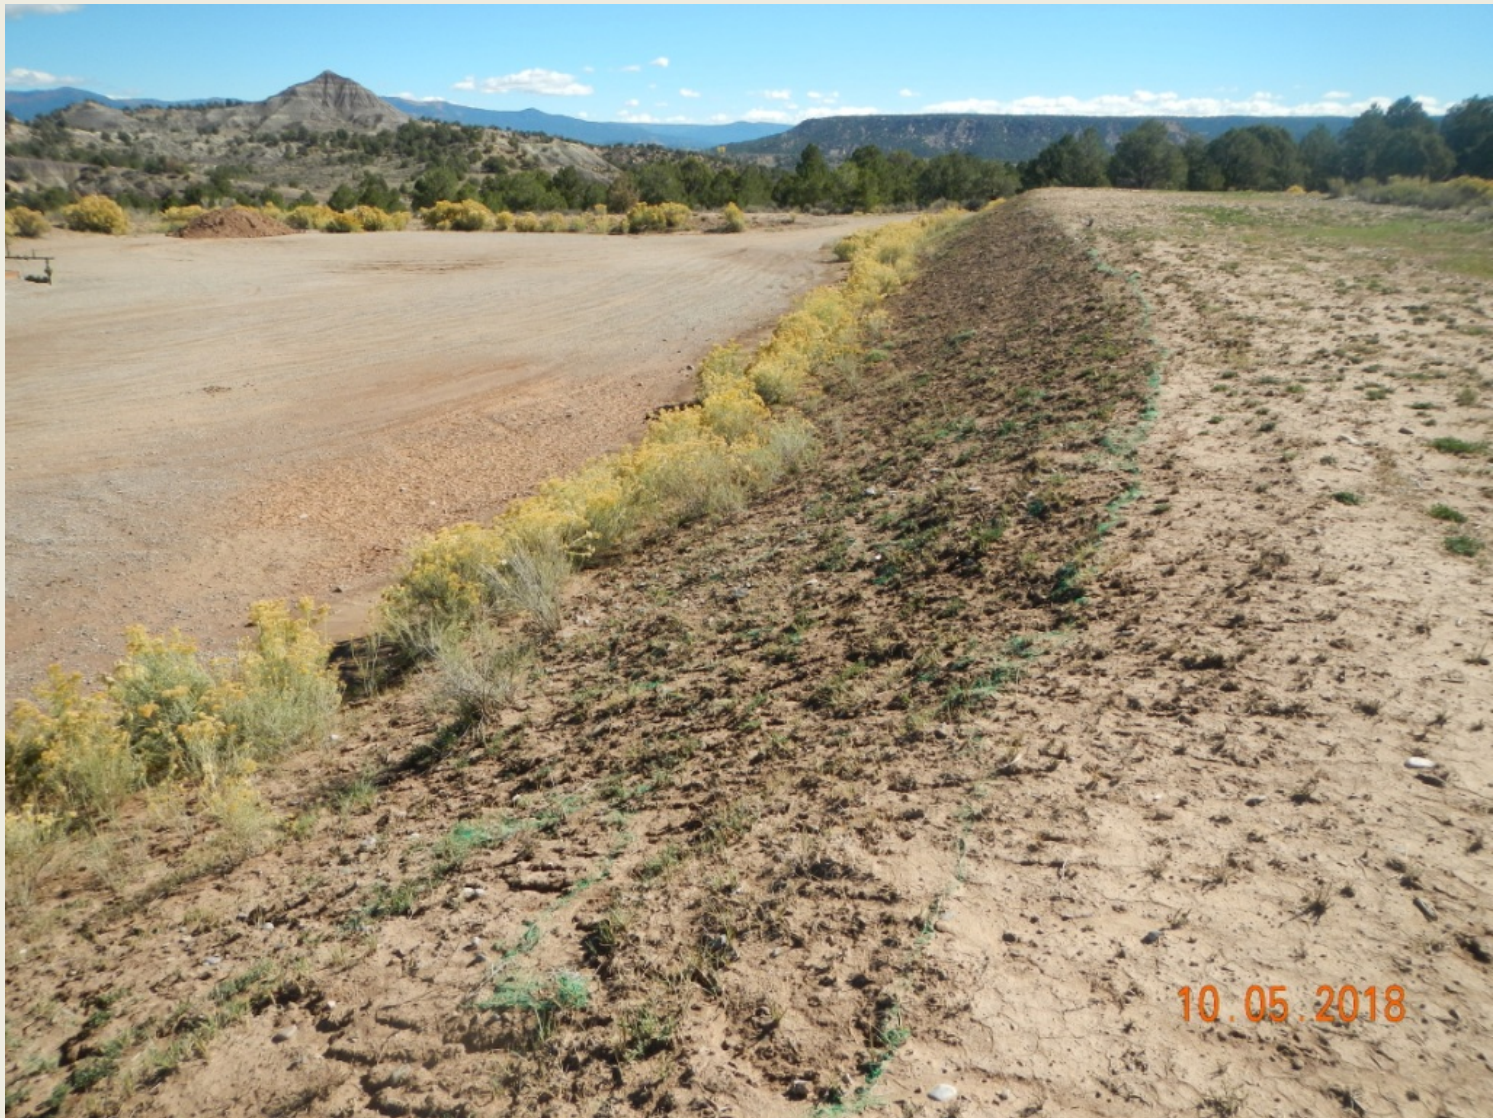
**Photo 4. View of middle fill slope from the western edge facing eastward. Green plastic debris needs to be cleaned.**

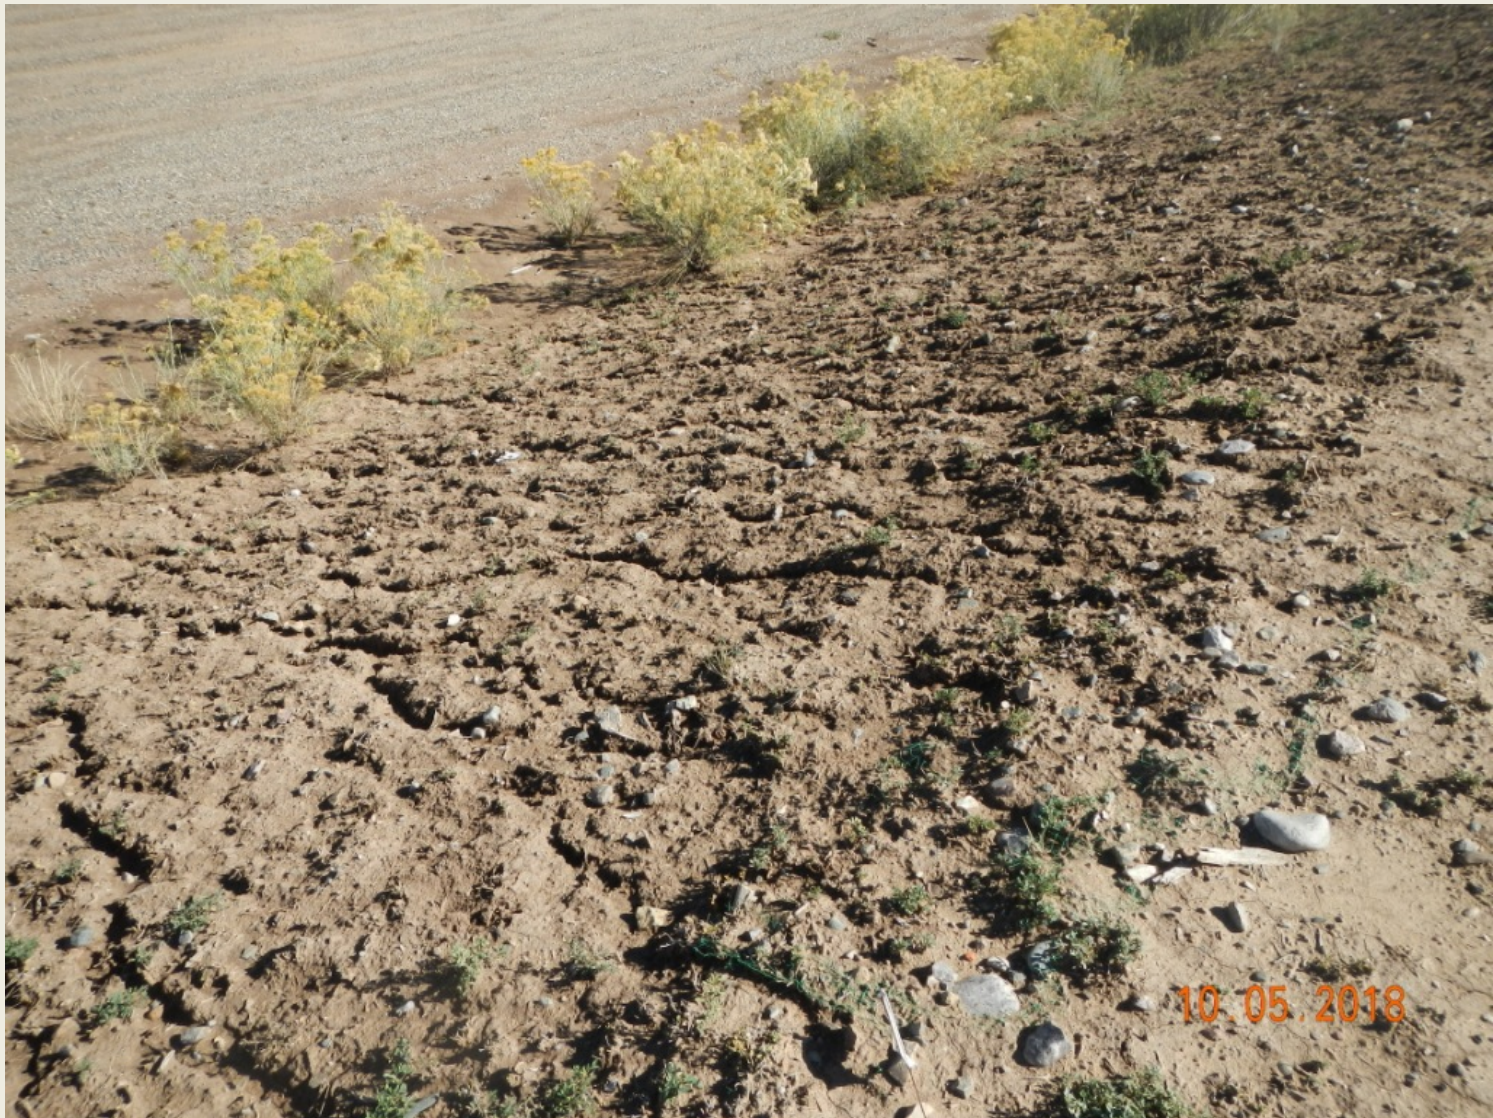
**Photo 5. View of rilling in the central fill slope and poor revegetation facing down-slope.**

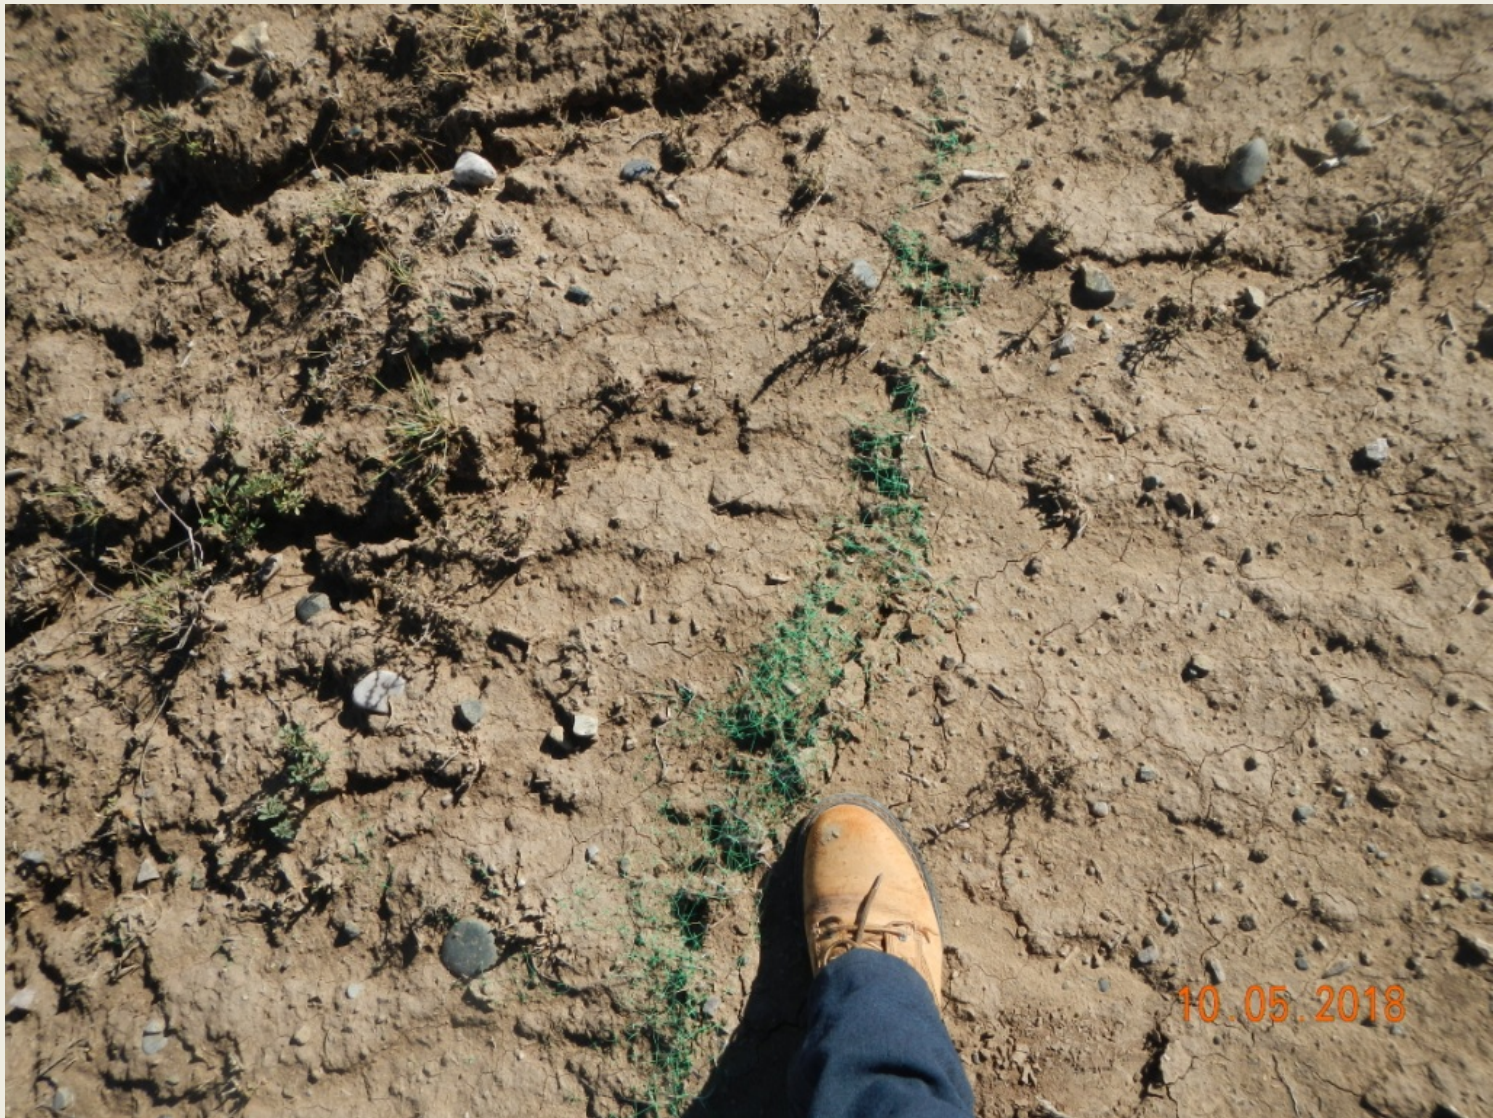
**Photo 6. Close-up view of green plastic debris in the central fill slope.**

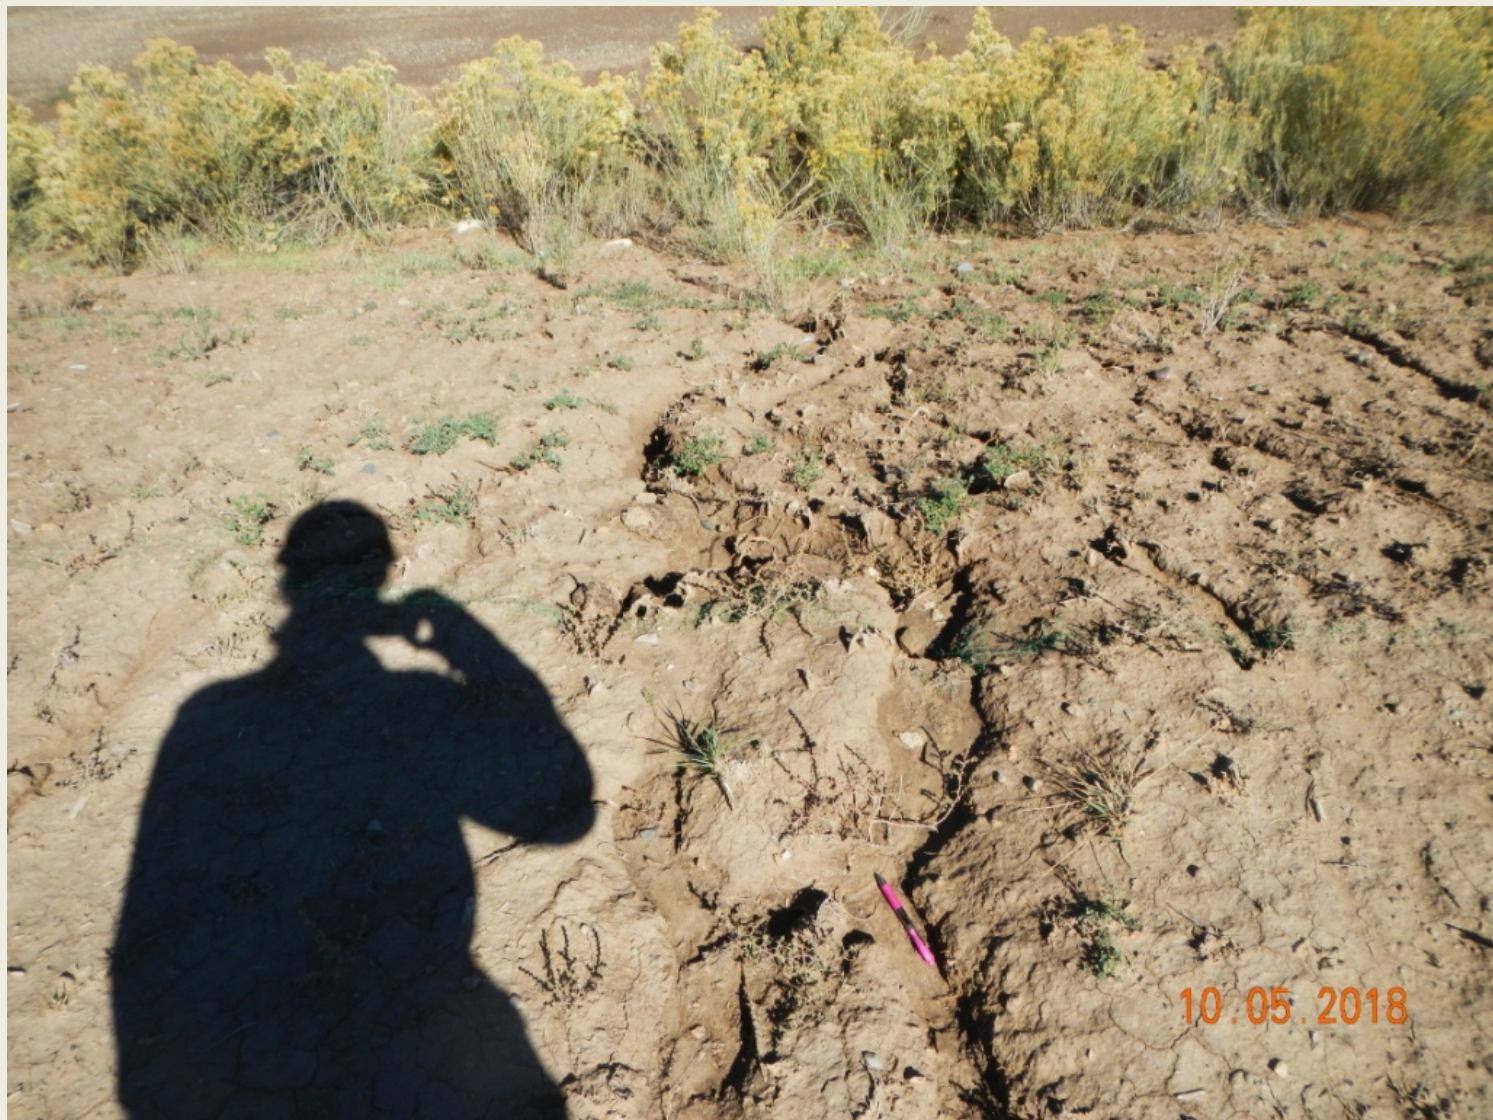
**Photo 7. View of more rilling up to 12 inches deep in the central fill slope.**
