Inspection Photos

Location Name: 05-103-08085 (TAIGA FED 14I-20-4-102)

Location ID: 315211

Inspection: 679701377

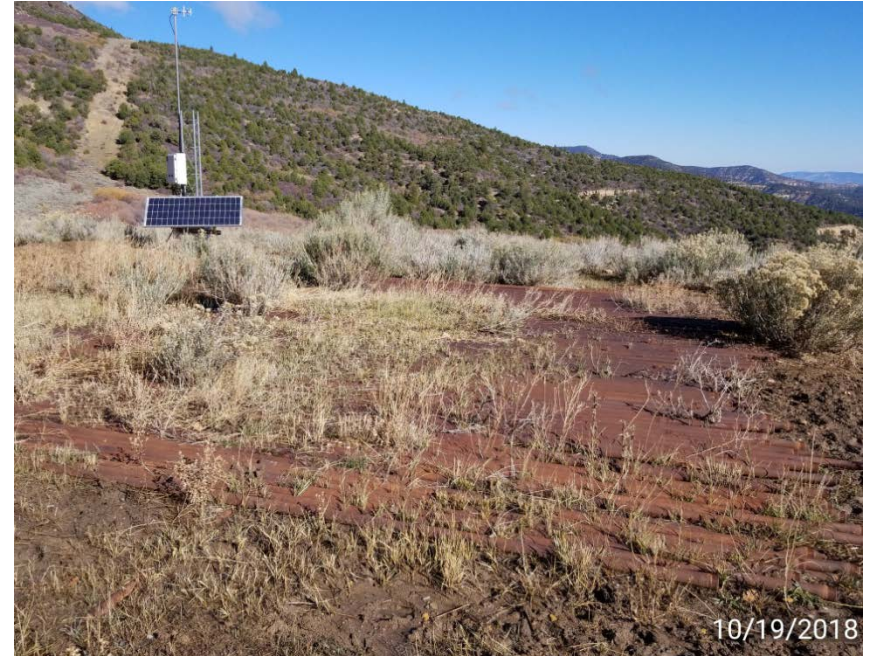
Unused equipment on location

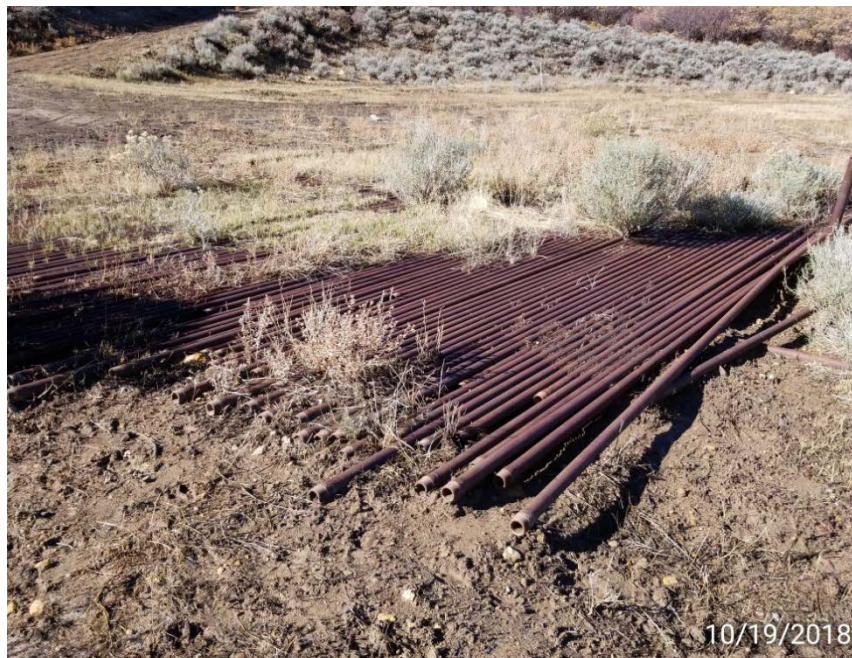
130 strings of tubing on location

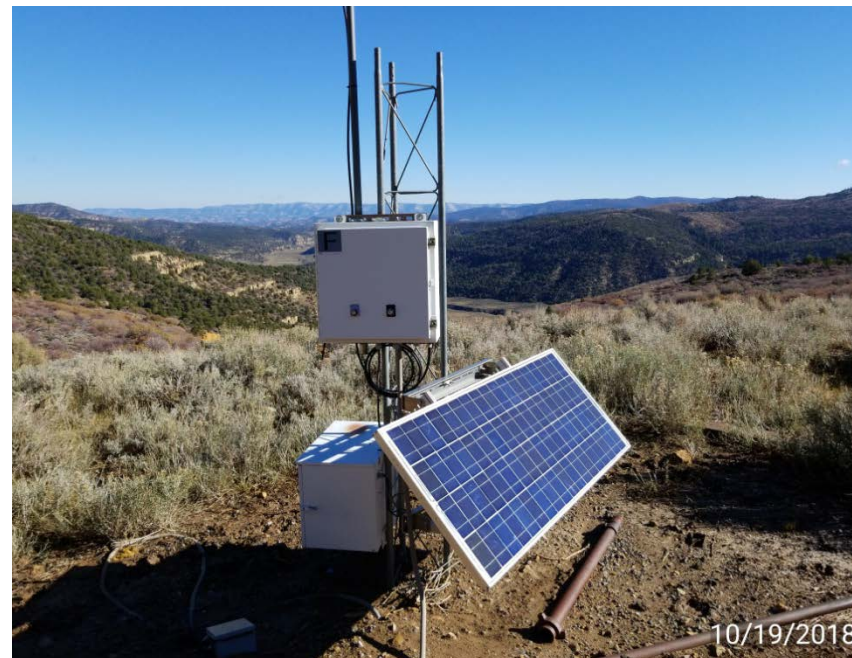
RTU on location

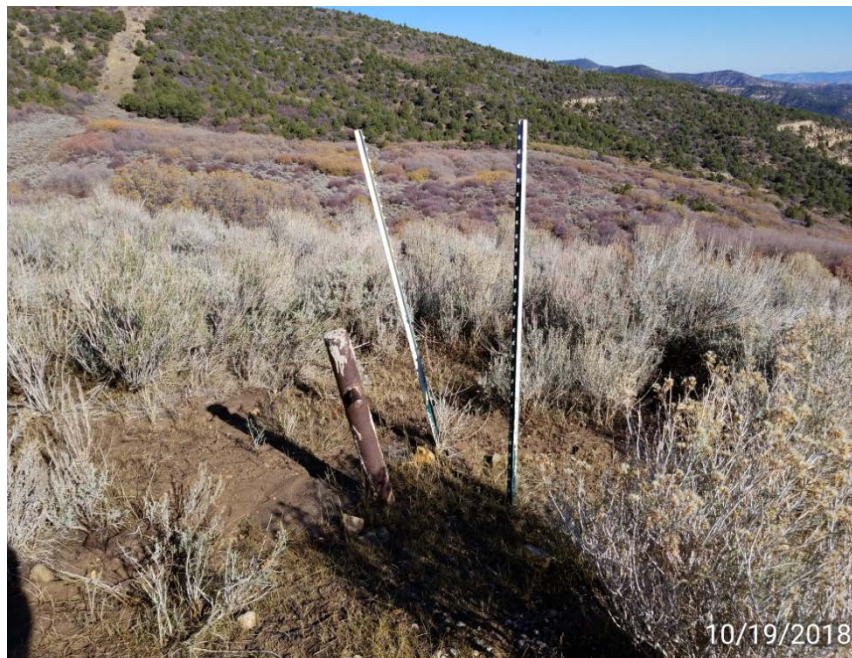
3 deadman on location

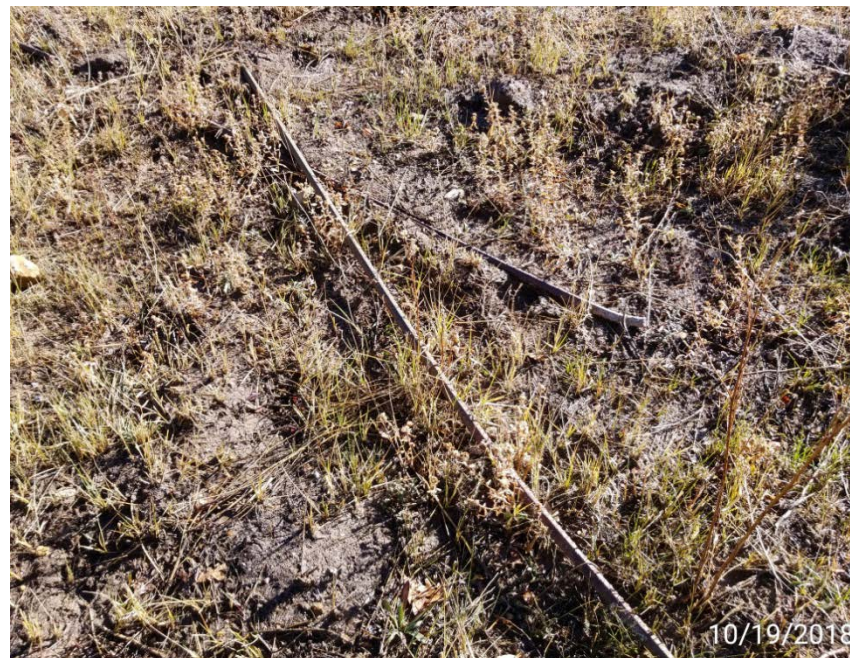
Rebar on location
