Inspection Photo
Jackson 15-28-692
API # 045-07633
Inspection # 689302148

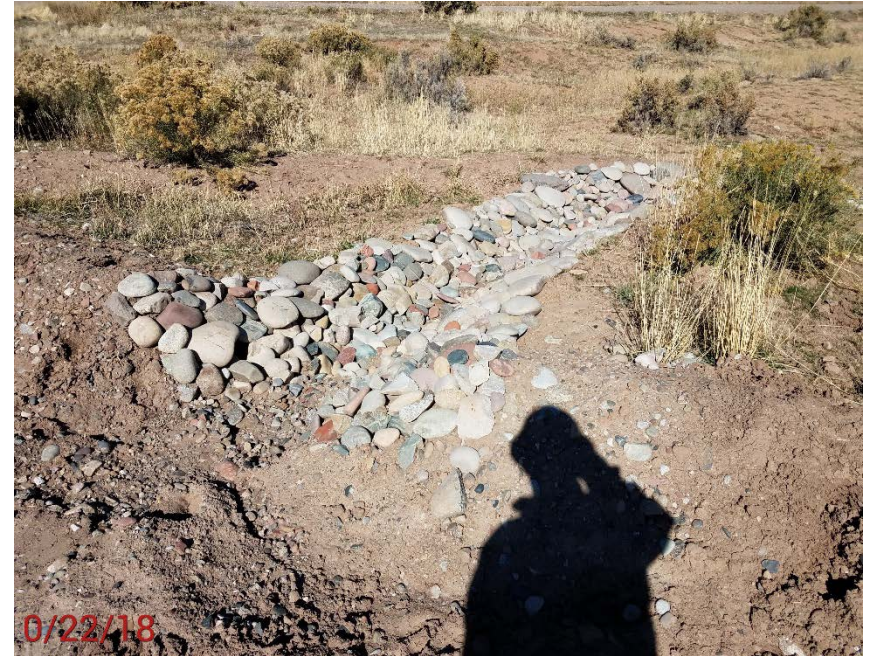
Location Photo #2, repaired storm water
