Inspection Photos

Operator: BP Production

API: 05-067-06208

Date: 10/05/2018

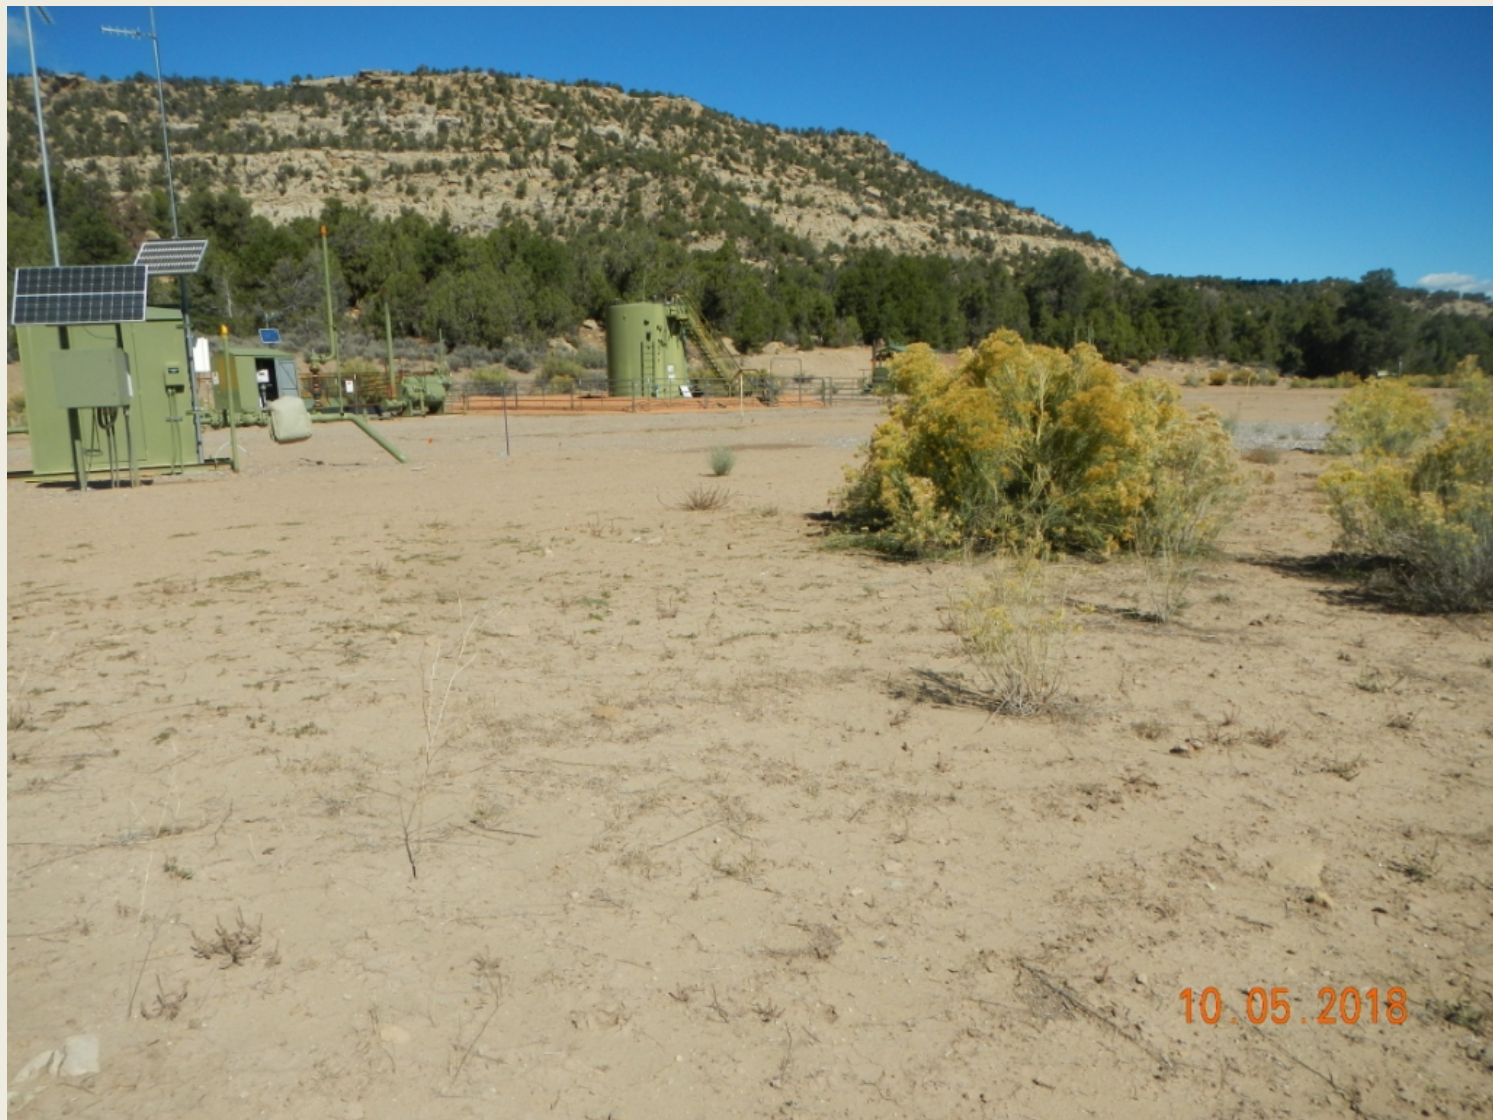
Photo 1. View of the project area from the southwestern corner facing center.

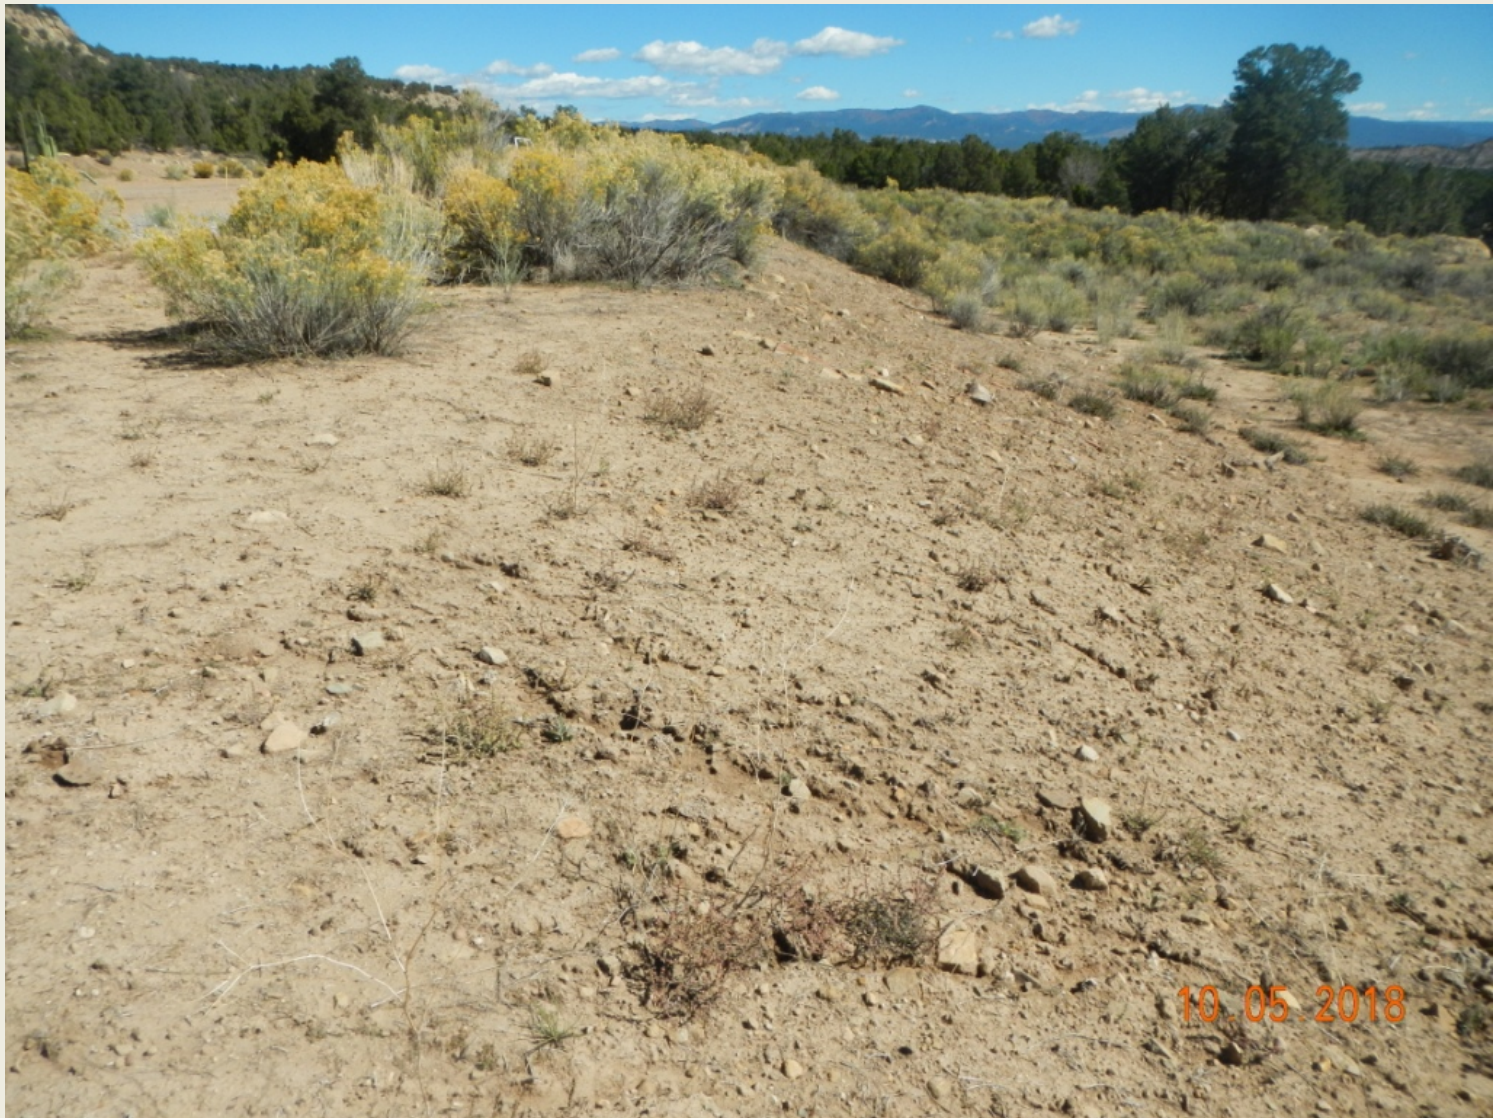
Photo 2. View of the southeastern portion of the project area from the southwestern corner facing northeastward. Revegetation is largely comprised of shrubs such as rubber rabbitbrush (*Chrysothamnus nauseosus*) and fourwing saltbush (*Atriplex canescens*), as well as sparse grasses such as western wheatgrass (*Pascopyrum smithii*).

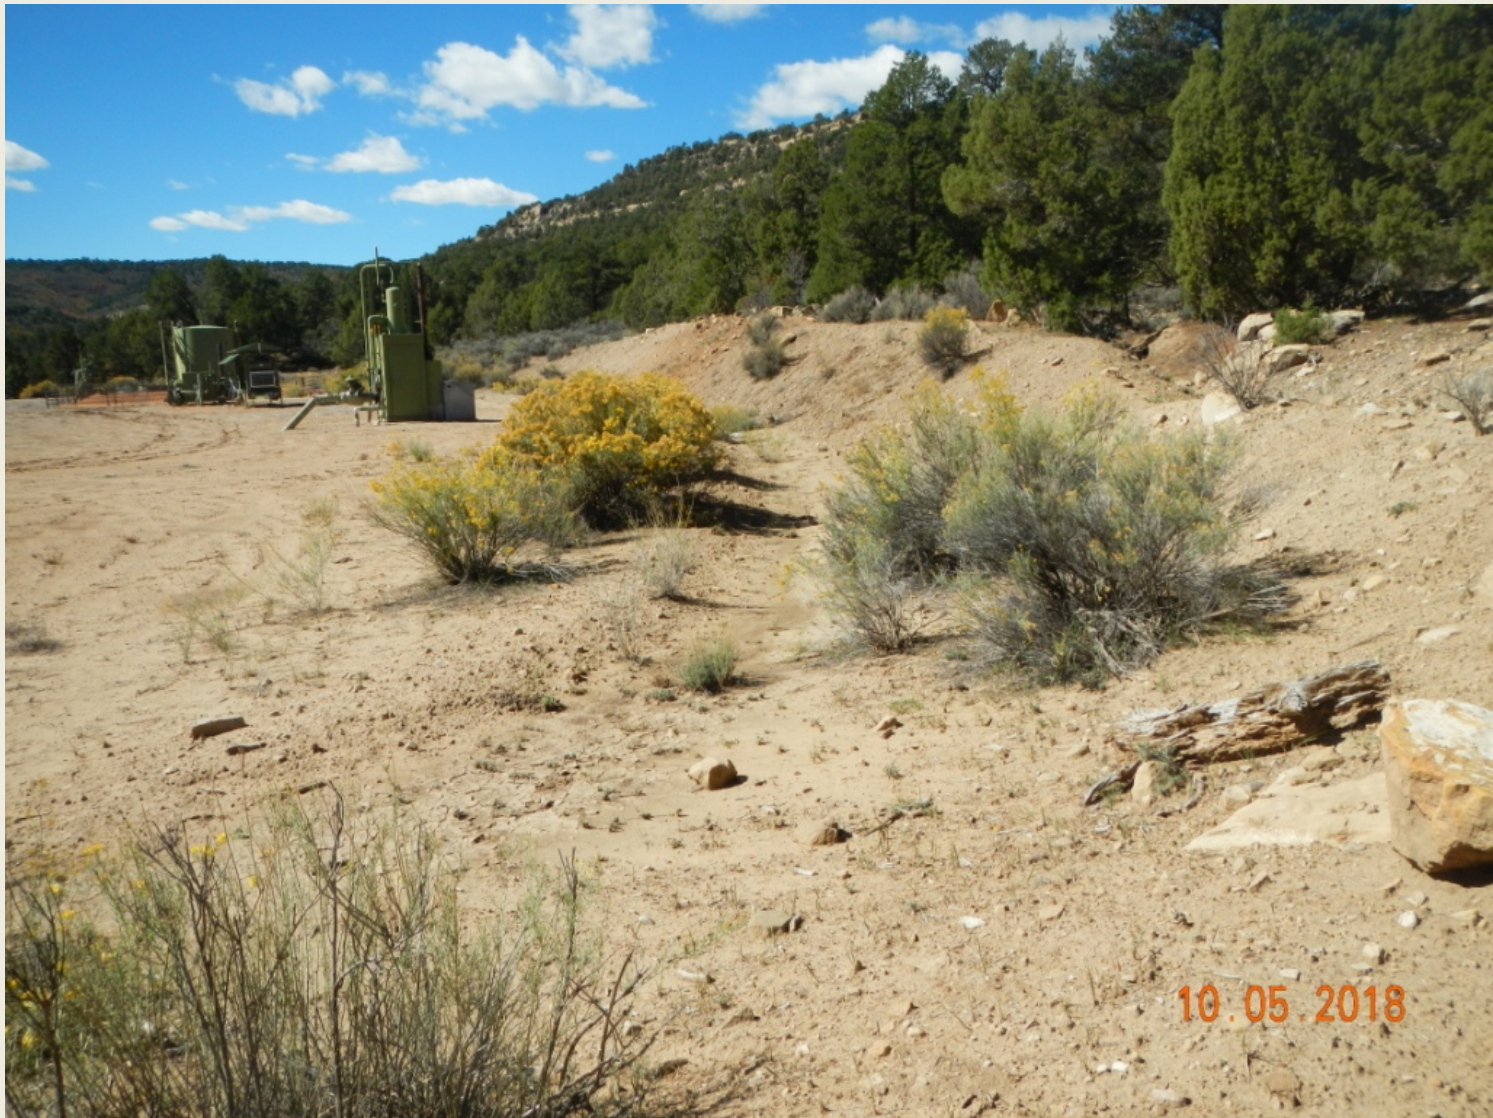
Photo 3. View of the northern project area from the northeastern corner facing southwestward.

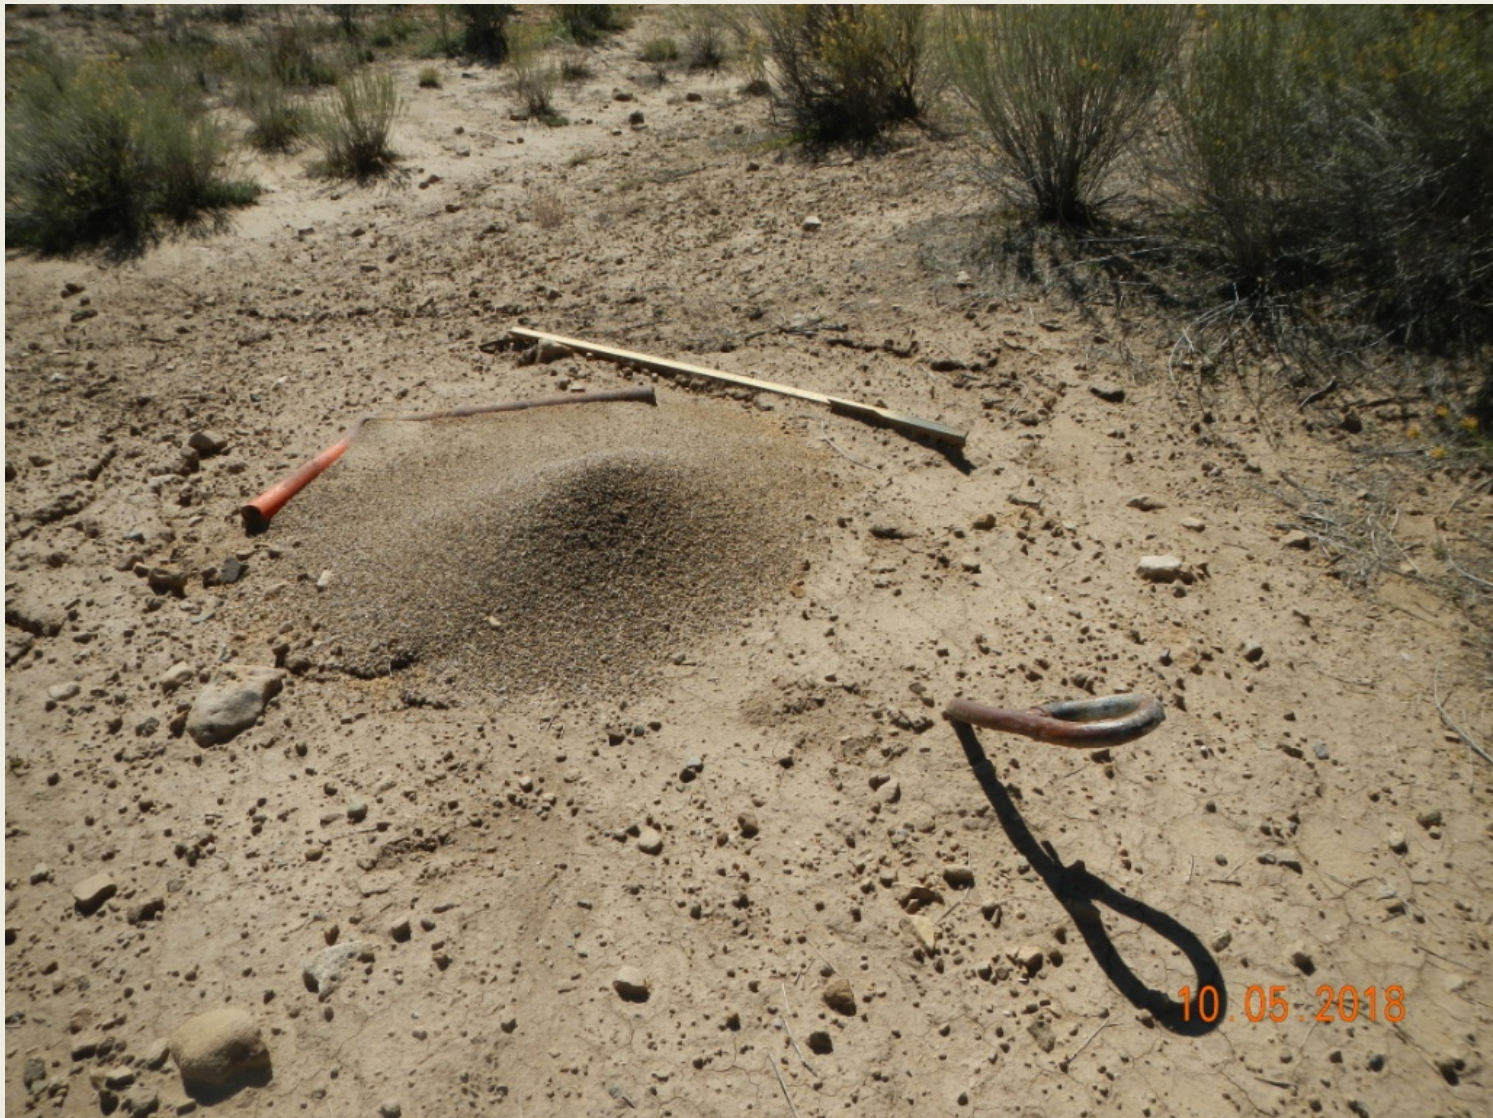
Photo 4. View rig anchor not marked within the southern project area.

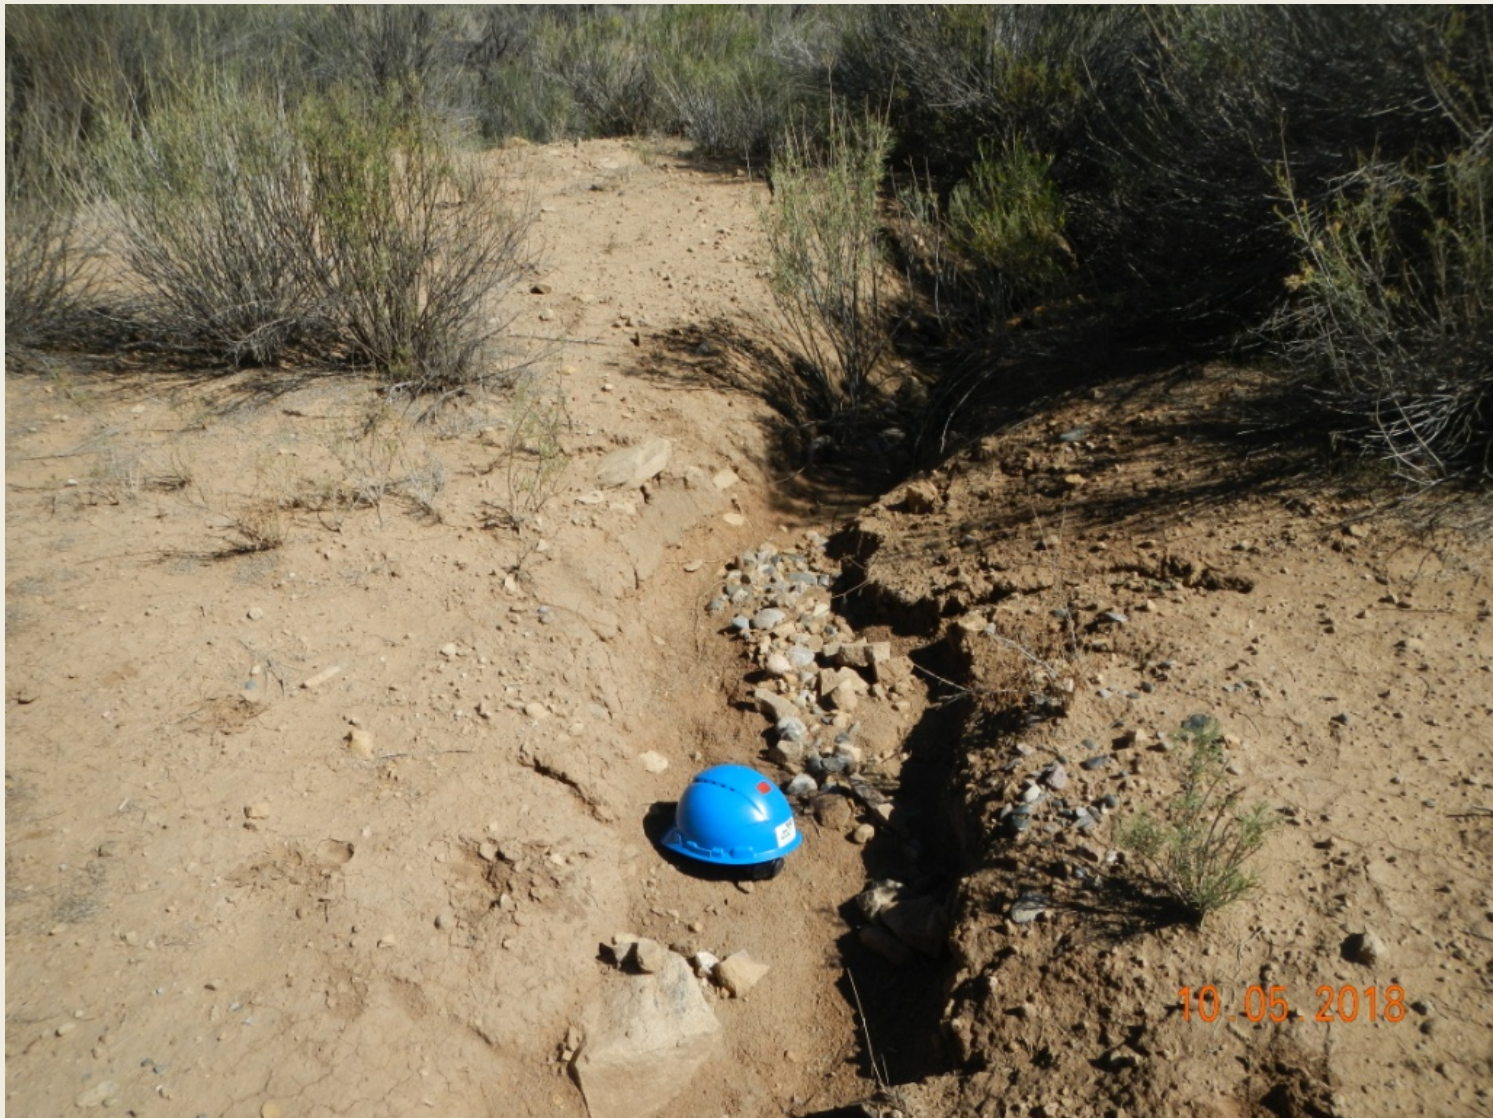
Photo 5. View of erosional channel approximately 3 feet wide and deep in the southeastern portion of the project area.

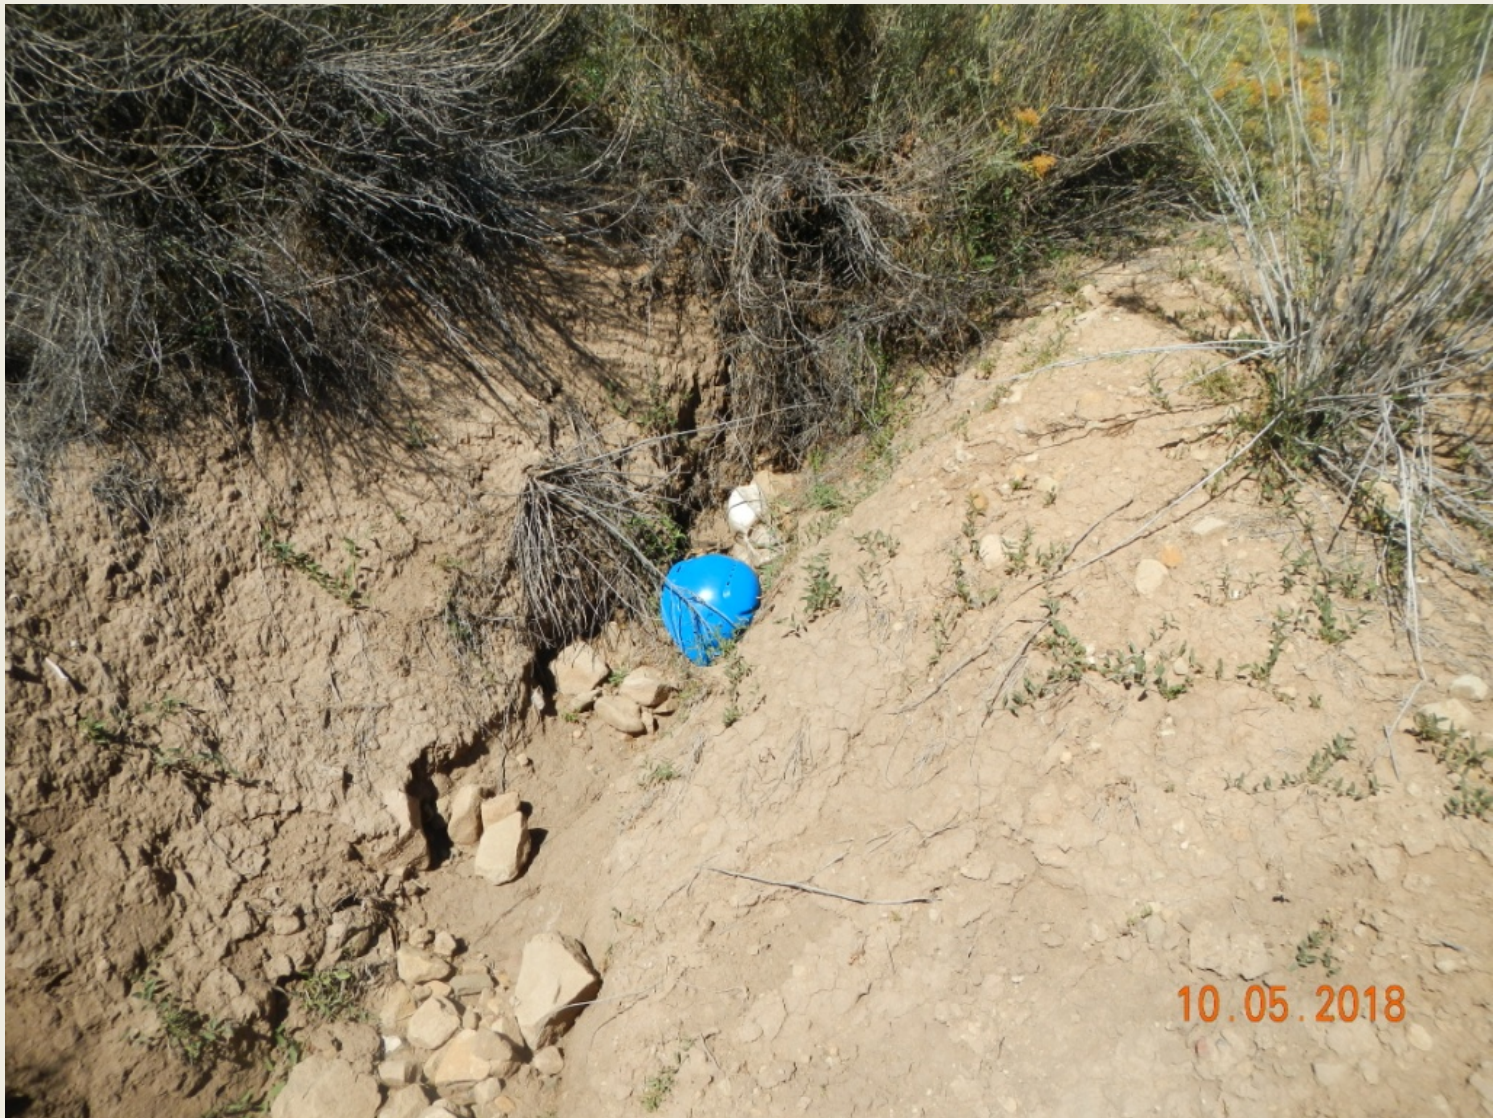
Photo 6. View of an other erosional channel within the southeastern project area that is approximately 3.5 feet wide and deep.

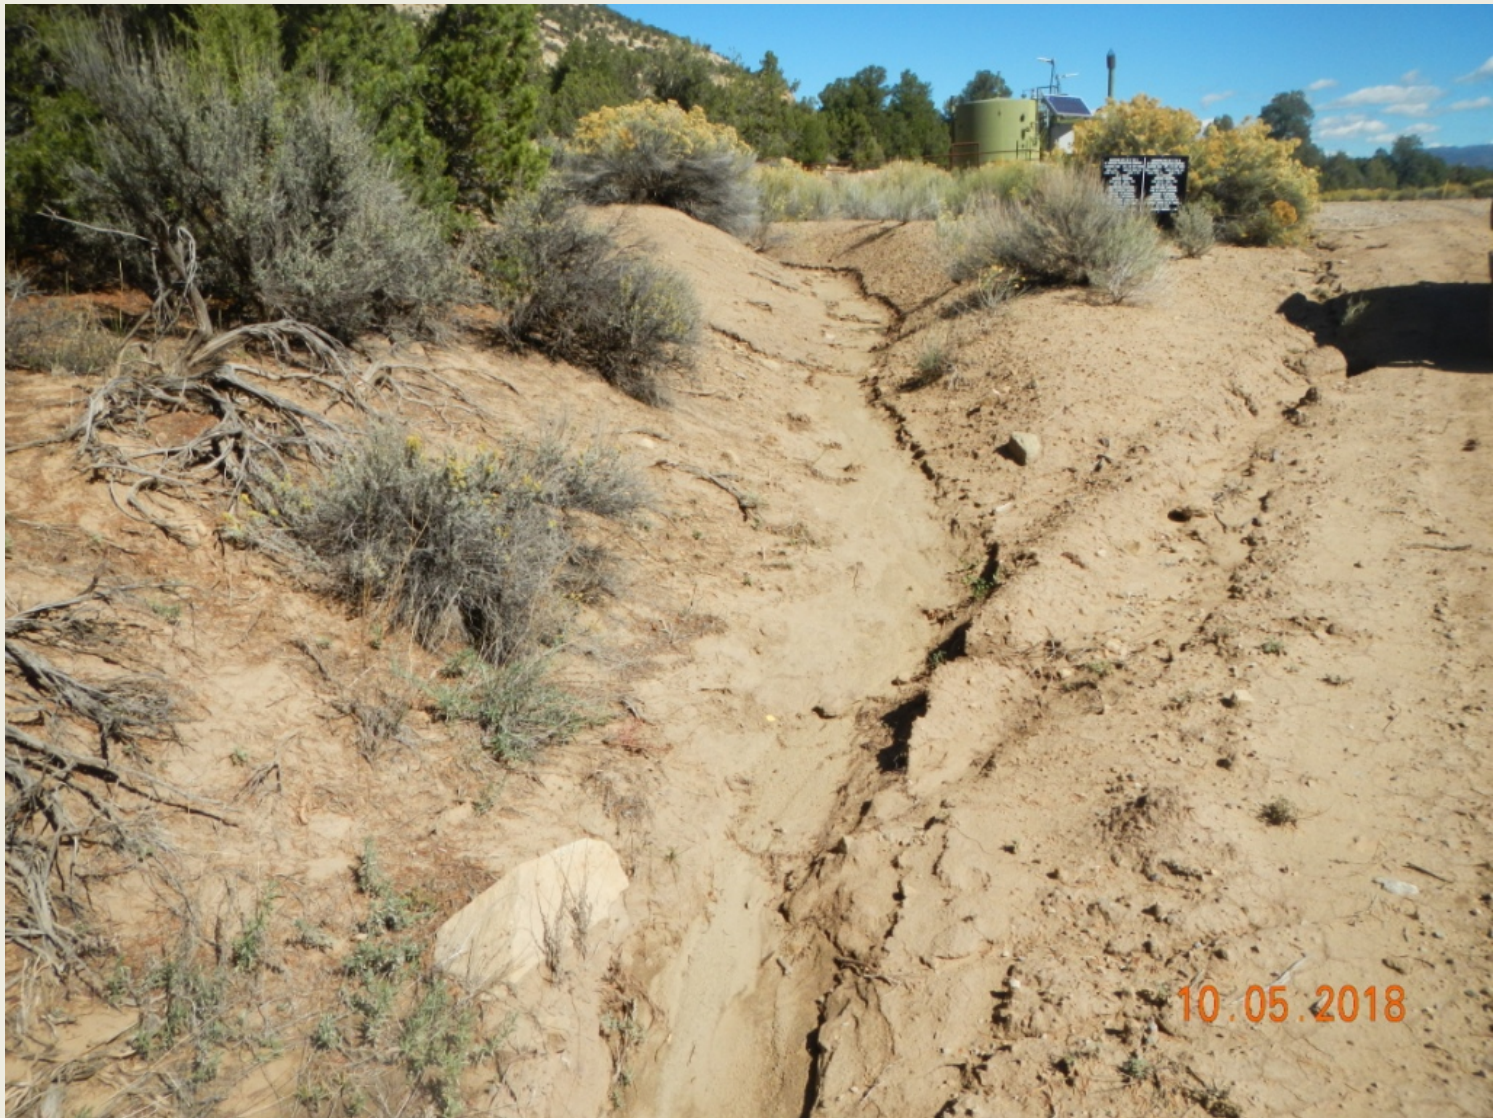
Photo 7. View of erosional channeling near the well pad entrance, north of access, where diverted stormwater from the well pad is not properly de-energized, and soils are not stabilized, resulting in erosional channeling and sediment deposition and transport off of the project area.

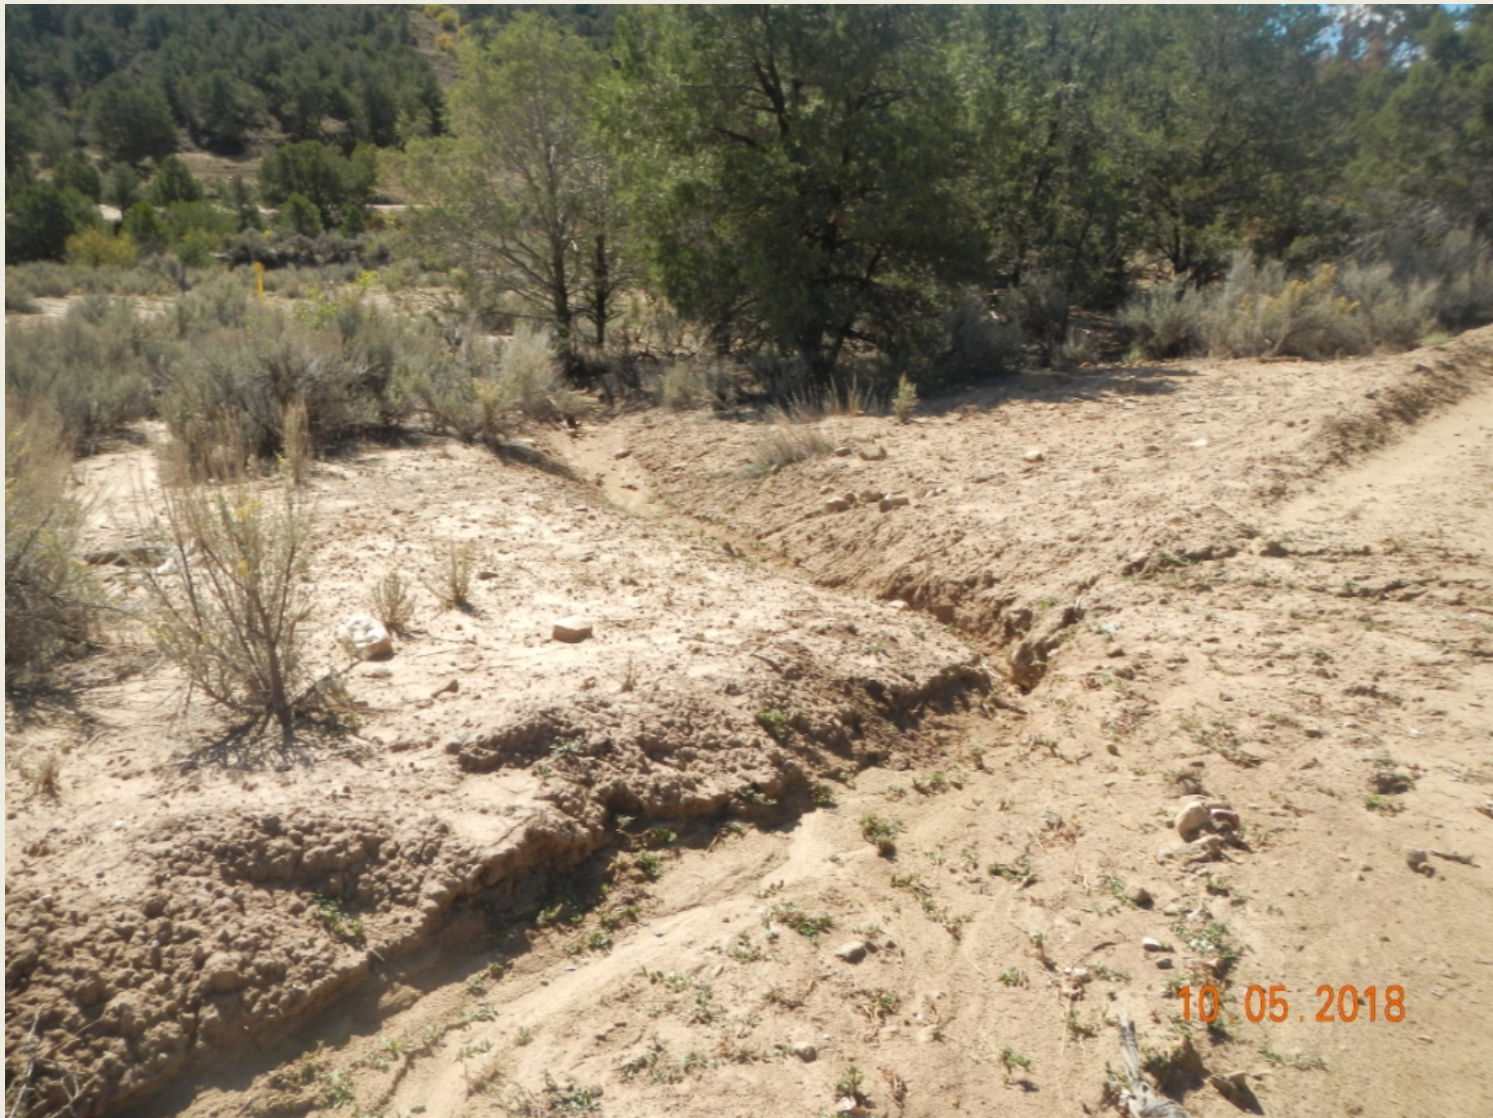
Photo 8. Downstream view of erosional channel, diverted from the well pad that is not properly stabilized or de-energized resulting in erosion and sediment deposition/transport south from the project area.

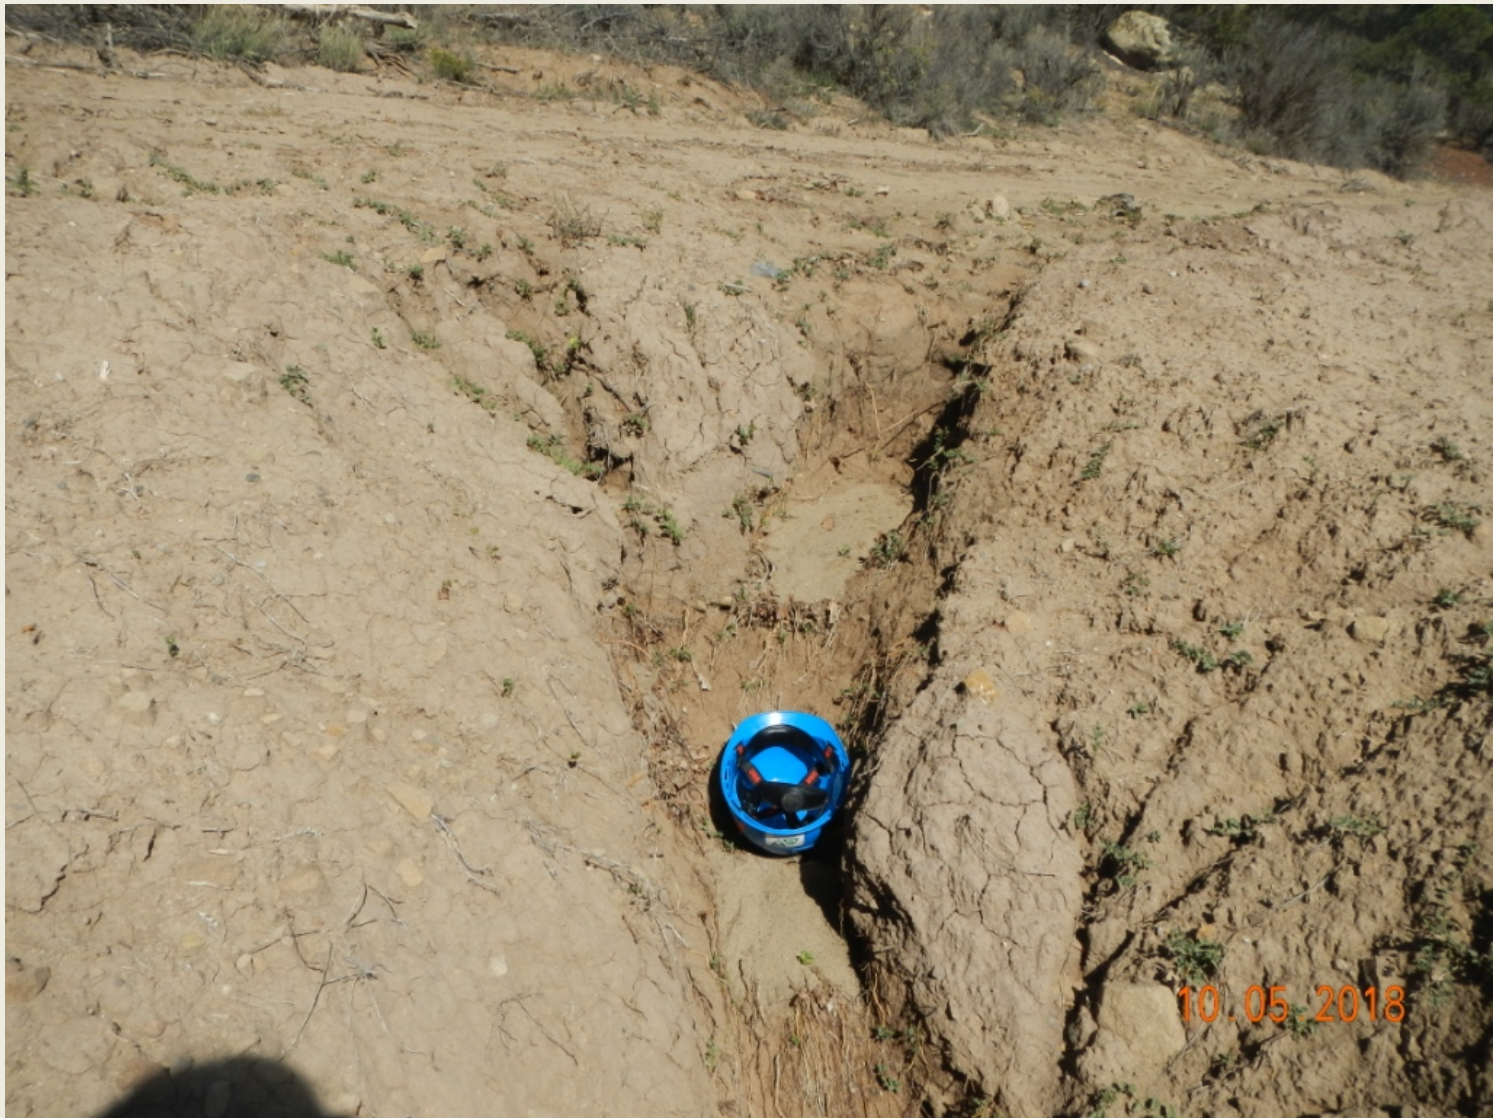
Photo 9. View of erosional channel up to approximately 2.5 feet wide and 1.5 feet deep from stormwater flows off of the access road.

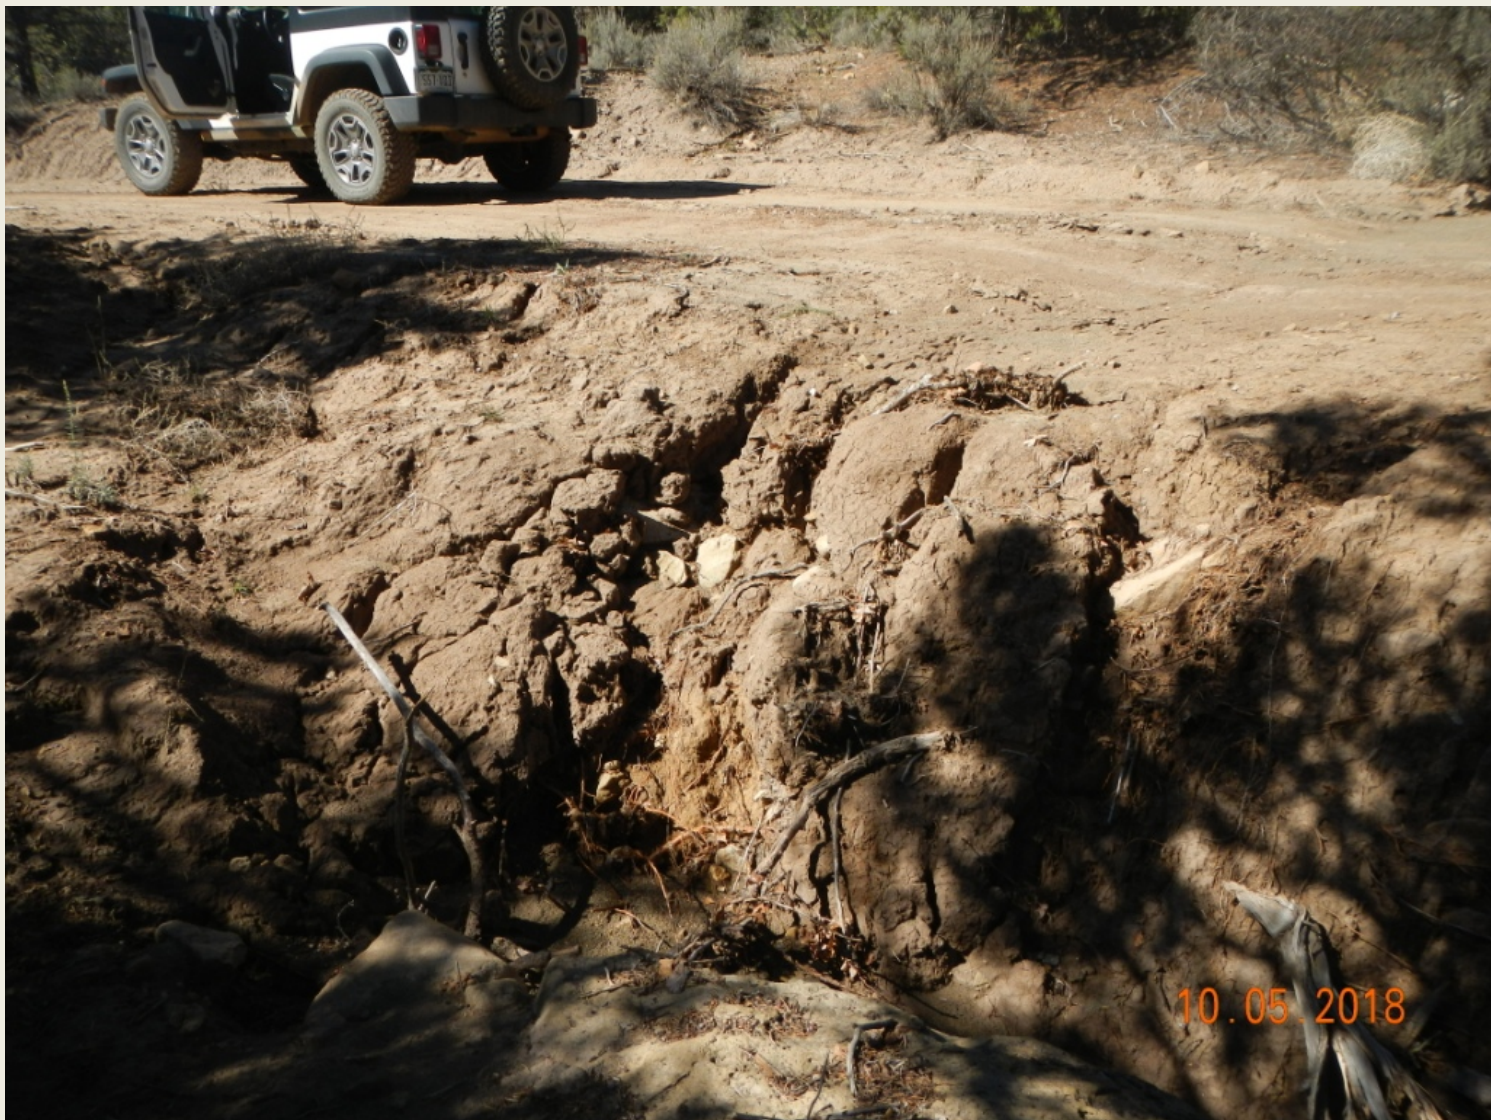
Photo 10. View of the another erosional channel where stormwater flows over the access road resulting in deep rilling and erosional channeling down-slope from the access road.

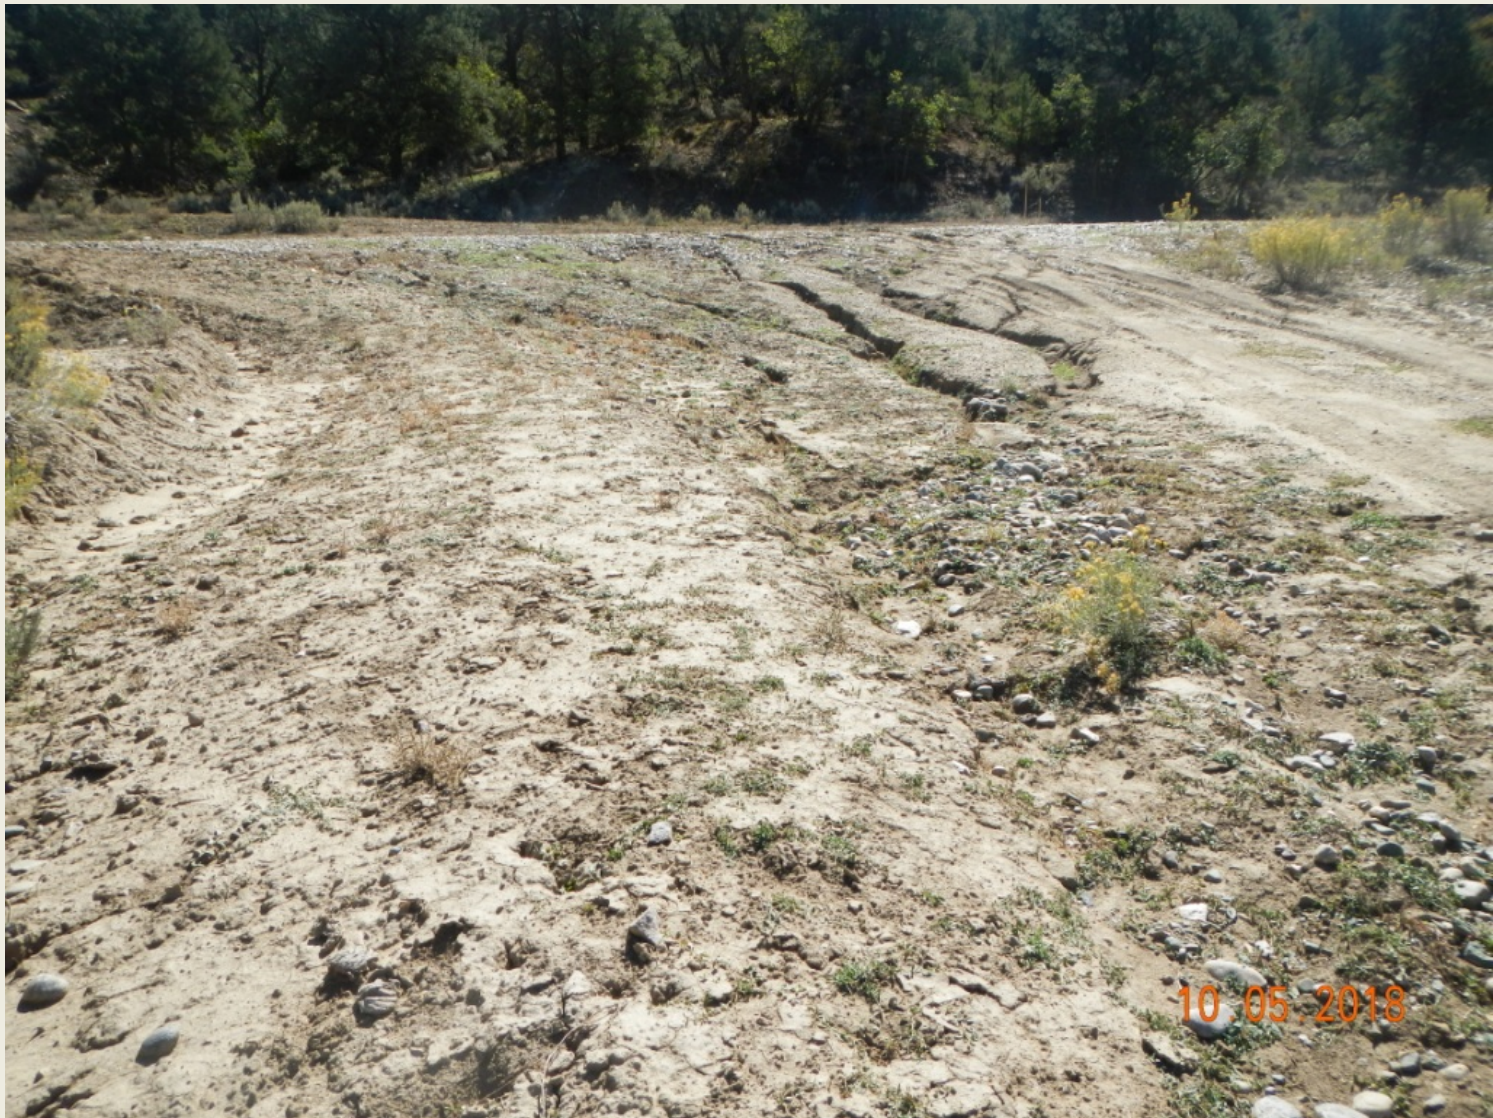
Photo 11. View of area at the beginning of the access road where stormwater is eroding a channel into the road base toward La Boca Creek.

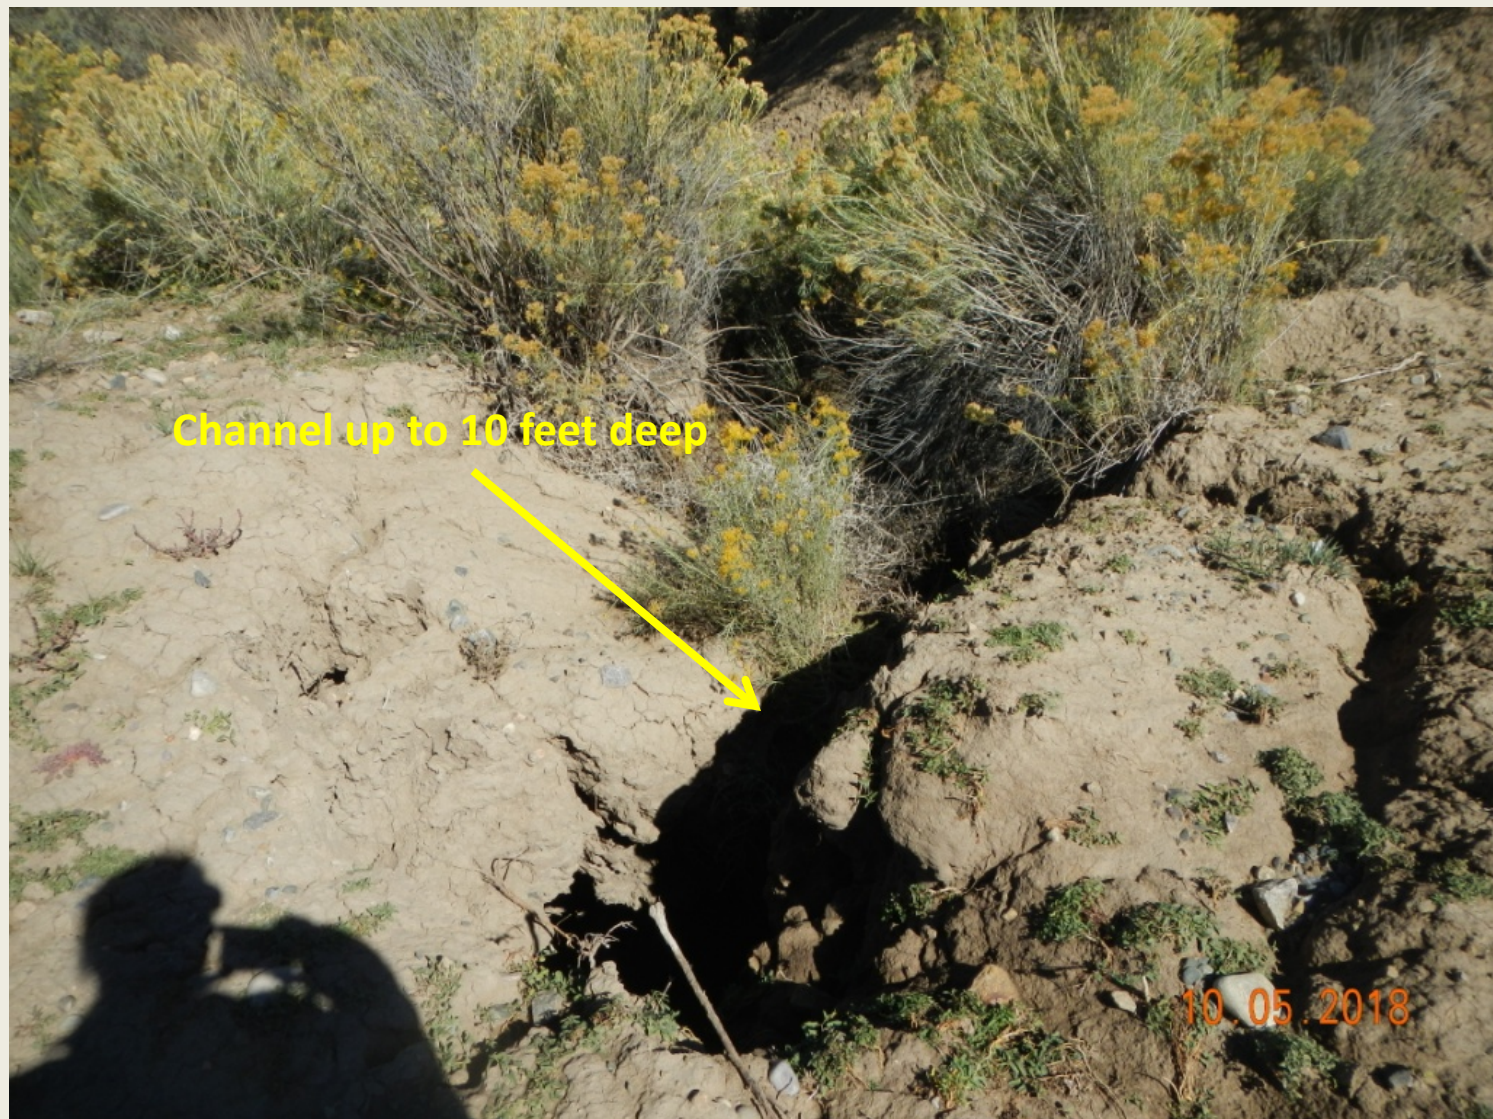
Photo 12. View of area downslope of Photo 12, where stormwater flows from the access road surface are eroding the bank of La Boca Creek, erosional channels up to 10 feet deep and 4 feet wide. Area where access road crosses over creek needs stabilization.
