Inspection Photos
Location Name: UPRR 60 Pan AM #2
Location ID: 320075

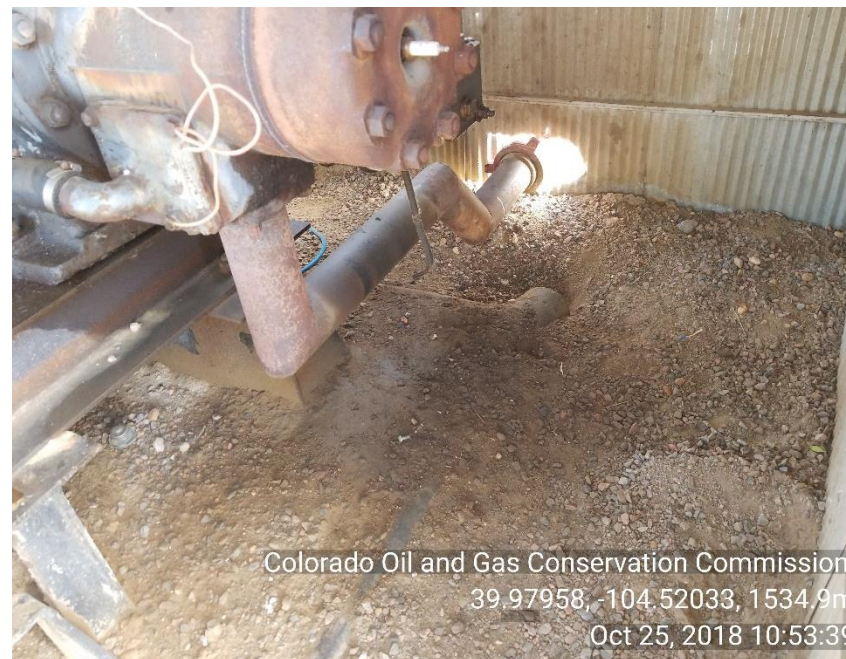
Photo 2 stained soil around PU motor
