# Inspection Photos

Operator: BP Production

API: 05-067-05139

Date: 10/05/2018

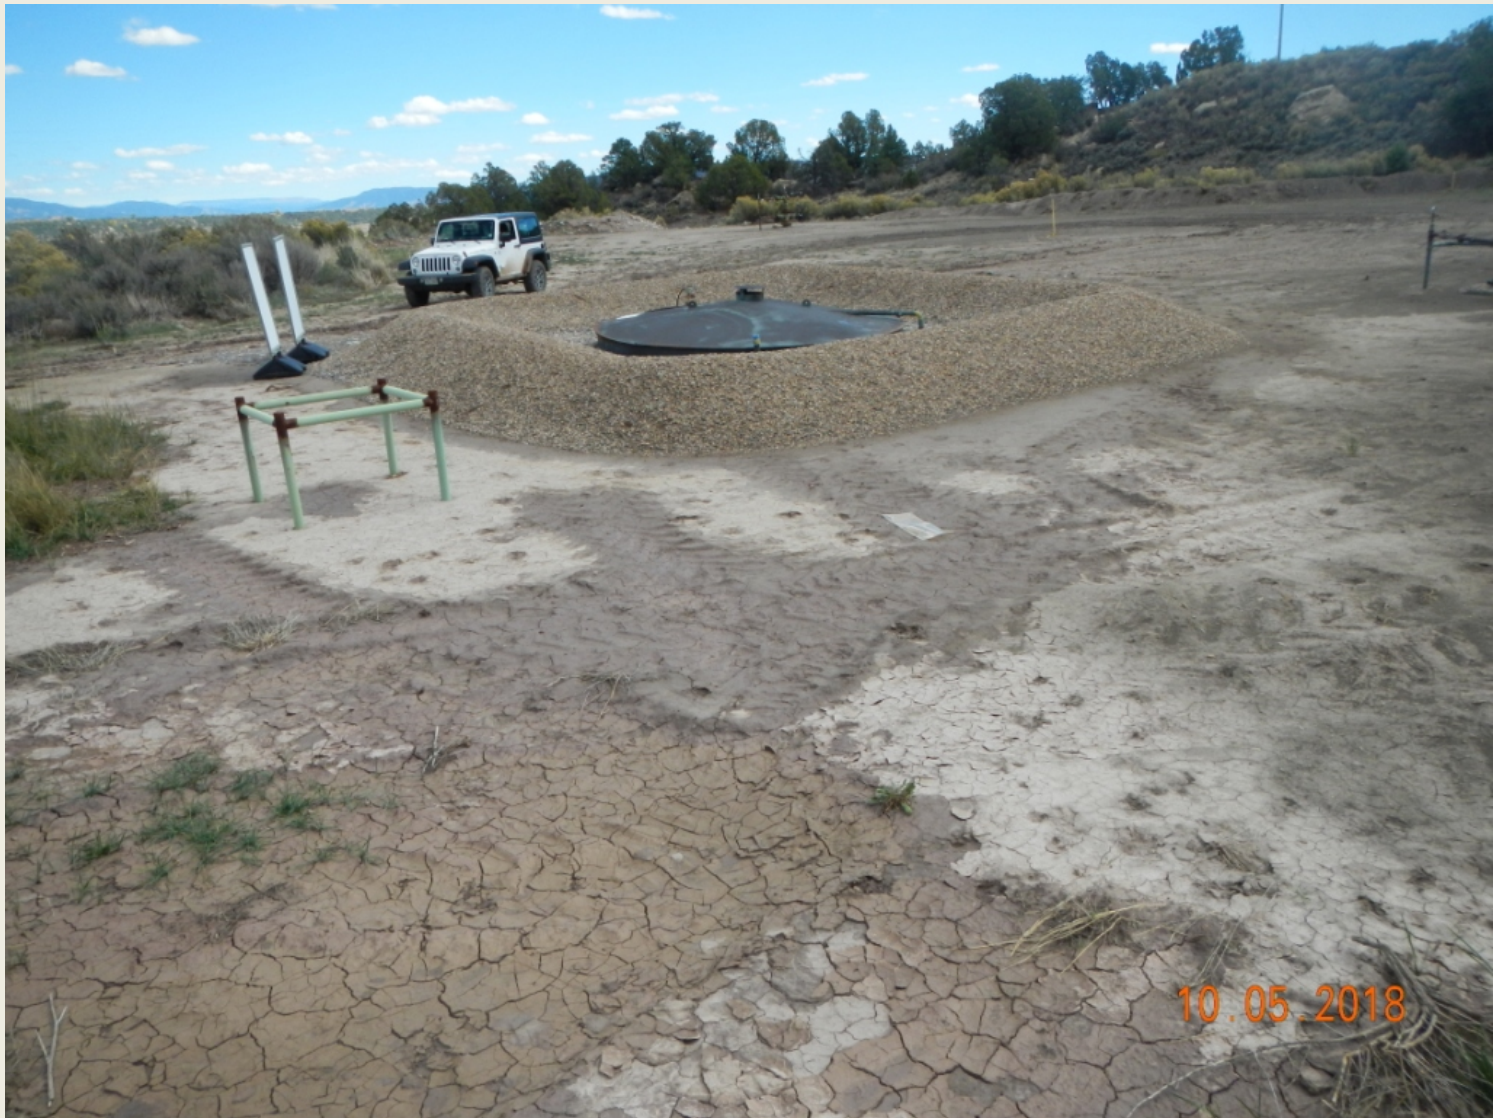
**Photo 1. View of the project area from the southwestern corner facing center.**

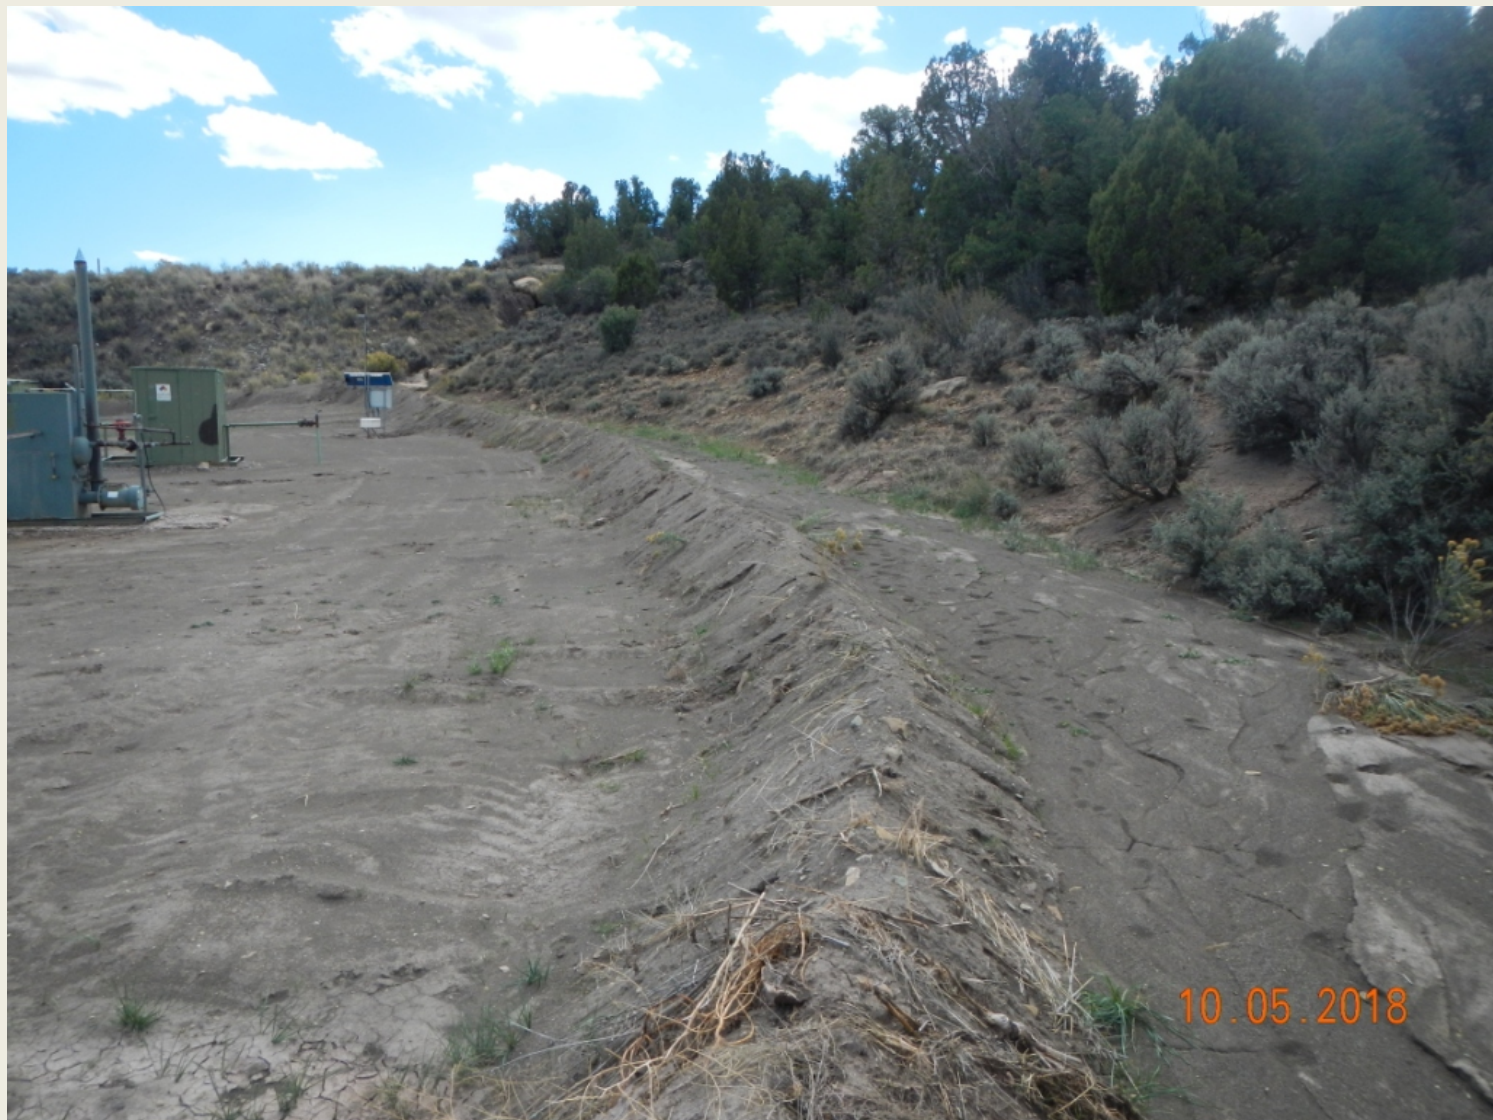
**Photo 2. View of the western project area from the northwestern corner facing southward. Berms are not stabilized and diversion is full of sediment.**

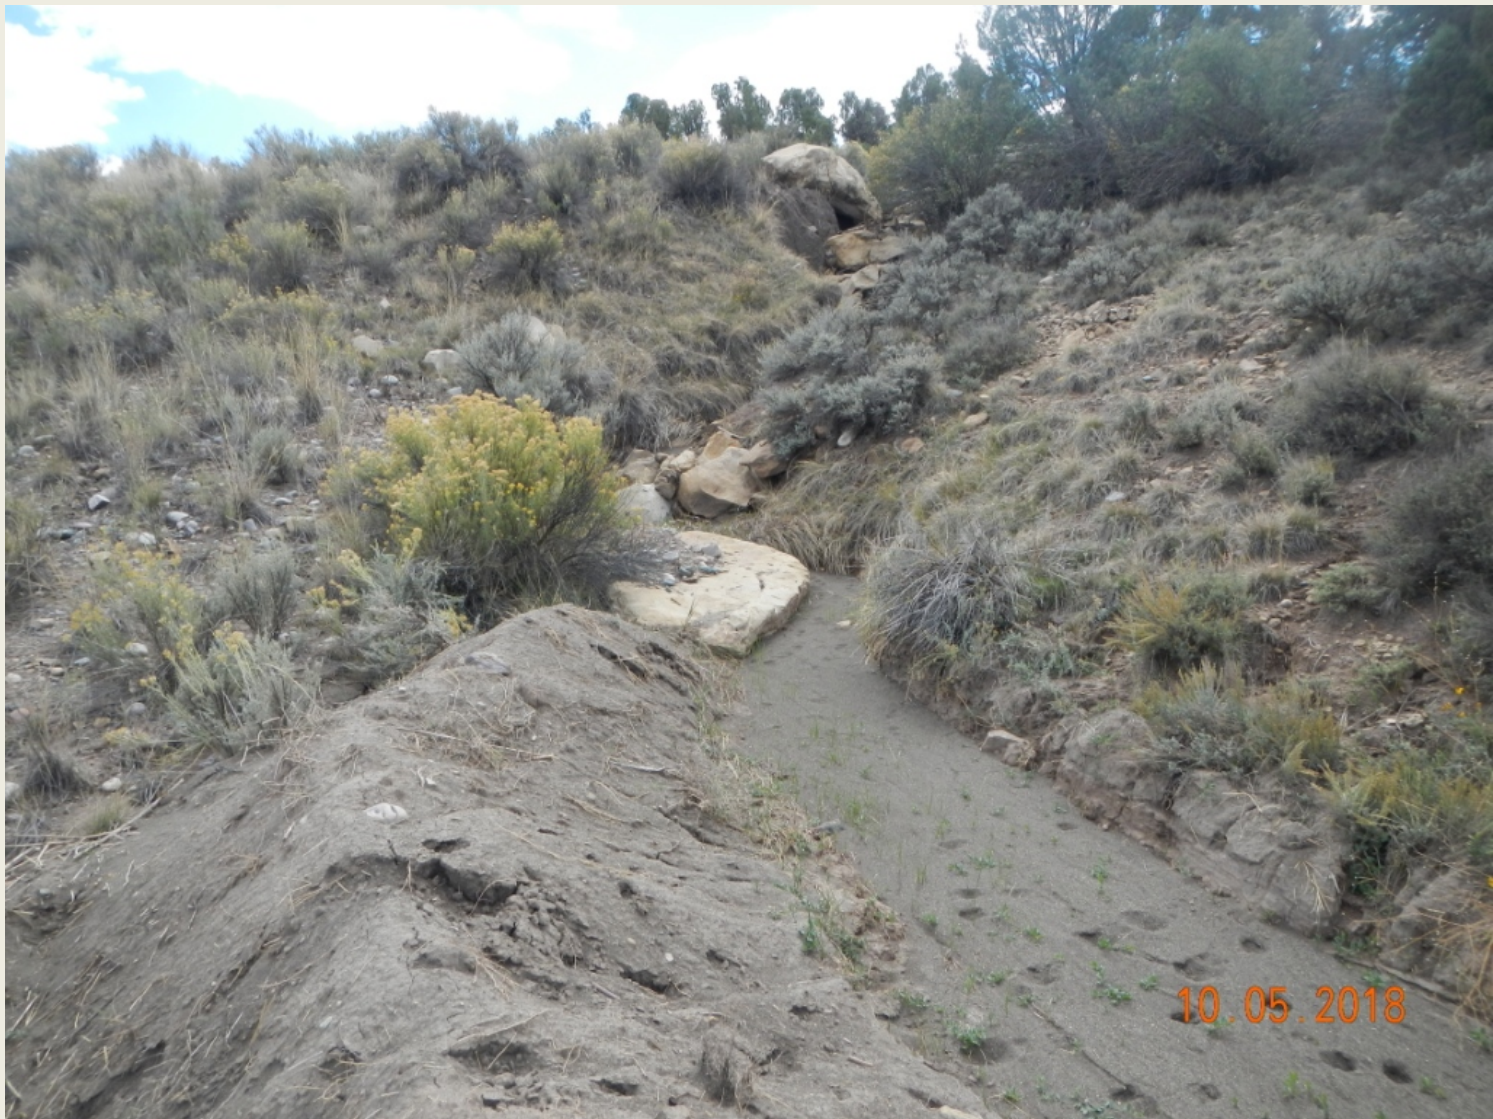
**Photo 3. View of the area in the southwestern corner of the project area where it appears that stormwater and sediment flows onto the project area toward the western diversion.**

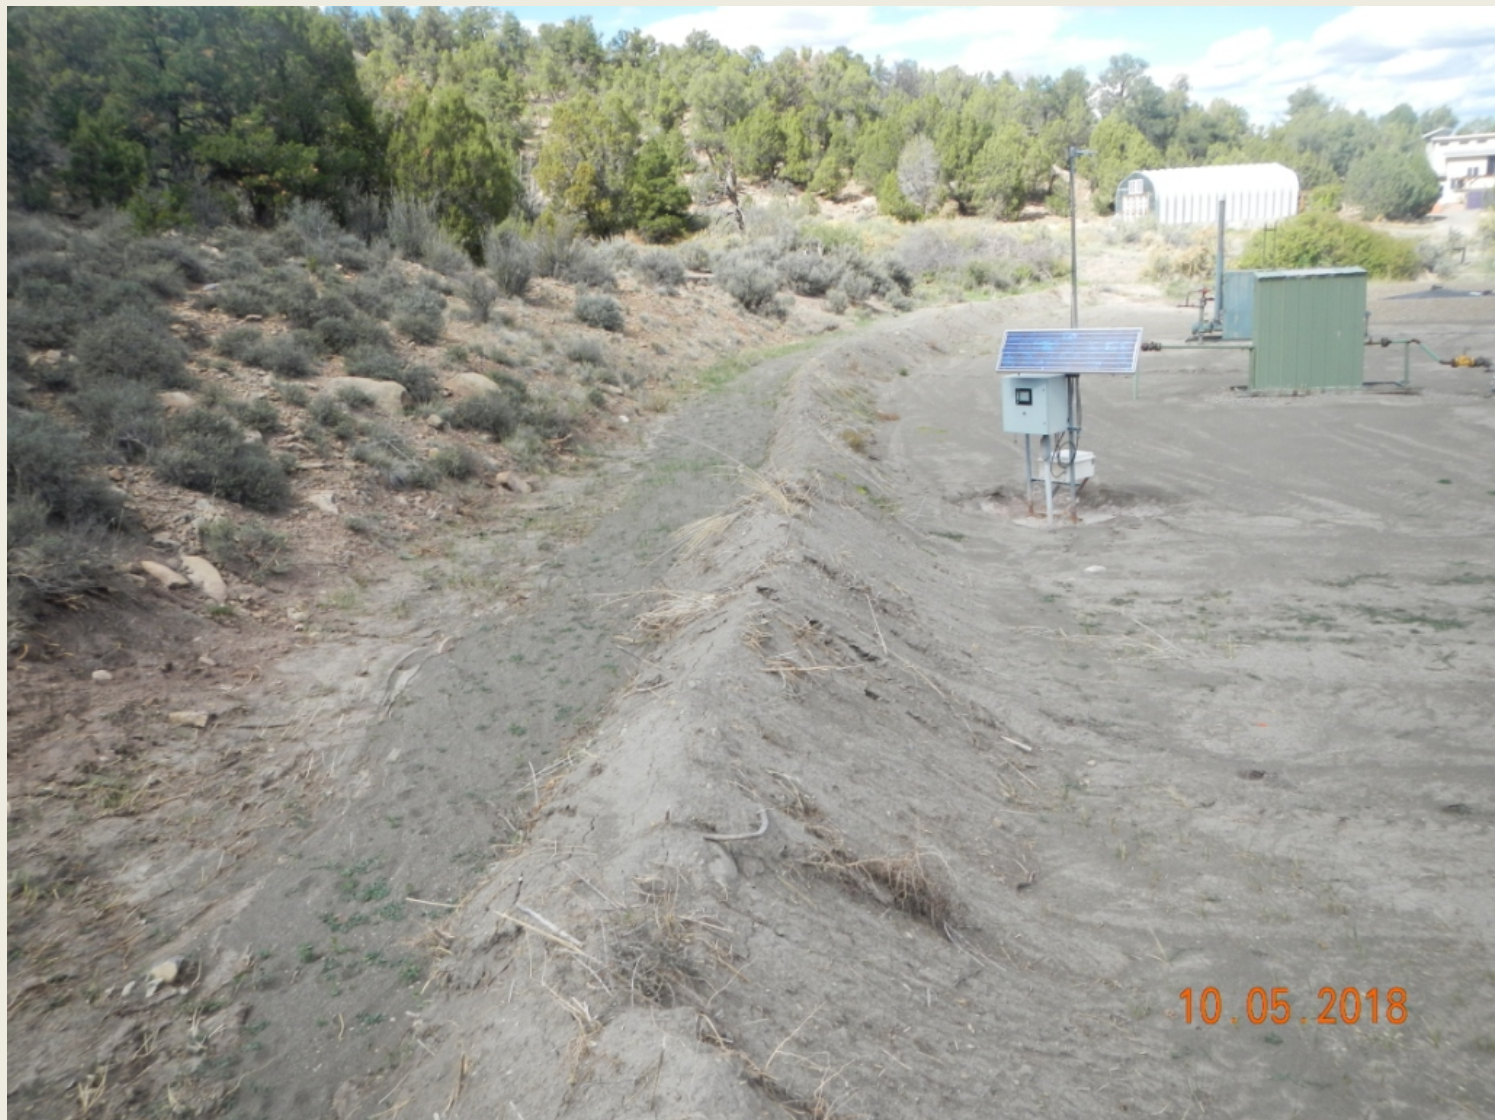
**Photo 4. Another view of the western project area from the southwestern corner facing northward, downstream from Photo 3.**

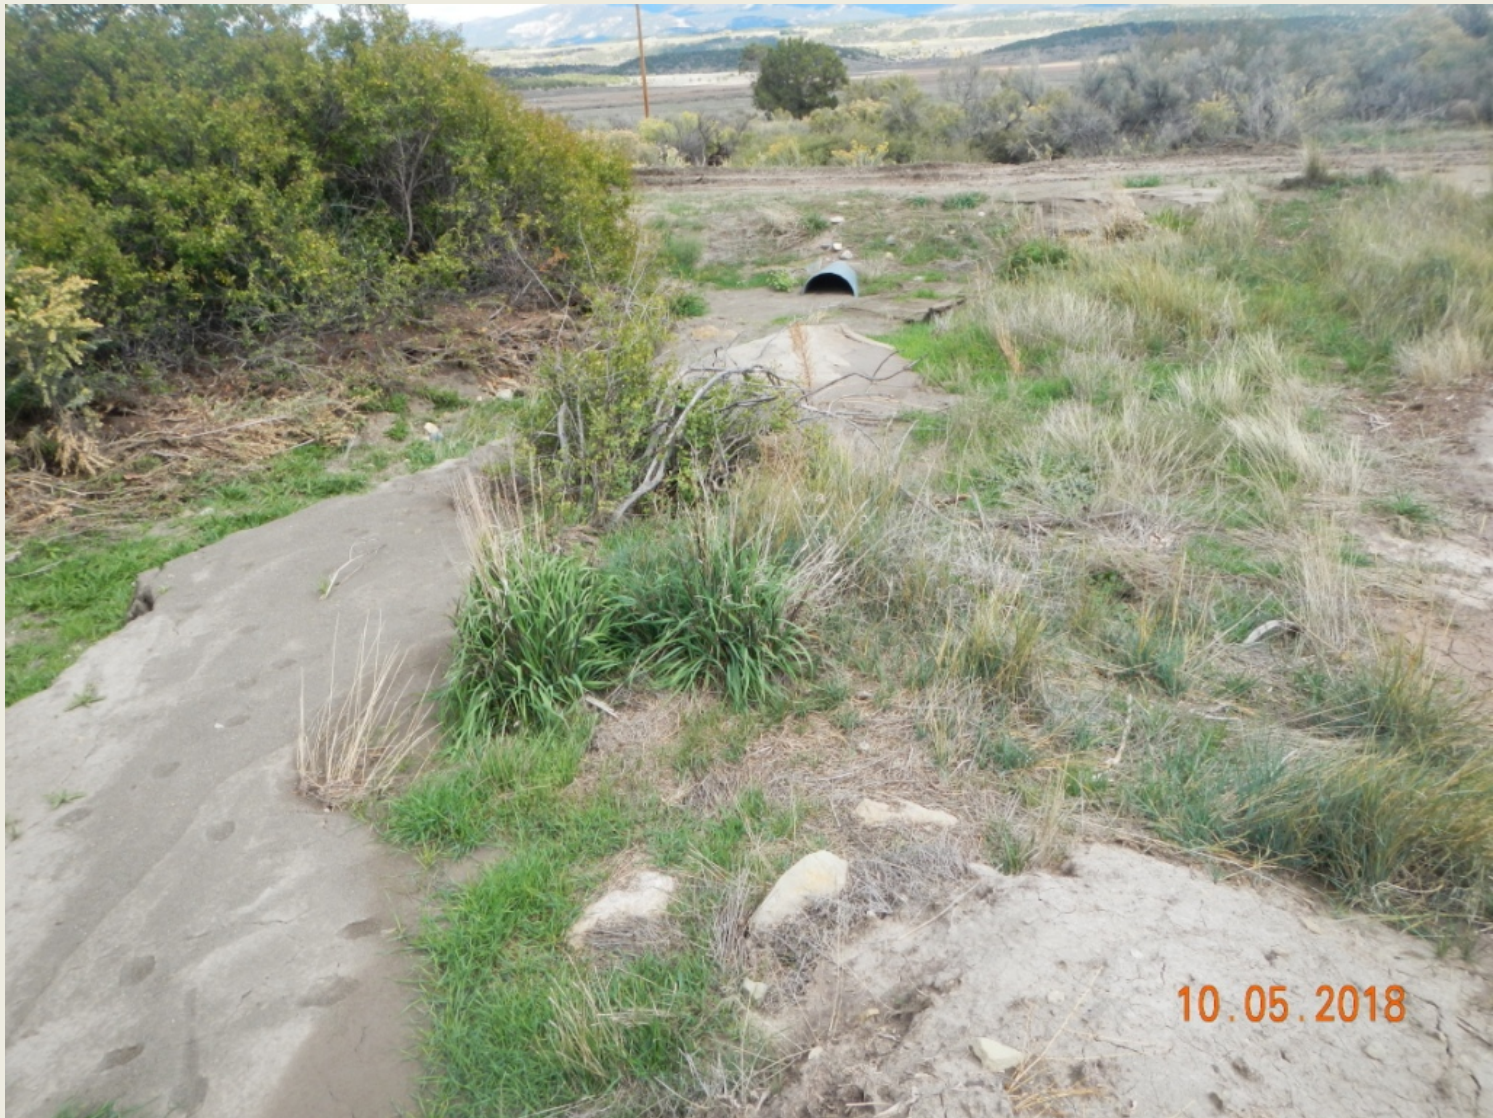
**Photo 5. View of area in the northwestern project area where diverted stormwater flows toward a culvert leading off of the project area. Sediment is not being properly managed. Culvert is half full of sediment.**

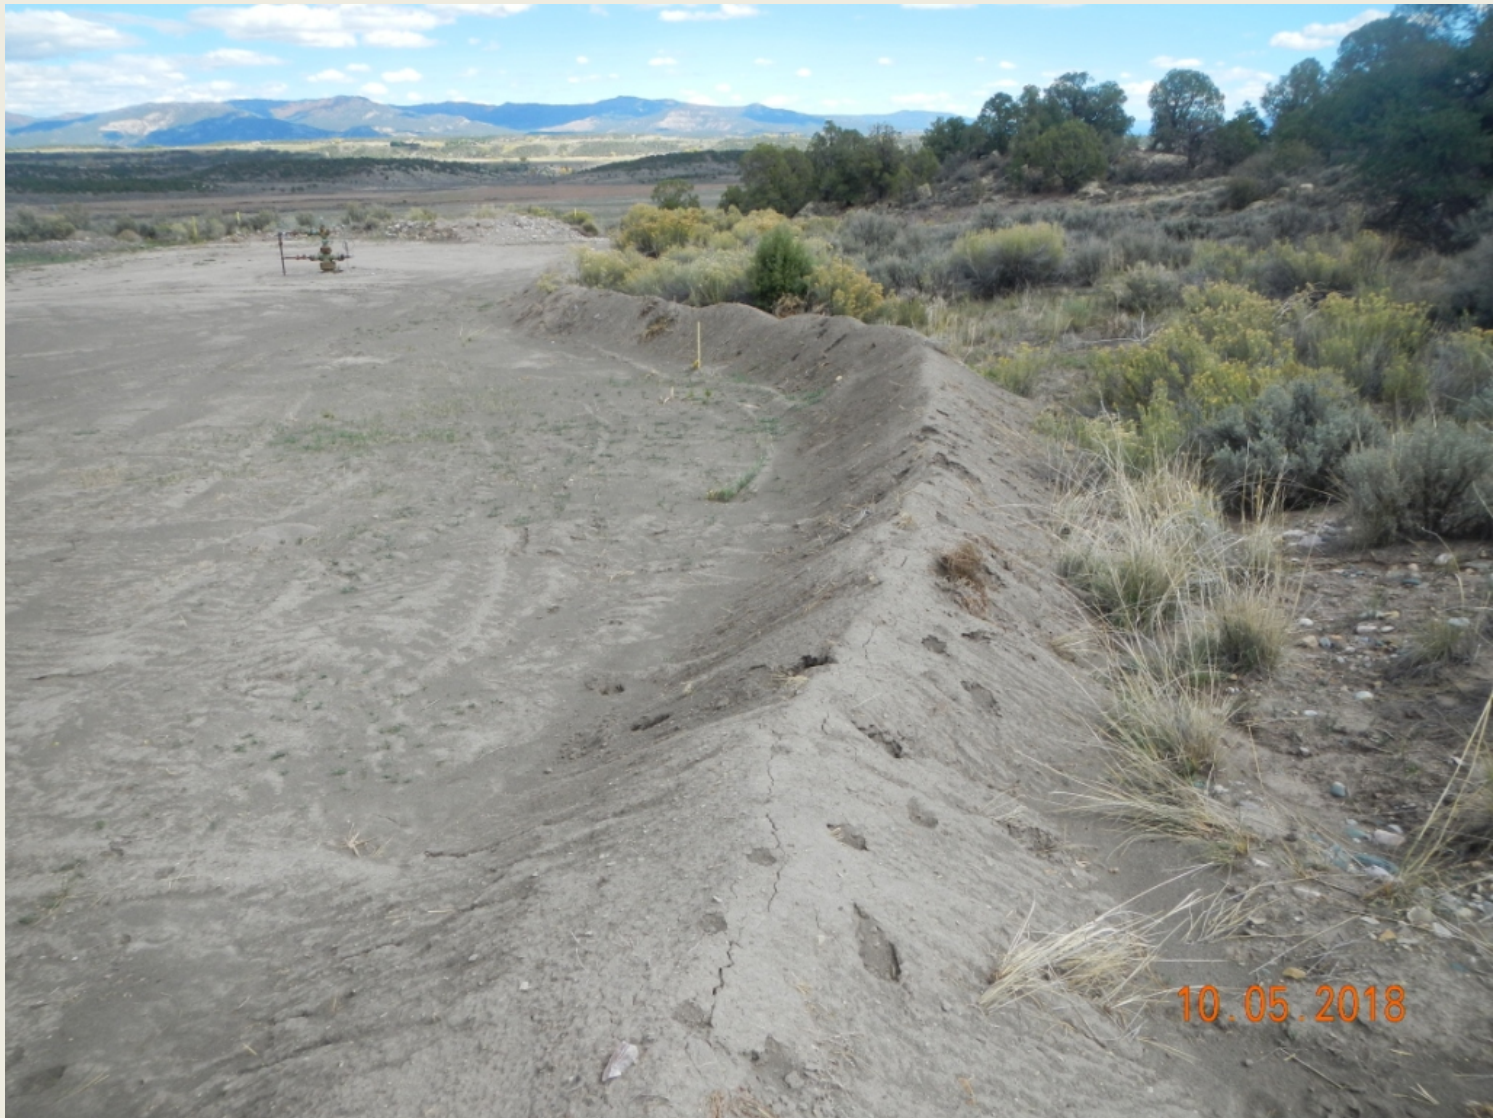
**Photo 6. View of the southern project area from the southwestern corner facing eastward. Berms are not properly stabilized.**

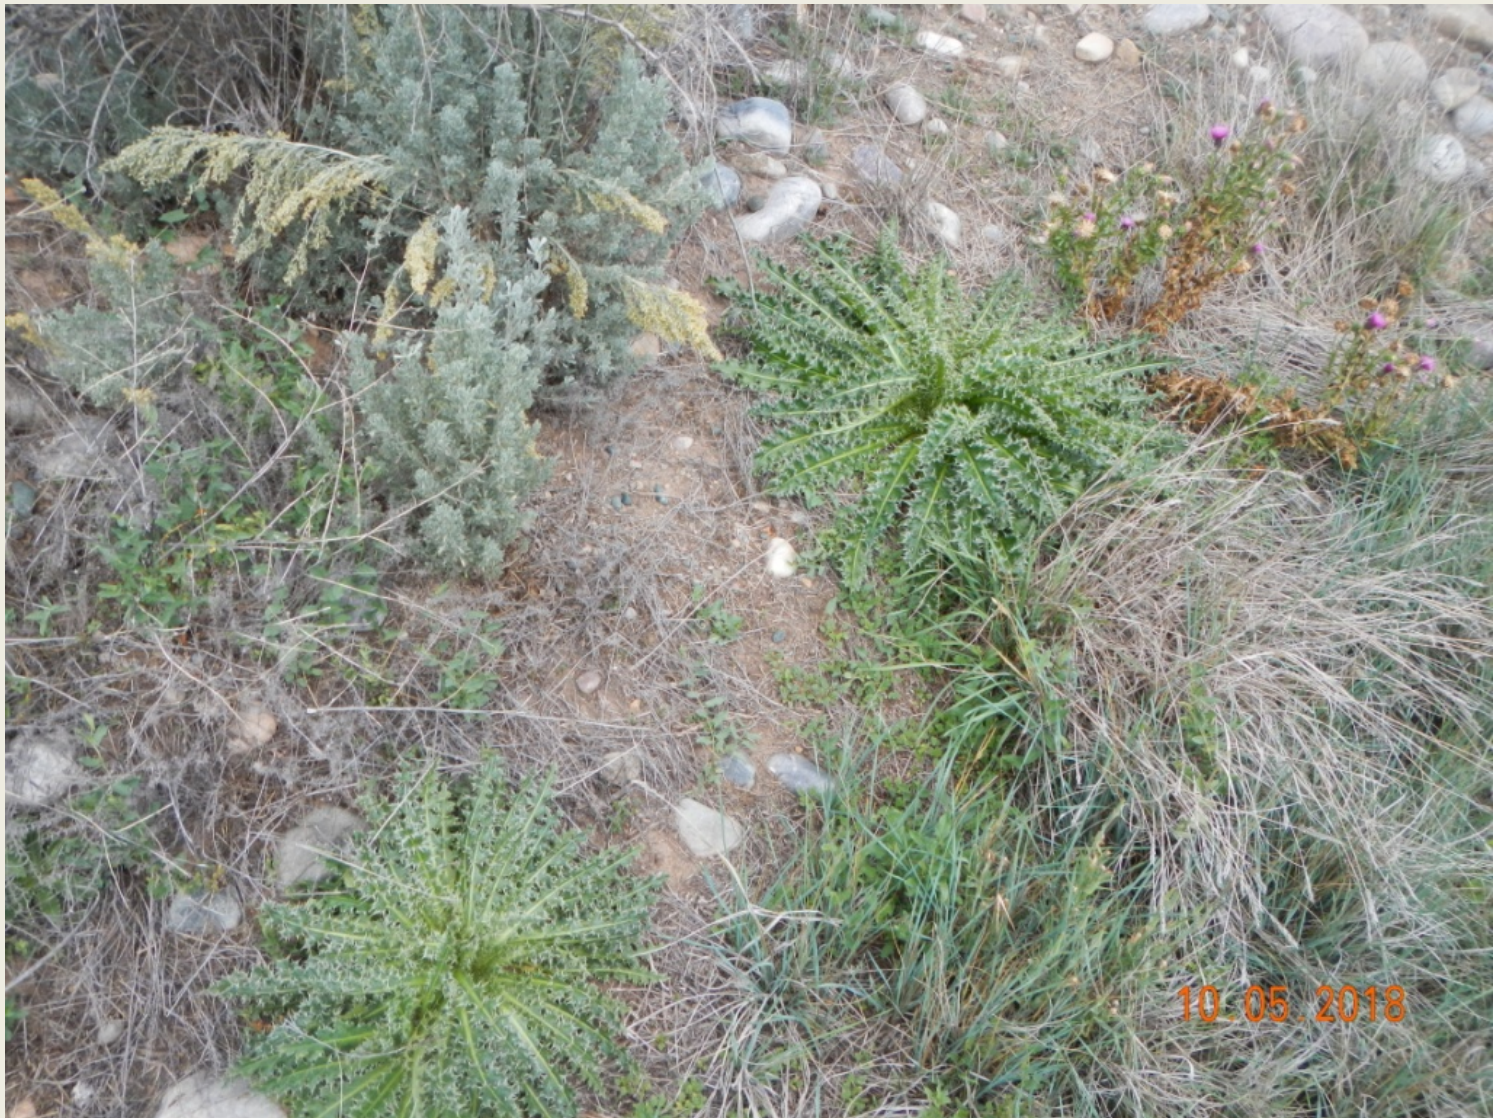
**Photo 7. View of musk thistles (*Carduus nutans*) within the northern interim reclamation area.**

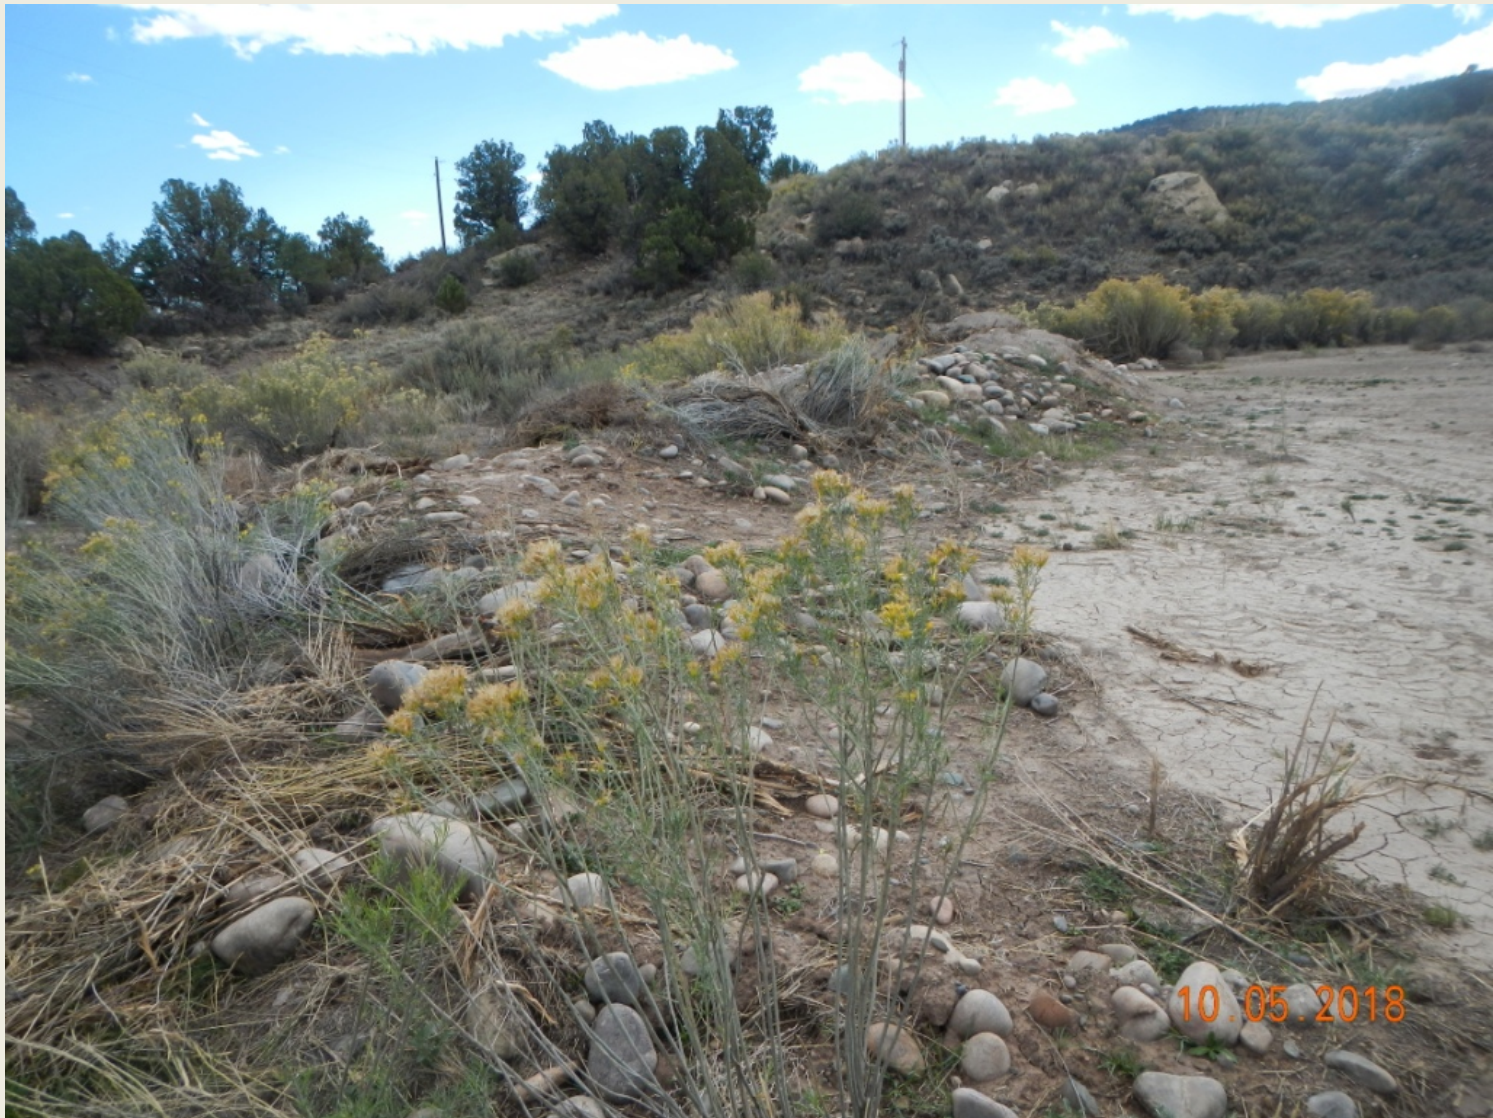
**Photo 8. View of the eastern project area from the northeastern edge facing southward. It appears well pad was cleared and soil/ rocks bermed along the edge.**

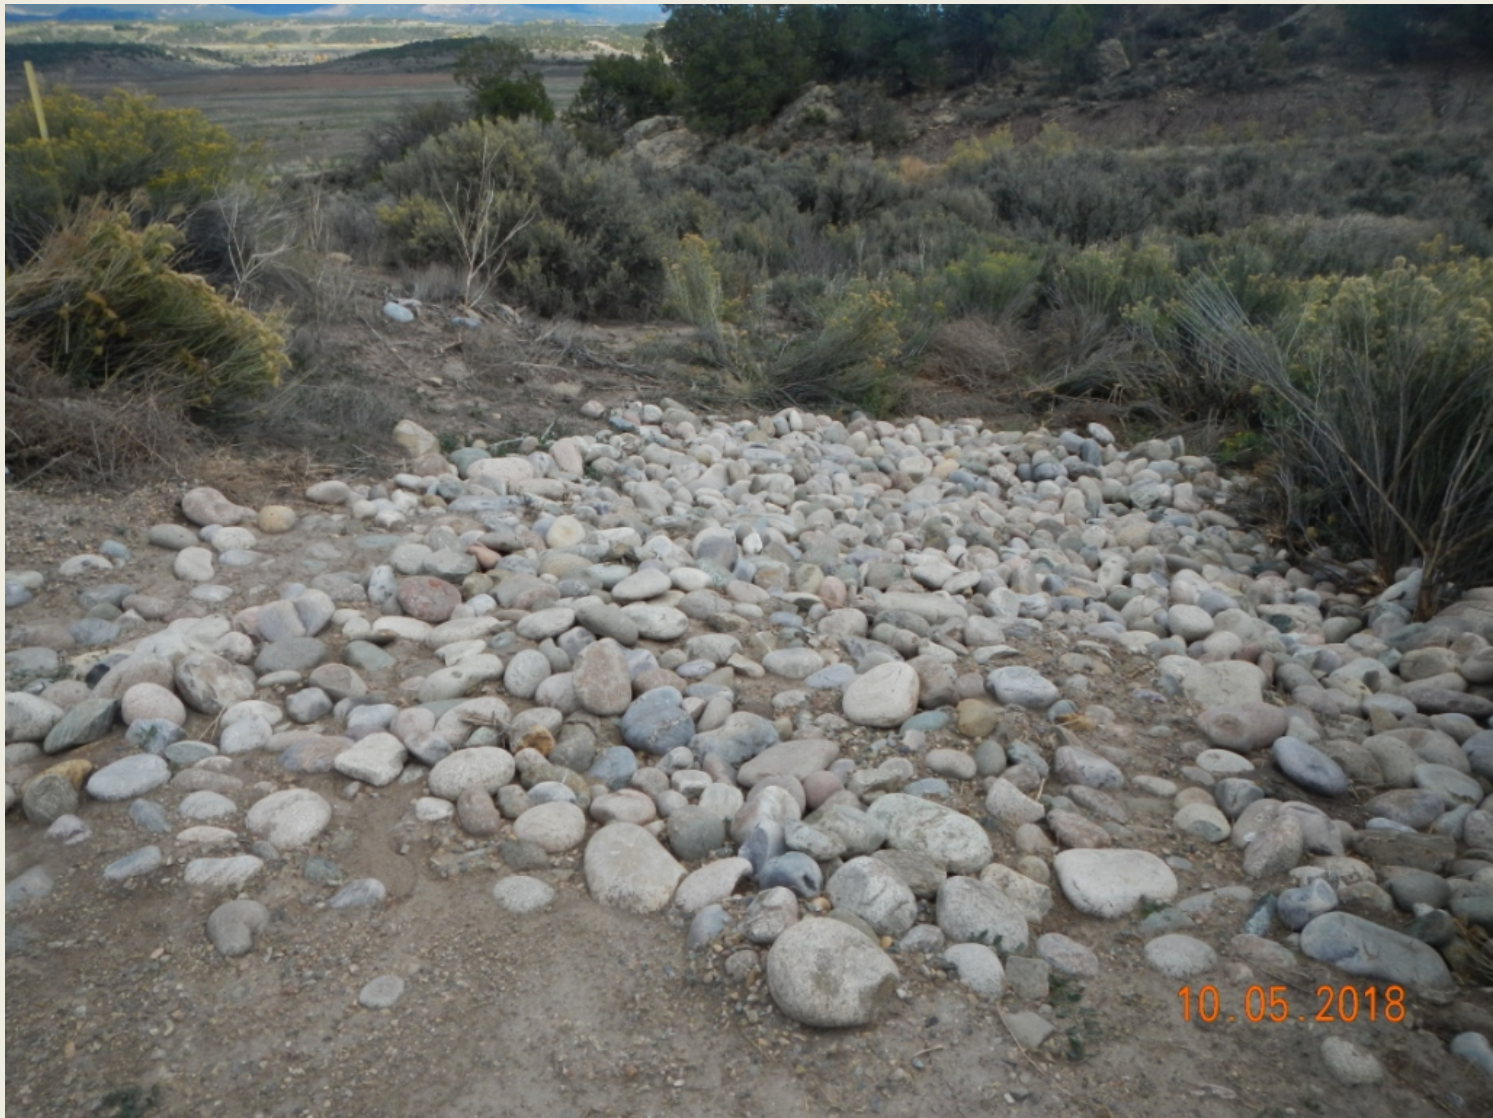
**Photo 9. View of cobble run-down in the southeastern project area.**
