# **INCIDENT INVESTIGATION REPORT**

## **Gregory Pad Fire**

### **Castle 7 Pump House**

**SANDRIDGE ENERGY**

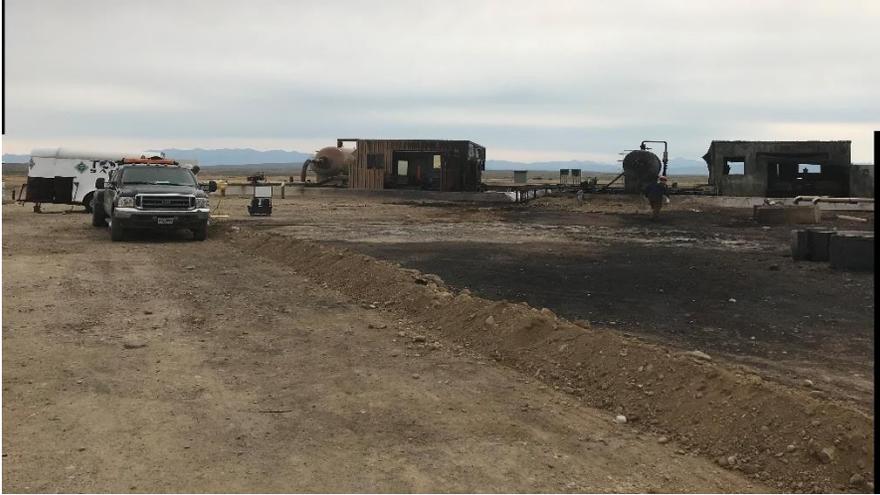
Photo 1: Wellpad View looking east at C8 and C7 Pump Houses, left to right Soot fallout inside and outside of containment dike is visible

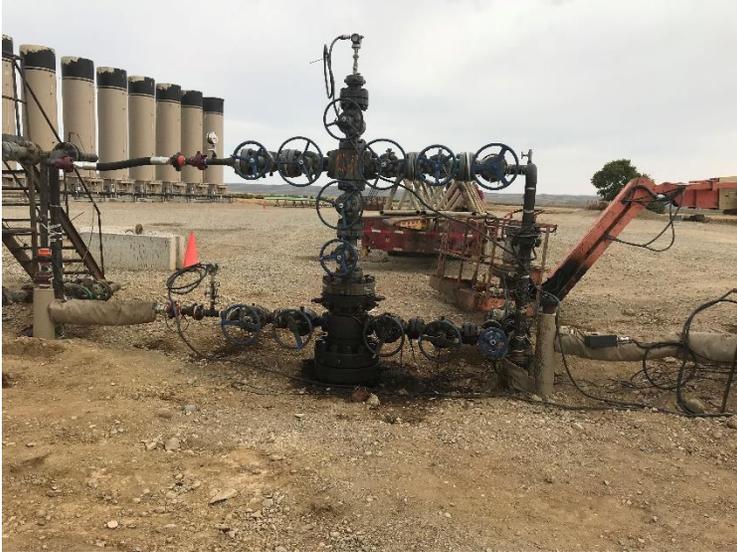
C7 Wellhead – instrumentation was not found to be damaged

Photo 2: C7 wellhead located NW of Skid C7

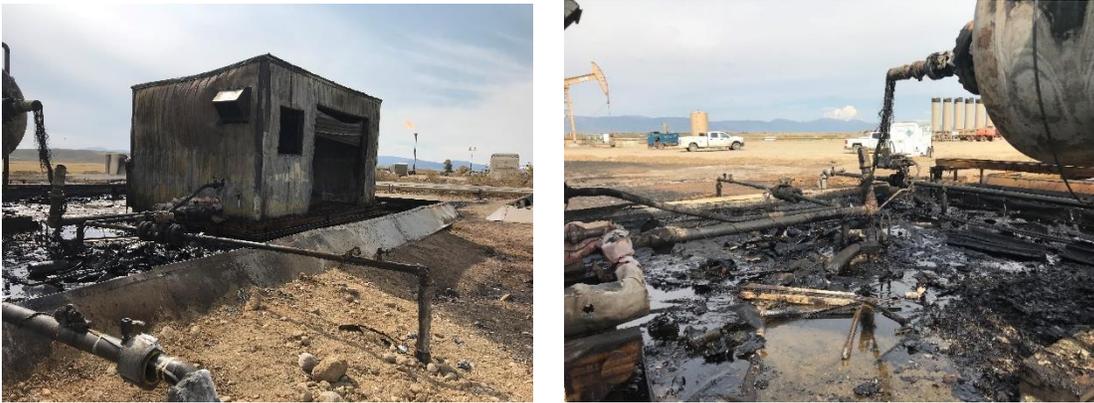
Damaged C7 Pump House, Separator with damaged suction hose and hydrocarbons inside containment

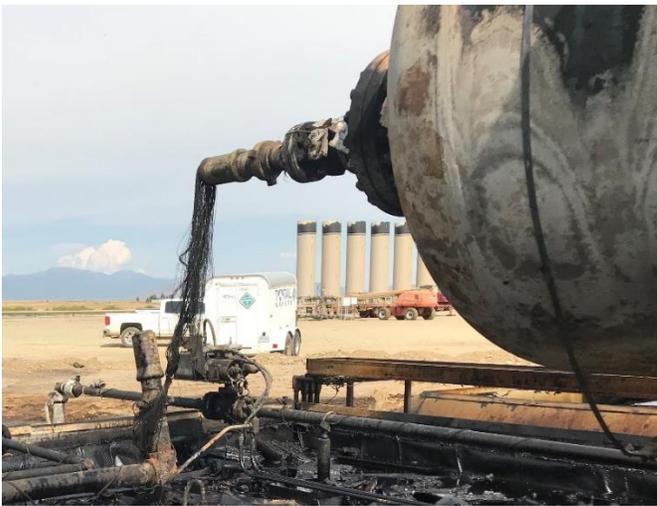
Photo 5: C7 Separator Closeup of Suction Hose Remains

- The metal flex suction hose for the water phase to the Triplex suction was destroyed, only strands of metal or reinforcing materials were left in place. This opened hose would allow vessel pressure to flow liquids from the pickup line at the bottom of the vessel with some hydrocarbons expected to follow the water phase.

- The higher pressure (5,000 psig) rated discharge flex hose was not damaged to the extent of the suction hose off the Power Fluid Vessel separator. The lower pressure (500 psig) metal flex hose on this suction line for water to the Triplex pump was destroyed with just strands of metal remaining.

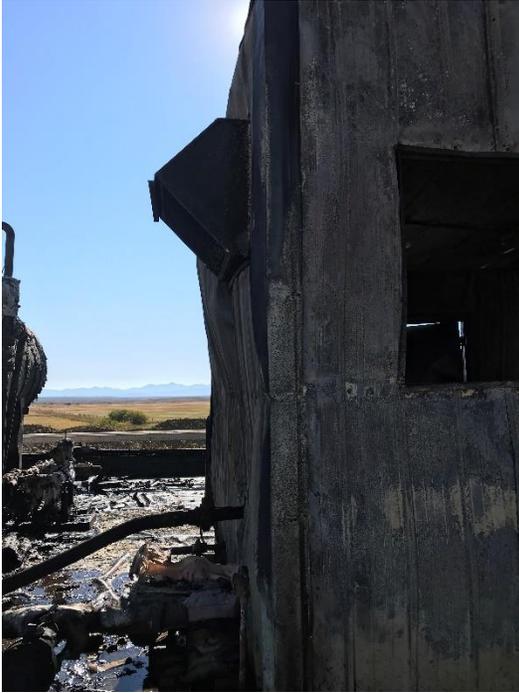
Photo of C7 Pump House north wall deformation facing the horizontal separator. The discharge line is above the suction line connect at this wall in the foreground.

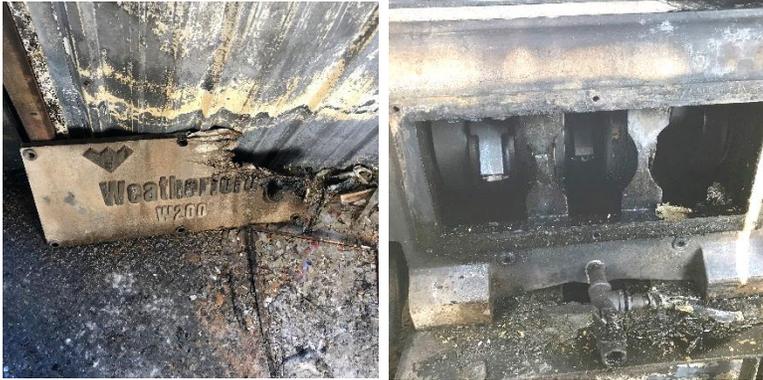
### C7 Triplex Pump Rear Inspection Cover Damage

C7 Triplex Pump rear inspection cover had approximately 10” off the upper right-hand corner melted or vaporized. There is a small metal slag pile in the right end inside of this cover visible in the second photo.

- a. Triplex rear inspection cover had a 10” section of the upper right-hand, vaporized or melted off, only a portion a small melted slag pile was found inside the cover area of the pump.

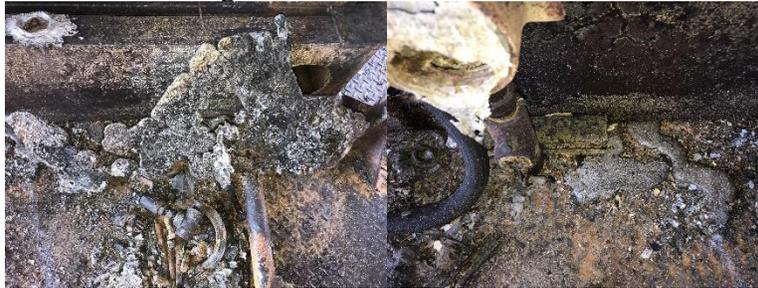
### C7 Top Inspection Cover Damage

Left photo shows remnants of top inspection cover on the Triplex pump located over the reciprocating plungers near the water flow through line of the pump. Left photo shows metal remnants of the metal cover. Right photo is a closeup of melted metal slag on the ground next to the cover.

The top, large “Cradle” inspection cover over the plungers was significantly melted on all sides and was falling apart. There were no hard, metal surfaces remaining, only solidified molten metal. The heat required to produce this could have been produced by an electrical Arc Flash.

- b. The thinner top cover was completely melted and solidified with no solid metal remaining. Metal with melted slag was observed on the skid deck.
  - c. Significantly blackened pump box observed where flow line pressure is increased up to 4,400 psig for return to wellhead.

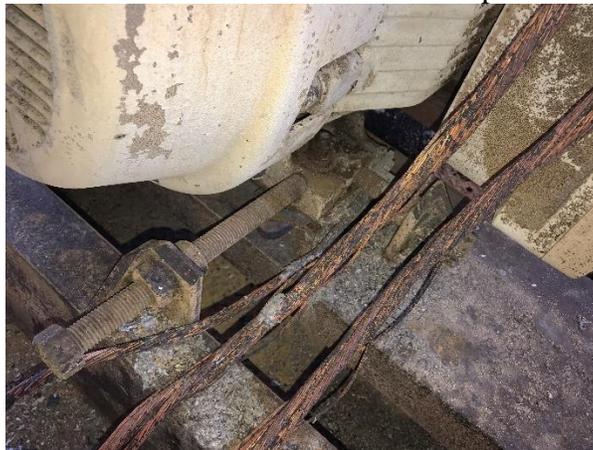
C7 Skid Pass Through Power Lines and Ground Line 200hp Motor

Ground line and first power line to the right have markings not shown on the second power line. Ground line looks damaged at its connection to the motor mount.

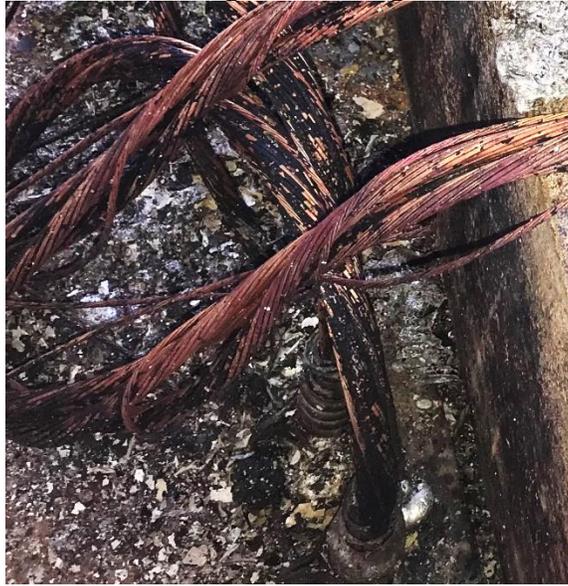
### C7 Motor Wiring Pass Through Skid Deck

The two power lines and ground line pass through the skid deck very closely. Wiring insulation is missing. There is a clamp holding the second power line in position over the first power line. The ground line is to the rear.

- d. Motor grounding wire was adjacent and close to the power lines going to the skid with all wire insulation missing. Potential existed for initial short between ground and power wires that may not have had adequate separation or insulation protection.

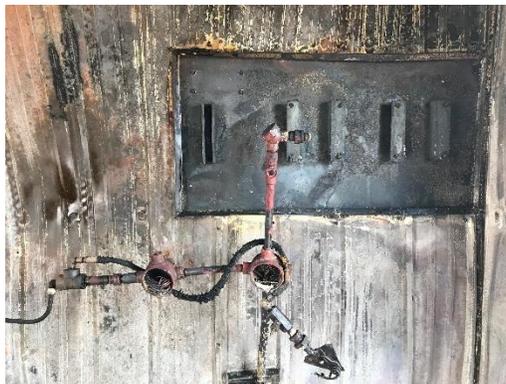
- Skid C7 pressure gauges and the transmitter mounted on the north wall were destroyed, with nothing remaining.

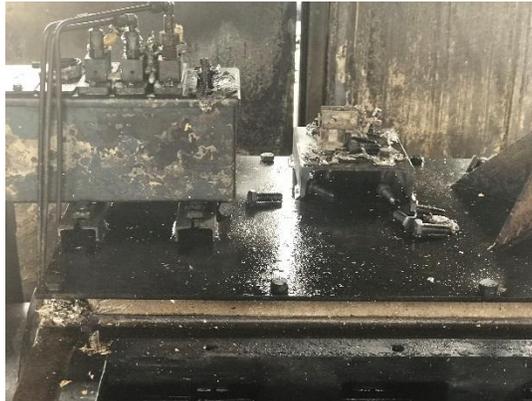
- Only remnants of the pump lubricator and vibration monitoring equipment on top of the C7 Triplex pump remained.

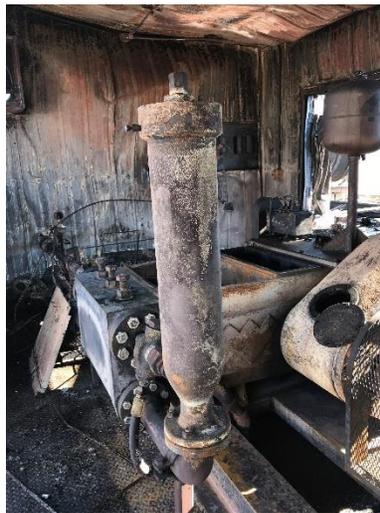
Triplex damage to the flow line pass through chamber of the C7 Triplex Pump.

Significant heat affected the rectangular box at the left end of the pump where the flow pressure is increased from approximately 250 psig up to 4,400 psig for return to the C7 wellhead. If heat is transferred to the suction or discharge steel lines inside the building, the heat can be transmitted to the steel lines outside the building that are insulated.

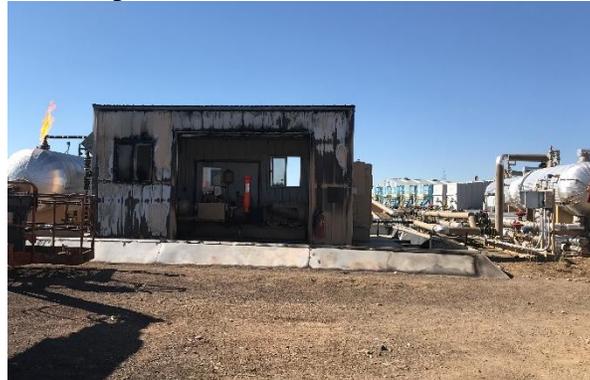
East side of C5 shows local shoot marks above piping to Triplex pump  
Allocation Vessels shown to right of C5 Pump House

Flame and soot marks appear above the suction and discharge lines outside of the pump house are similar to C6 marks. Soot marks were present inside also. It is evident here that it was heat from the C7 fire that caused the wiring and insulation to ignite.

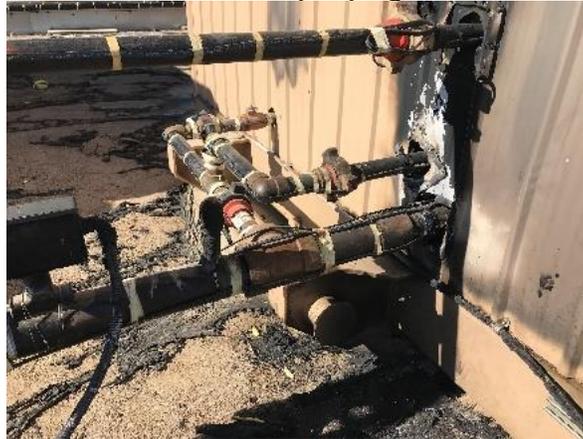
### C5 Pump Piping

C5 Close up photo of pump piping and wall soot marks

The C6 and C5 pump houses show significantly darker soot marks above the insulation on their Triplex pump suction and discharge piping at the outside wall of the pump house. Soot marks extended in a narrow pattern 5 feet above the piping. Soot marks on C5 and C6 above pump piping insulation are considerably darker than the soot marks from the C7 Pump House area fire as shown on the side edges of the pump houses. These patterns are evidence that external heat from the C7 Pump House area was sufficient to cause the insulation burning and this dark soot pattern.

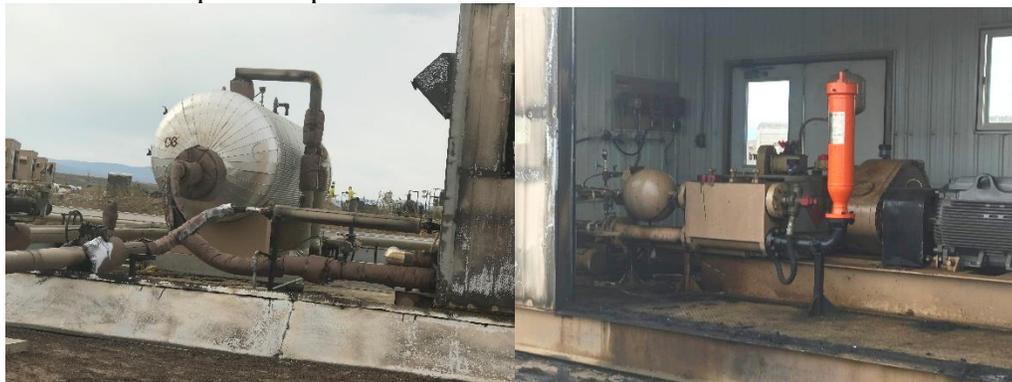
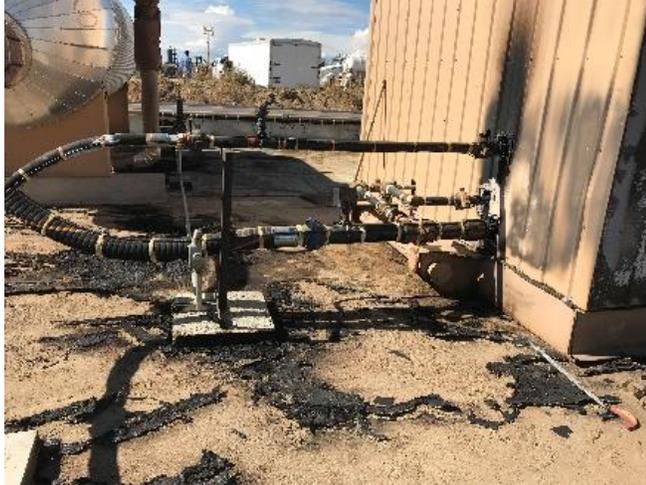
### C6 Separator and Pump House photos

C6 External wiring, instrumentation, insulation wall, doors and windows were damaged. Internal heat damaged wiring.

- Building damage: front window damaged. East and north walls facing C7 were heavily damaged.
- Similar heat caused the insulation fire and pump wall soot marks above the piping into the Pump House that damaged the wall facing C7 Pump House.

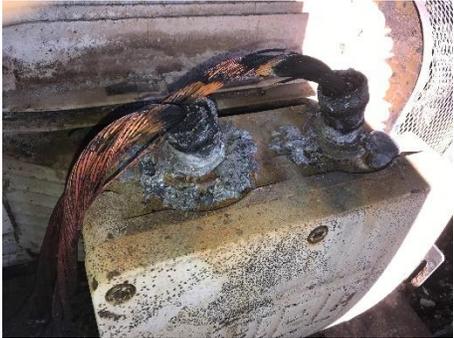
Potential Initiator Findings/Factors	Discussion	Conclusion
<p><b>1. Damaged power lines into motor with melted metal connectors.</b> Bare power wires to motor after the incident. Angulated damage indicates power lines were leaning to one side of the connectors into the motor. Possible source of short and meltdown</p>

<p>The power lines enter in a curved route that leans the weight of the wiring to one side of the connector. These lines are subject to vibration from the pump and motor. Heavy wire weight can have motion during transport for another risk of rubbing or scraping wiring insulation. Heat damage in this area was significantly below the temperatures required to cause the Triplex pump inspection covers to melt.</p>	<p>These motor wires may have been an initial source for a short or local sparking condition against the connector or the housing. This is a Less Than Adequate (LTA) condition and is a possible power line short. REC: Consider proper weight support for power lines to avoid side leaning against connectors or housings for possible shorts. .</p>

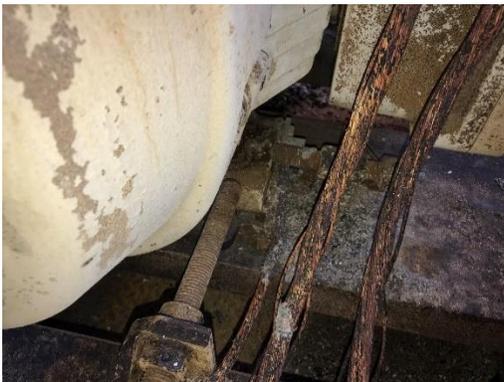
2. **Skid deck opening finding of potential for adjacent ground and power lines to motor to be damaged and short.** Bare wiring found passing through C7 skid deck to motor for 2 power lines and ground line that may have been in contact. This power line feeds the Triplex motor in Finding 1. Possible signs of sparking and soot are visible near the ground wire connection to the motor base anchor connection.

Enlarged view of ground wire to motor base connection and adjacent power lines.

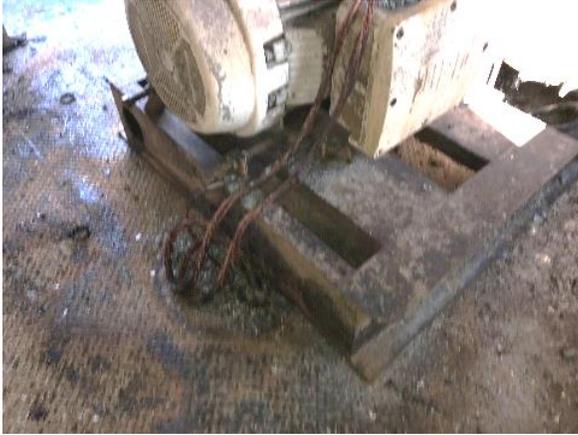
**3. Motor supply wire potential damage to power lines passing through skid deck to 200hp motor.**

**Closeup view of C7 power lines through connectors into oversized cut openings**

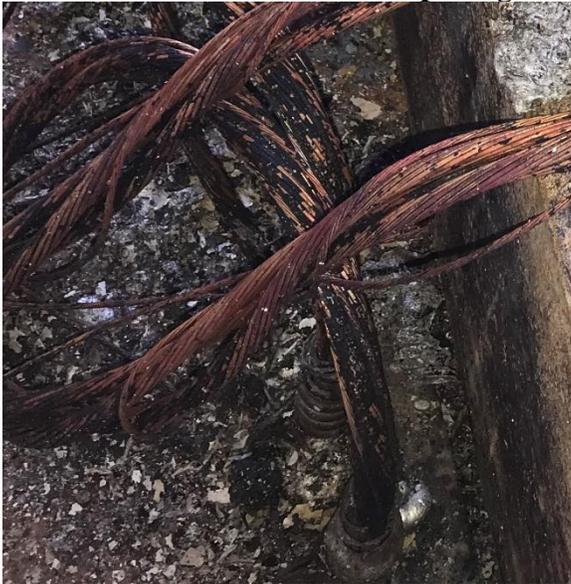
Rough cut skid deck openings without sleeve or other protection and cause rubbing or scraping from vibrations of operation or from transportation.

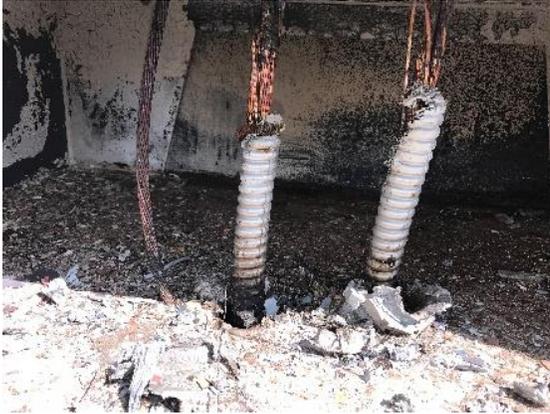
**4. Damage to protective conduit on power lines passing through Power Panel Box to Triplex skid.**

**C7 looking up from under the Power Panel Box bottom shows ground wire and conductor without insulation.**

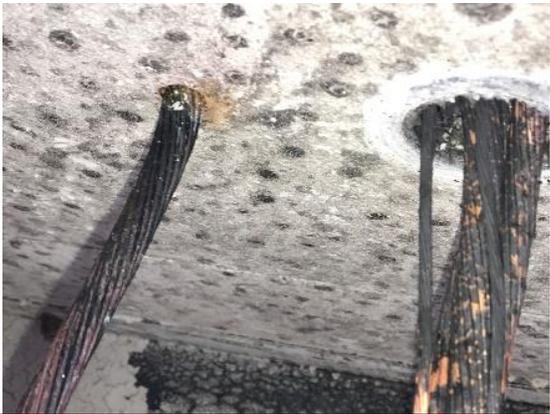
Corrugated conduit insulation cover separated or melted about 6" from the bottom of the panel exposing power wires. Do not know when the separation occurred.

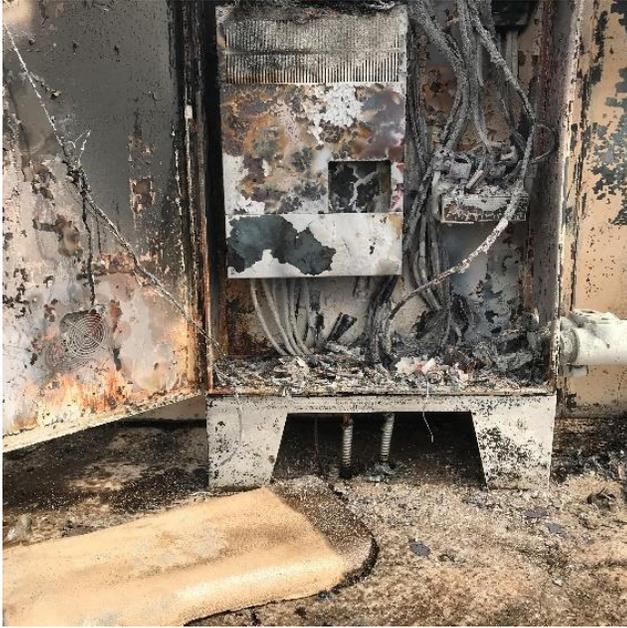
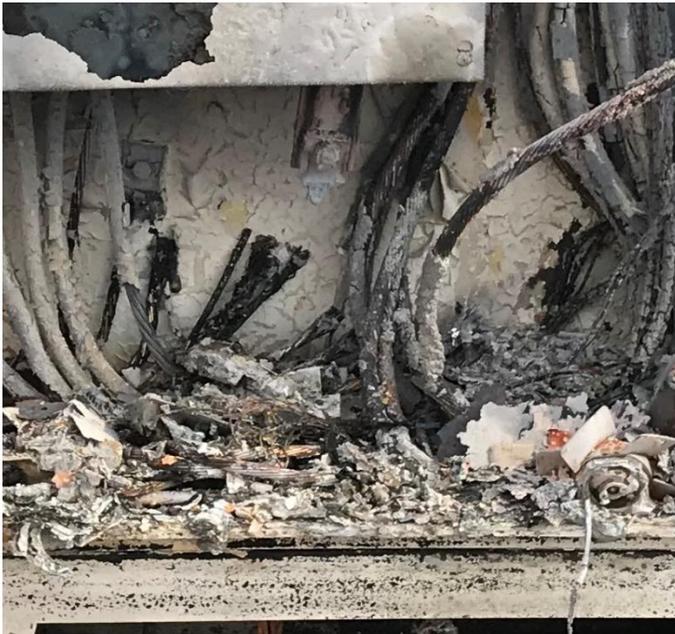
**5. High voltage conductors in Power Panel Box had vaporized wire ends and connecting lugs**

The orange and yellow high voltage conductors are aligned vertically about 6" apart in the lower section of the power box. Electricity transferred through air between conductors is a definition of Arc Flash, this appears to be the case here.

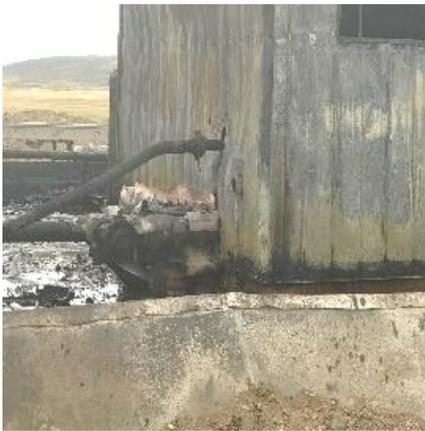
Bottom line is location where 4” suction steel pipe connects to the skid flange. Both suction and discharge lines connect to the skid at flanges outside of the skid.

The suction and discharge lines connect to the Triplex pump within a couple feet from the melted top inspection cover. Both lines are insulated up to the connection point before the skid wall. There is a potential that excessive heat could be transferred to the steel piping that could cause the insulation to burn outside the Power House.

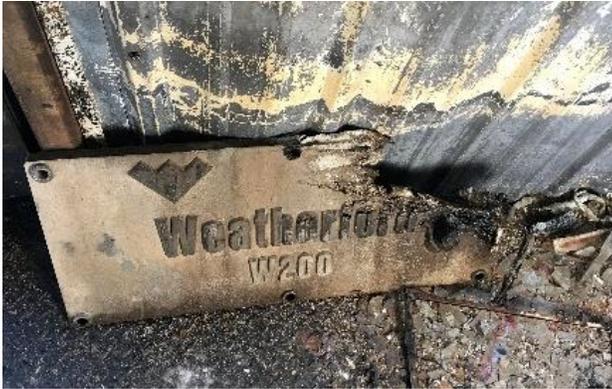
Rear Inspection Cover over connecting rods:  
C7 cover missing upper right-hand section:

Rear Triplex inspection cover allows access to the connecting rods of the pump, mechanical section. Melted metal slag was found inside the cover location on the right end where the melt of the cover occurred. Melting of metal can occur with Arc Flash incidents, temperatures from 5,000 to 30,000 degrees F are possible.

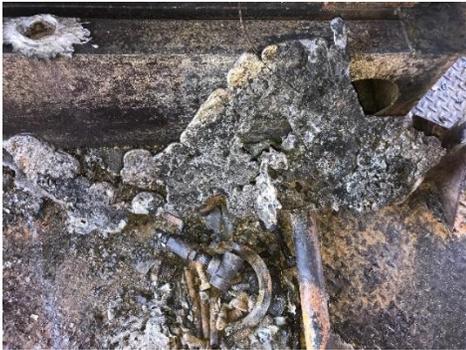
Top inspection cover over the discharge and suction piping into the pump:  
 C7 photo below of the top inspection cover remnants after high temperature melting. No solid metal remaining, falls apart when lifting.

Top inspection cover was lighter weight and is not as securely sealed to air exposure than the rear inspection cover. The Top Inspection cover is within 2 feet of the suction and discharge lines into the Triplex pump and within 8 feet of the wall location where these lines are insulated outside the walls of the Pump House.. If one of these lines got sufficiently hot like the similar lines at C6 and C5 from the Triplex pump, they could have caused the initial small fire.

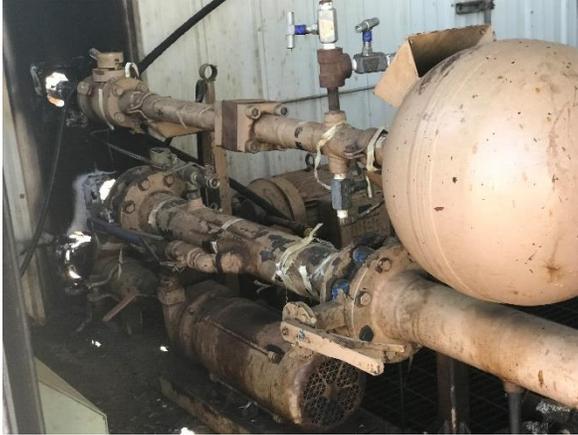
Photo shows black soot marks that are on the inside of C7 pump house with none on the outside.

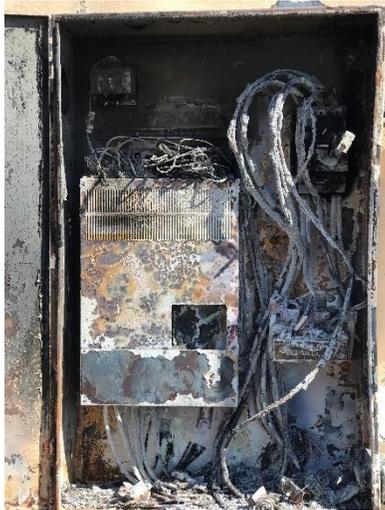
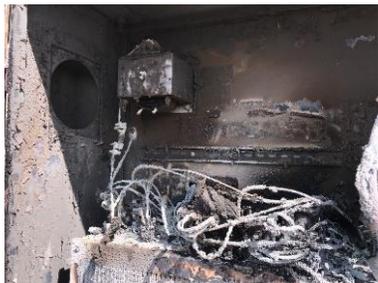
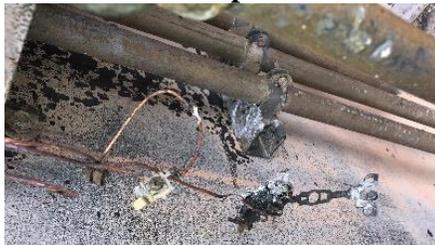
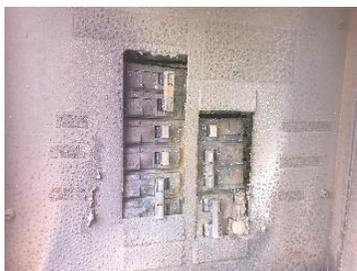
**C7 Outside Receptacle and breakers**

**9. Low voltage area for fuses, circuit breakers burned up in upper part of Power Panel Box.** Lower and middle sections not affected.

In this area high voltage is transformed to lower voltage. If there is a higher current flow or voltage pass through the lower voltage equipment can get damaged. If there was a low voltage short in the pump house, it could have triggered a short getting back to this equipment.

<p><b>REC:</b> Low voltage systems should be considered for electrical inspections and should be exterior weather protected.</p>
<p><b>10. Newer Skids C6 and C8 have power lines to the Triplex motor passing overhead from the Power Panel Box through the Pump House wall instead of through the bottom of the box, under the skid deck and passing through the skid deck to the motor. See C6 motor and overhead wiring photos below.</b></p>

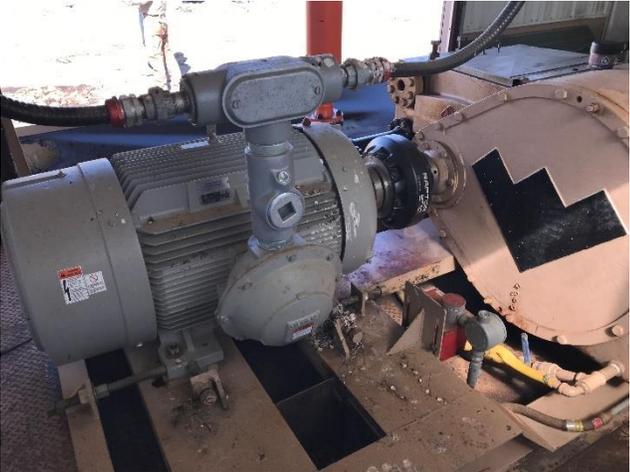
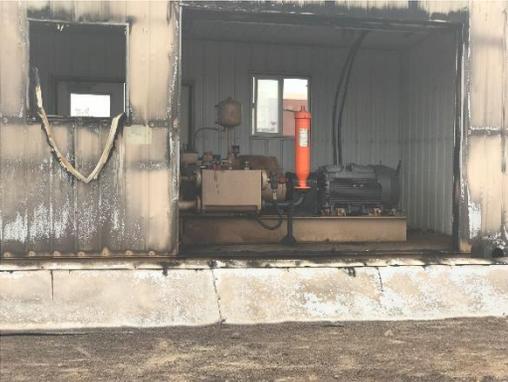
<p><b>C6 Window damage and wall damage</b></p>	<p>This appears to be a better design to enable better inspection, testing and maintenance on these lines.</p>	<p>Good change to be considered for all Triplex skids. <b>REC:</b> Consider changing the routing of the power lines to the motor on all skids.</p>
