**Inspection Photo
Jolley KP 514-17
API # 045-17678
Inspection # 689302235**

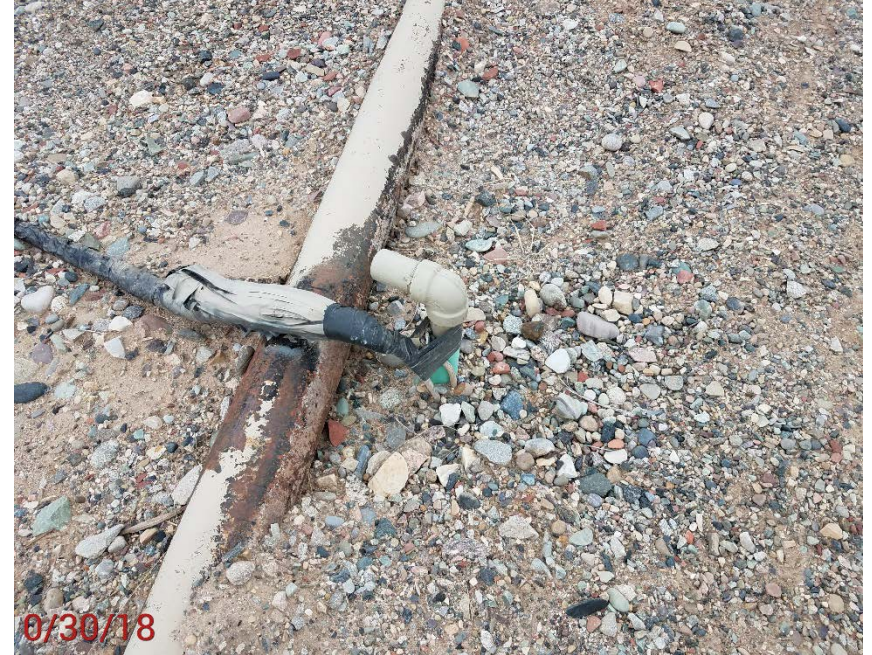
Location Photo #4, Unmarked flow line.

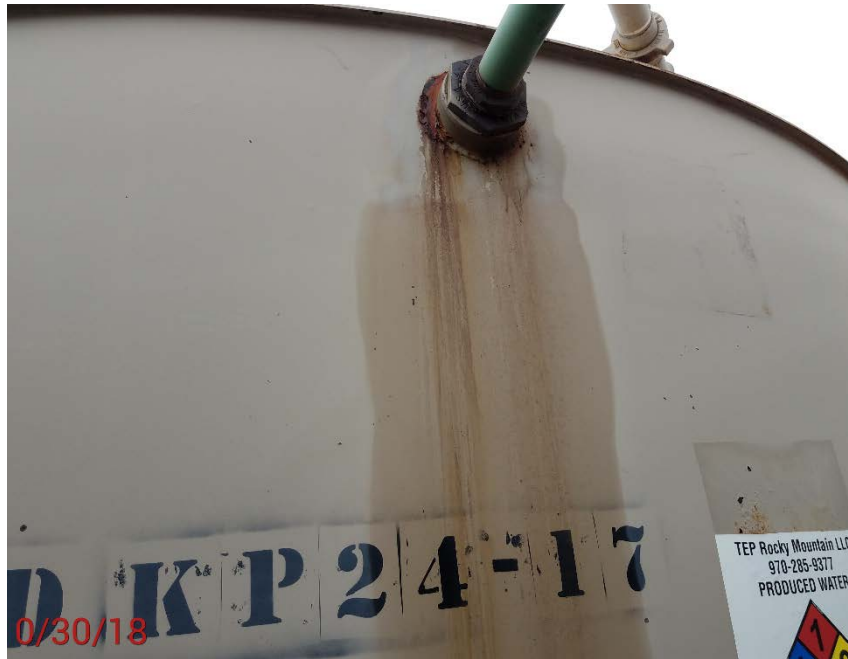
Location Photo #5, Mechanical condition of tank fitting.

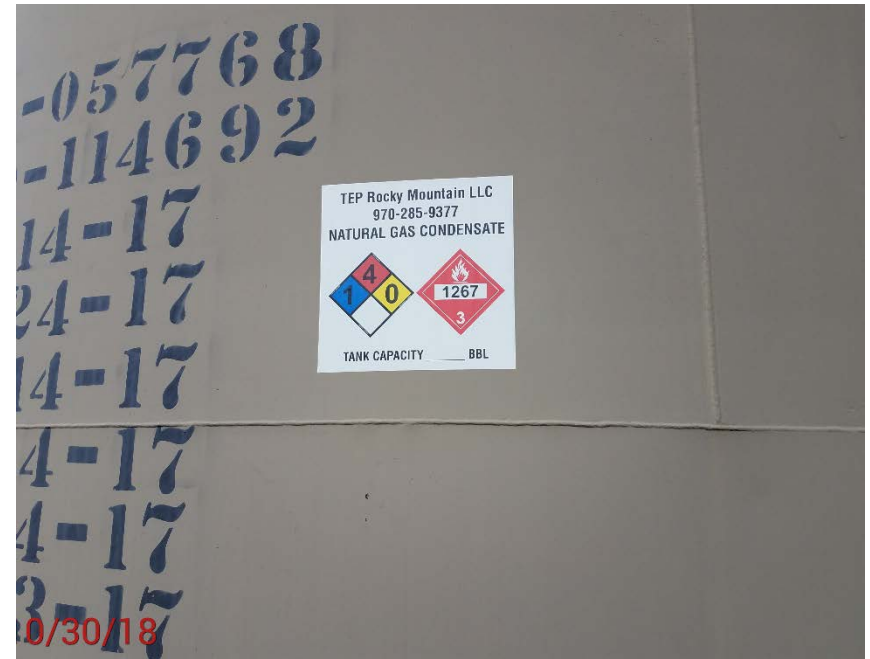
Location Photo #6, Missing capacity on all tanks

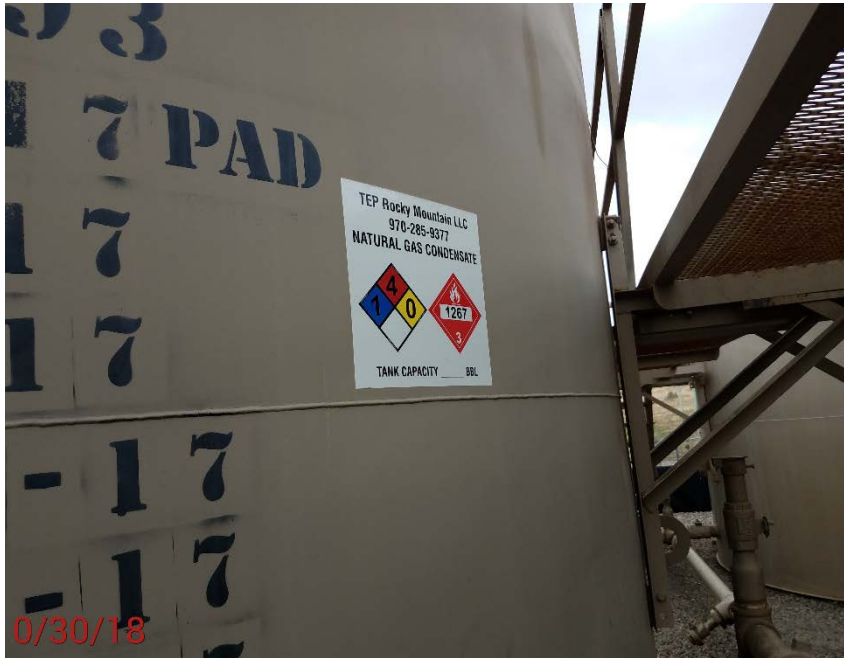
Location Photo #7, Missing capacity on all tanks

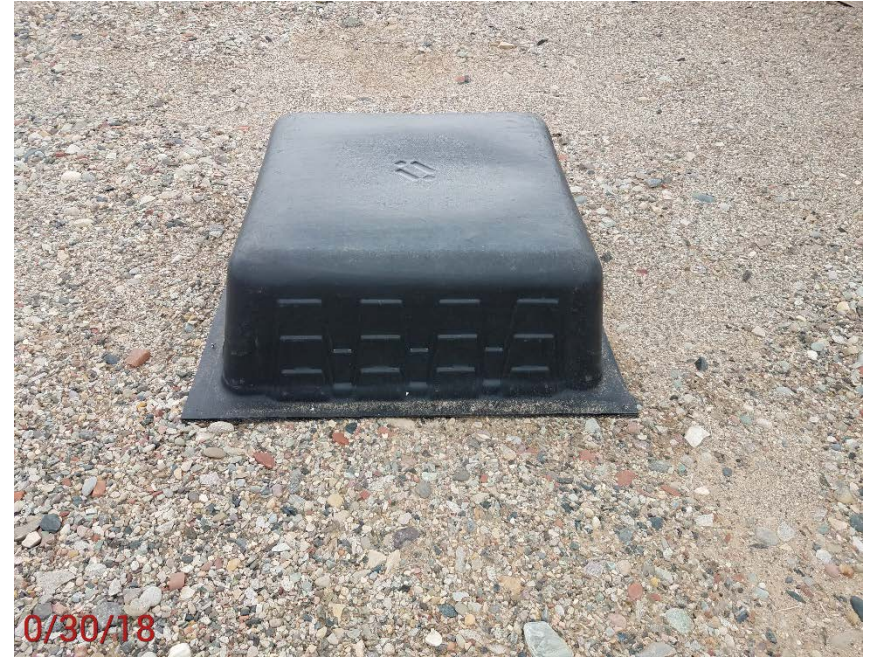
Location Photo #8, unused equipment.
