# Inspection Photos

11/1/2018

Operator: FRITZLER RESOURCES INC - 31257

Location ID: 316908

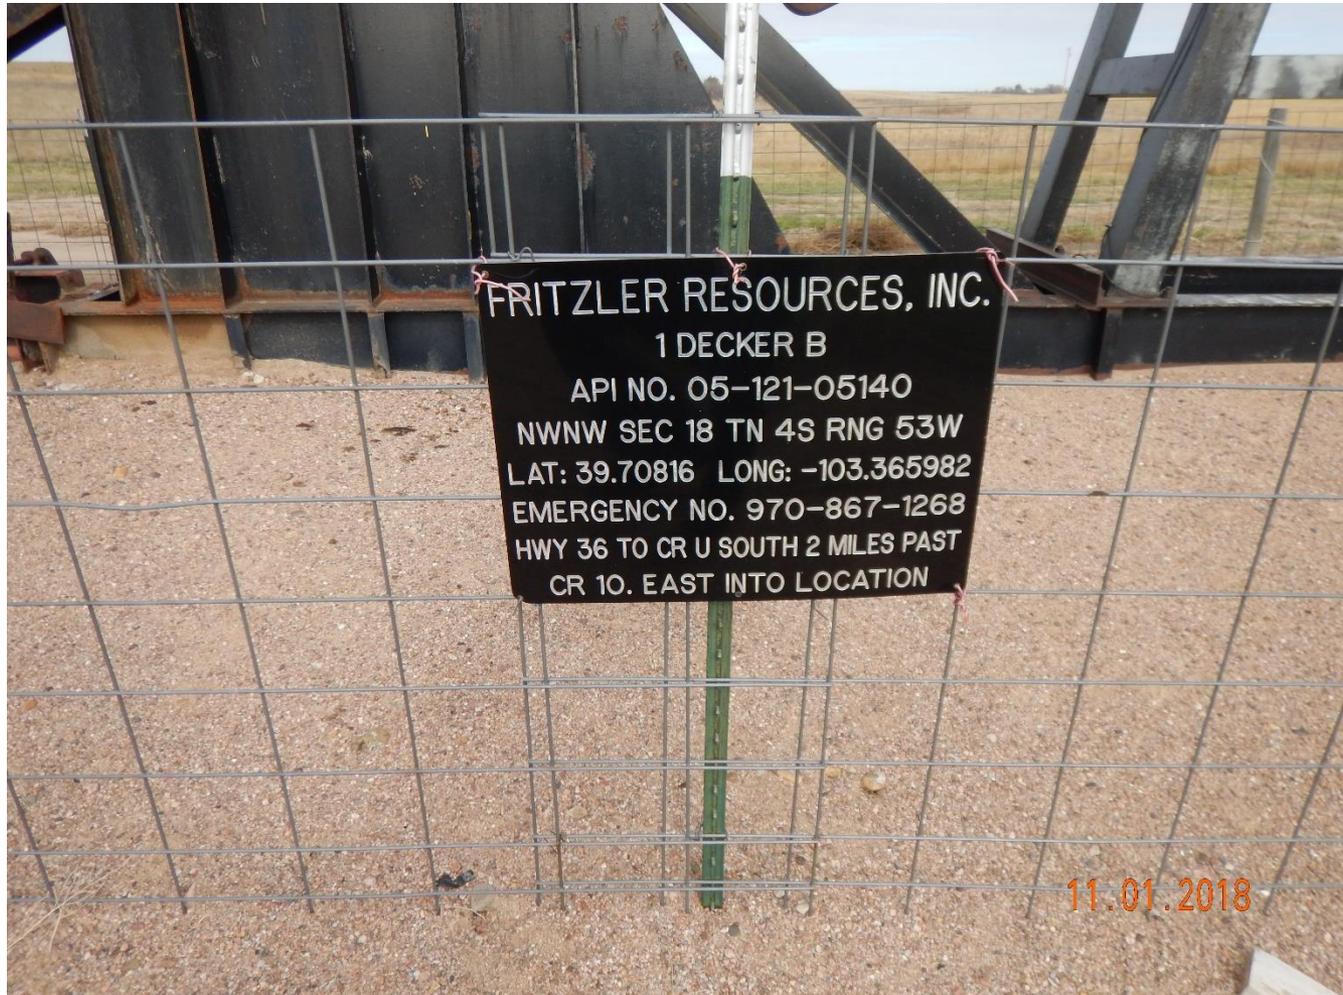
**Photo 1:** Photo of sign at well

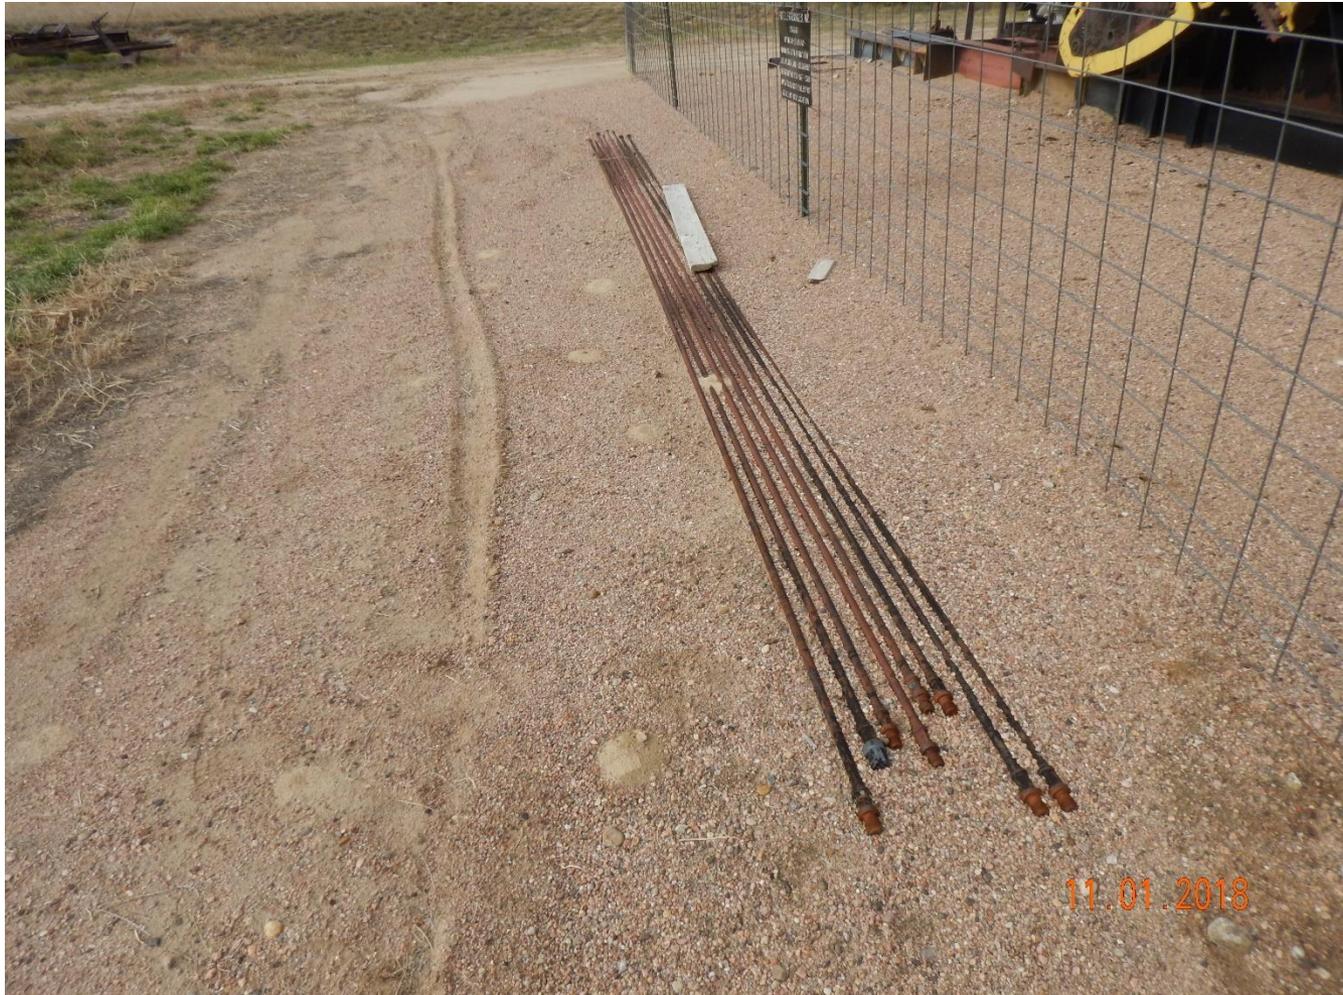
**Photo 2:** Photo taken from the south end of the pump unit, facing west. Photo shows unused equipment being stored on location.

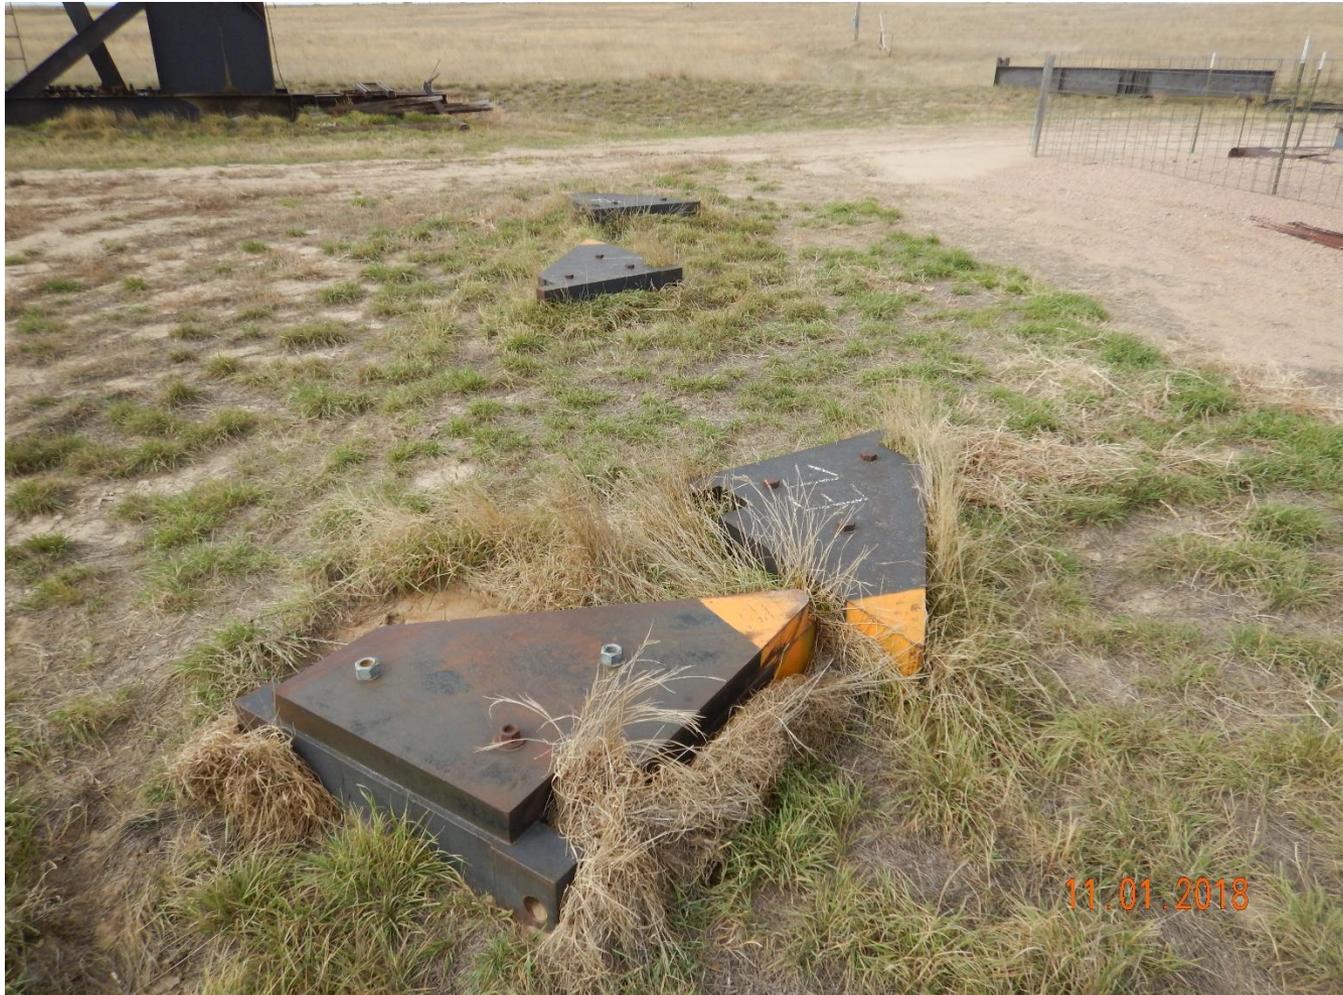
**Photo 3:** Photo taken from the south end of the pump unit, facing west. Photo shows unused equipment being stored on location.

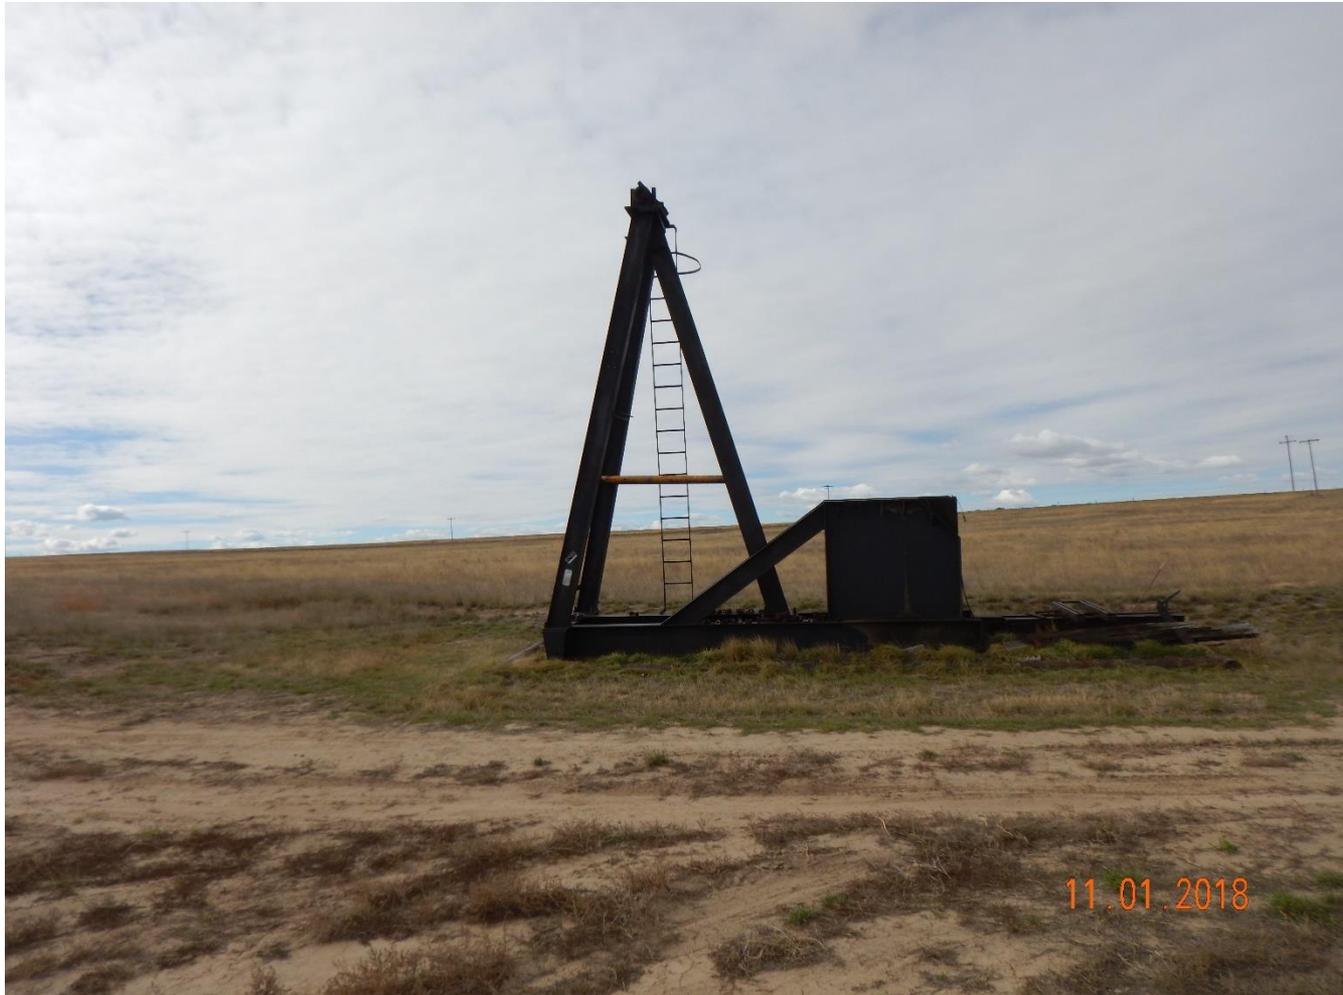
**Photo 4:** Photo taken from the south end of the pump unit, facing west. Photo shows unused equipment being stored on location.

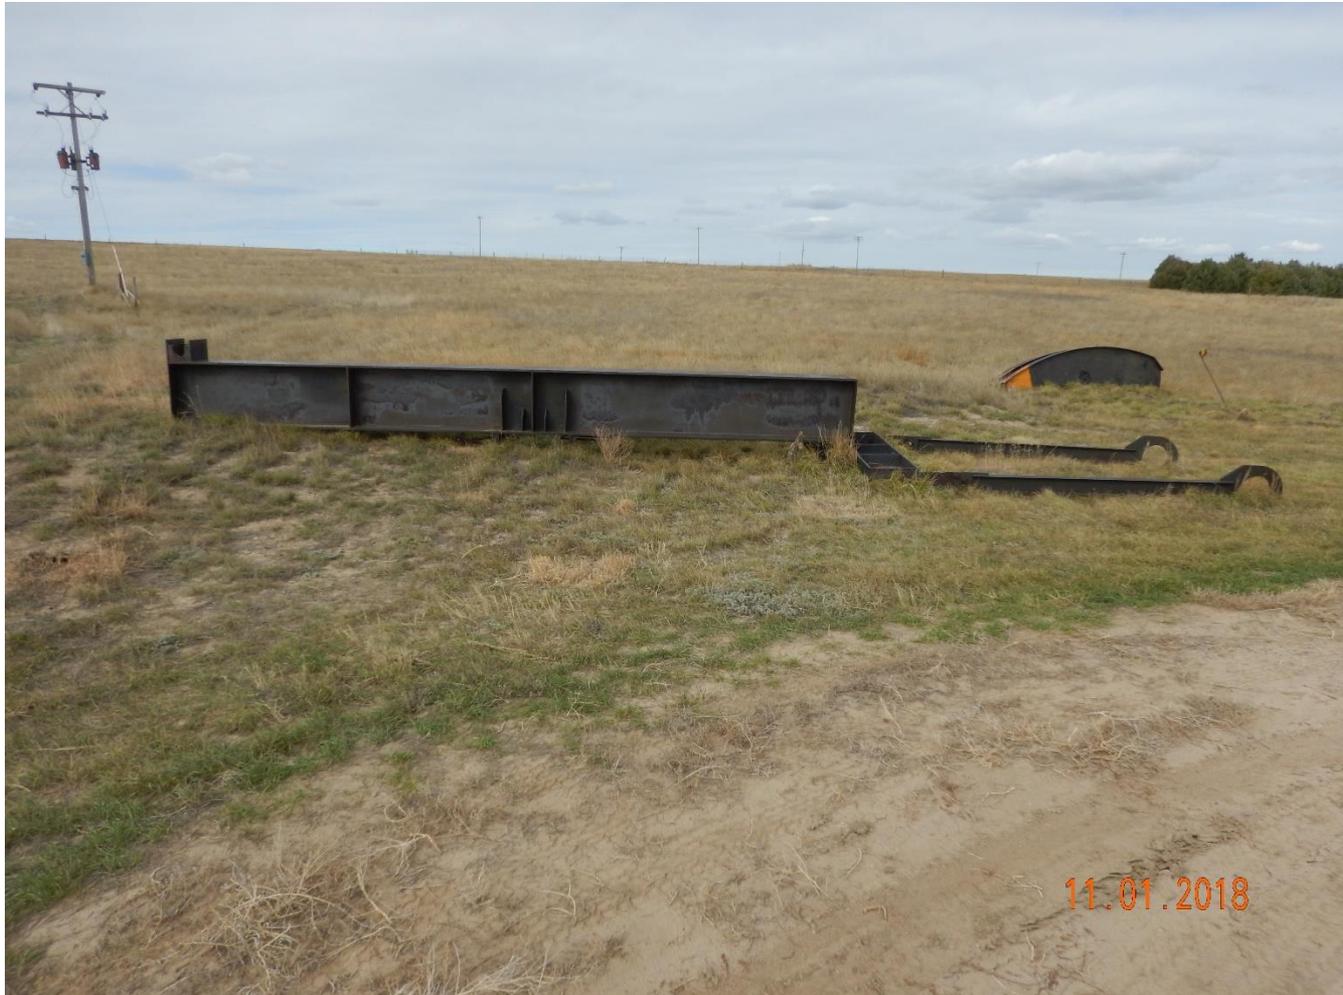
**Photo 5:** Photo taken from the west end of the pump unit, facing west. Photo shows unused equipment being stored on location.

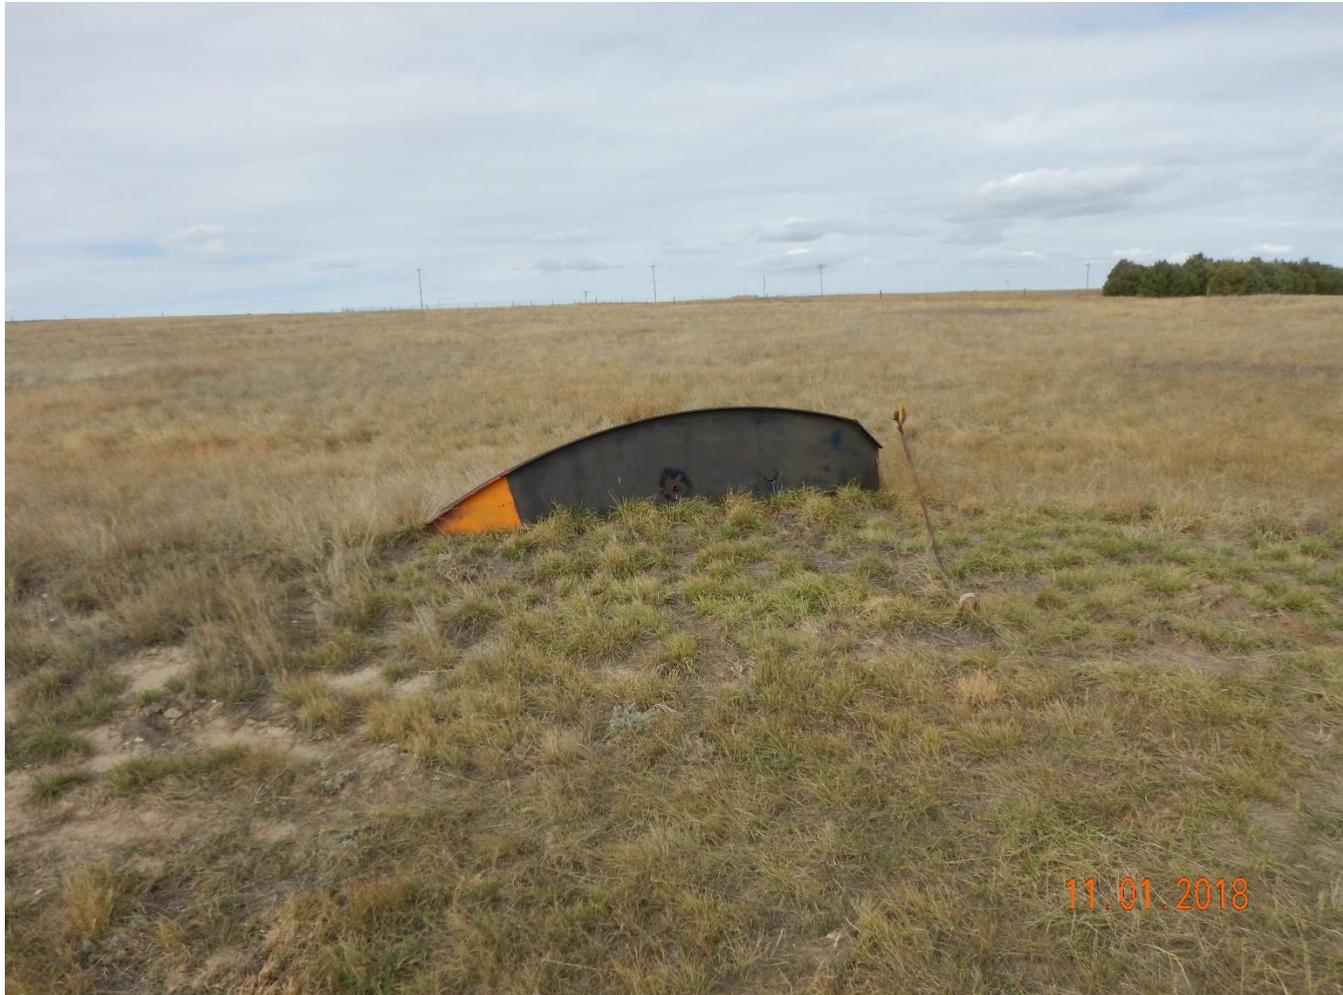
**Photo 6:** Photo taken from the northwest end of the location, facing west. Photo shows unused equipment being stored on location.

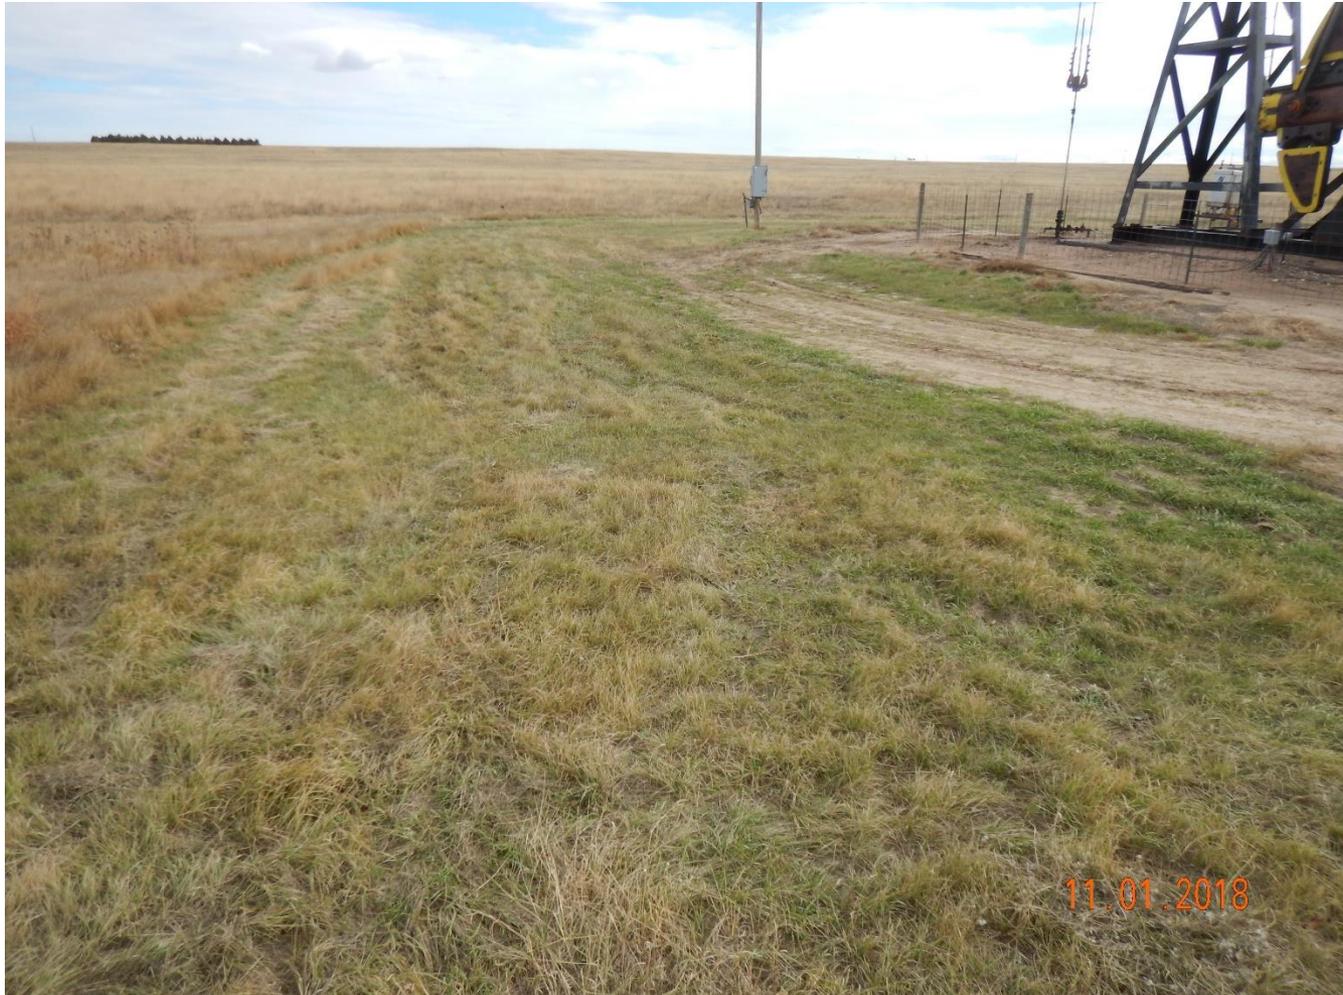
**Photo 7:** Photo taken from the northwest end of the location, facing east. Photo shows vegetation over the interim areas.

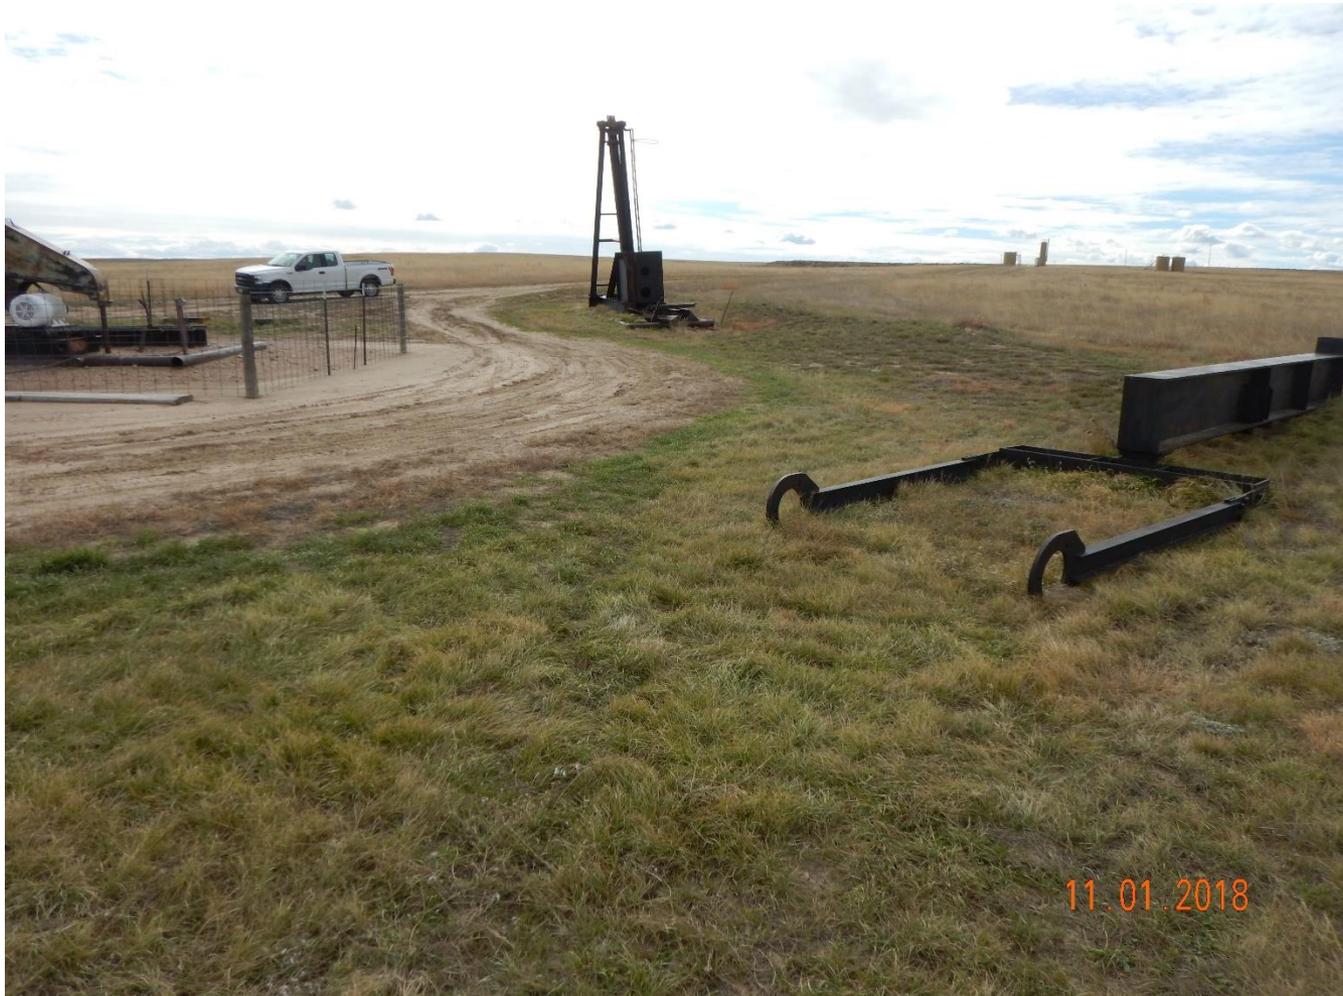
**Photo 8:** Photo taken from the northwest end of the location, facing south. Photo shows vegetation over the interim areas, as well as unused equipment being stored on location.

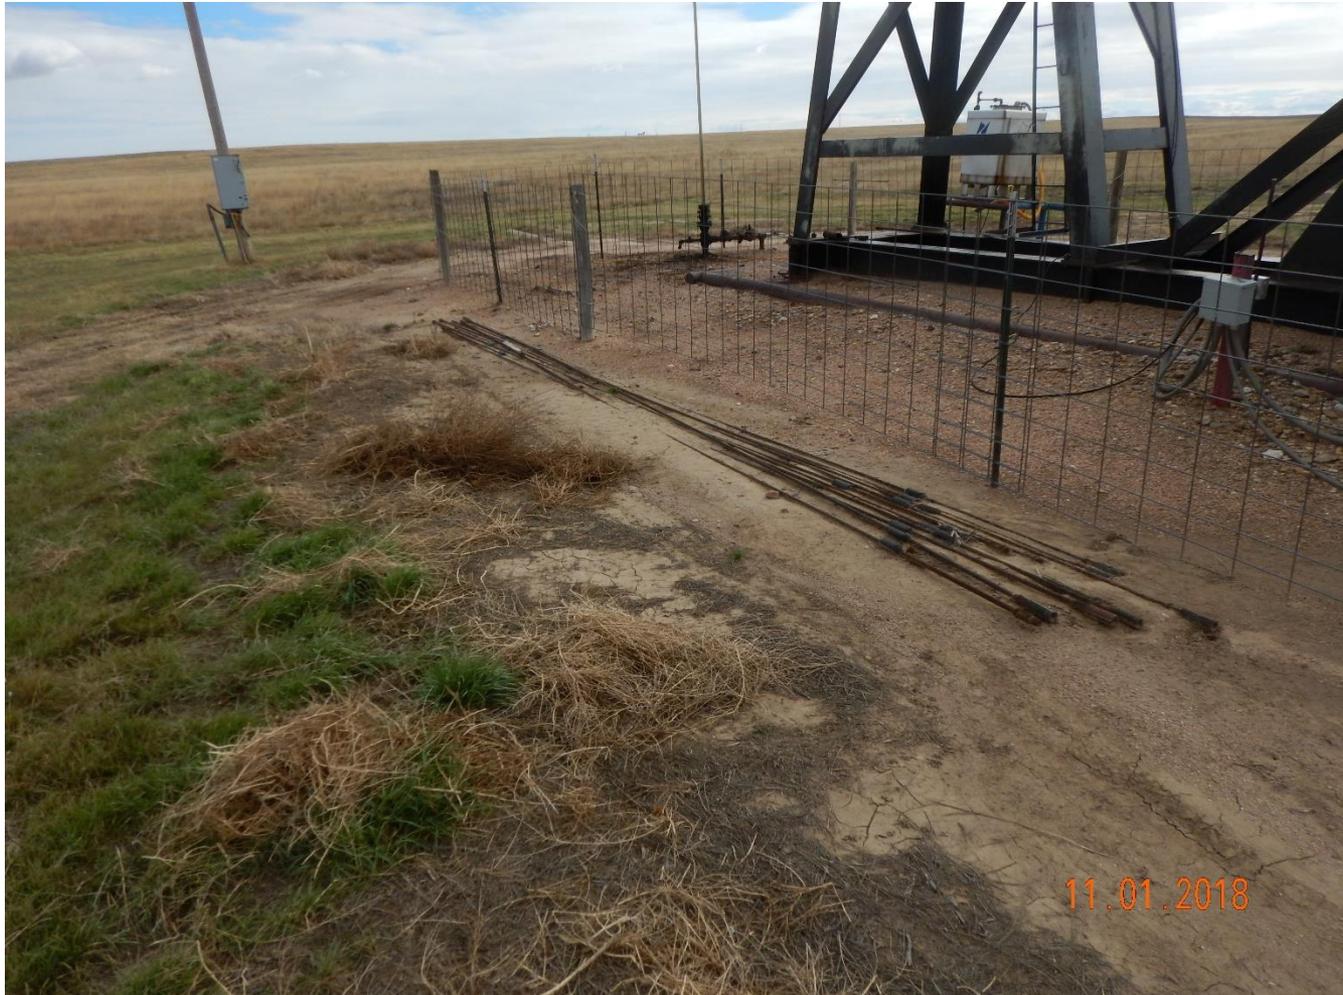
**Photo 9:** Photo taken from the north end of the pump unit, facing east. Photo shows unused equipment being stored on location.

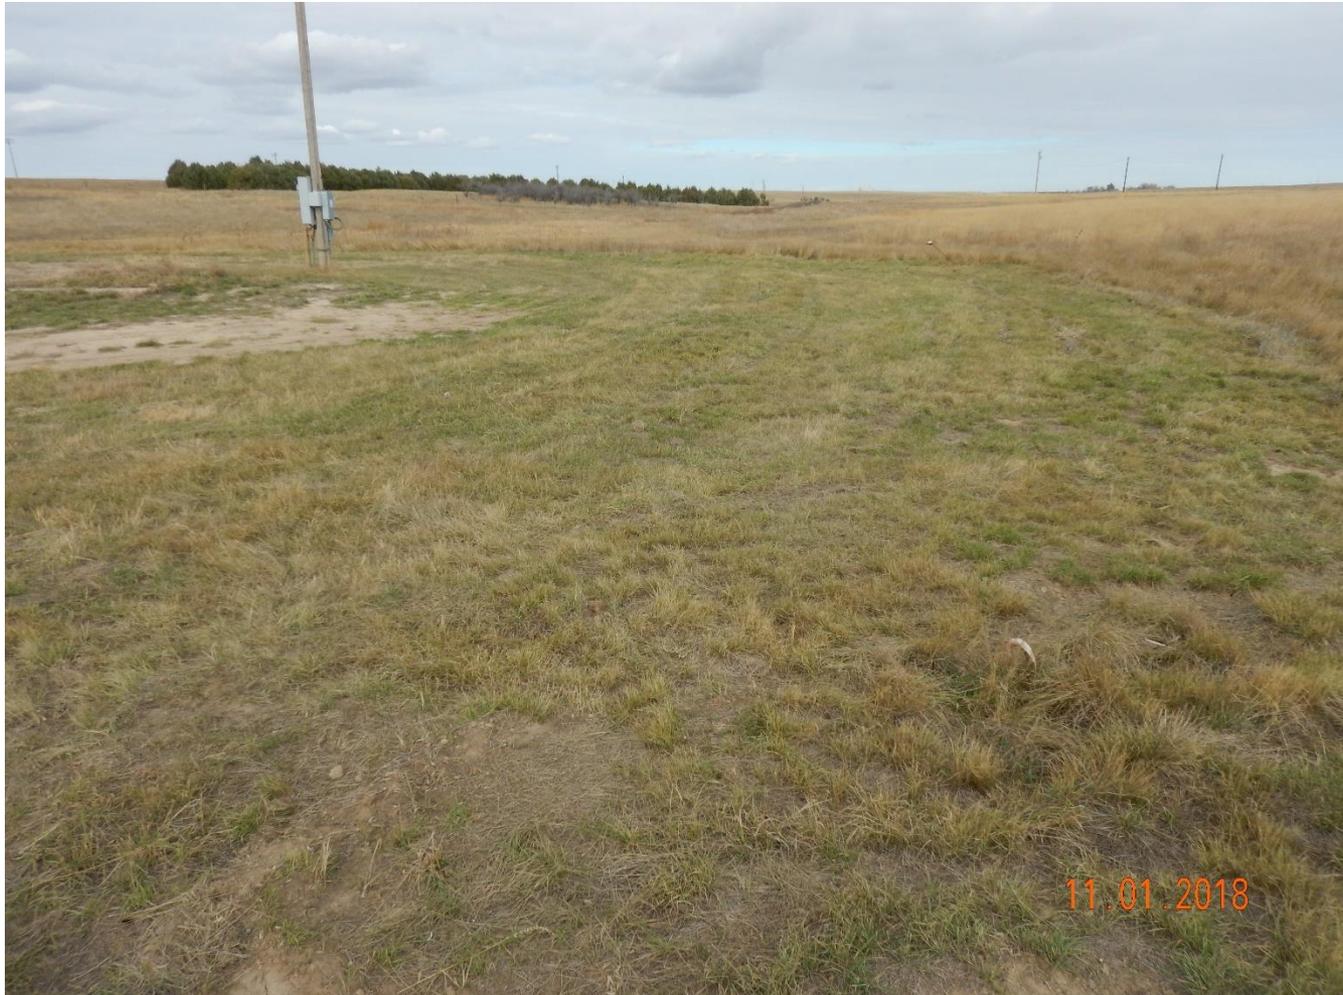
**Photo 10:** Photo taken from the southeast end of the location, facing north. Photo shows vegetation over the interim areas.

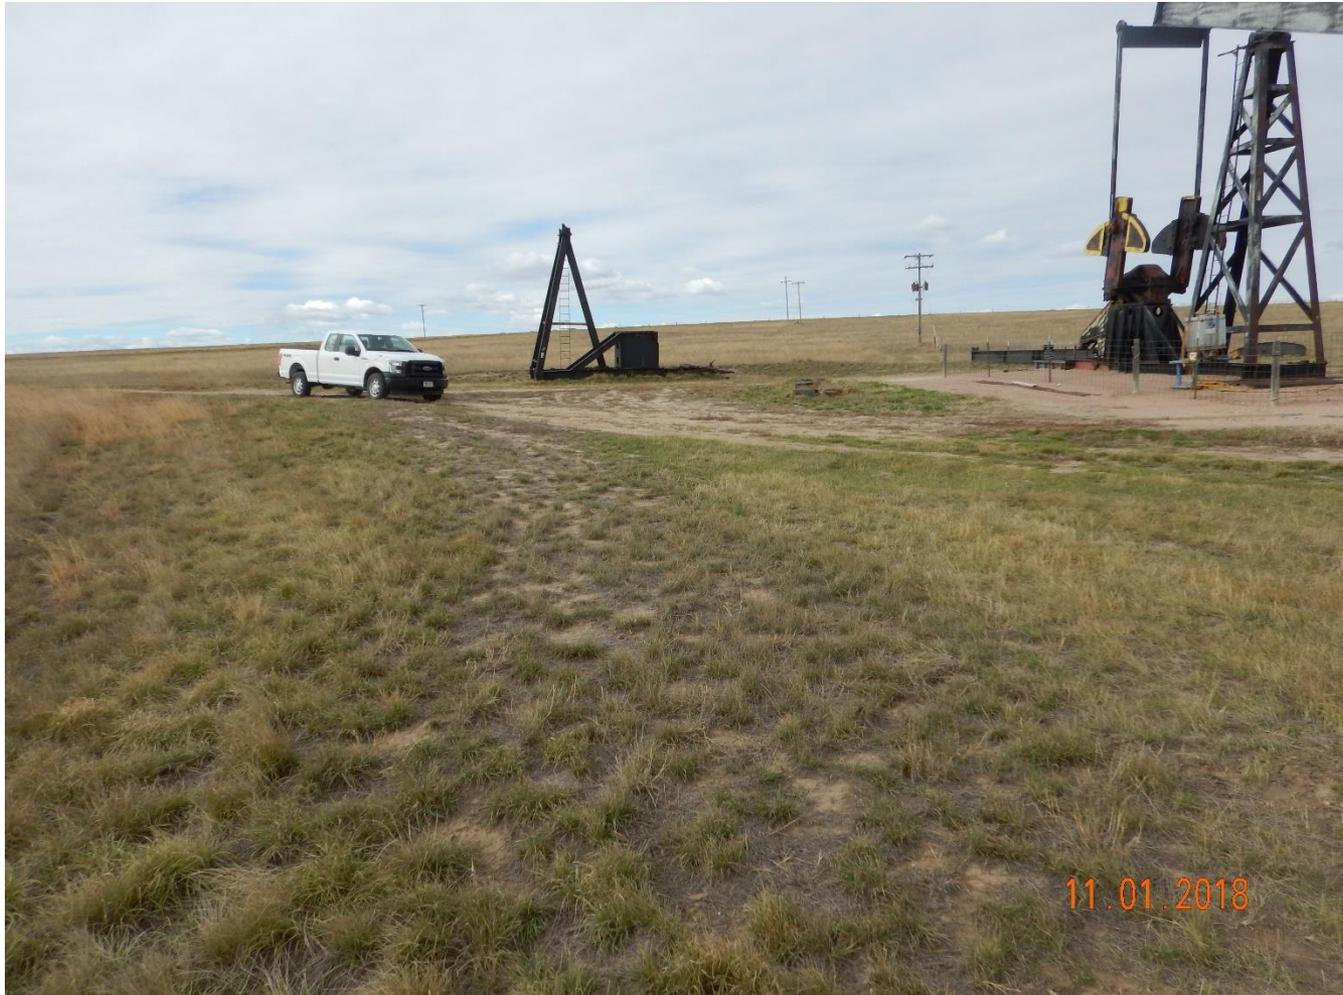
**Photo 11:** Photo taken from the southeast end of the location, facing west. Photo shows vegetation over the interim areas.

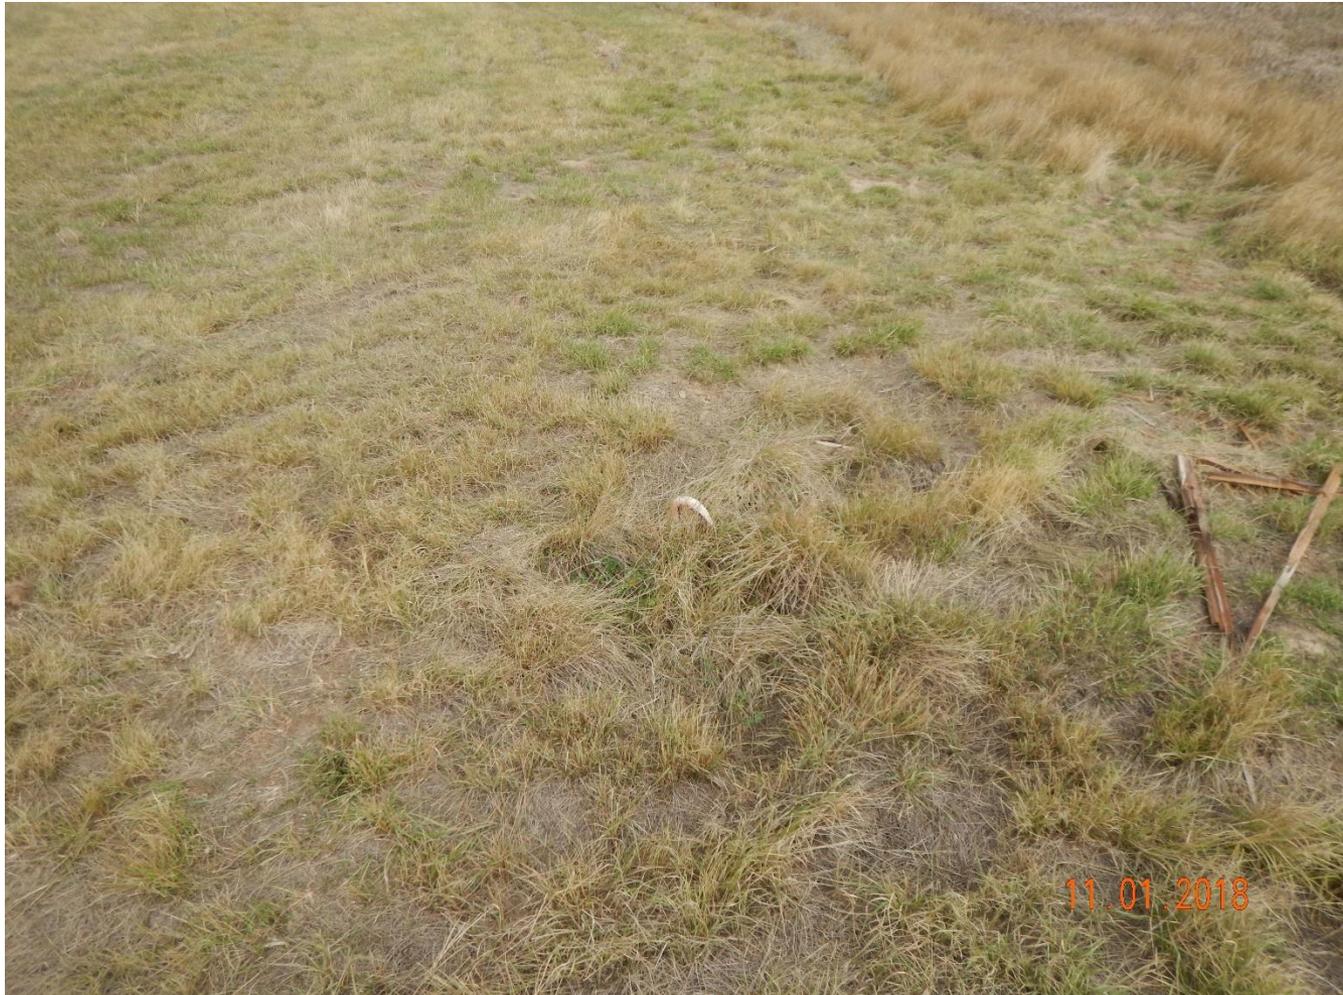
**Photo 12:** Photo taken from the southeast end of the location, facing north. Photo shows anchor without proper marking.

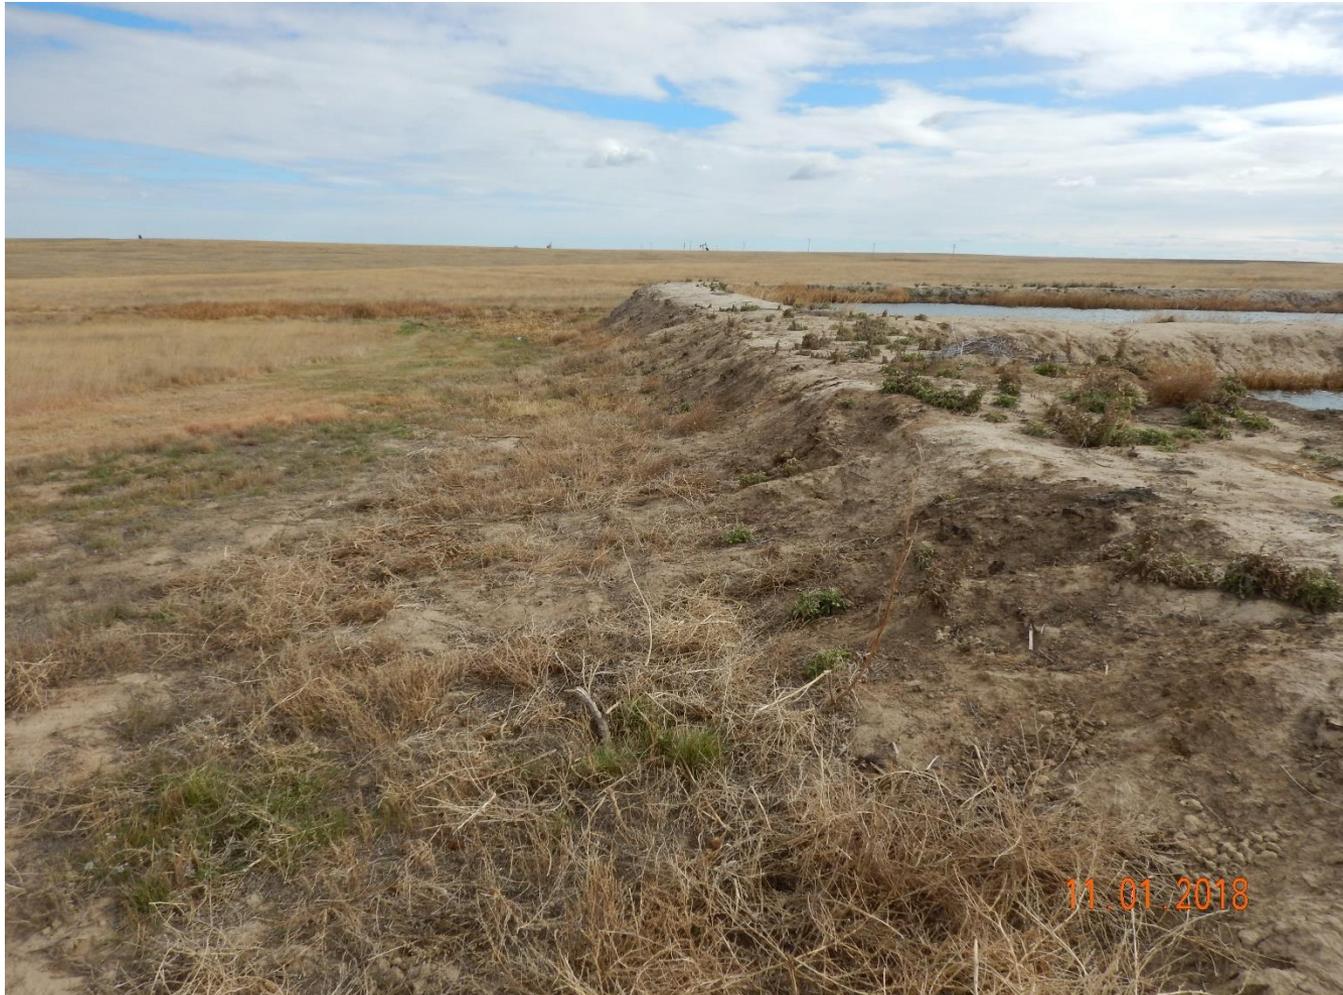
**Photo 13:** Photo taken from the northwest corner of the pits, facing east.

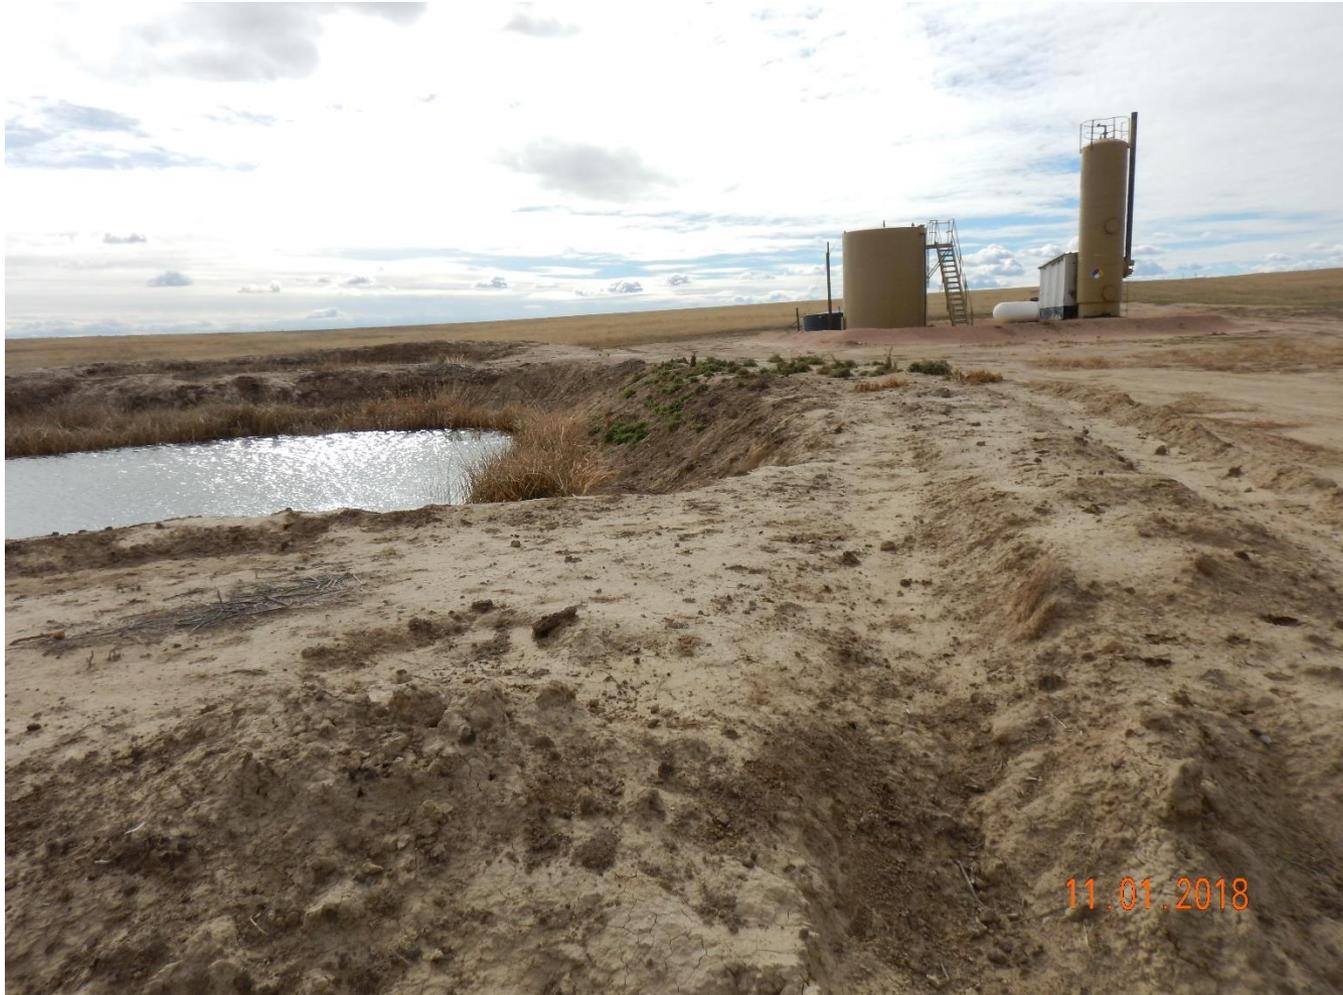
**Photo 14:** Photo taken from the northwest corner of the pits, facing south.

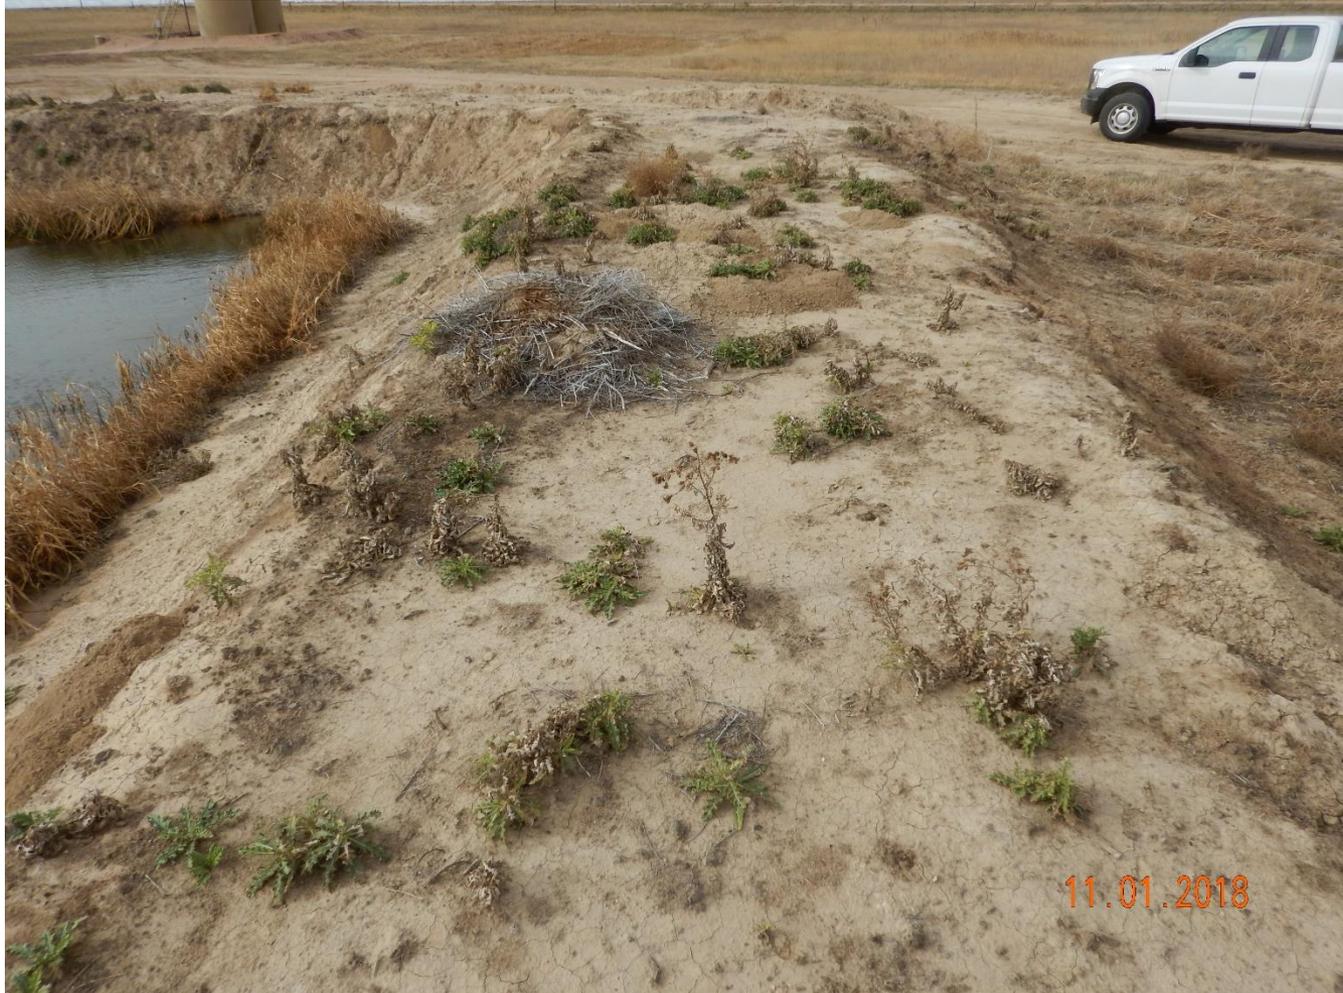
**Photo 15:** Photo taken from the north end of the pits. Photo shows what appears to be Canada thistle rosettes on the pit. Some plant appear to have matured and have seeded out. This is a Colorado State listed noxious weed and needs to be managed.

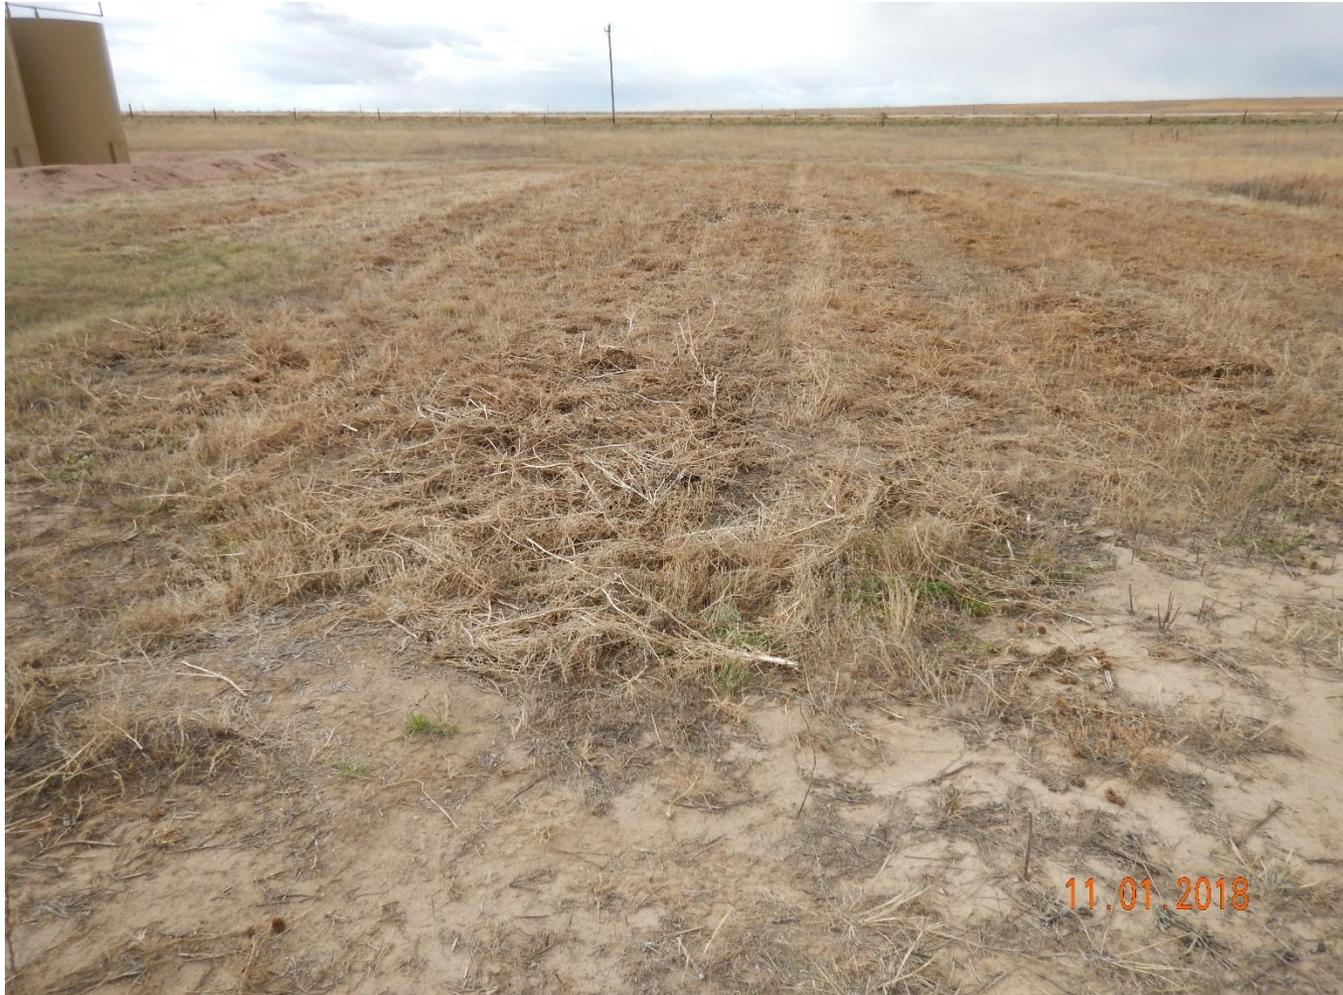
**Photo 16:** Photo taken from the north of the tanks, facing west. Photo shows “landfarm” area under remediation project #8509. Vegetation seen in photo is predominantly undesirable weedy plant species. Mowing operations appear to have been conducted.

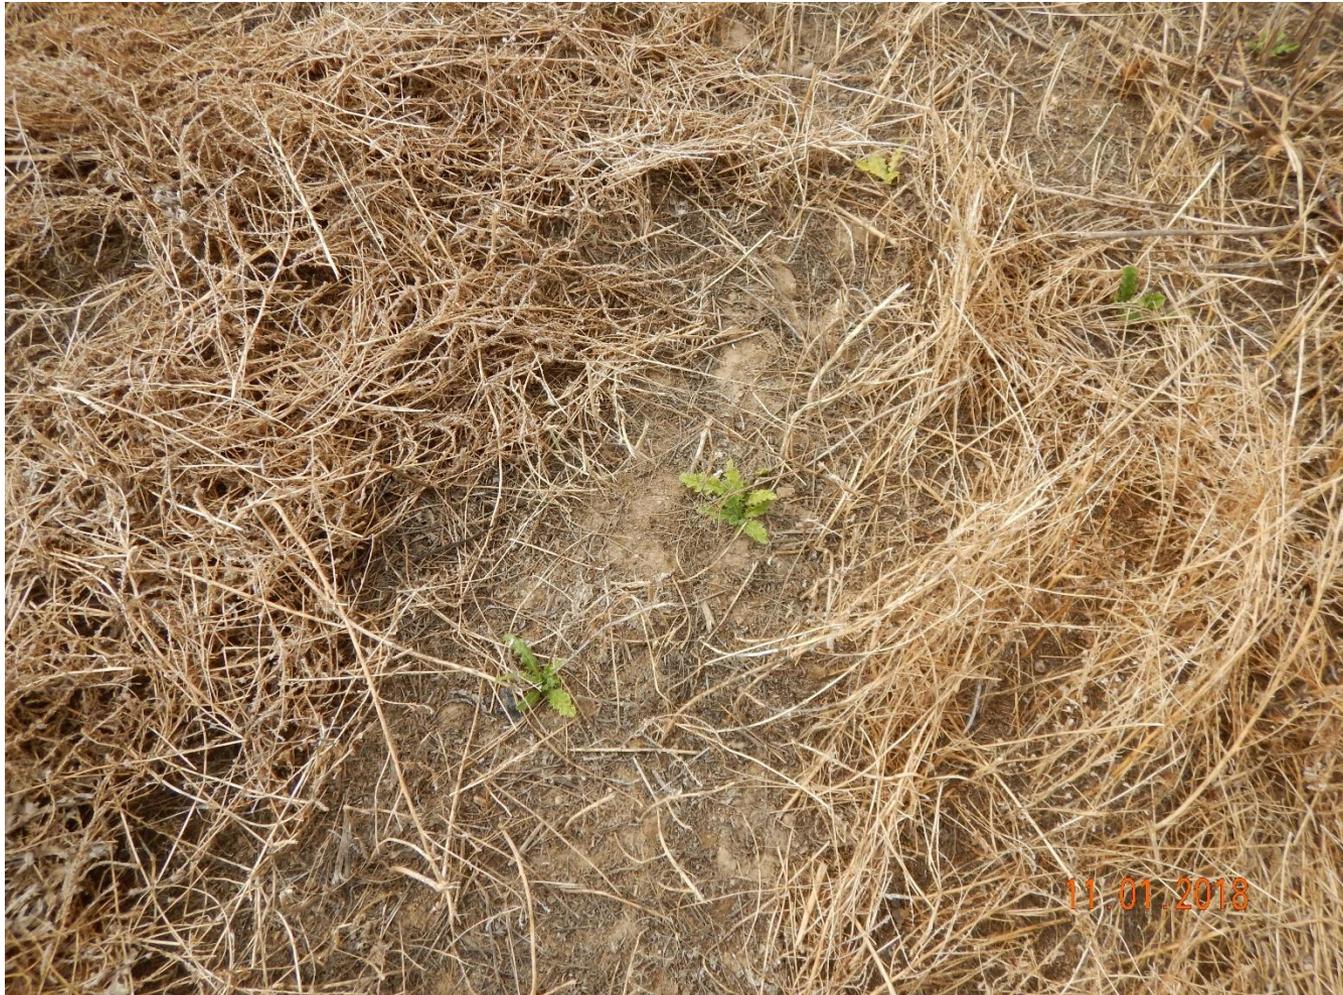
**Photo 17:** Photo taken from “landfarm” area. Photo shows vegetation predominantly undesirable weedy plant species. Photo also shows what appears to be Canada thistle rosettes (green plants).
