# Inspection Photos

11/1/2018

Operator: FRITZLER RESOURCES INC - 31257

Location ID: 316908

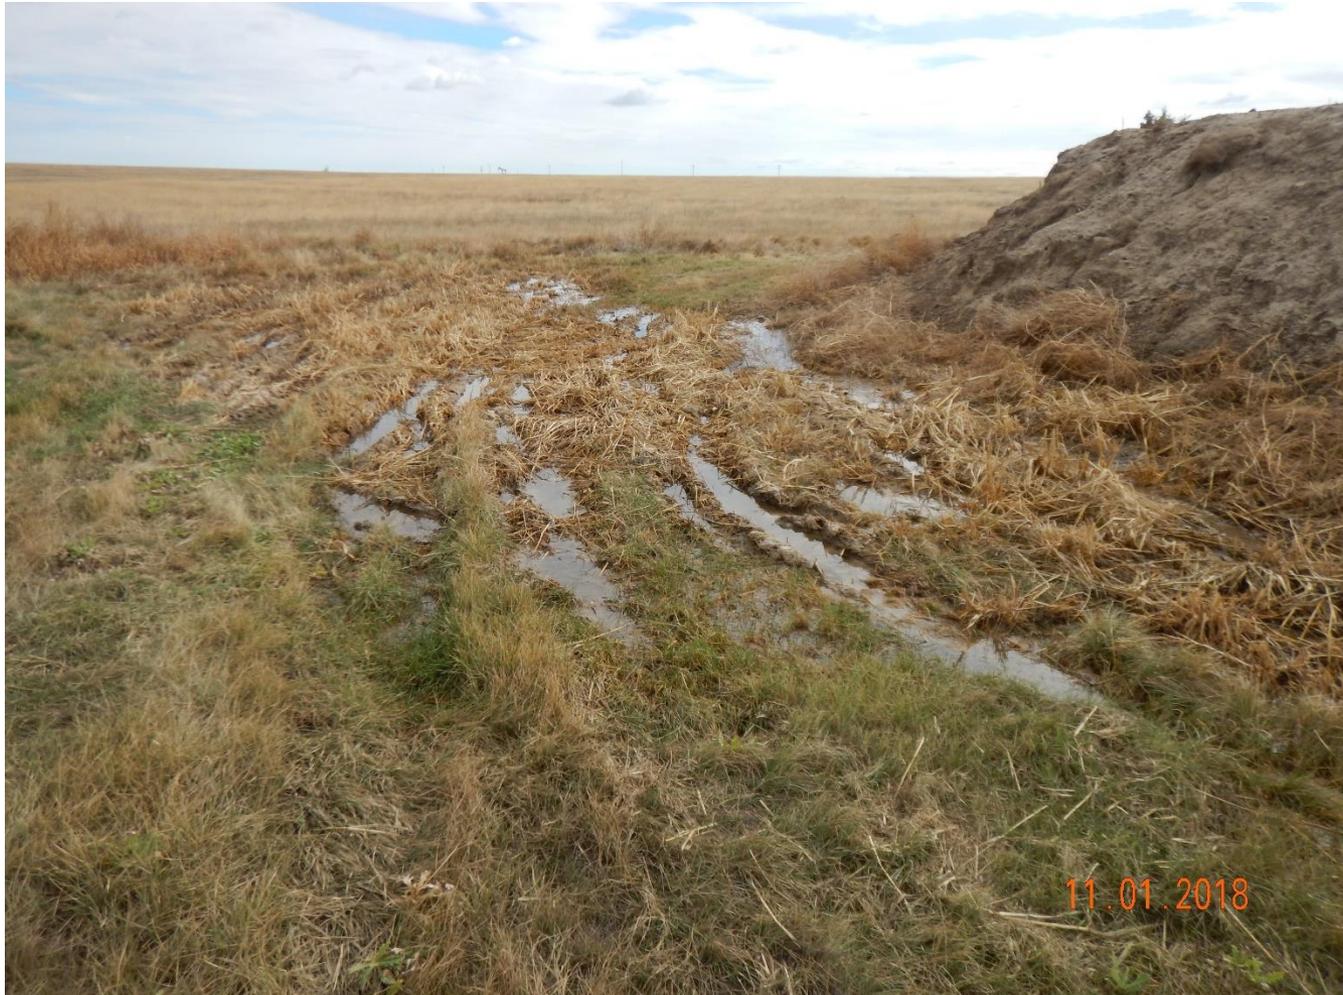
**Photo 18:** Photo taken from the northeast end of the pit facing east. Photo shows produced water being discharging from the base of the pit.

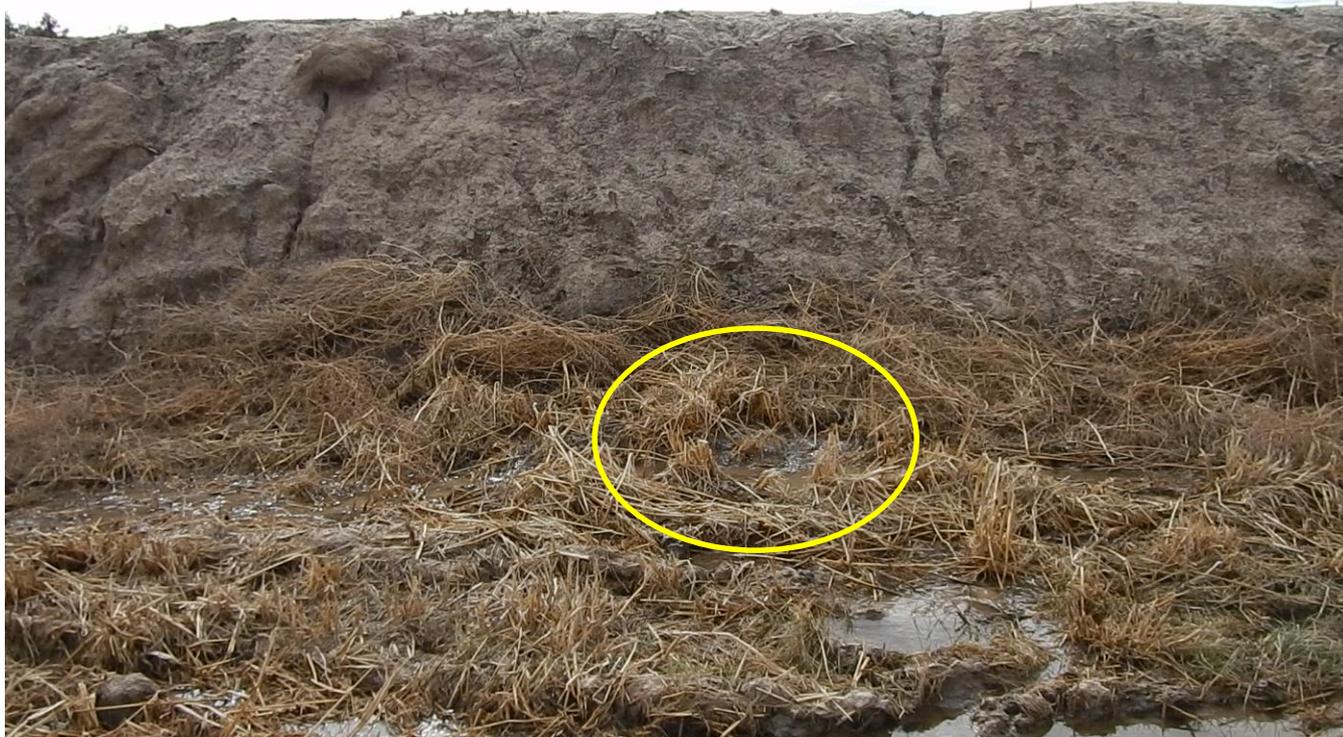
**Photo 19:** Photo taken from the northeast end of the pit, facing north. Photo shows area where water was observed actively spilling from the base of the pit.

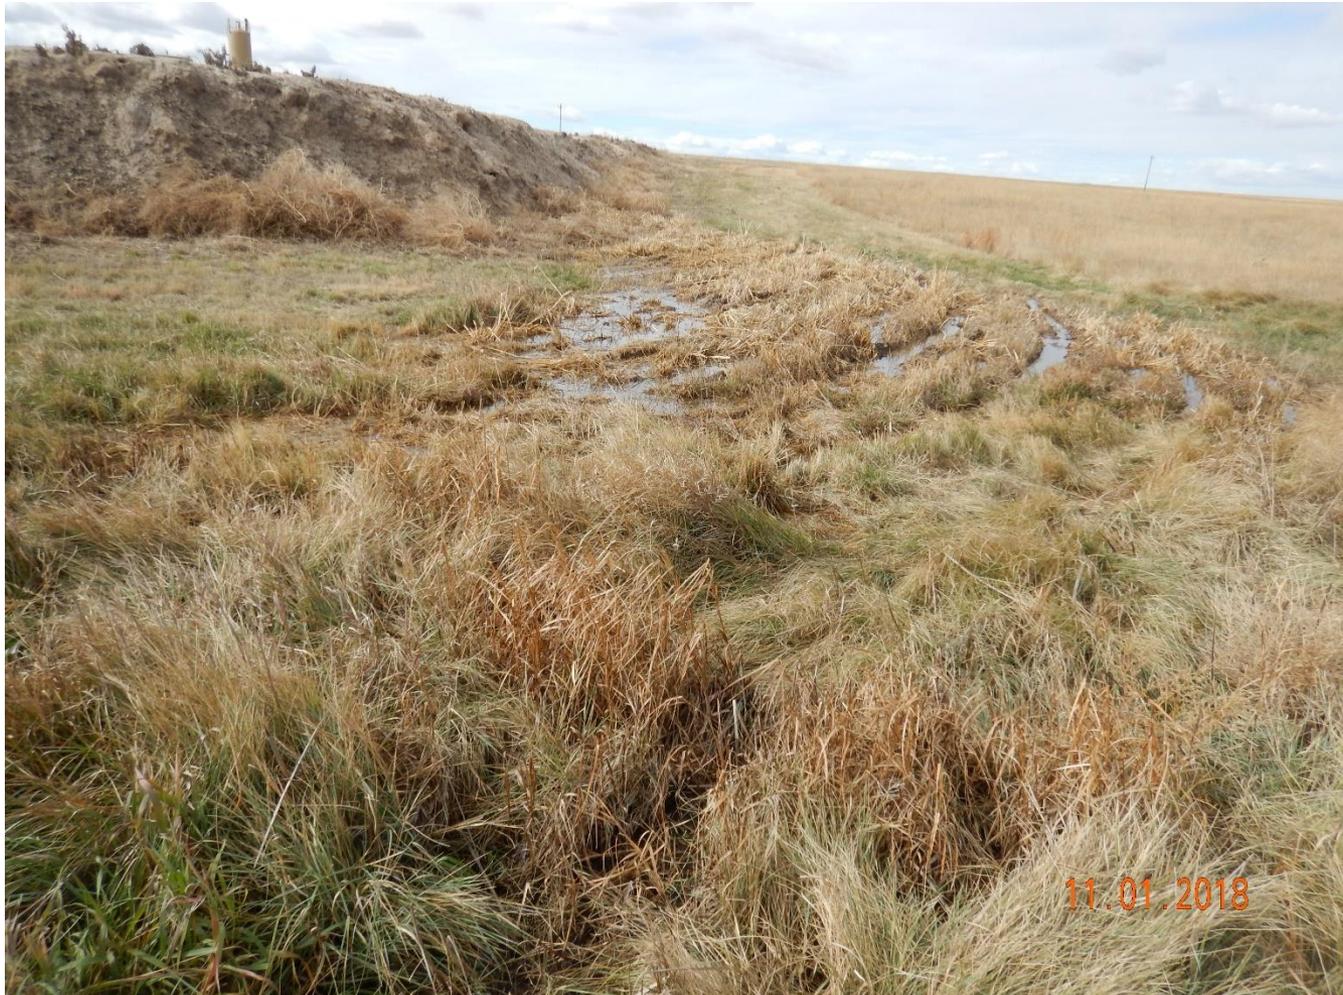
**Photo 20:** Photo taken from the east of the pit facing west. Photo shows produced water being discharging from the base of the pit.

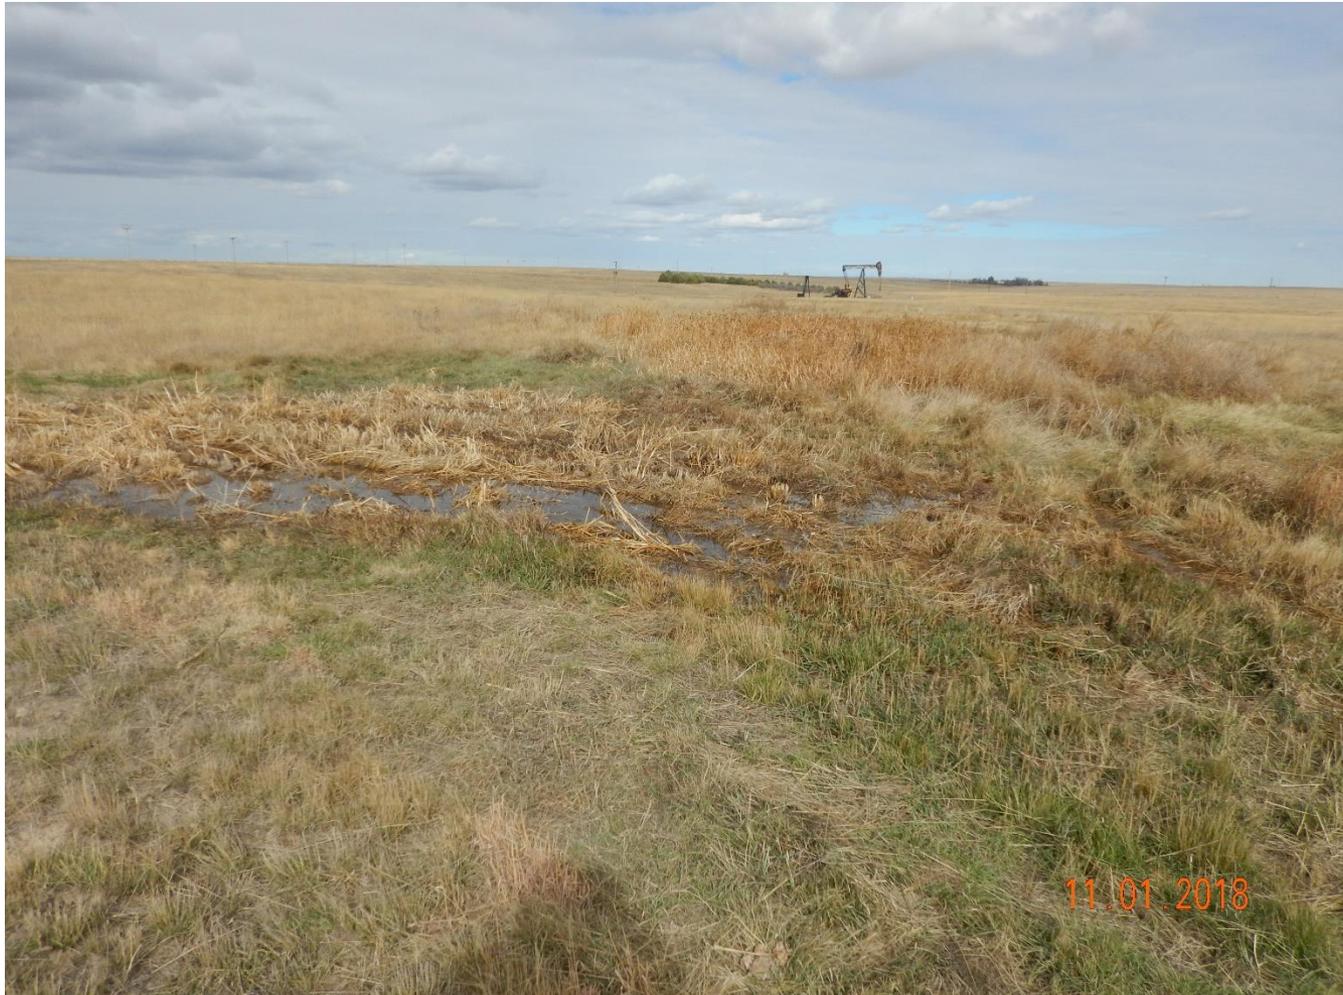
**Photo 21:** Photo taken from the east of the pit facing north. Photo shows produced water being discharging from the base of the pit.

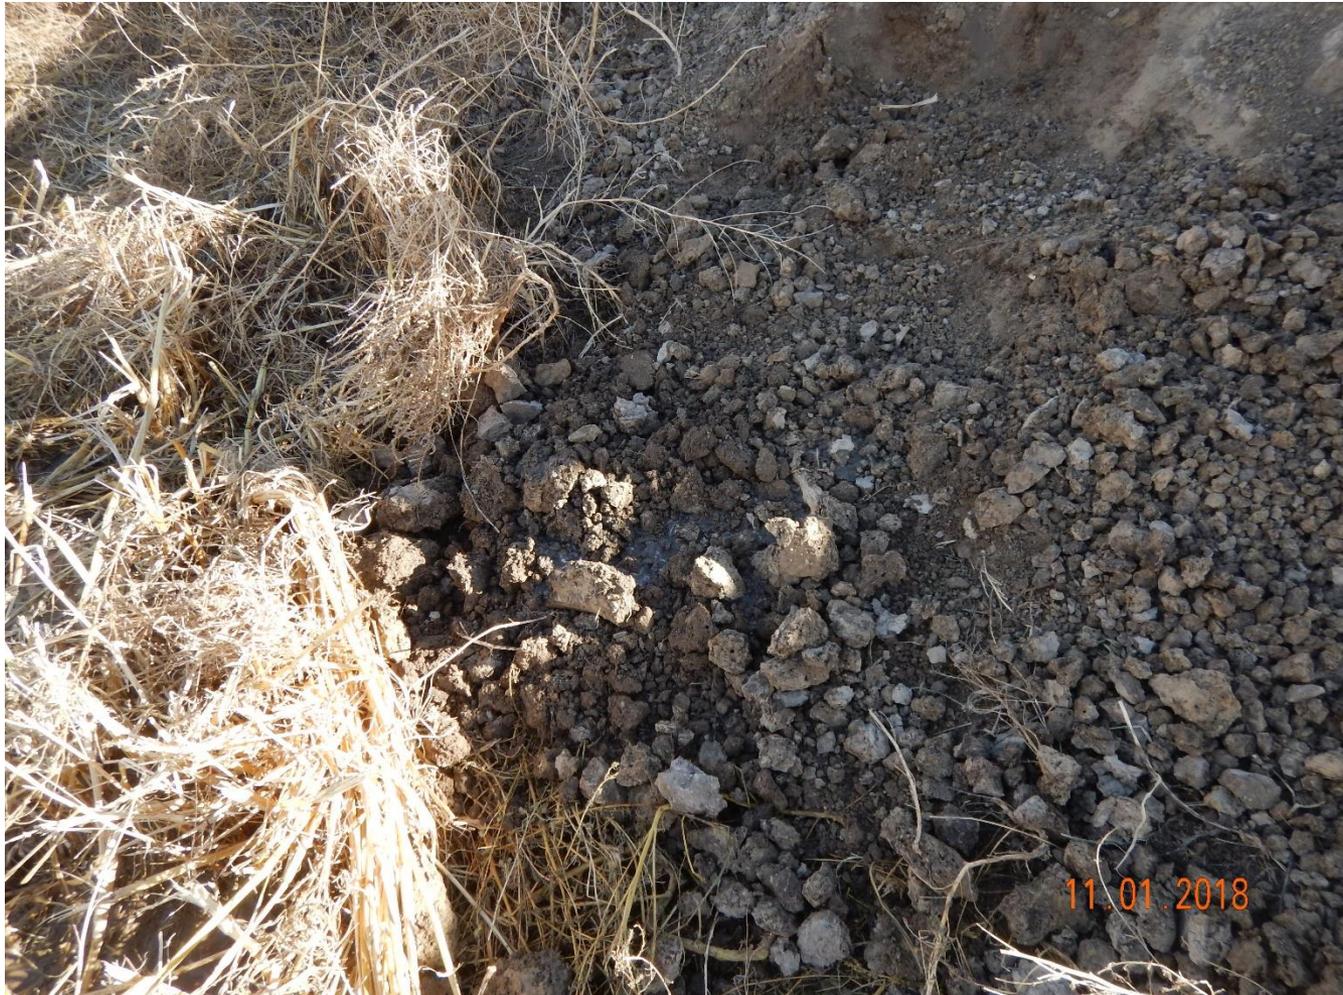
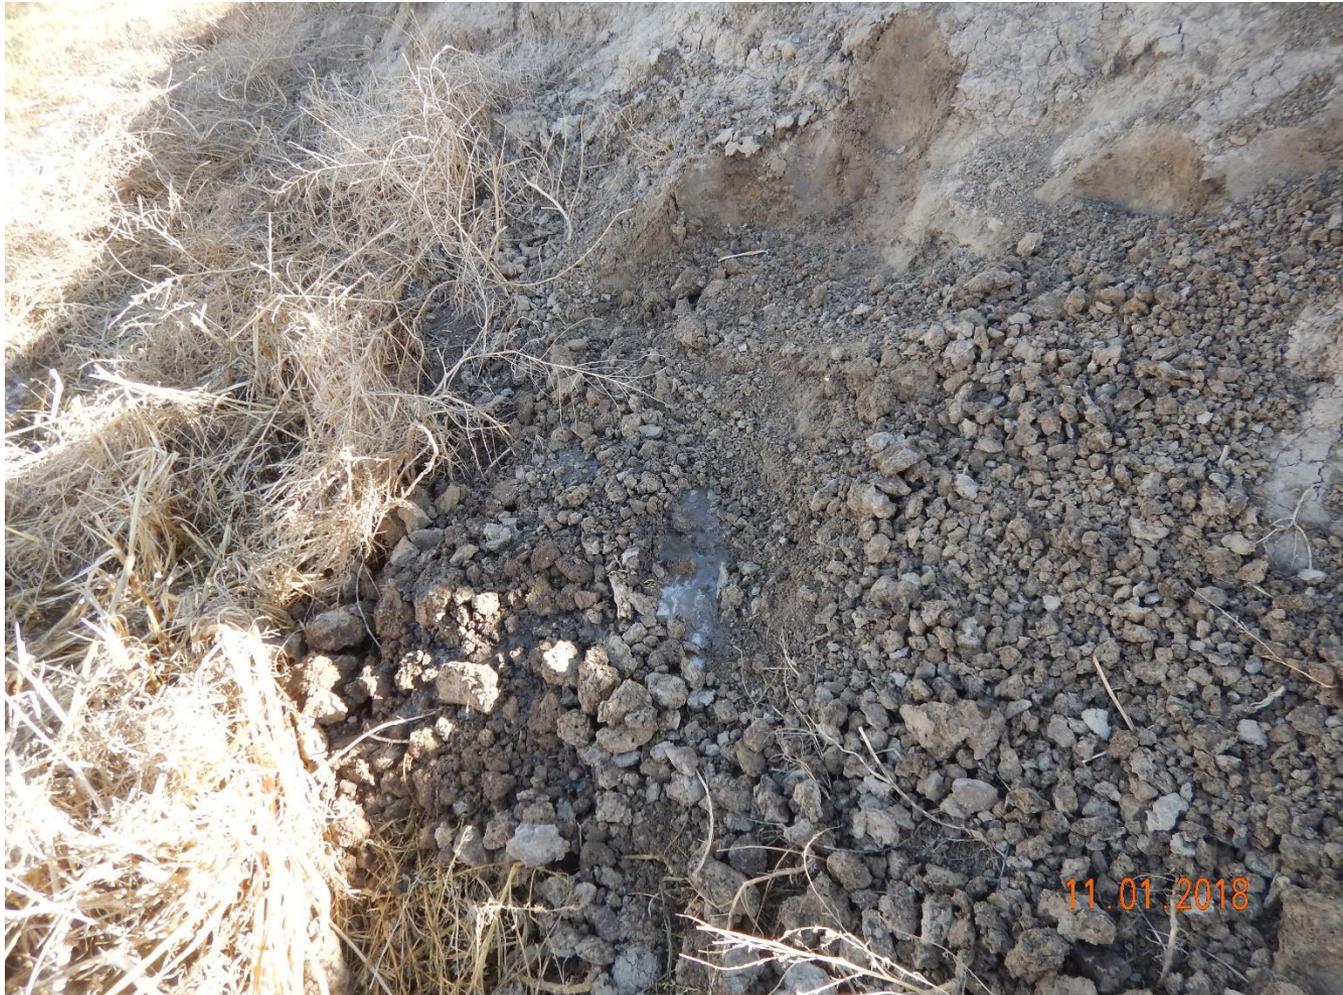
**Photo 22:** Photo taken from the northeast end of the pit. Operator arrived on site at 14:22 hours and began to dig at the sidewall of the pit. Photo shows the area of the pit currently leaking.

**Photo 23:** Continued from photo 22.
