COLORADO
Oil & Gas Conservation
Commission
Department of Natural Resources

API# 007-06120
SPILL# 457801
LOC# 320854
Doc# 2303202
Date: 9/24/2018

Subject: Alamosa Drilling Chavez #1 Water Analytical Results

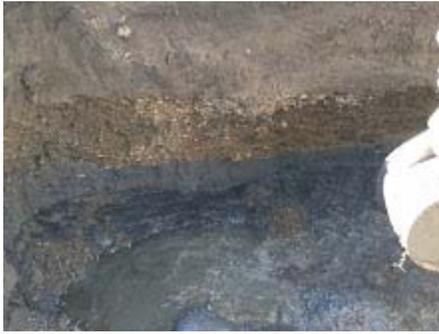
IMG_0193.JPG
2886K

Attached are the analytical results for the three (3) water samples collected from the Chavez #1 site as well as a few pictures for your reference. Please let me know if you have any suggestions on how the state would like to proceed after reviewing the information. IMG_0193 is the western wall, IMG_0191 is the excavation after we finished up on Friday, September 14, and IMG_0225 is what the excavation looked like on September 19. We also potholed approximately 20 feet and 40 feet to the west of the excavation in order to delineate the contamination. We did run into soil that had a hydrocarbon odor in the bottom of both potholes.
