Inspection Photos

Location Name: Pond G Centralized E&P Waste Management Facility

Facility ID: #437578 Pit ID: #414402

Inspection Date: November 1, 2018

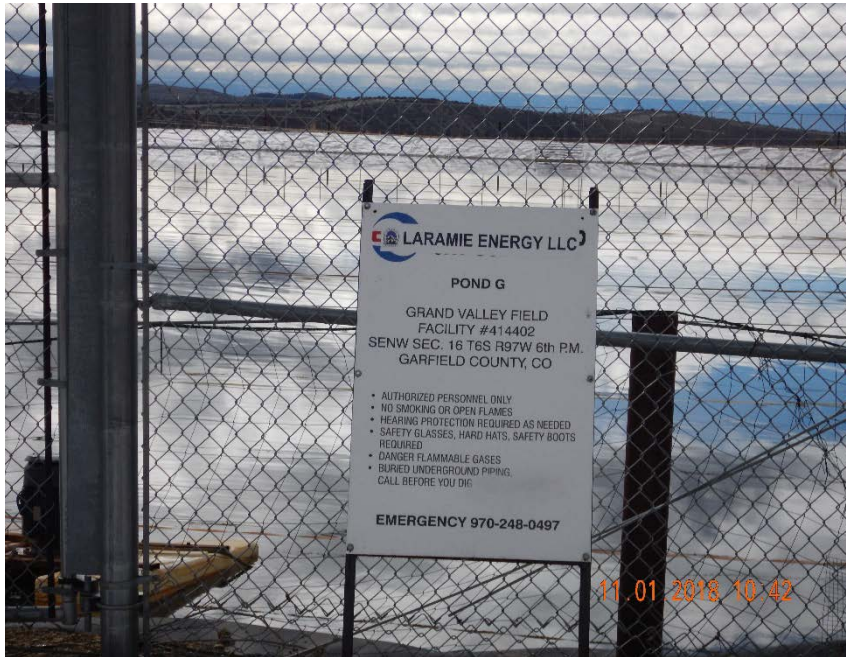
Photo #1 – Pit facility sign located on north side of pit.

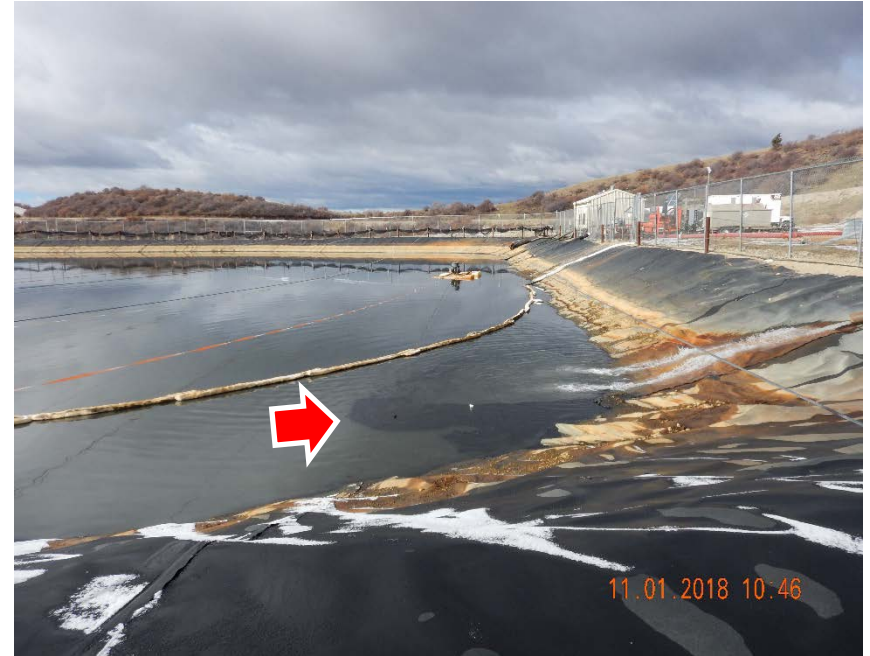
Photo #2 – View of north side of pit from NE corner. Note that bird netting was absent from pit and free product was present on top of pit fluids in NE corner (red arrow). Operator was notified about oil on pit via phone on inspection date.

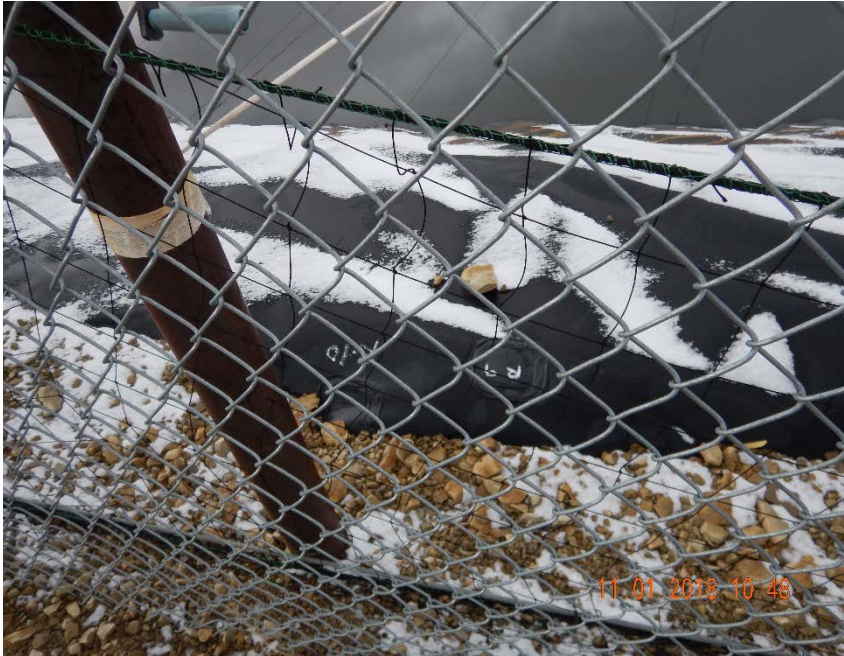
Photo #3 – Patches observed in liner on east side of pit. Liner has been repaired in response to previous Field Inspection Report (doc #681701069).

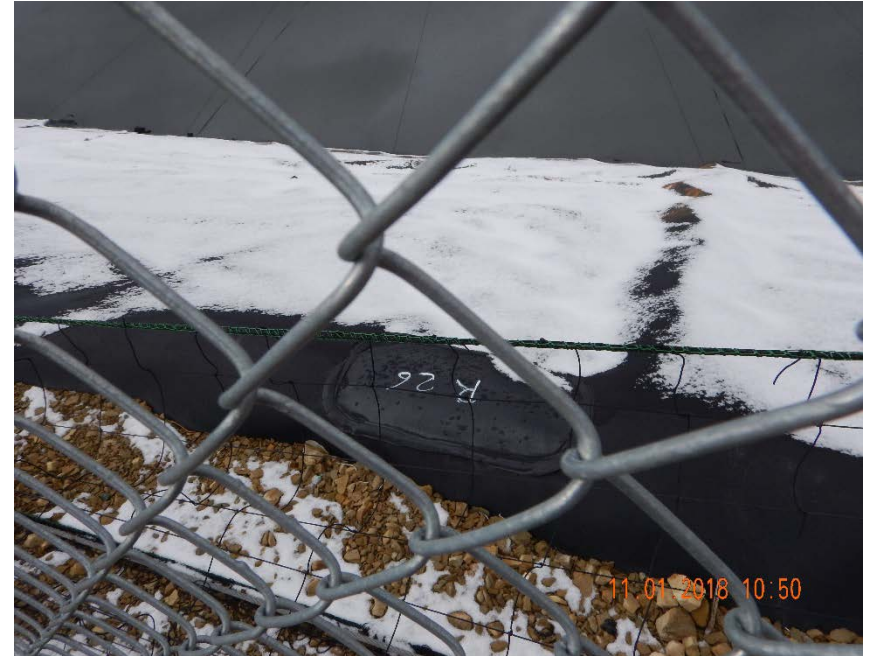
Photo #4 – Additional patch observed in liner on east side of pit. Liner has been repaired in response to previous Field Inspection Report (doc #681701069).

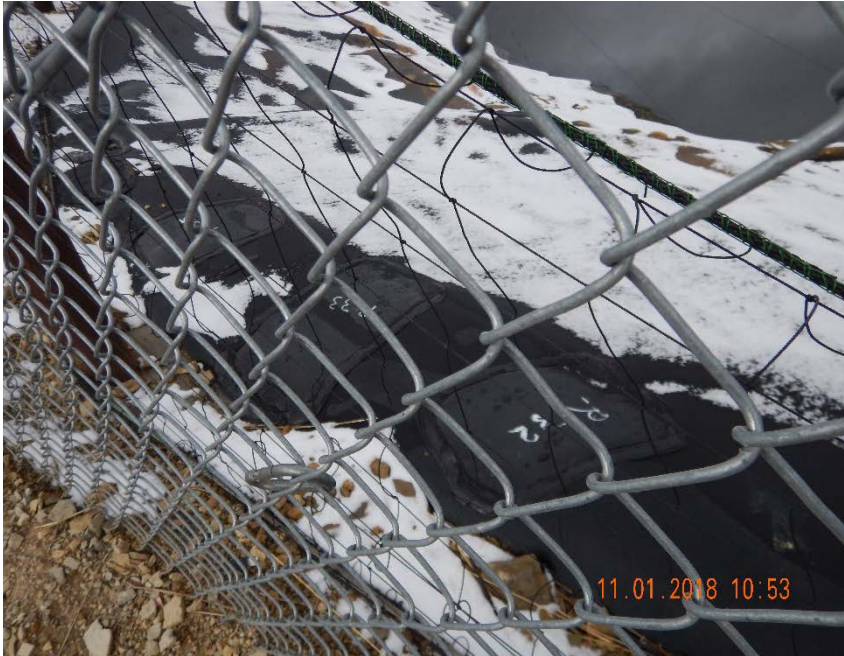
Photo #5 – Patches observed in SE corner of pit liner. Liner has been repaired in response to previous Field Inspection Report (doc #681701069).

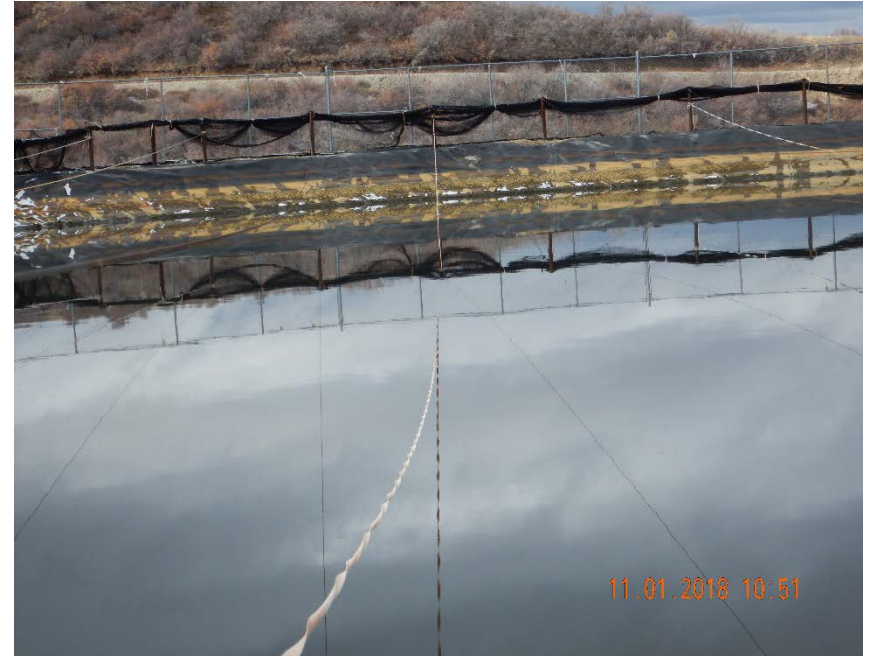
Photo #6 – Ratchet strap on south end of pit sagging into pit contents.

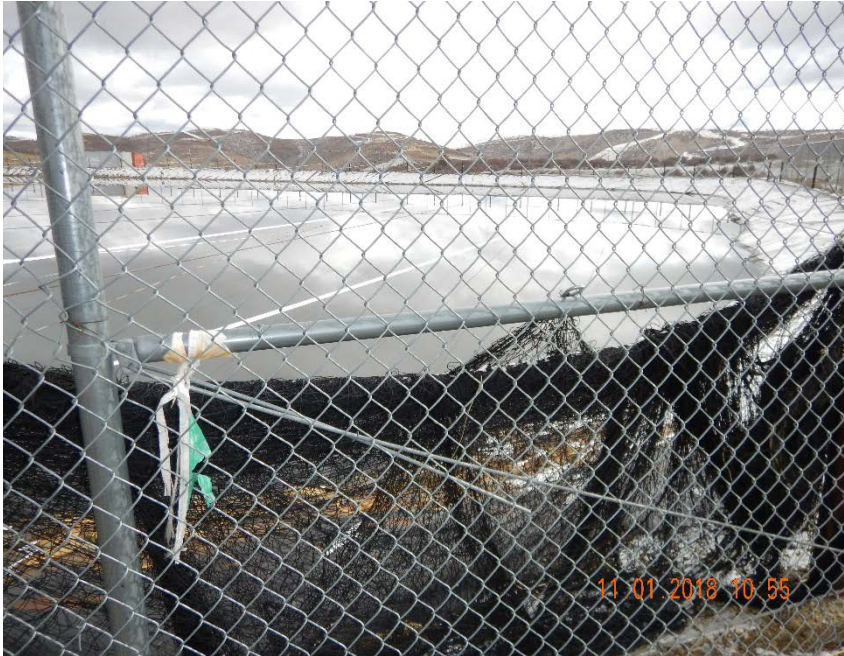
Photo #7 – View of bird netting from SW corner of pit. Operator indicated via 11/1/2018 phone call that netting had been removed for the winter to prevent damage caused by snow accumulation, per an agreement between the operator and CPW.

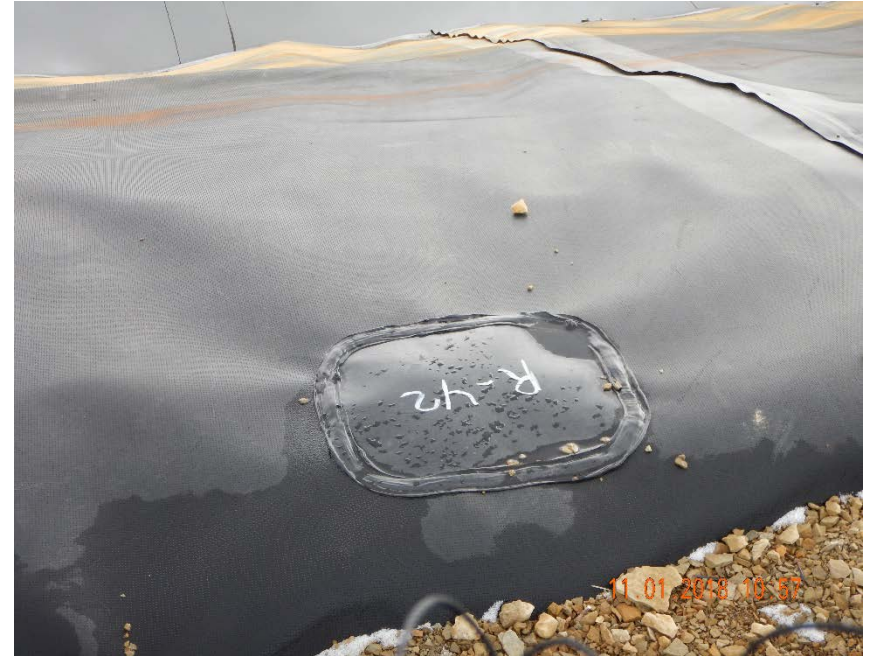
Photo #8 – Additional patch observed in liner on west side of pit.

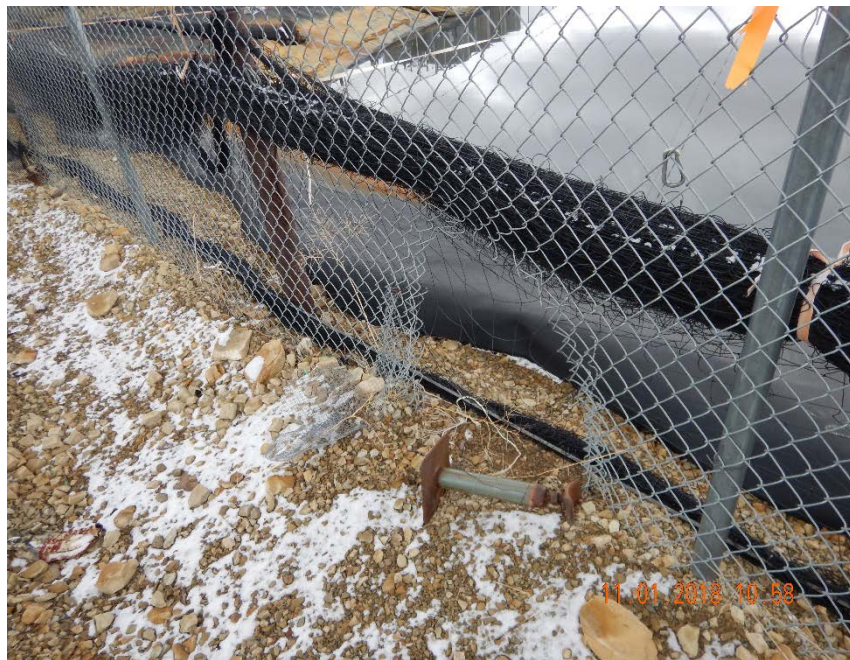
Photo #9 – Hole in NW corner of pit fence.

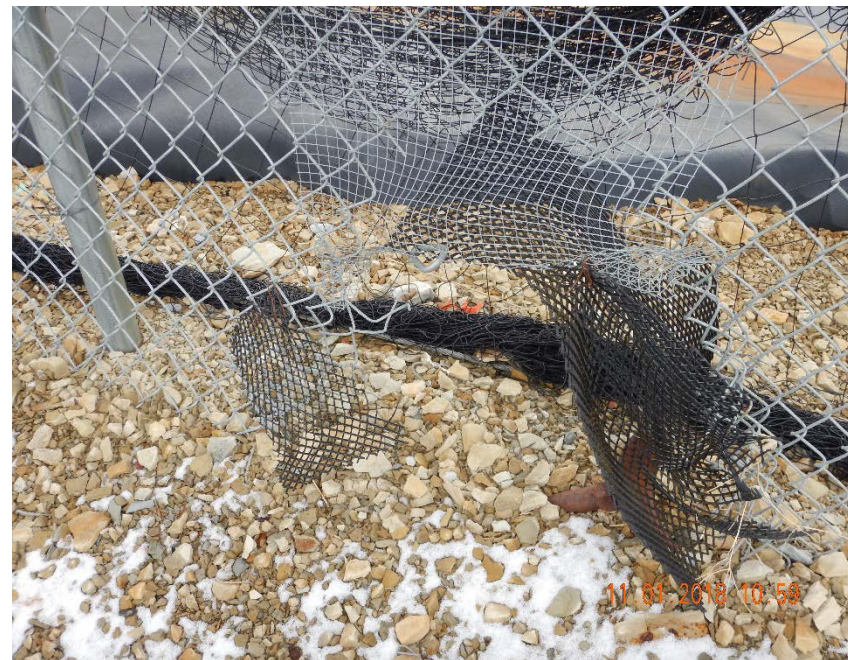
Photo #10 – Additional hole in NW corner of pit fence.

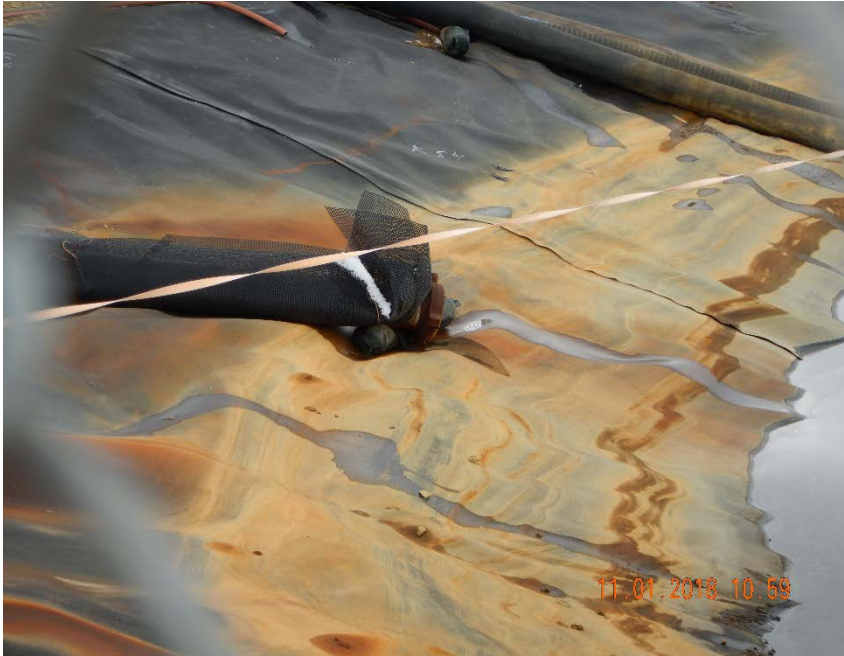
Photo #11 – Sandbag beneath inlet hose in NW corner of pit has been repositioned to prevent direct contact between hammer union and pit liner.

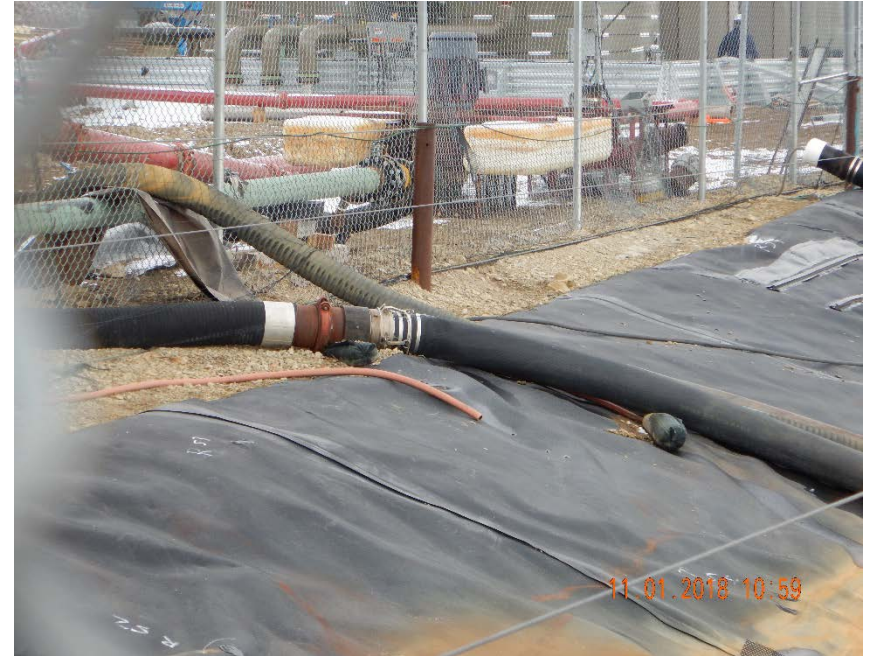
Photo #12 – Second inlet hose in NW corner of pit has been repositioned to prevent direct contact between metal fittings and pit liner.

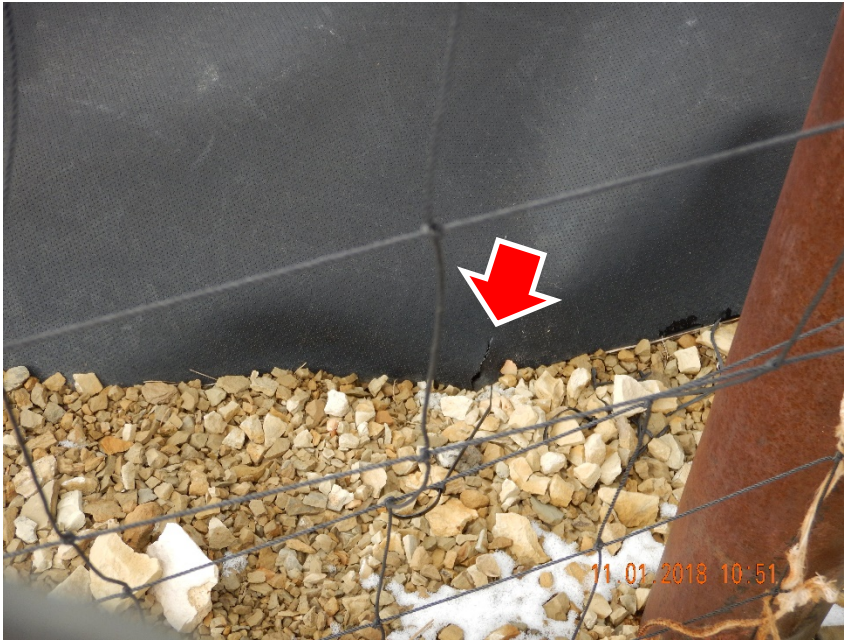
Photo #13 – Tear in pit liner observed in SE corner of pit, along anchor trench.

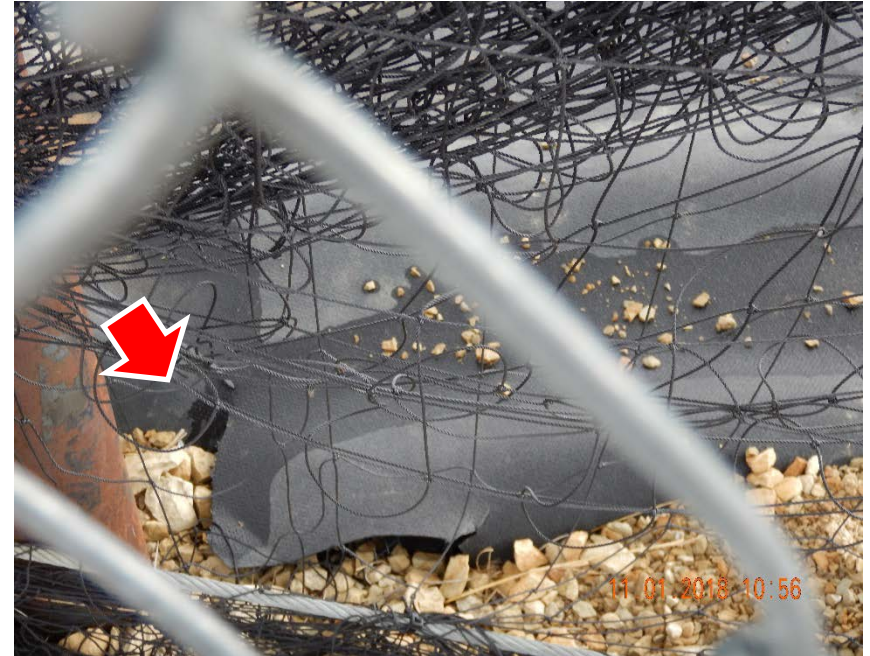
Photo #14 – Tear in pit liner observed in SW corner of pit, along anchor trench.

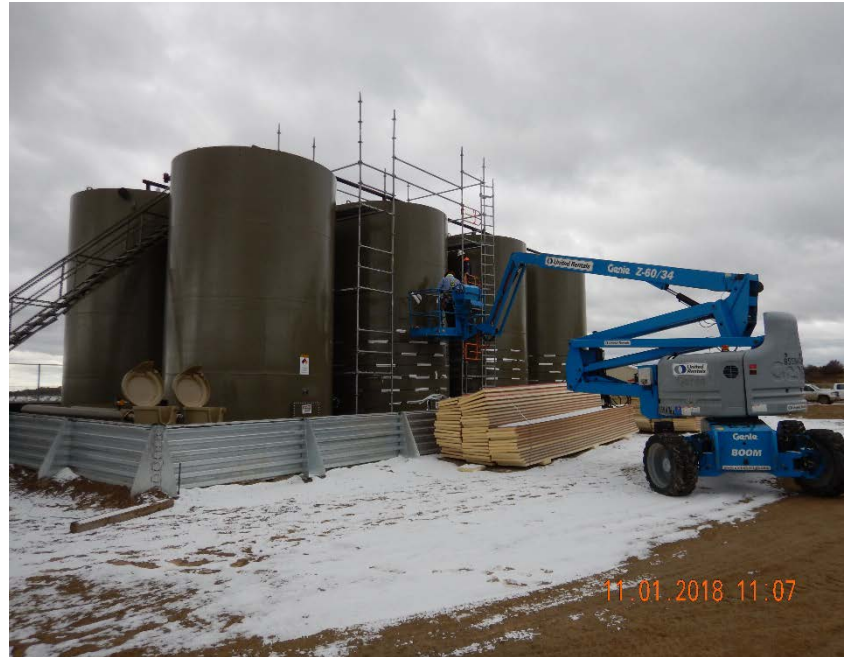
Photo #15 – Contractors were on location to install tank insulation on inspection date.
