Inspection Photos

Operator: WPX Energy

API: 05-067-05752

Date: 10/24/2018

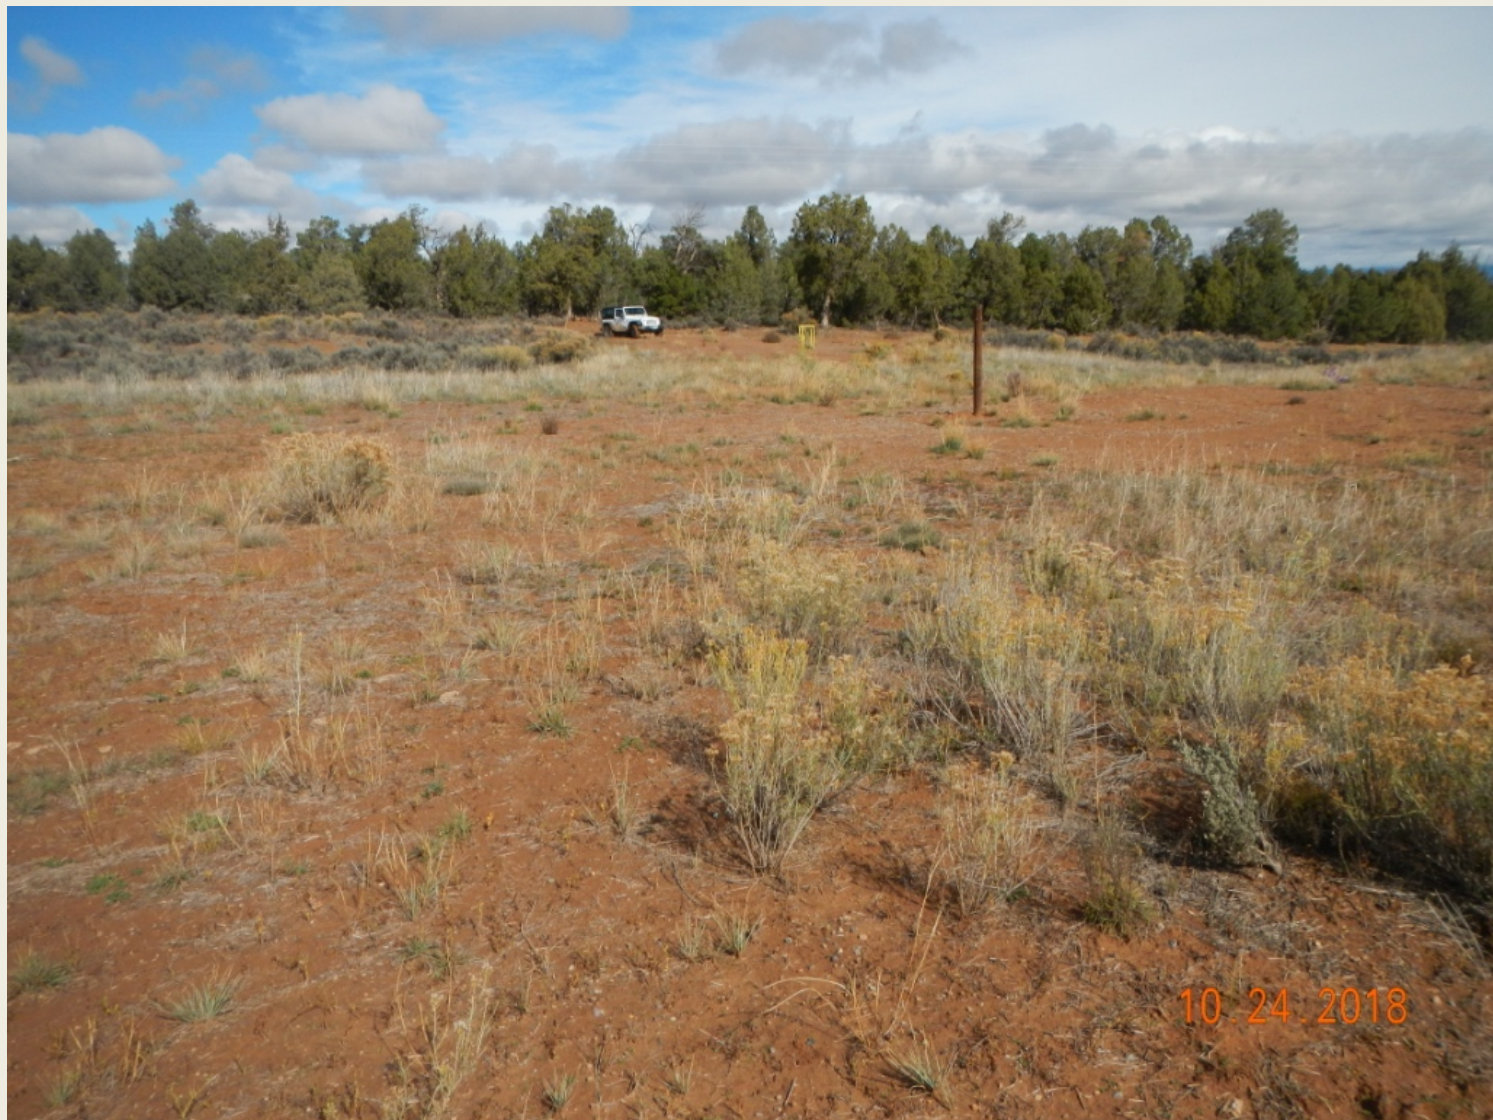
Photo 1. View of the project area from southern edge facing west toward the well head marker (in the background). Revegetation is patchy within the reclamation areas with grasses such as crested wheatgrass (*Agropyron cristatum*), western wheatgrass (*Pascopyrum smithii*), as well as rubber rabbitbrush (*Chrysothamnus nauseosus*).

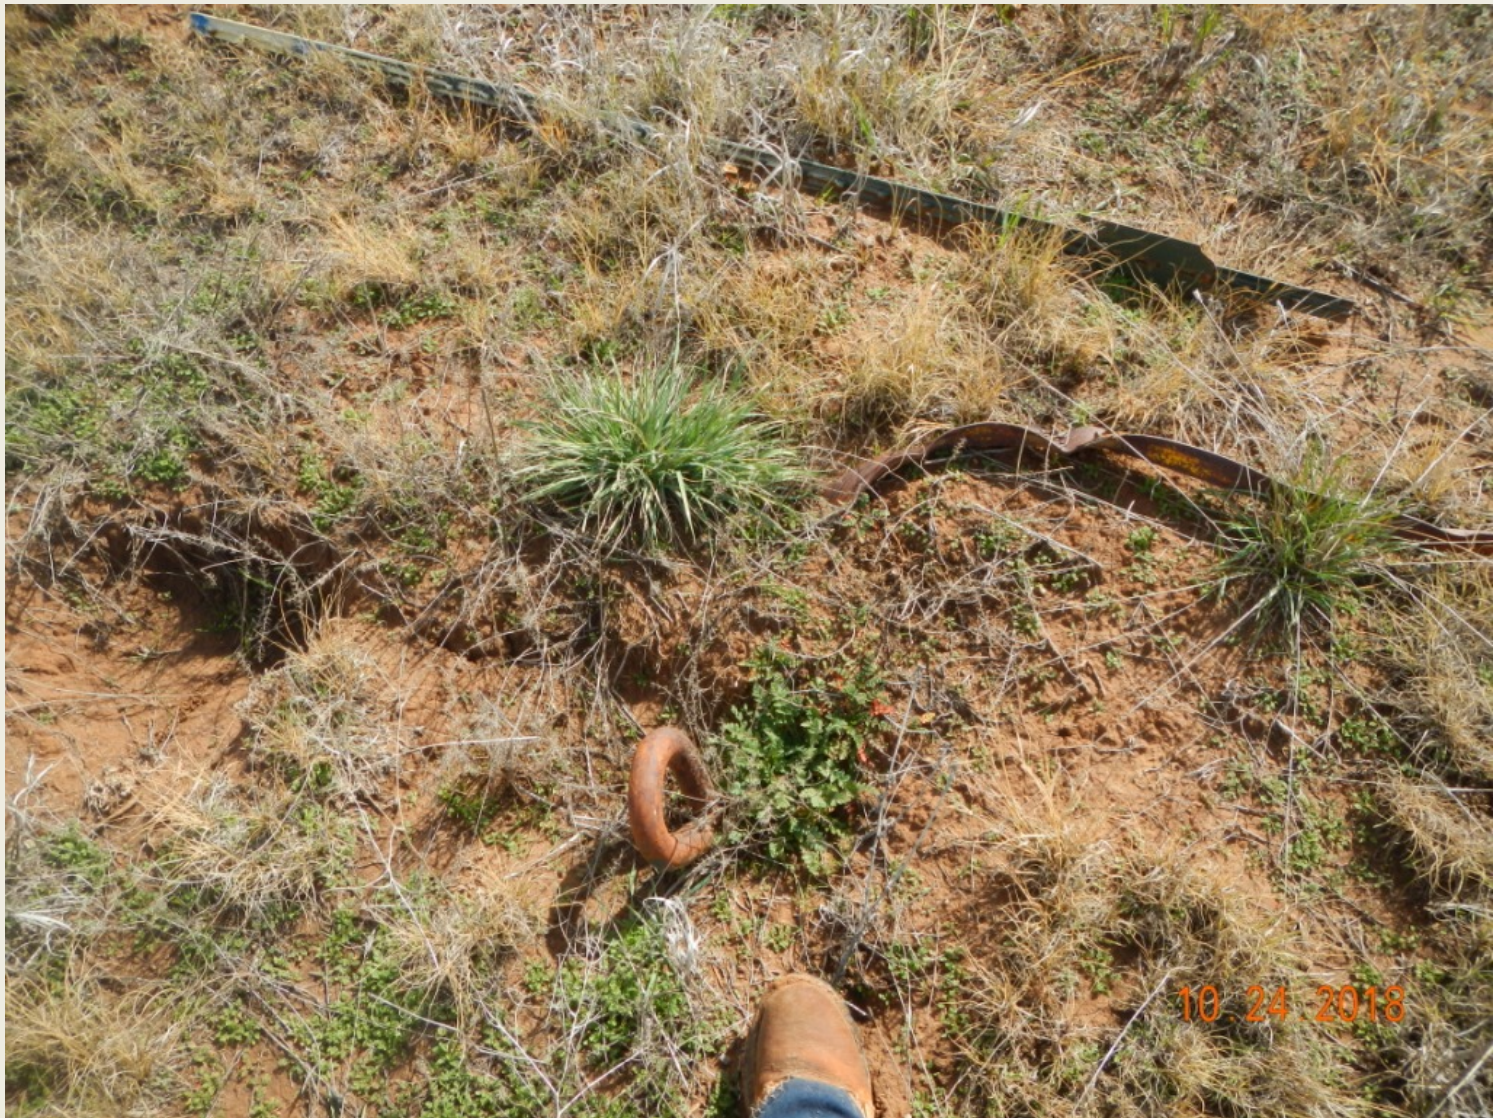
Photo 4. View of anchor marker in place and debris that needs to be removed.

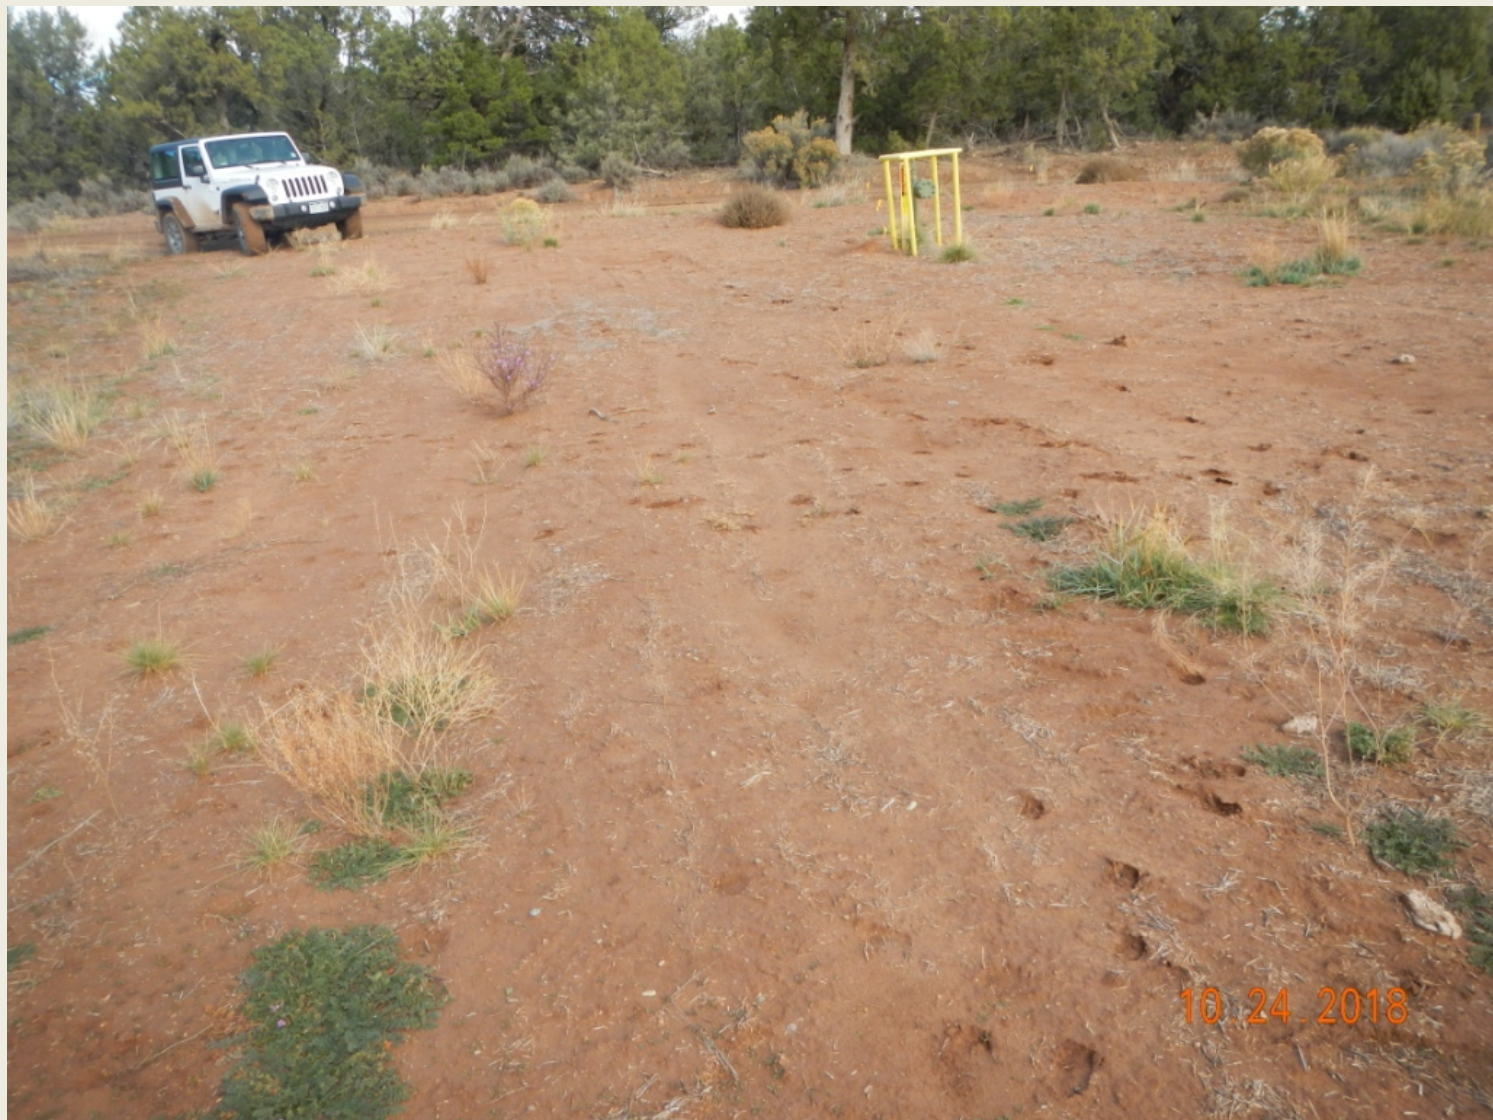
Photo 5. View of the beginning of the access road, with poor revegetation.
