**Inspection Photo**  
**Kelley 34-14**  
**API # 045-10055**  
**Inspection # 689302279**

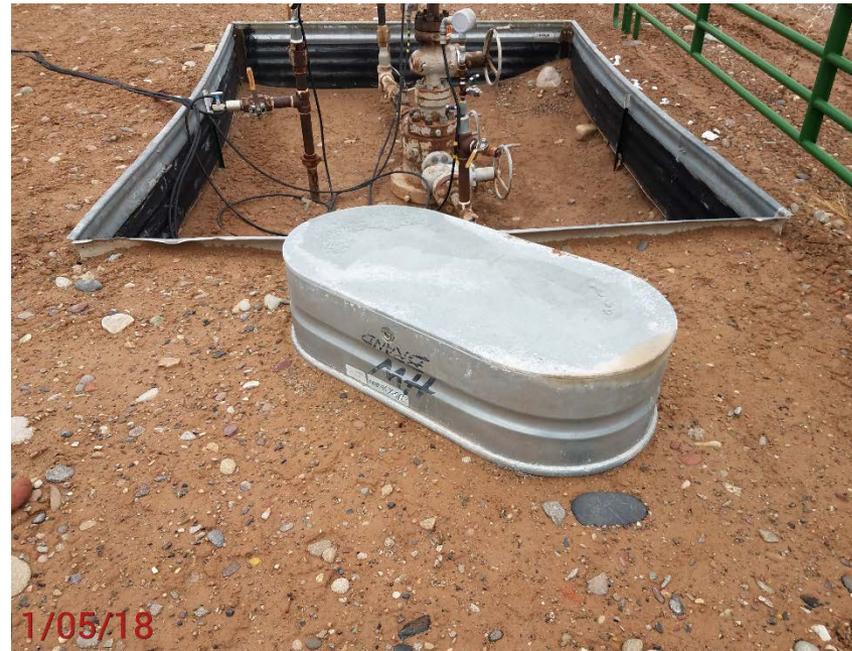
**Location Photo #4, unused equipment near wellheads**

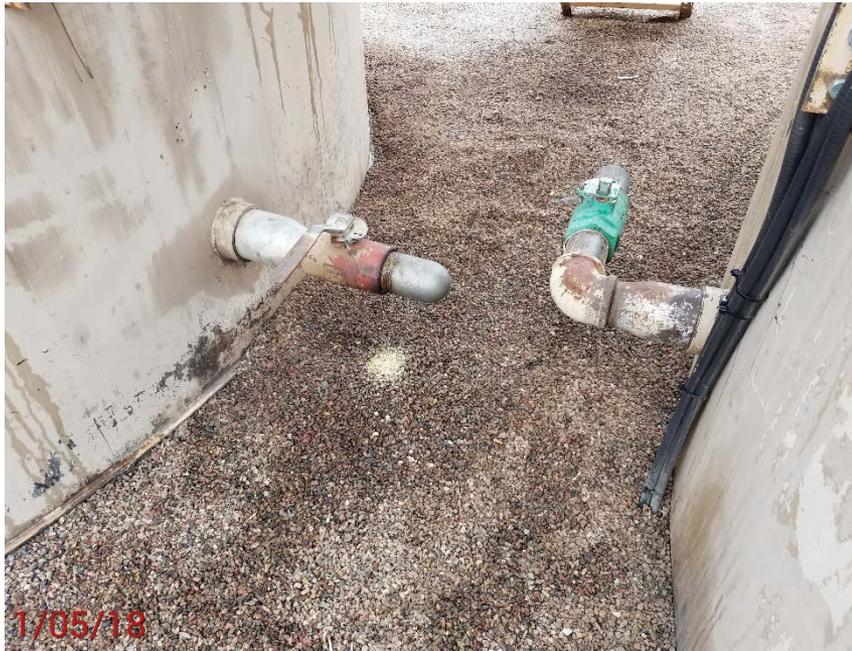
**Location Photo #5, mechanical condition on 3" valve, oily stained ground**

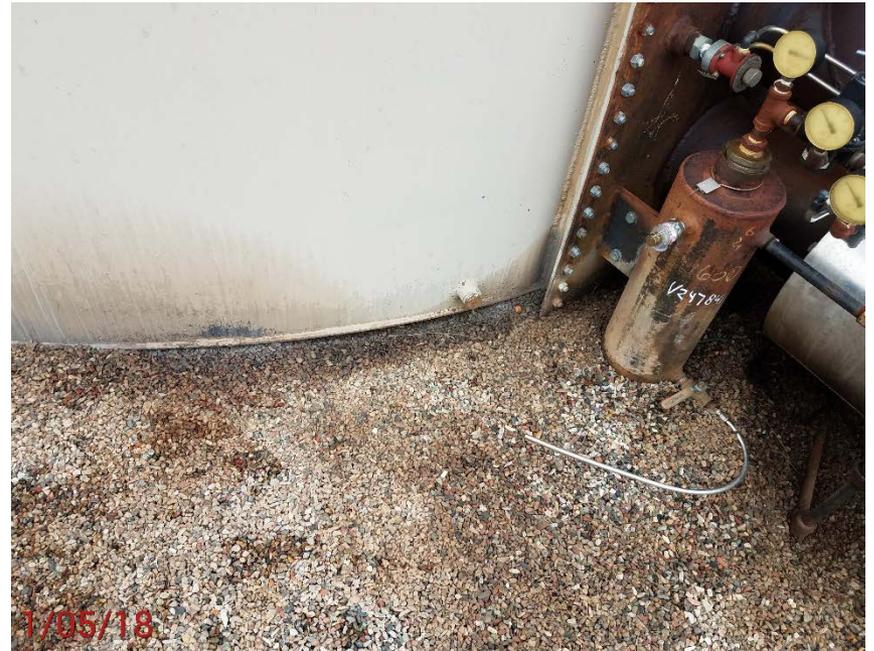
**Location Photo #6, oily stained ground**

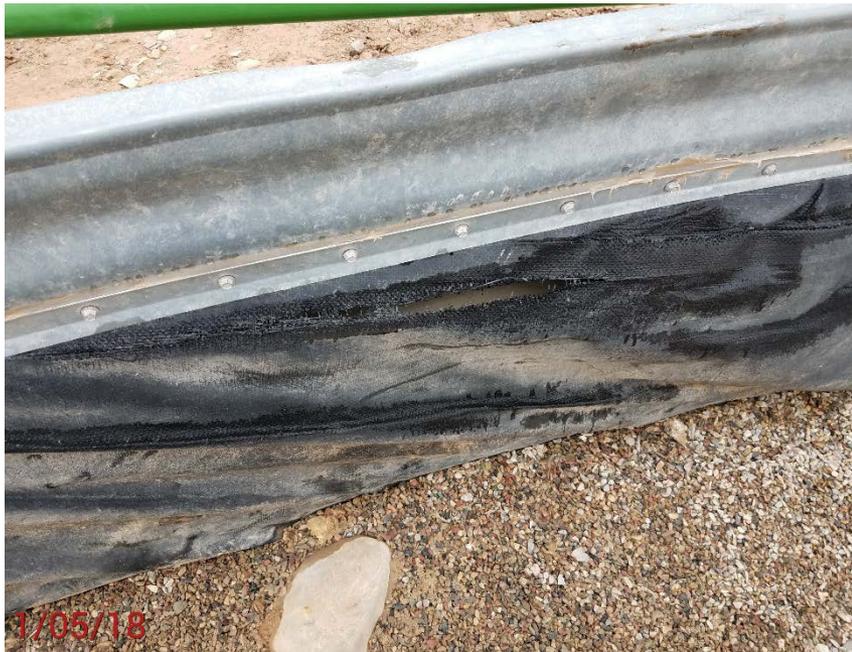
**Location Photo #7, holes in secondary containment liner**

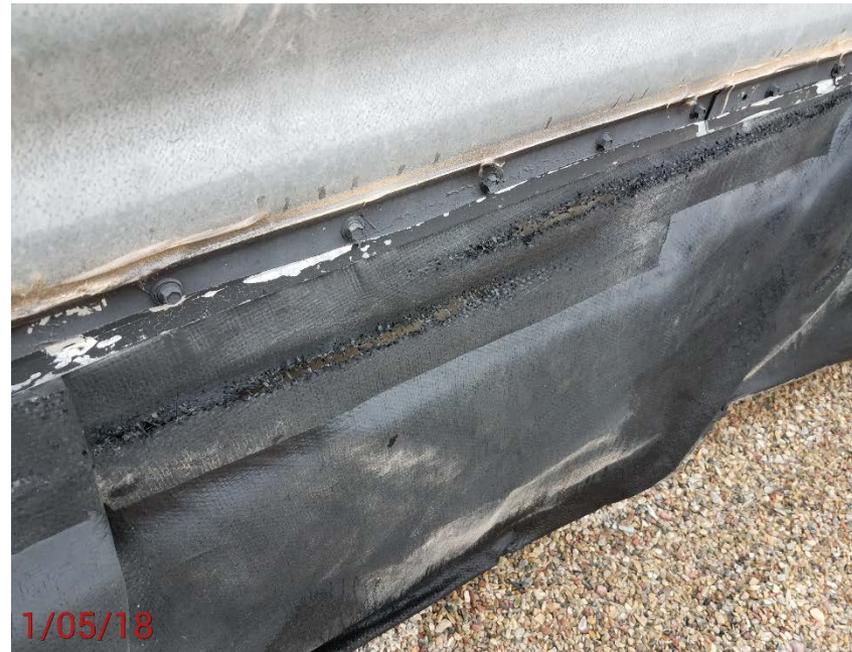
**Location Photo #8, holes in secondary containment liner**

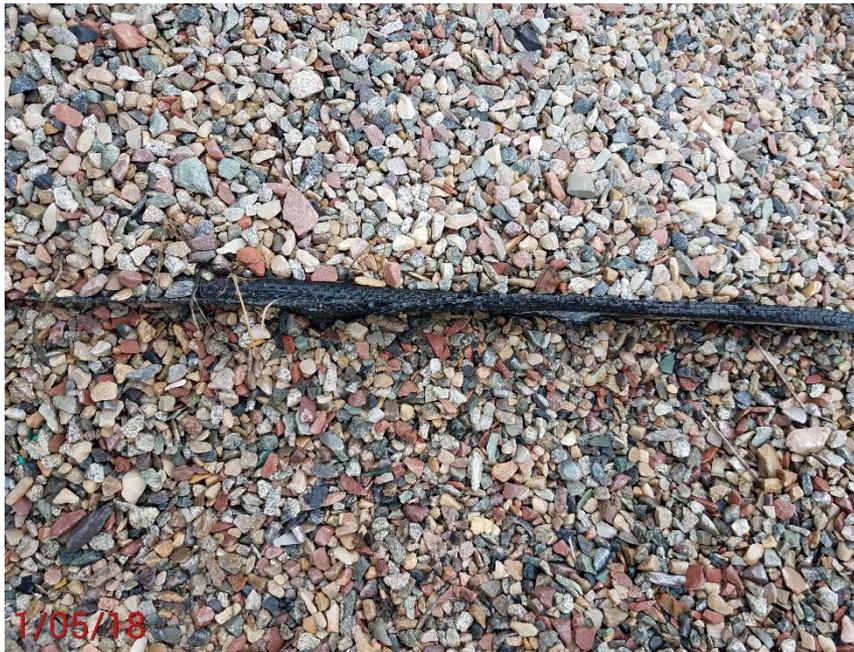
**Location Photo #9, holes in secondary  
containment liner**

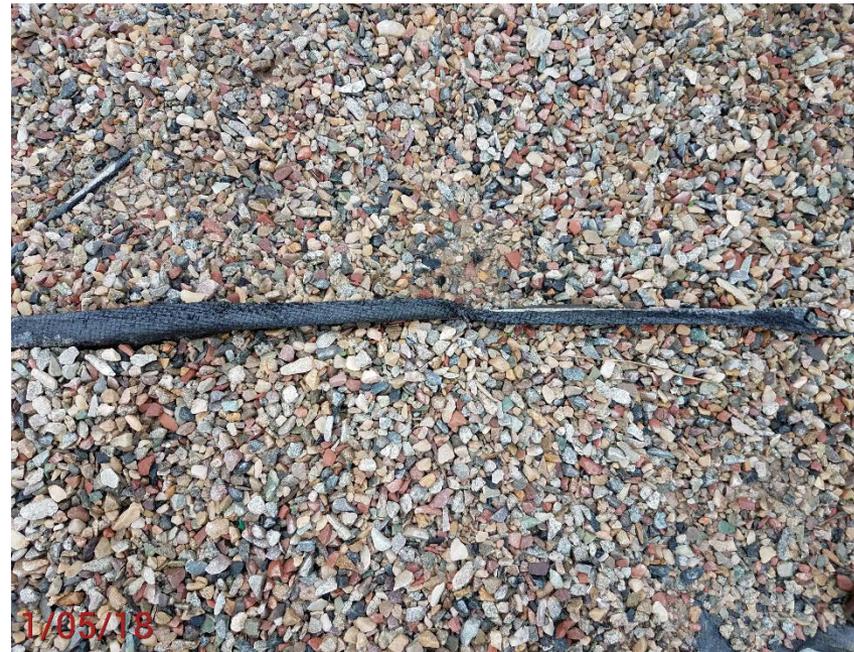
**Location Photo #10, holes in secondary  
containment liner**

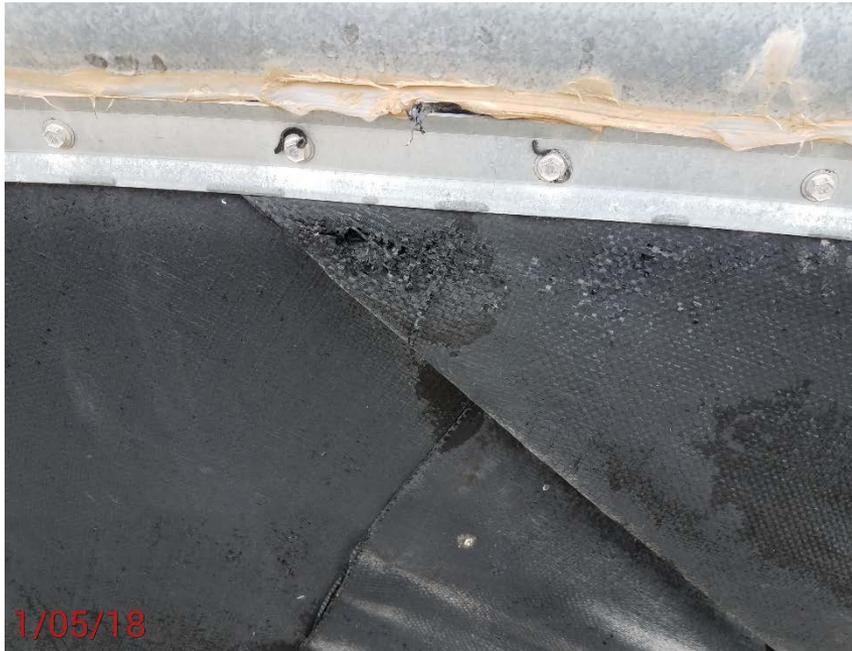
**Location Photo #11, holes in secondary containment liner**

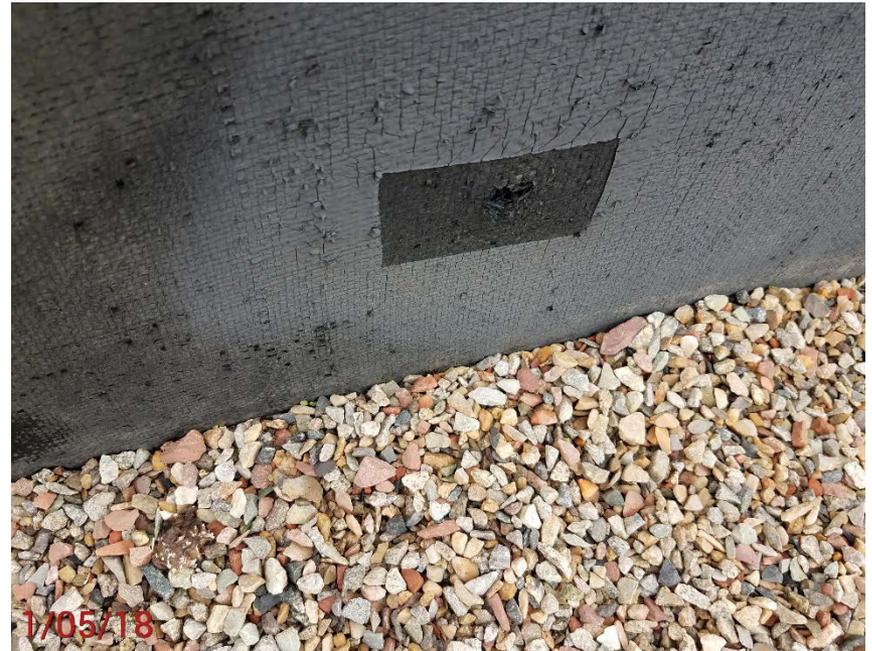
**Location Photo #12, holes in secondary containment liner**

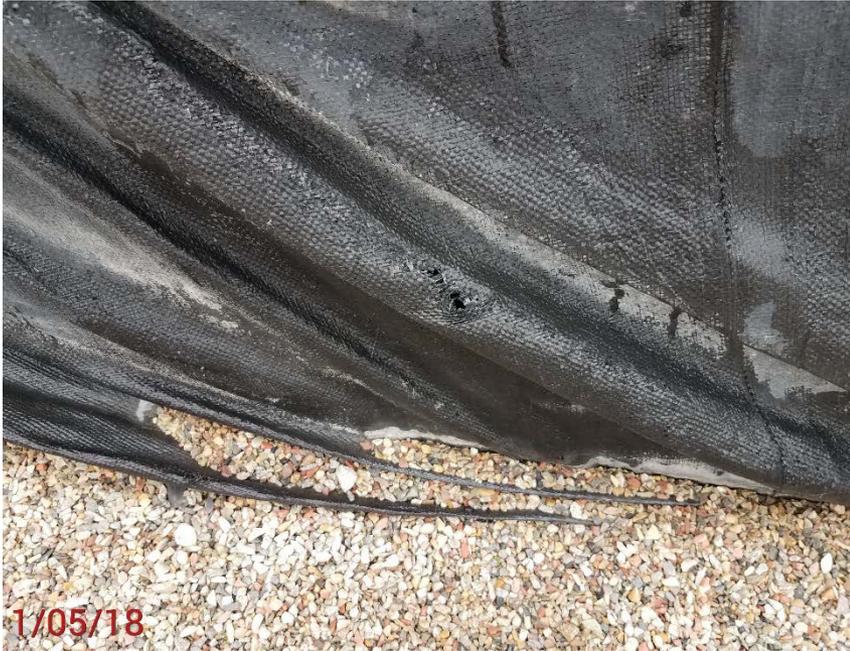
**Location Photo #13, holes in secondary  
containment liner**
