**Inspection Photo
Brynildson 19-8
API # 045-13518
Inspection # 689302285**

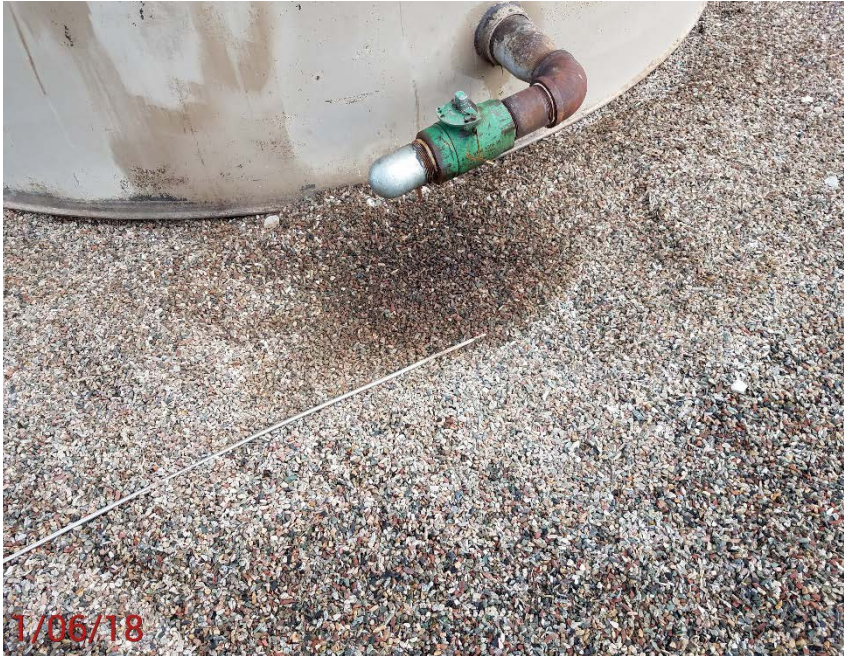
Location Photo #3, Oil stained rock in battery containment.
