**Inspection Photo**  
**Brynildson 14A-20-692**  
**API # 045-17146**  
**Inspection # 689302290**

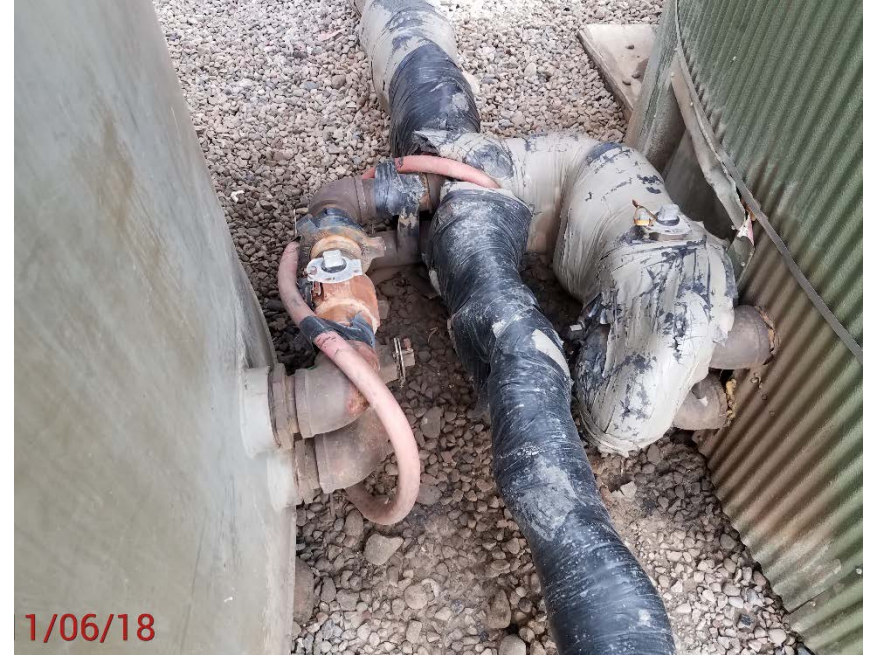
**Location Photo #4, Stained rock below valves.**

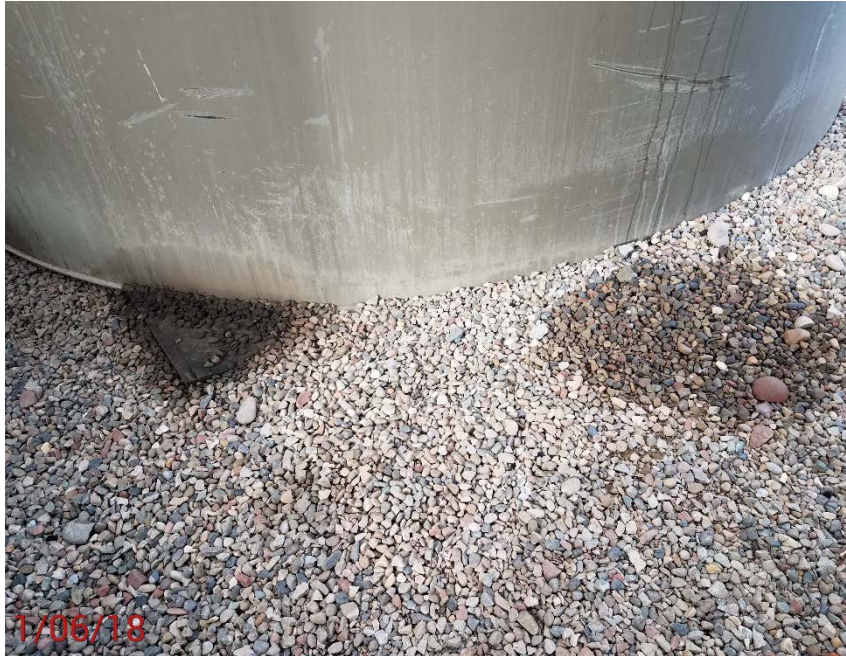
**Location Photo #5, Stained rock in battery containment.**

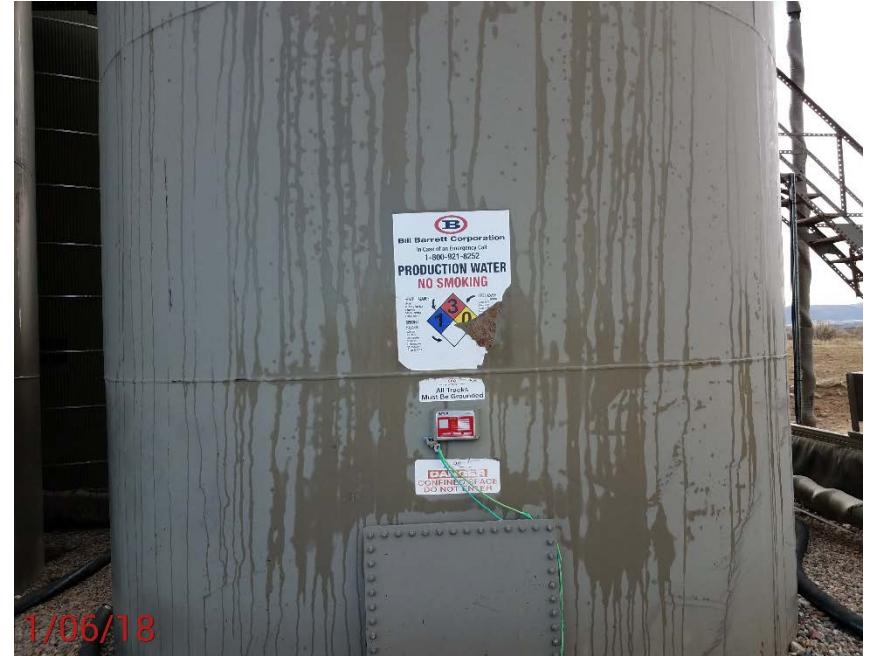
**Location Photo #6, Missing BBL capacity, Inaccurate sign, Non legible.**

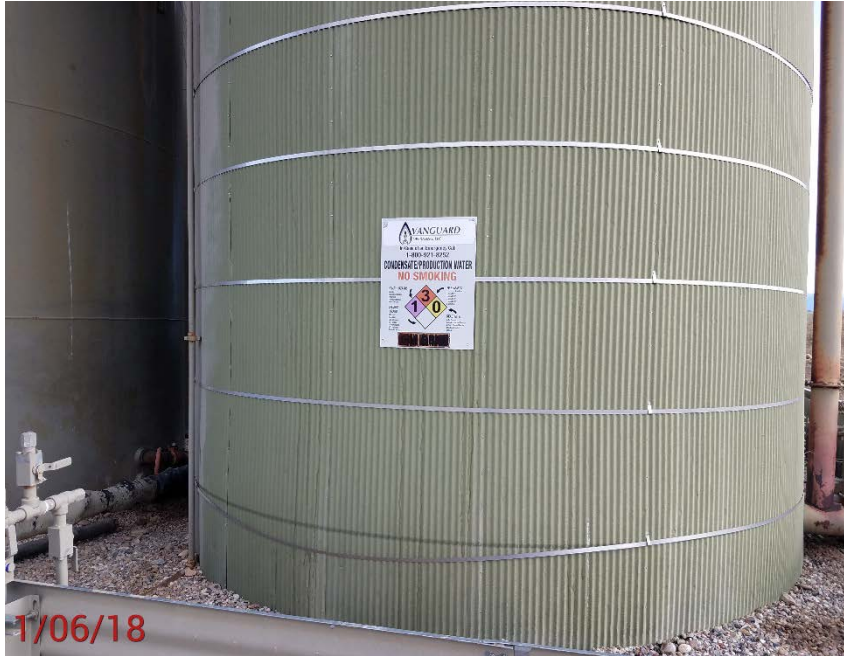
**Location Photo #7, Non legible BBL capacity.**

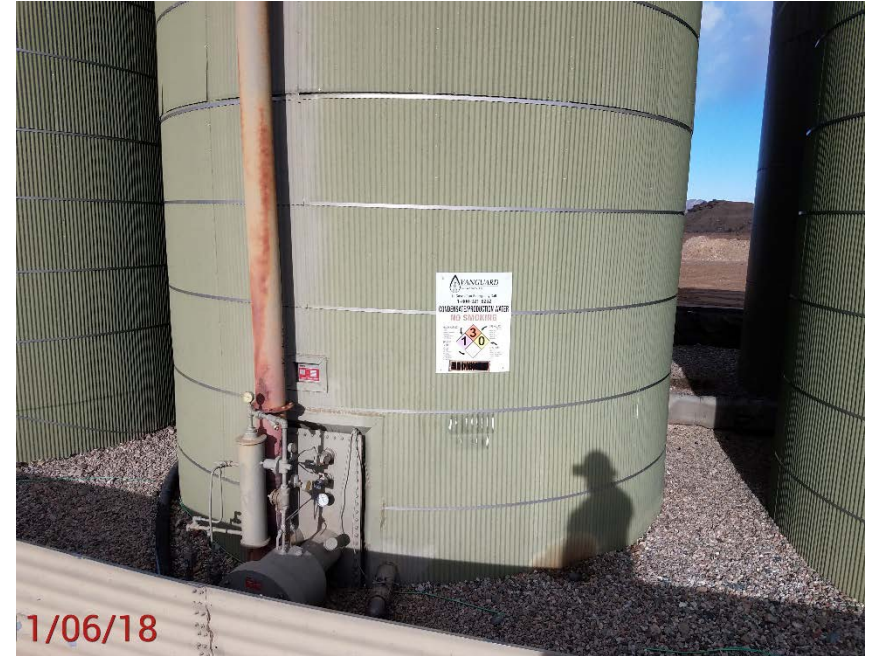
**Location Photo #8, Non legible BBL capacity.**
