**Inspection Photo
Shideler 29-11C
API # 045-11853
Inspection # 689302297**

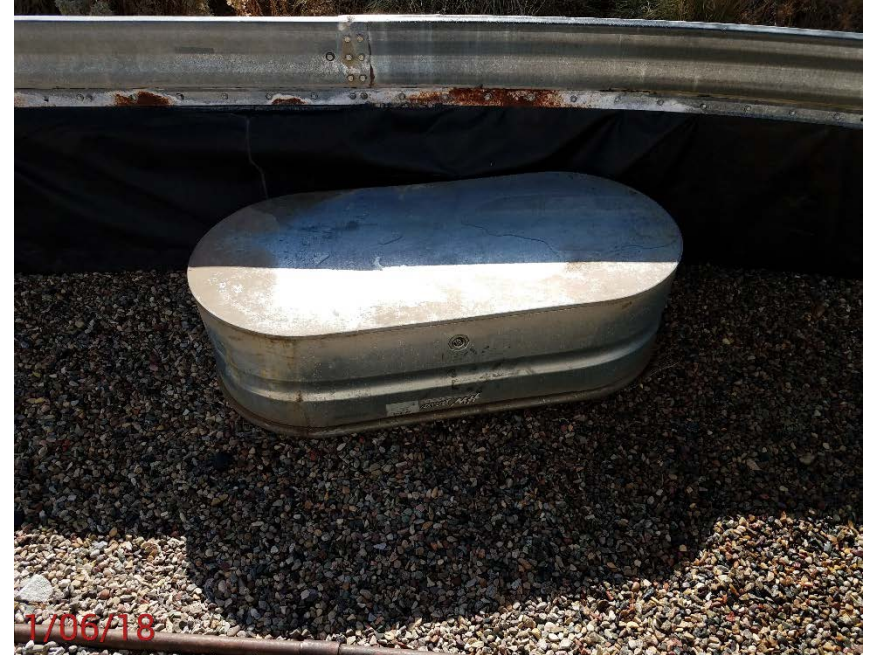
**Location Photo #2 Unused equipment in
battery containment.**

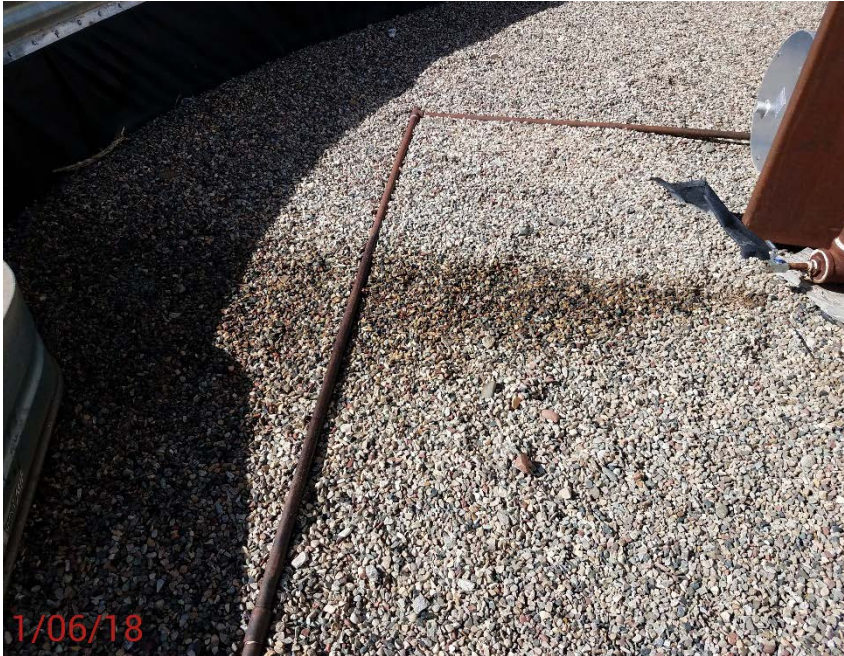
Location Photo #3, Oil stained rock in battery containment.

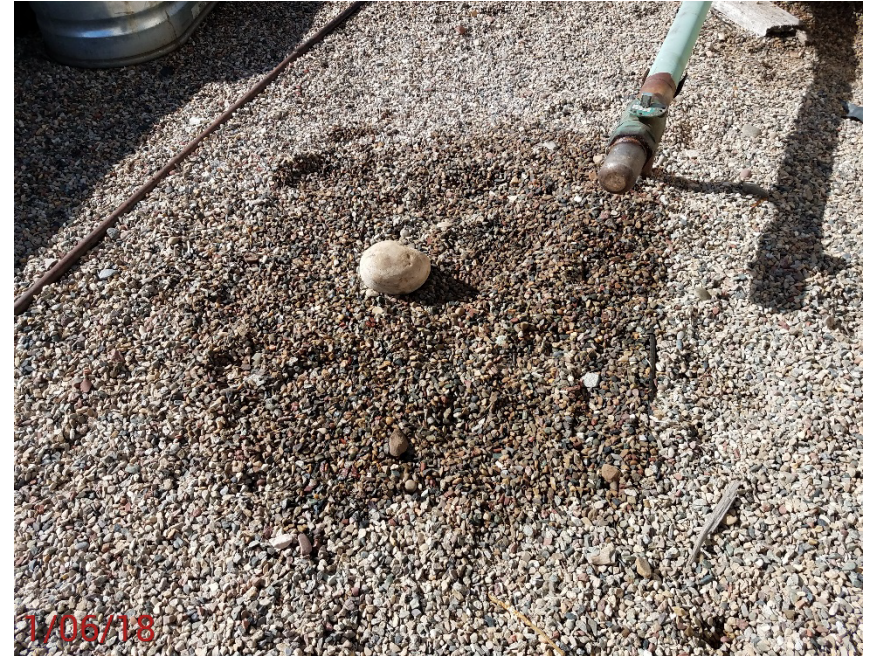
Location Photo #4, Oil stained rock in battery containment.

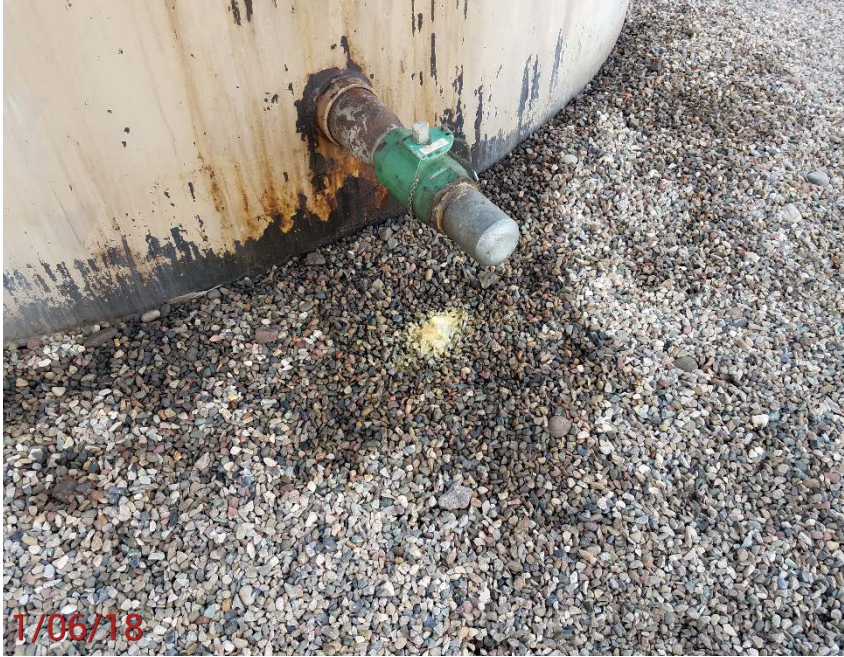
Location Photo #5, Oil stained rock in battery containment. Mechanical condition of valves.

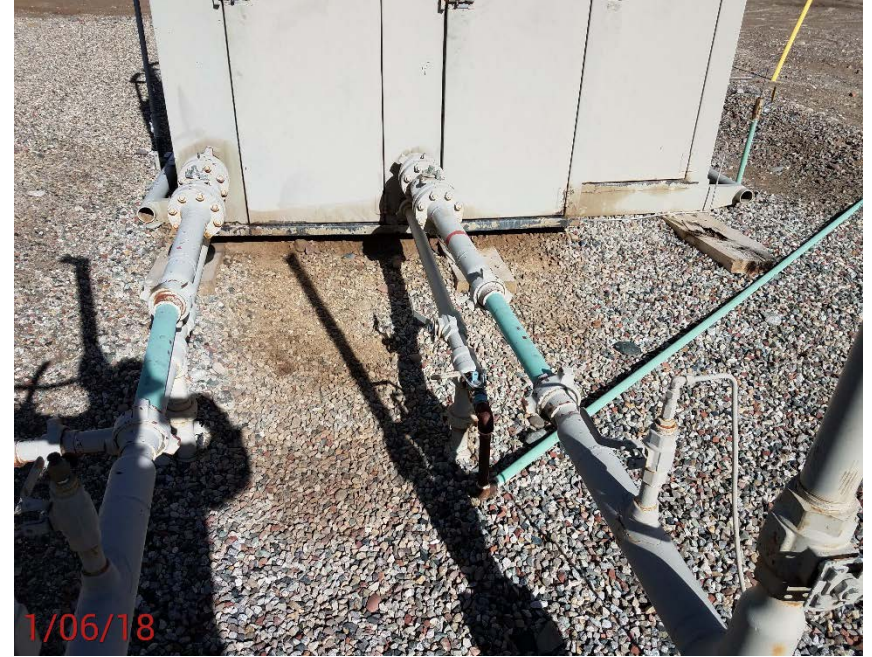
Location Photo #6, Stained rock under and around separator.

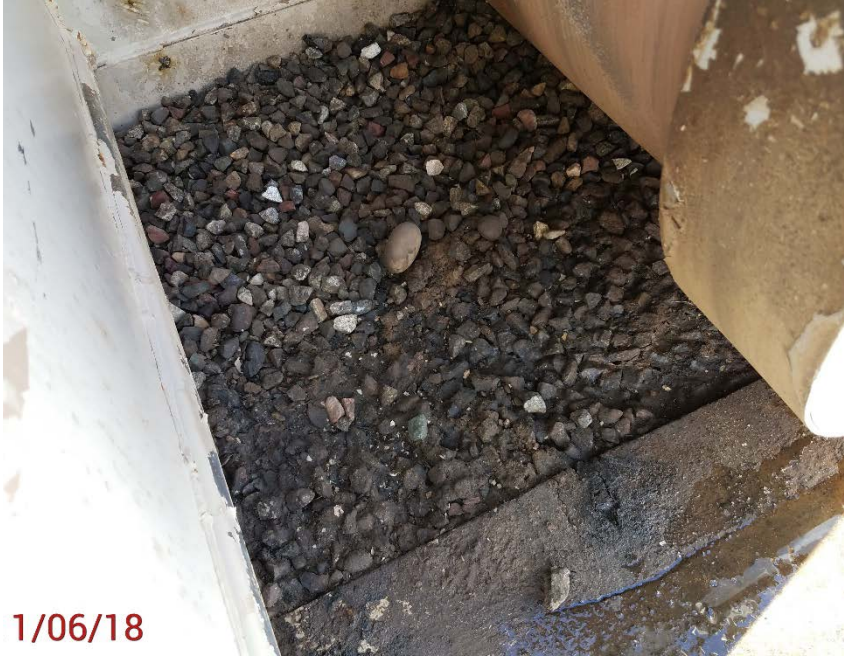
Location Photo #7, Oily stained rock under separator by burner unit.

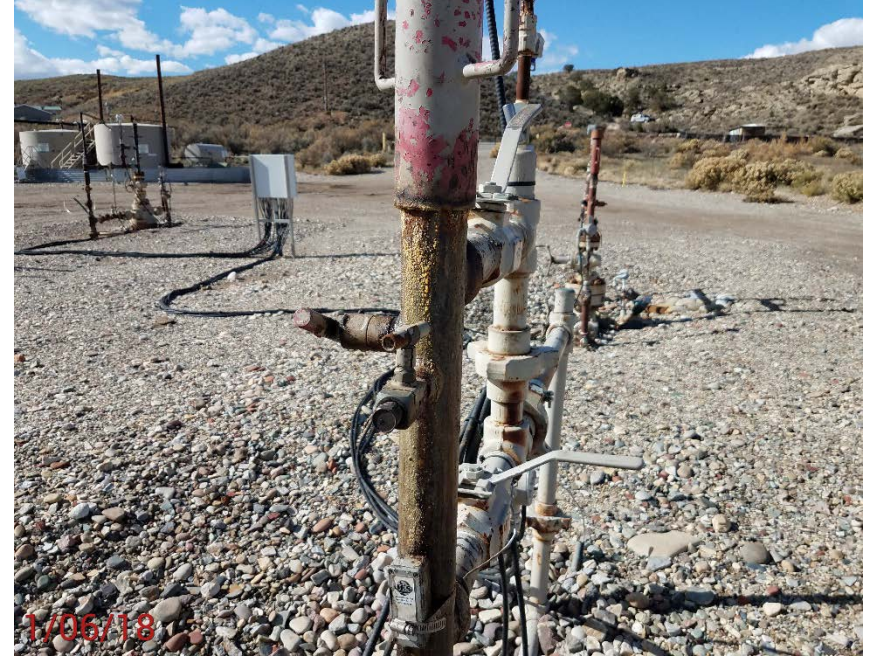
Location Photo #8, Mechanical condition of lubricator on wellhead.

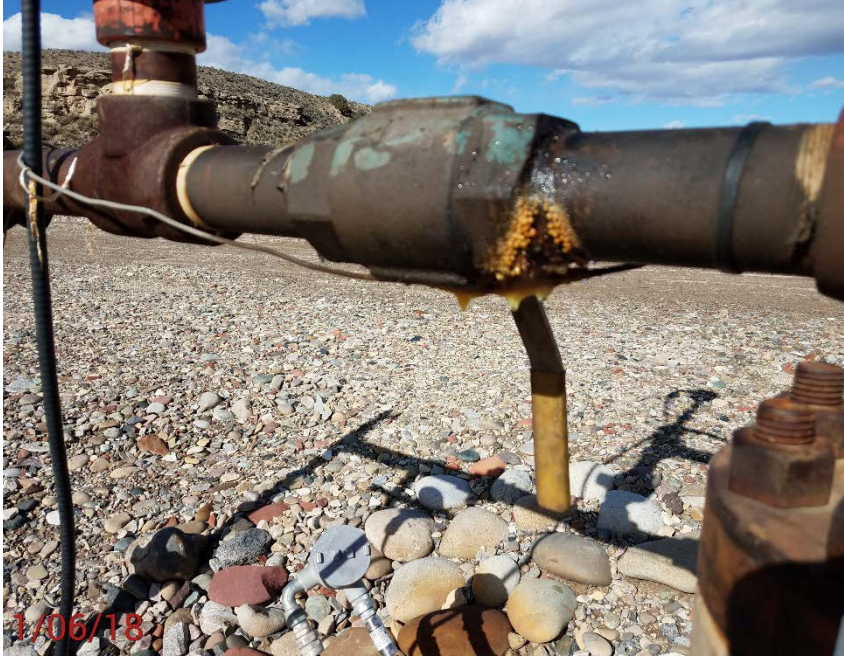
Location Photo #9, Mechanical condition of valves in flow line.

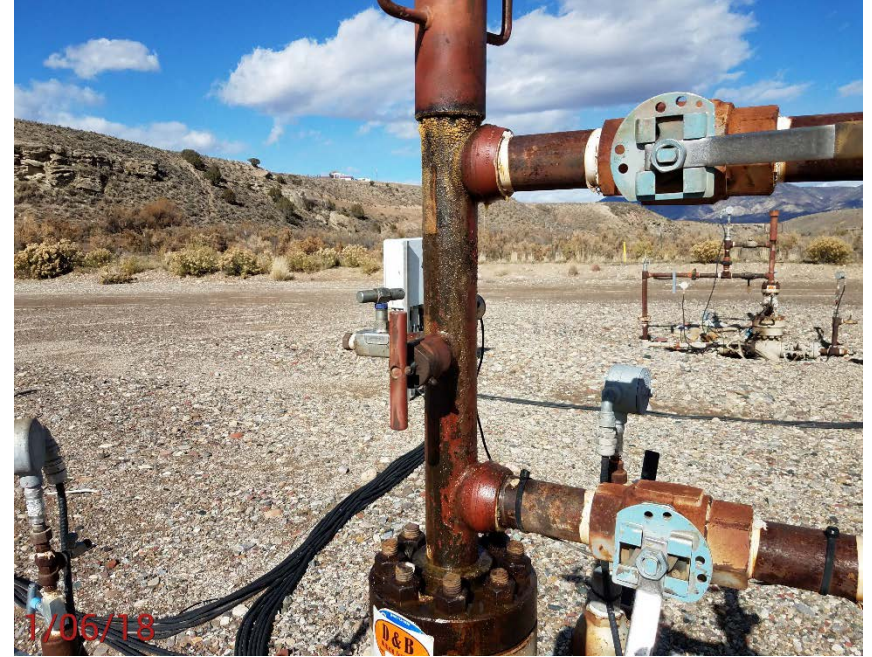
Location Photo #10, Mechanical condition of lubricator on wellhead
