Inspection Photos

Operator: BP Production

API: 05-067-08631

Date: 10/24/2018

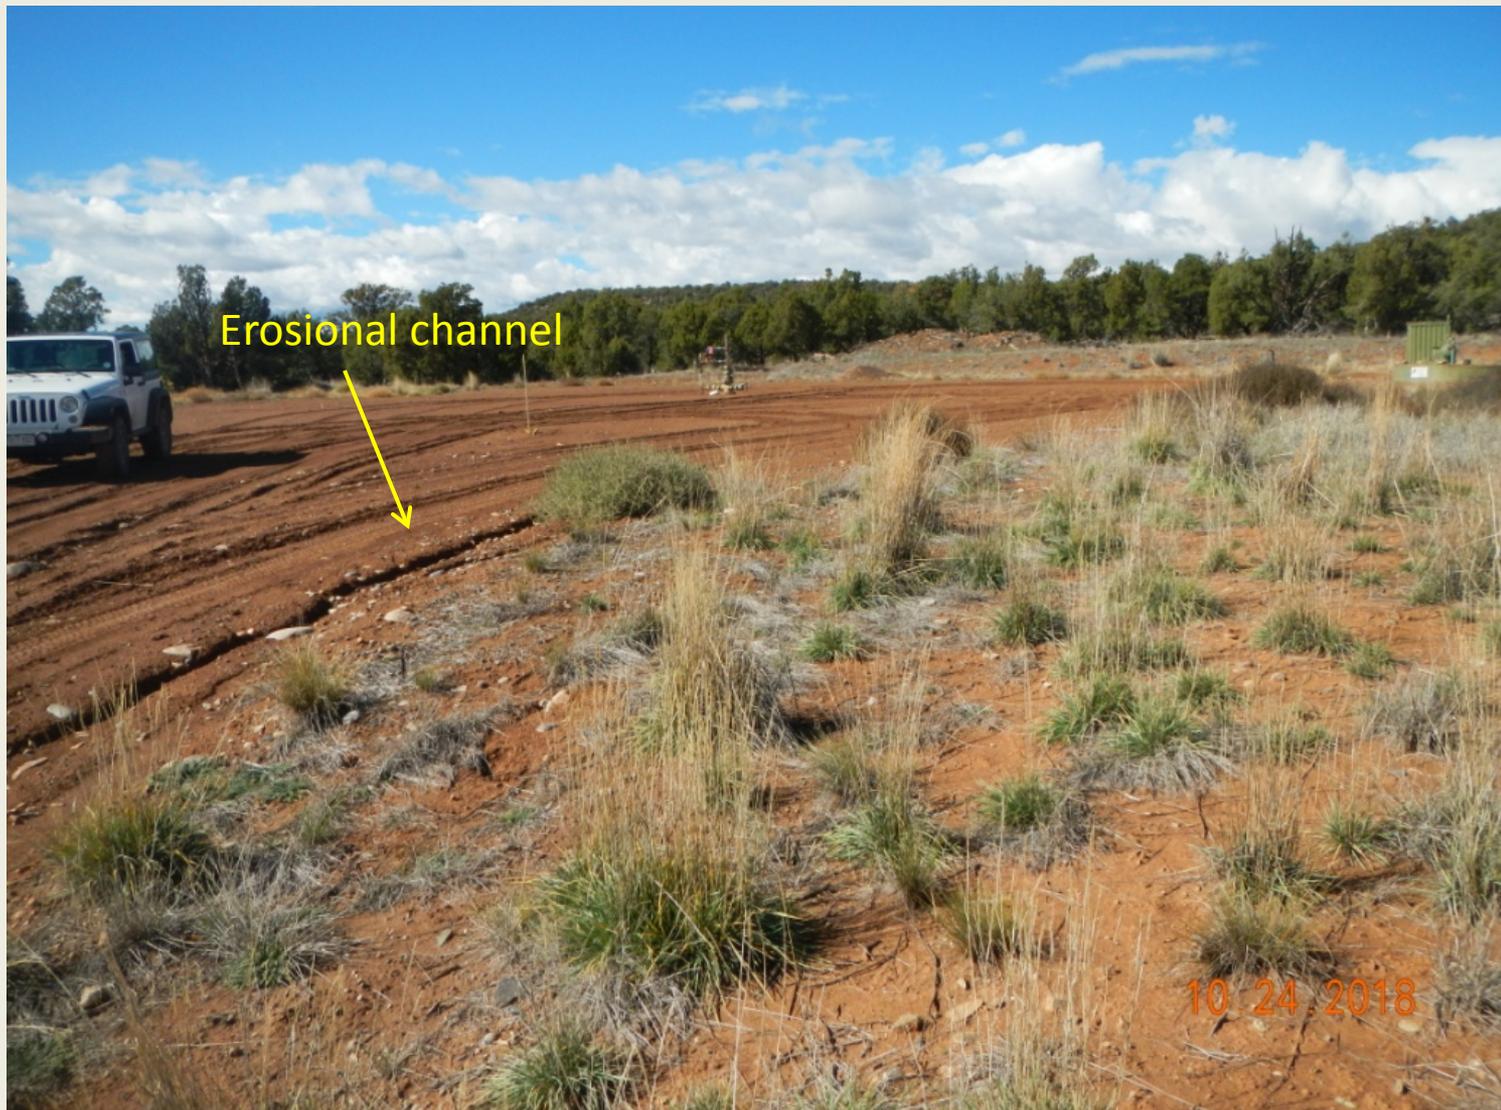
Photo 1. View of the project area from the eastern well pad entrance facing center. Stormwater flows from the well pad are eroding a channel approximately 6 inches wide and deep that flows eastward, down the access road. This needs stabilization.

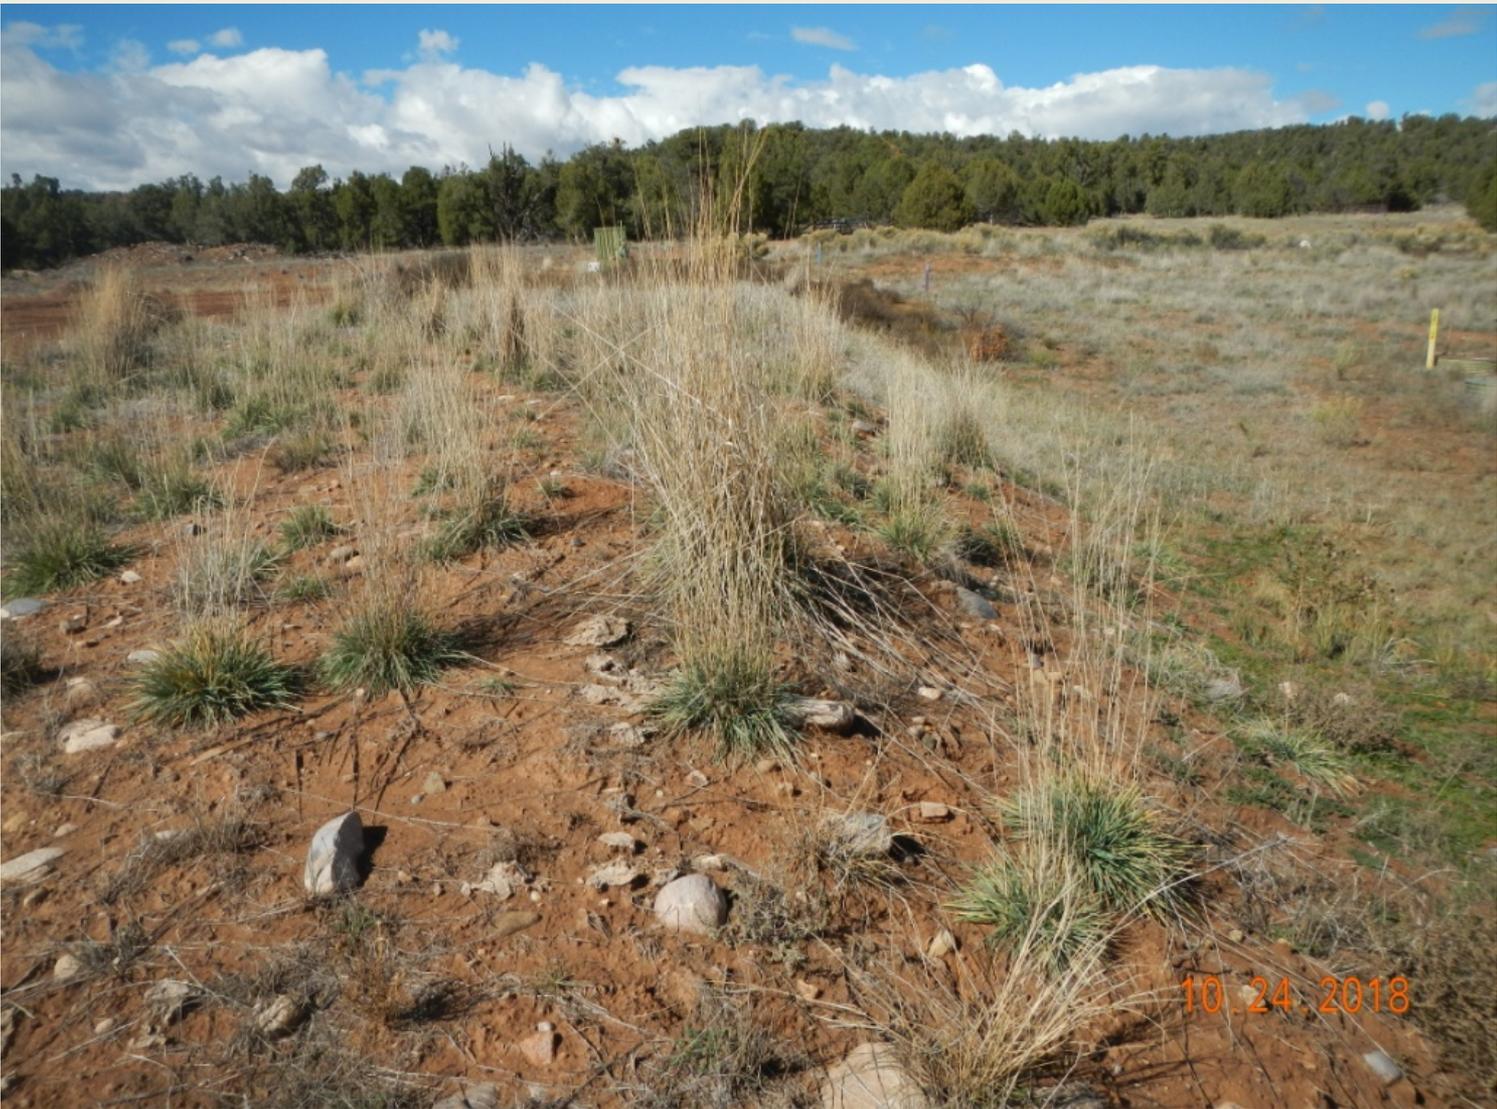
Photo 2. View of the northeastern project area from the eastern corner facing northward. Revegetation is progressing with grasses such as crested wheatgrass (*Agropyron cristatum*), and intermediate wheatgrass (*Thinopyron intermedium*).

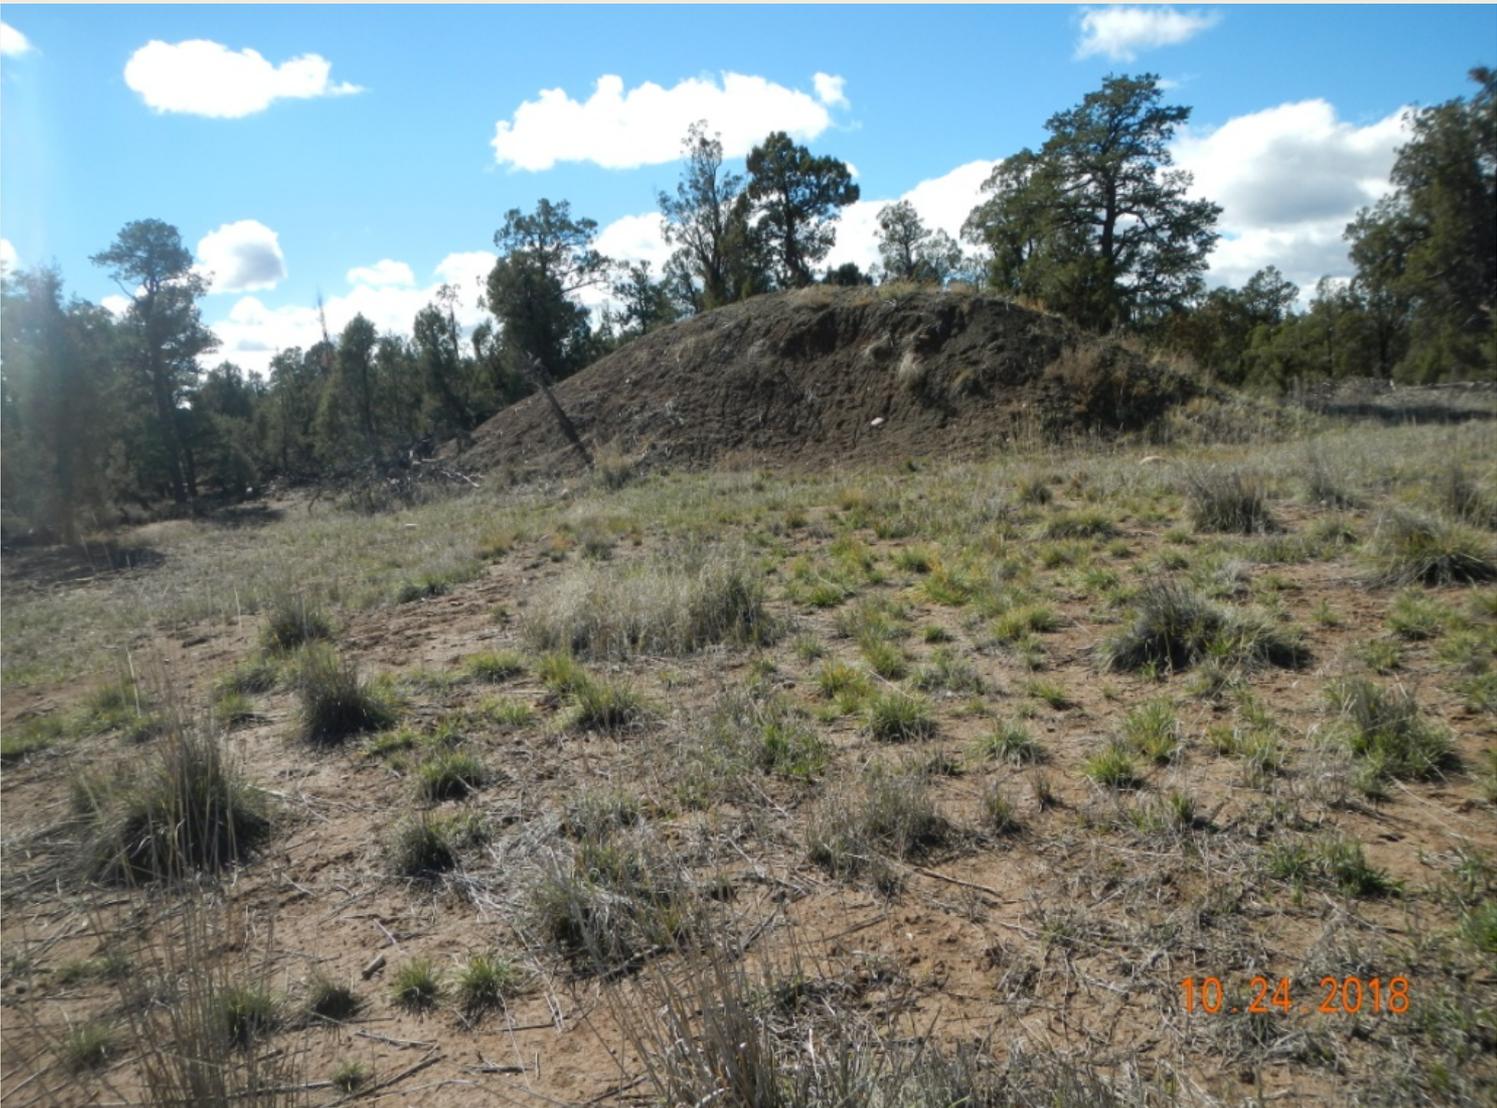
Photo 3. View of the southern project area from the edge of the working area facing southward. Soil is stockpiled here.

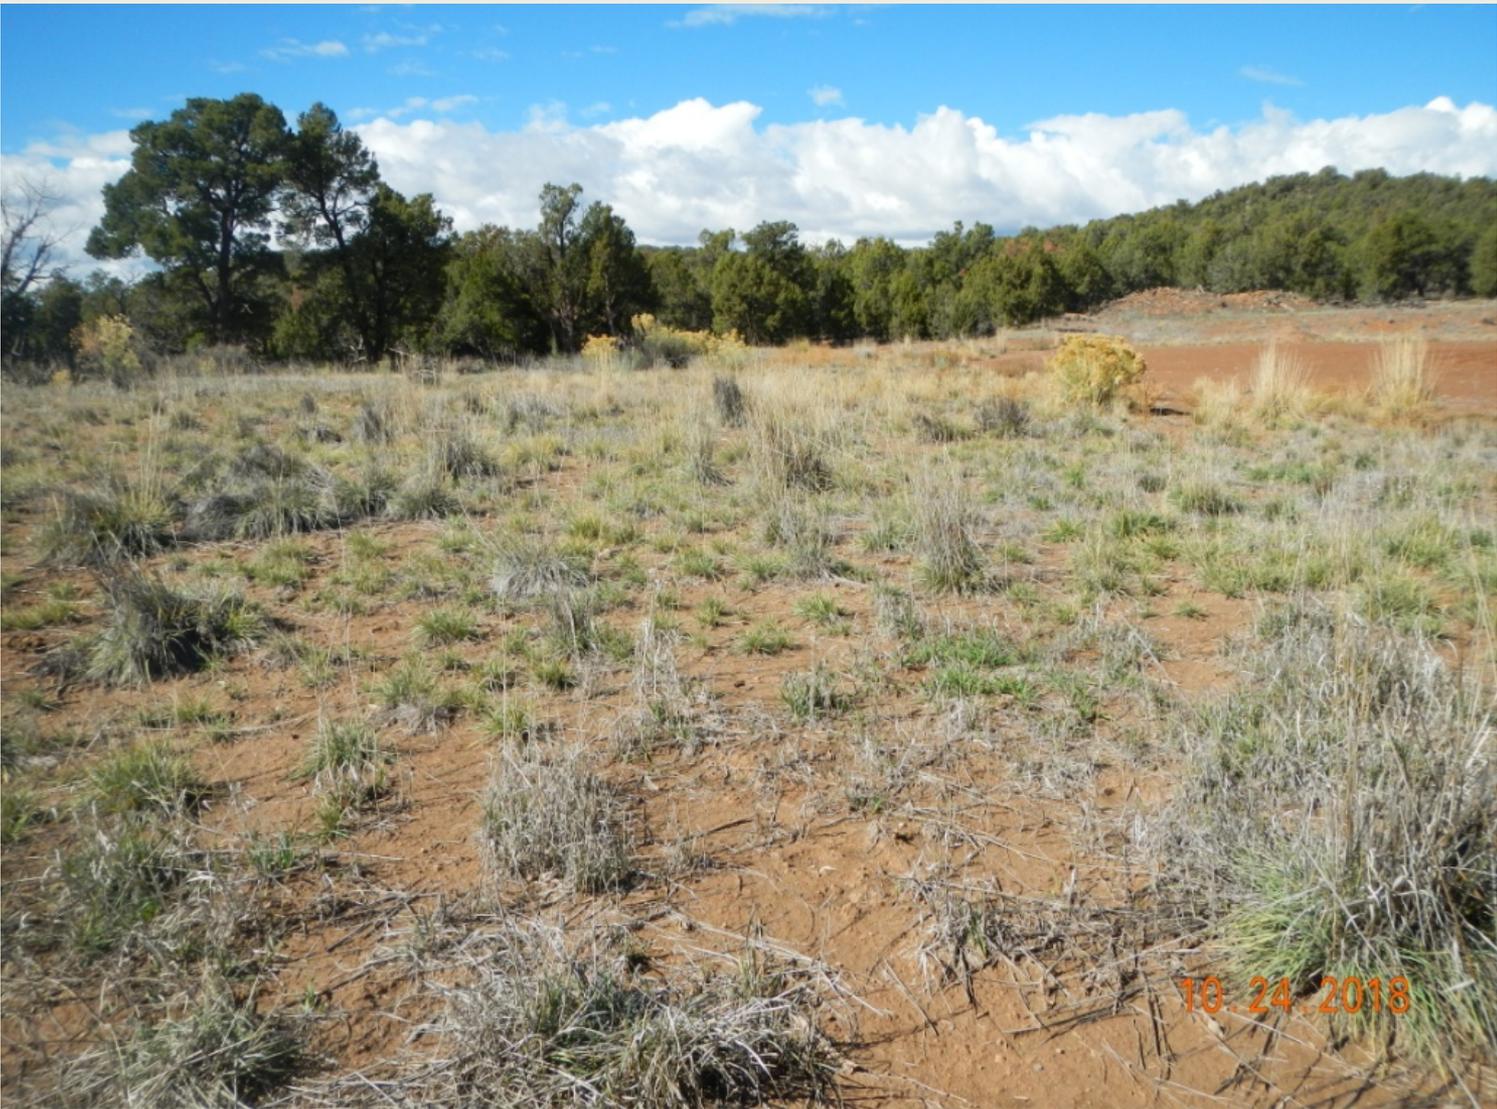
Photo 4. View of the western project area from the southern corner facing northward.

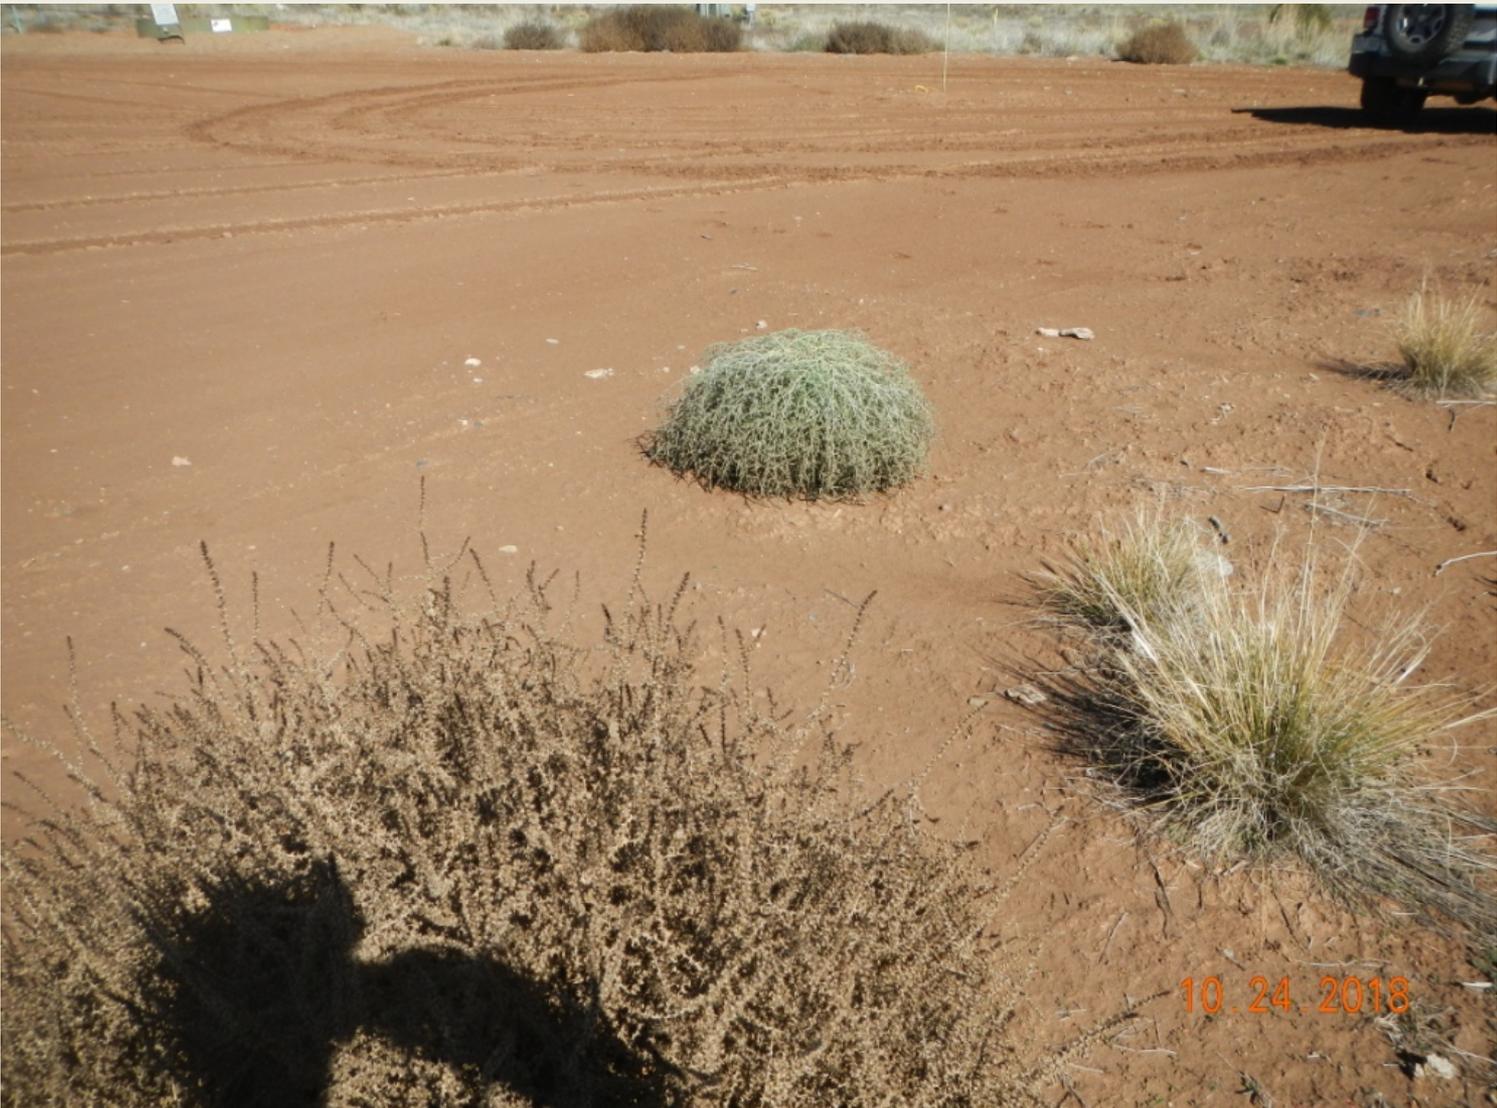
Photo 5. View of Russian thistle (*Salsola tragus*) debris within the project area that is broken off and will blow.
