Inspection Photos

Operator: BP Production

API: 05-067-05787

Date: 10/24/2018

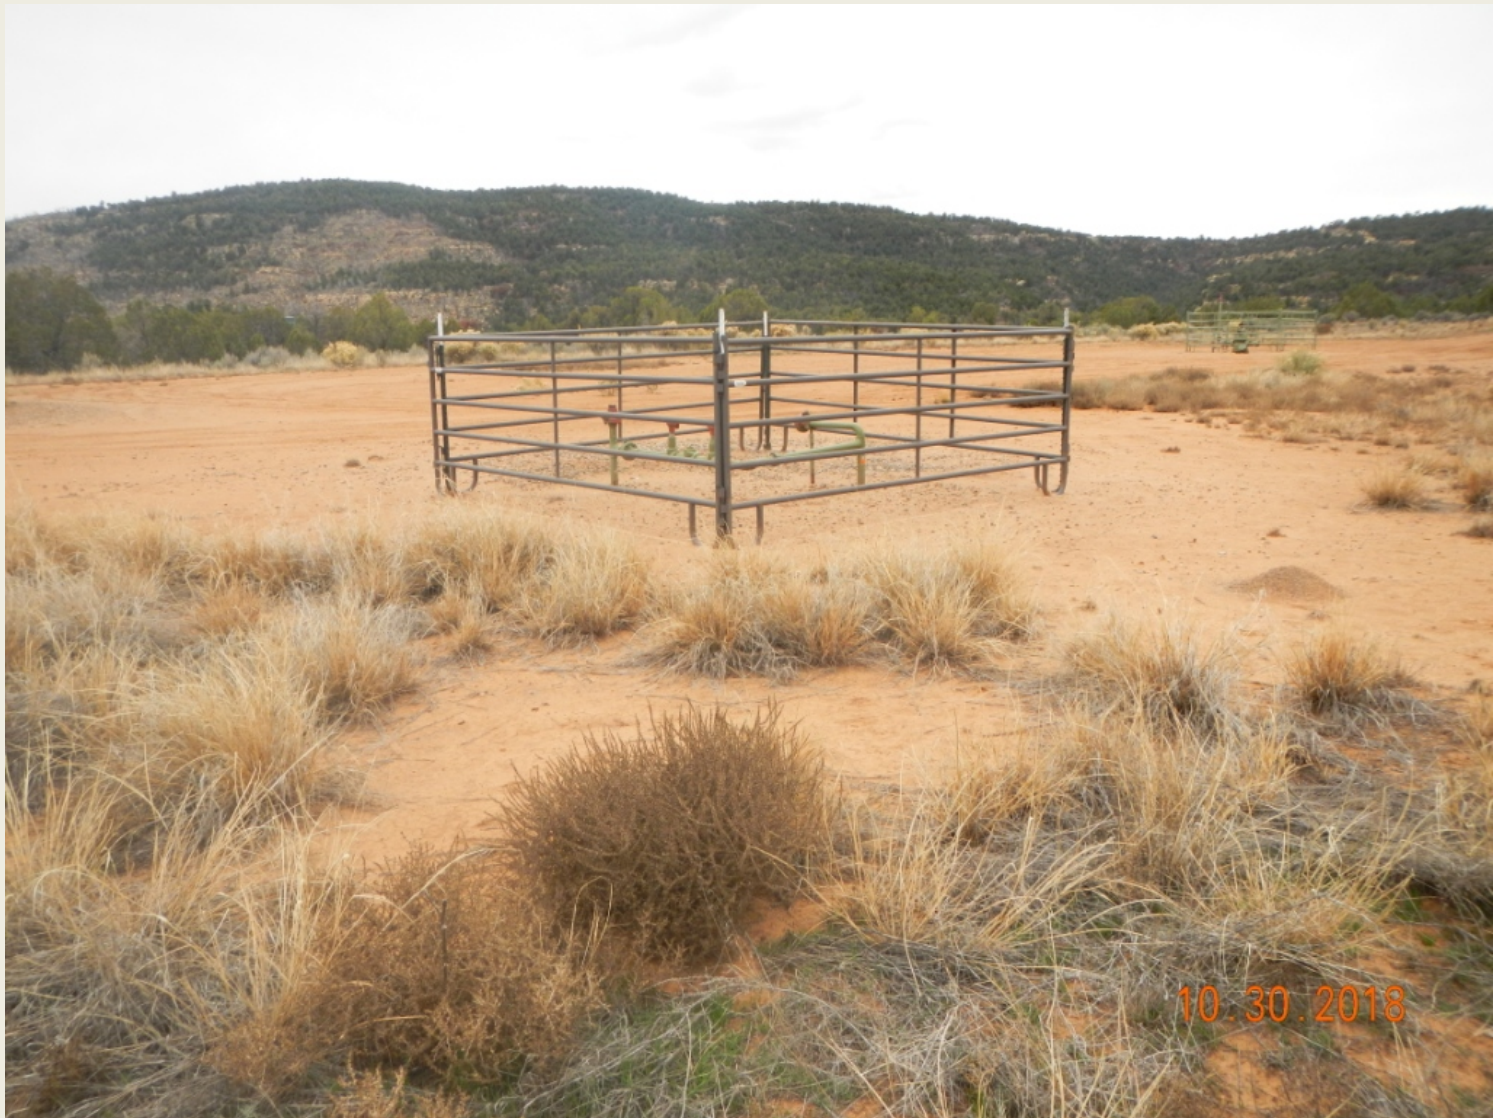
Photo 1. View of the project area from the northeastern corner facing center.

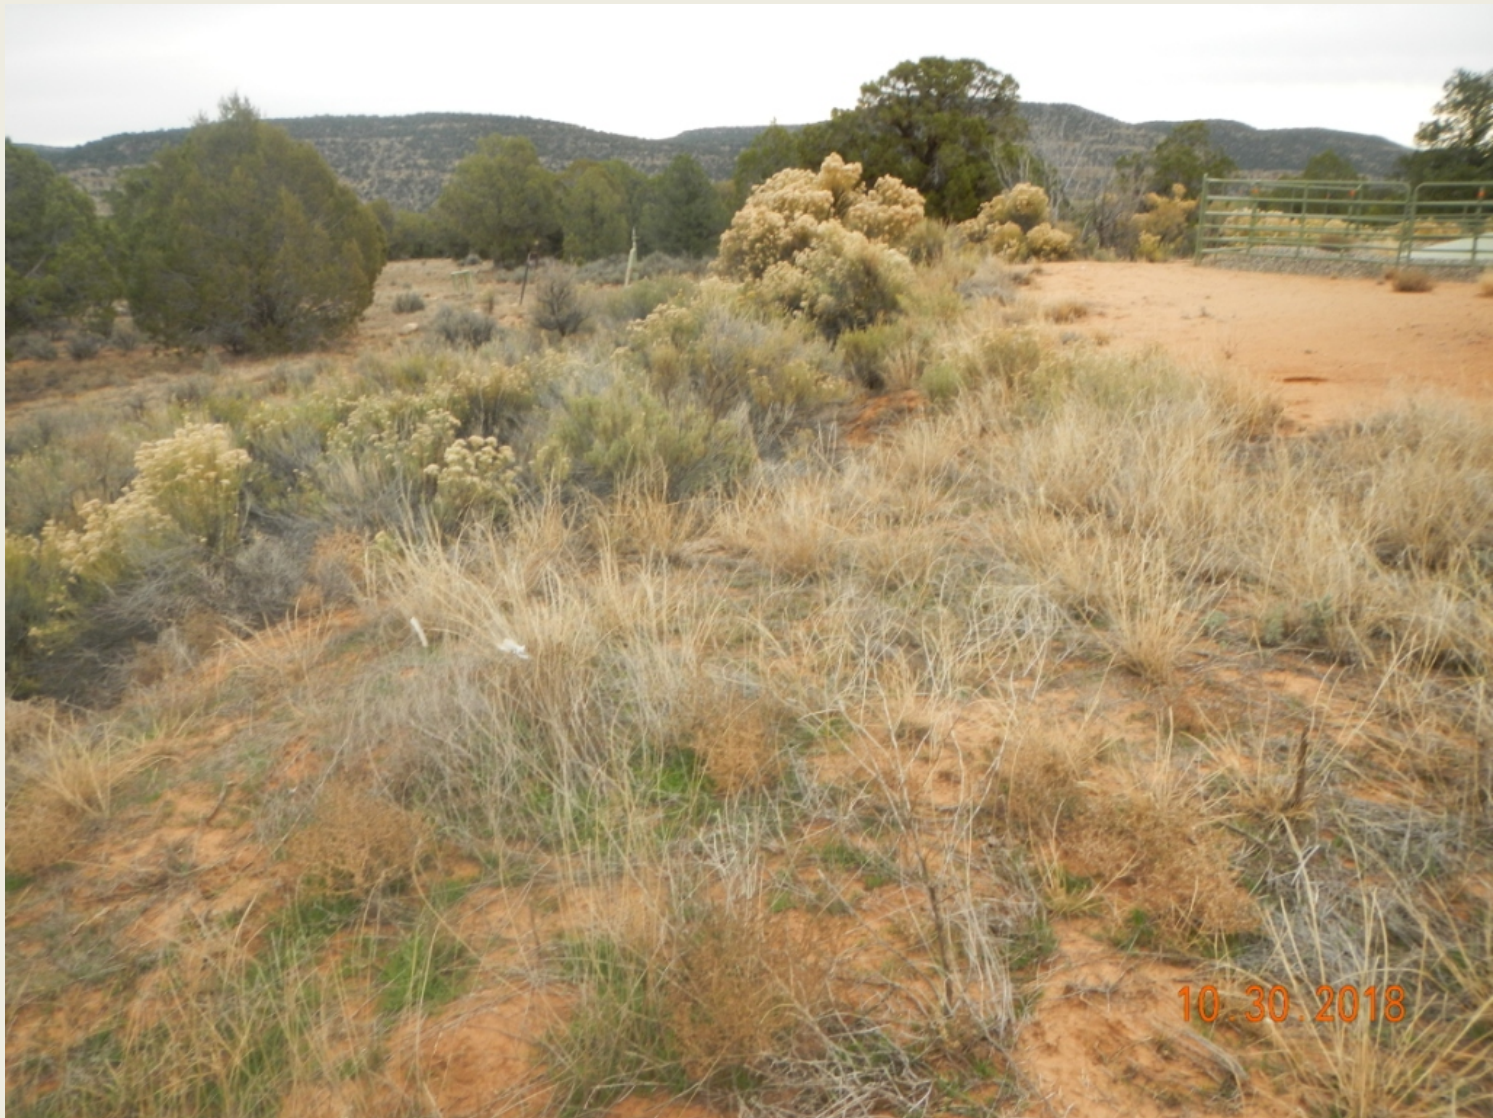
Photo 2. View of the eastern project area from the northeastern corner facing southward. Revegetation is progressing with grasses and shrubs such as sand dropseed (*Sporobolus cryptandrus*) and rubber rabbitbrush (*Chrysothamnus nauseosus*).

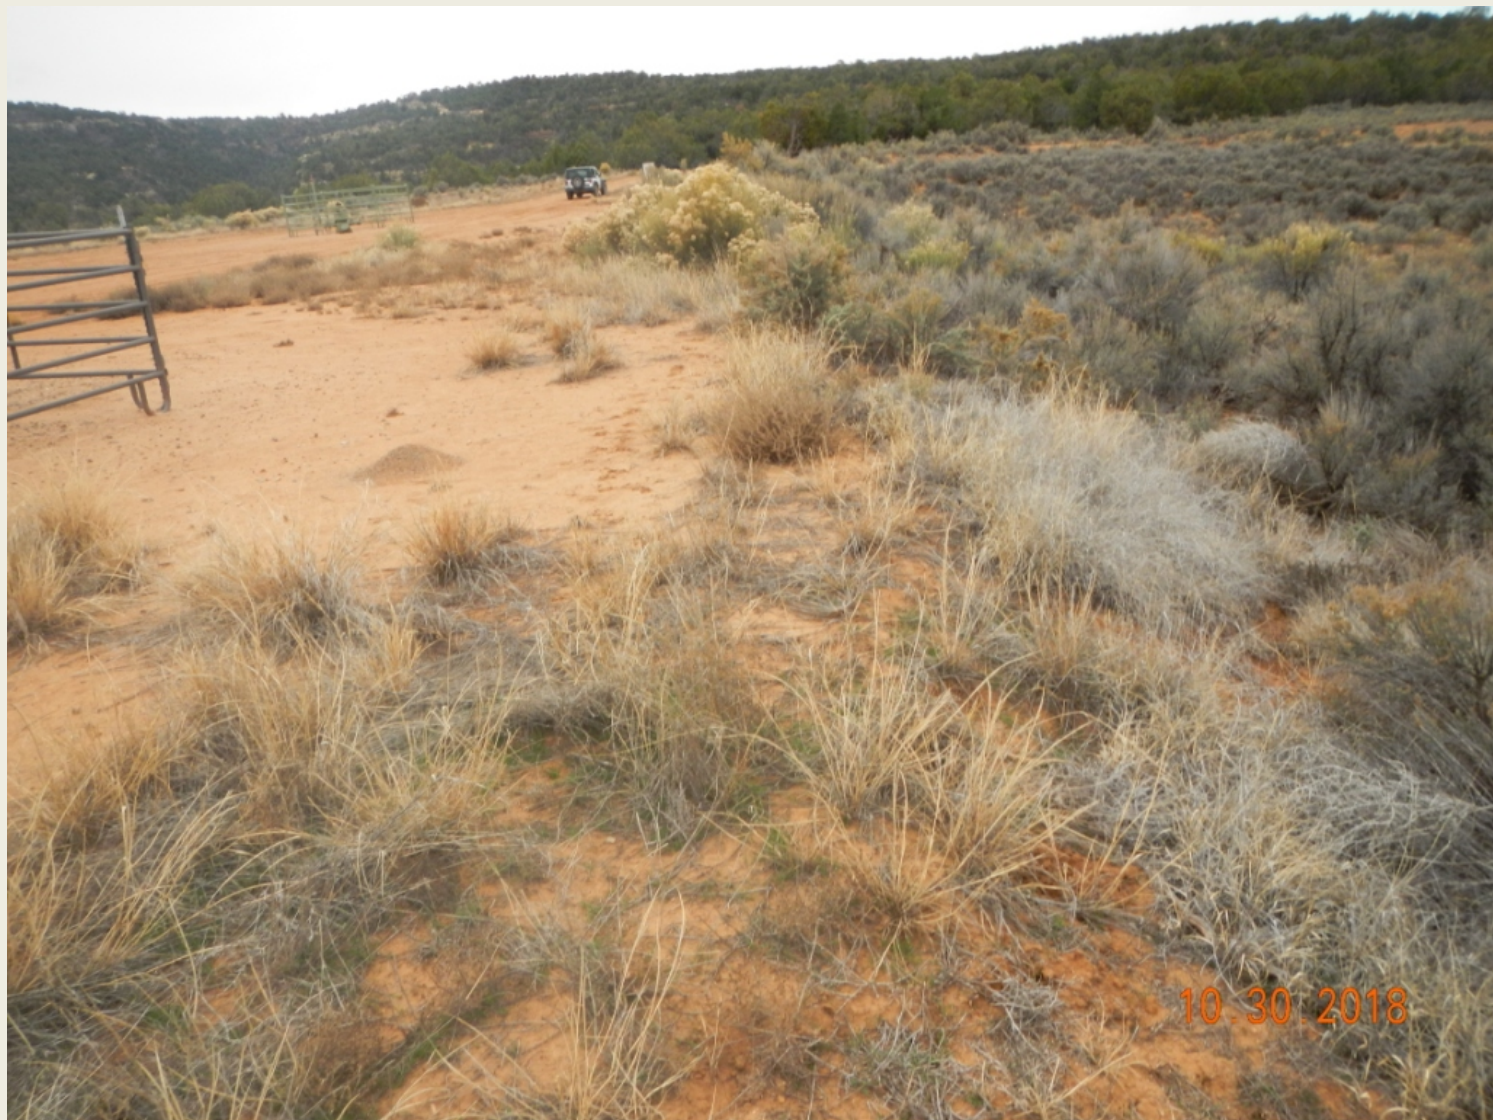
Photo 3. View of the northern project area from the northeastern corner facing westward.

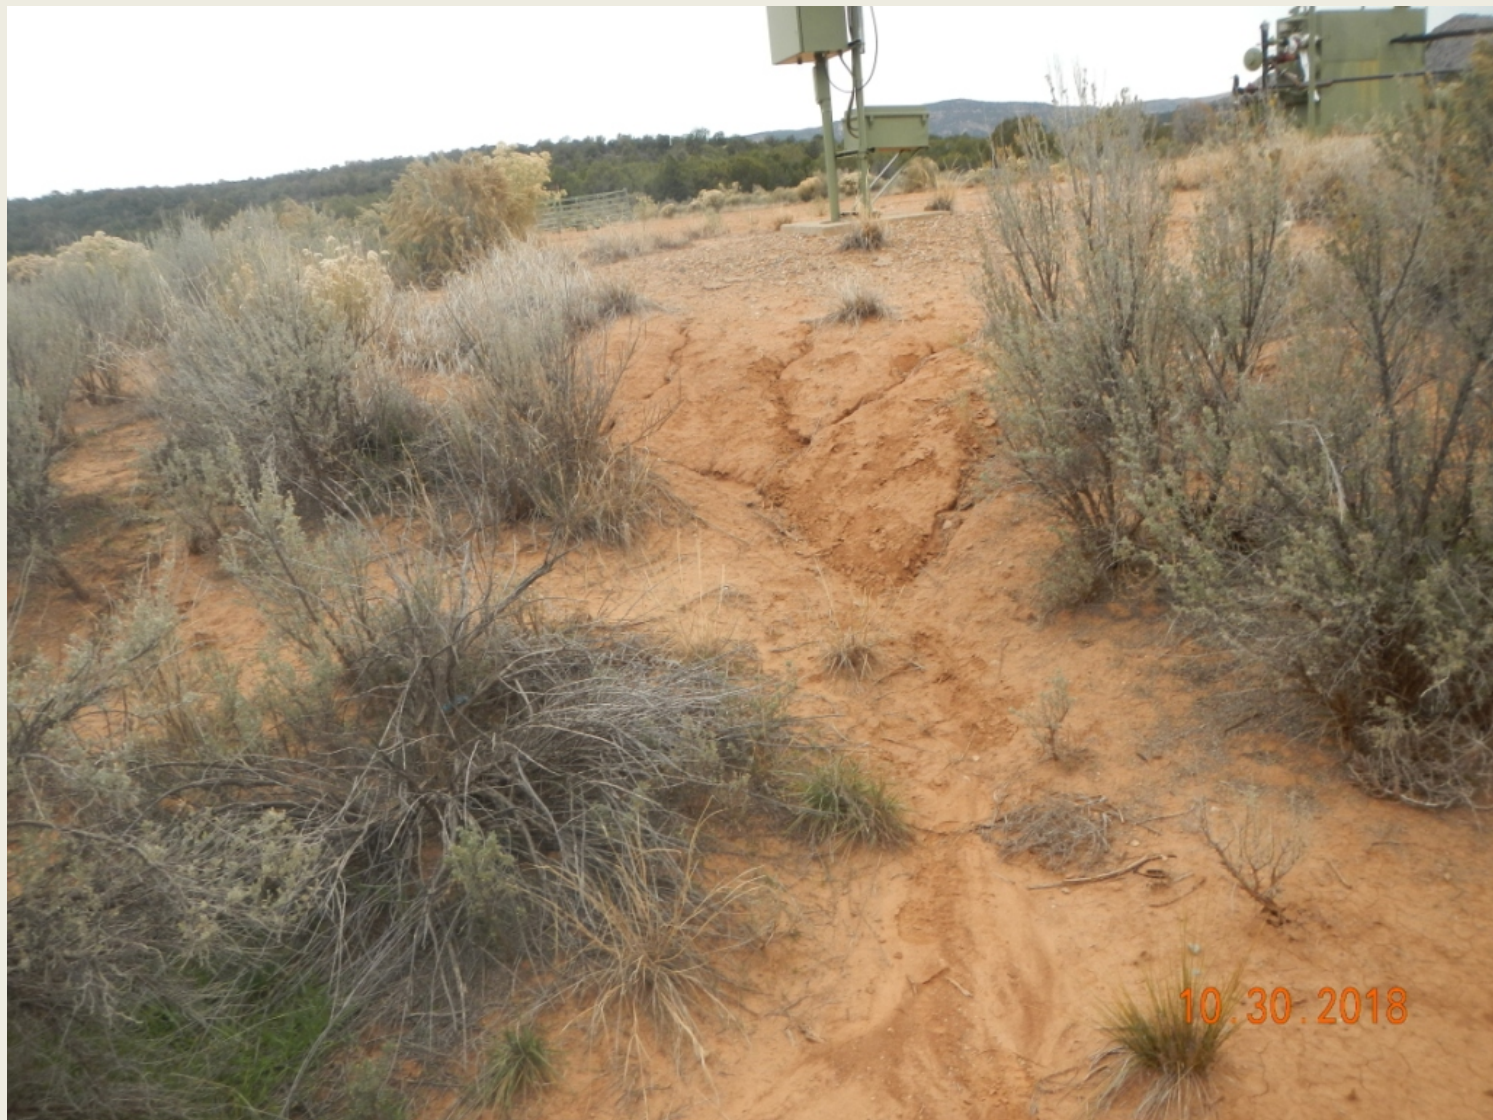
Photo 4. View of erosional channel in the southeastern project area.

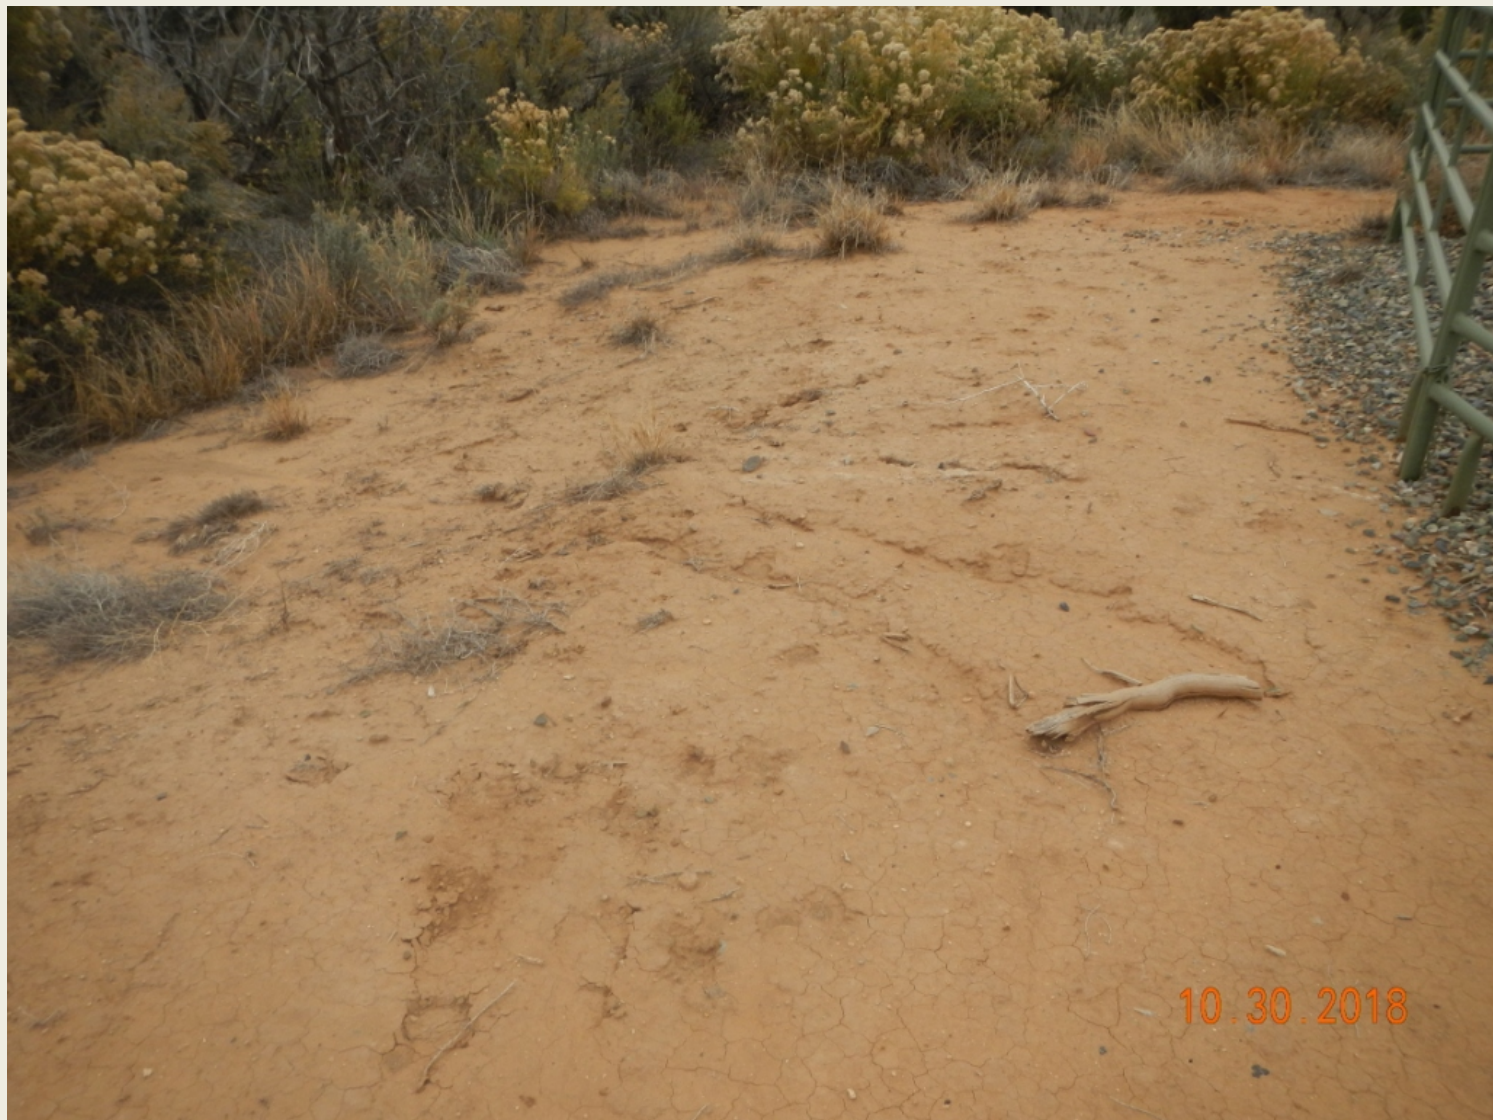
Photo 5. View of erosional rilling within the eastern project area.

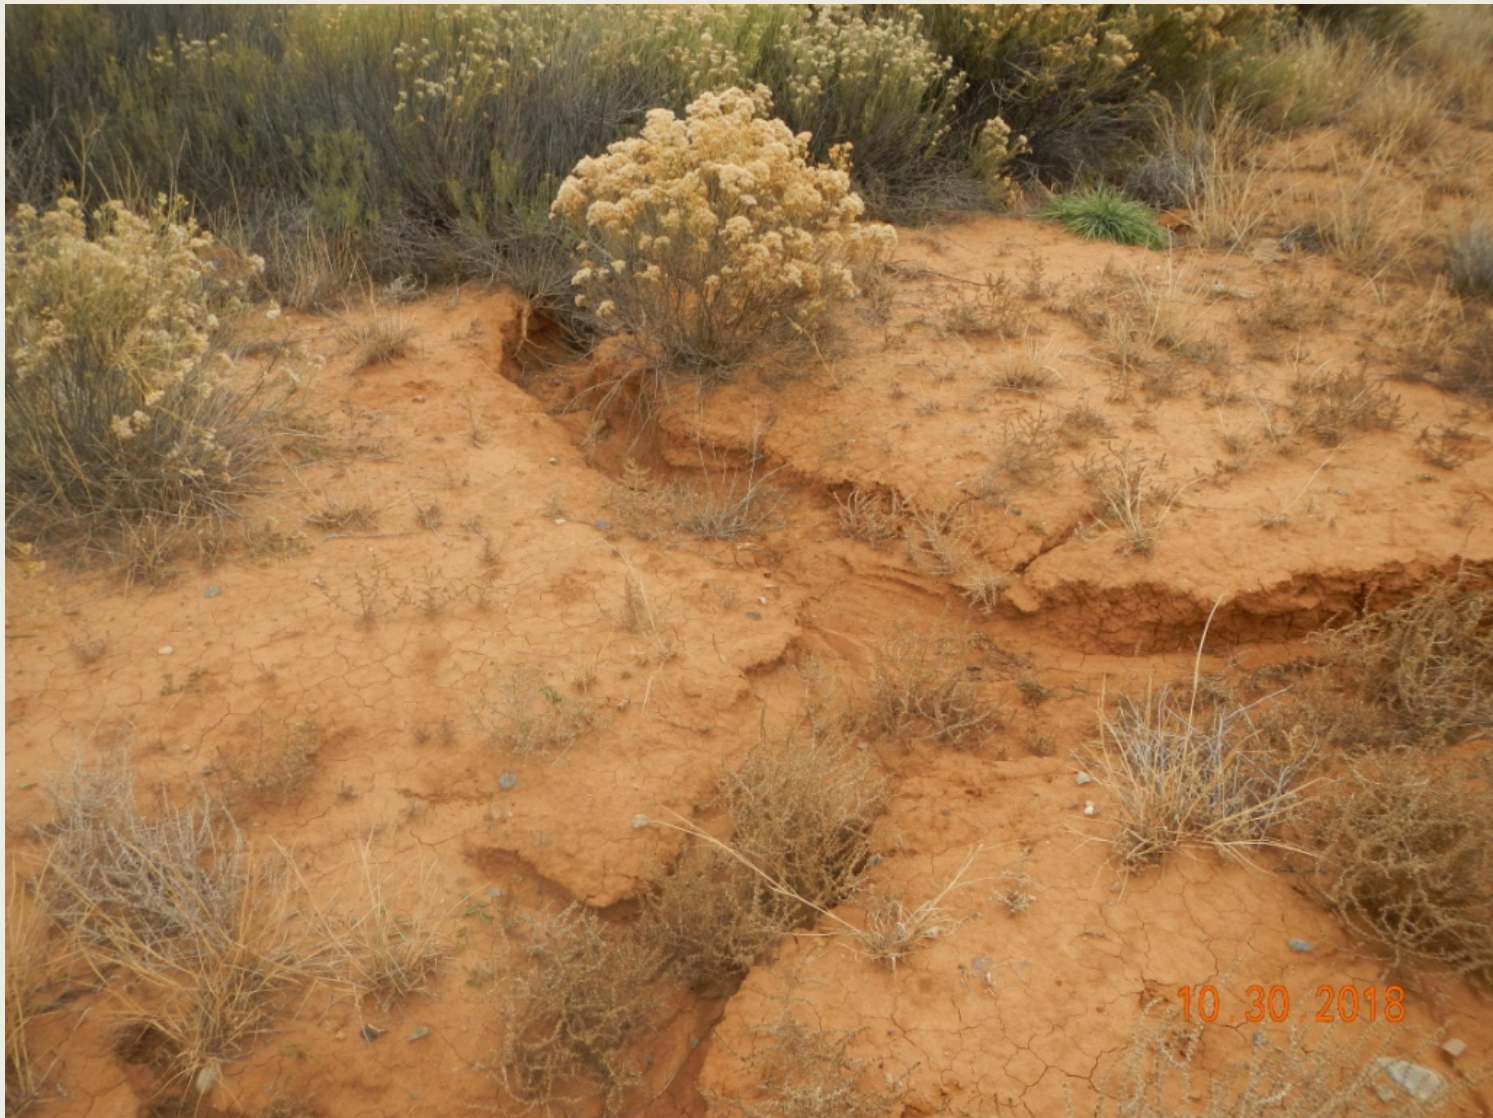
Photo 6. View of erosional channel within the northern file slope, approximately 2.5 feet wide and deep>
