**Inspection Photo**  
**Roles 13-10**  
**API # 045-06953**  
**Inspection # 689302325**

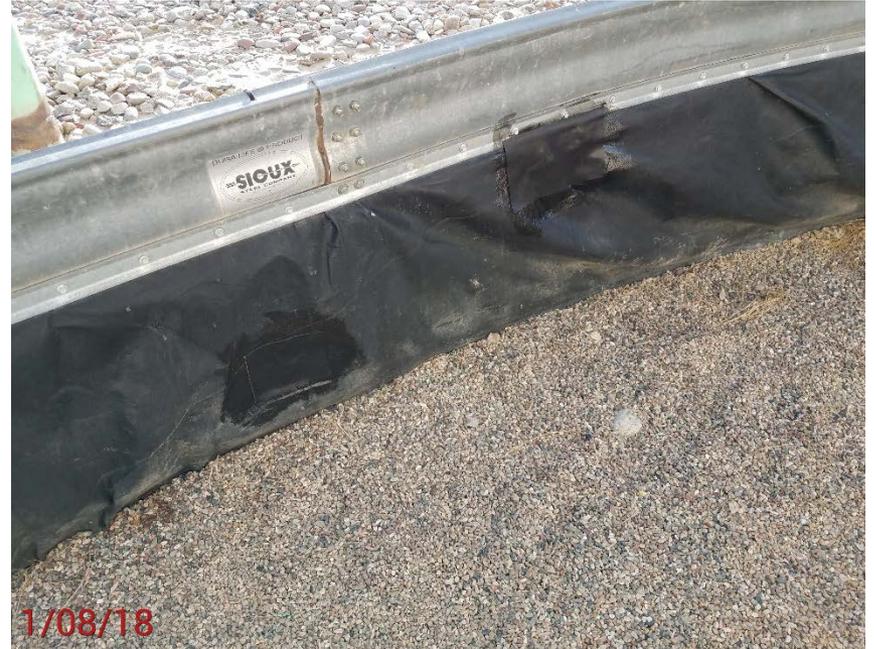
**Location Photo #2 secondary containment repaired.**

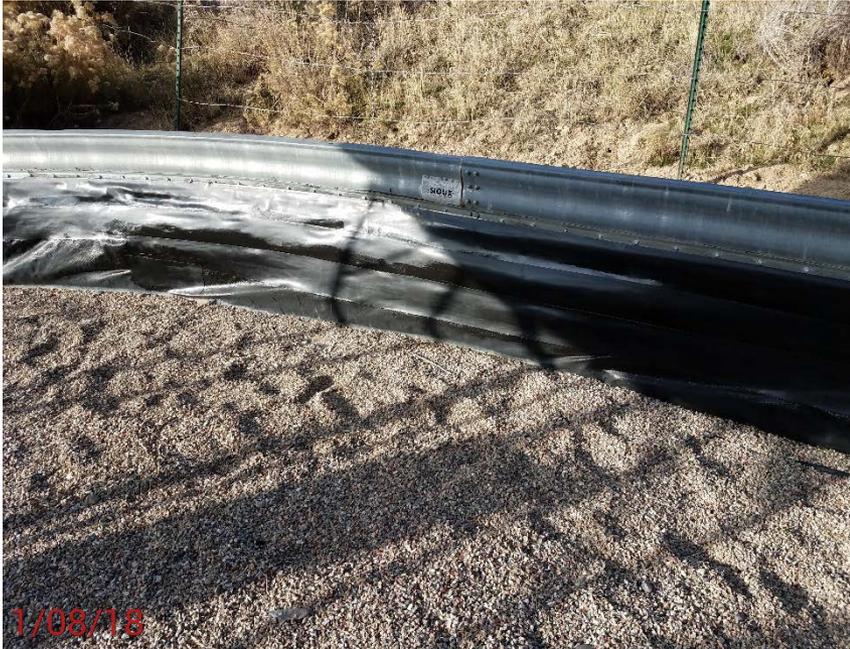
**Location Photo #3, secondary containment repaired.**

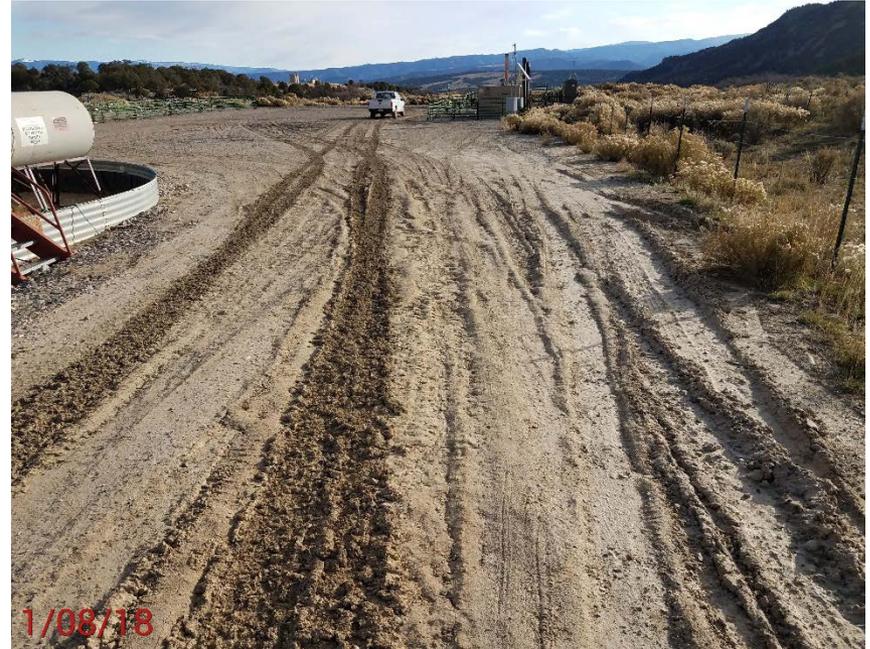
**Location Photo #4, Access road storm water issue unresolved.**

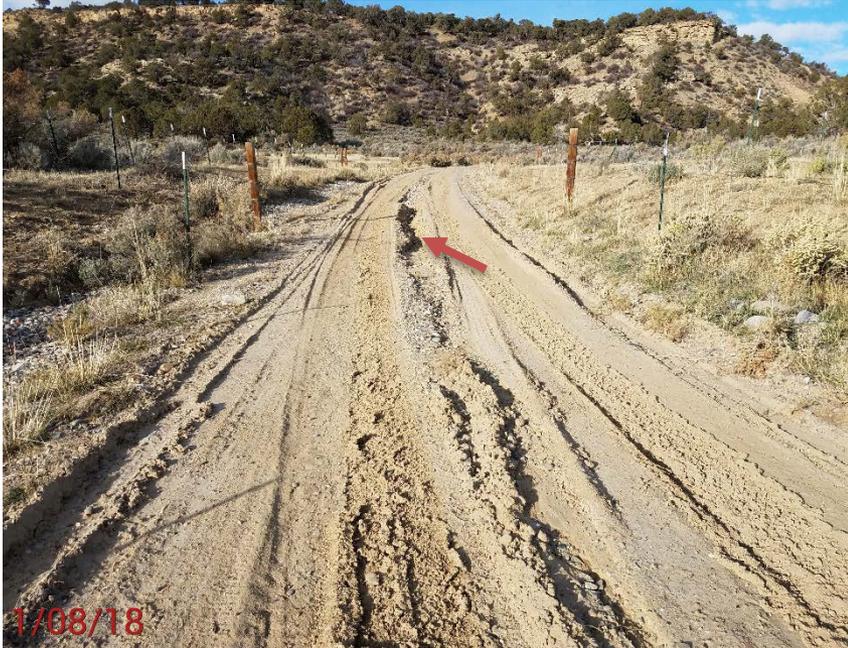
**Location Photo #5, Sediment being moved onto location. Rilling occurring in middle of road.**

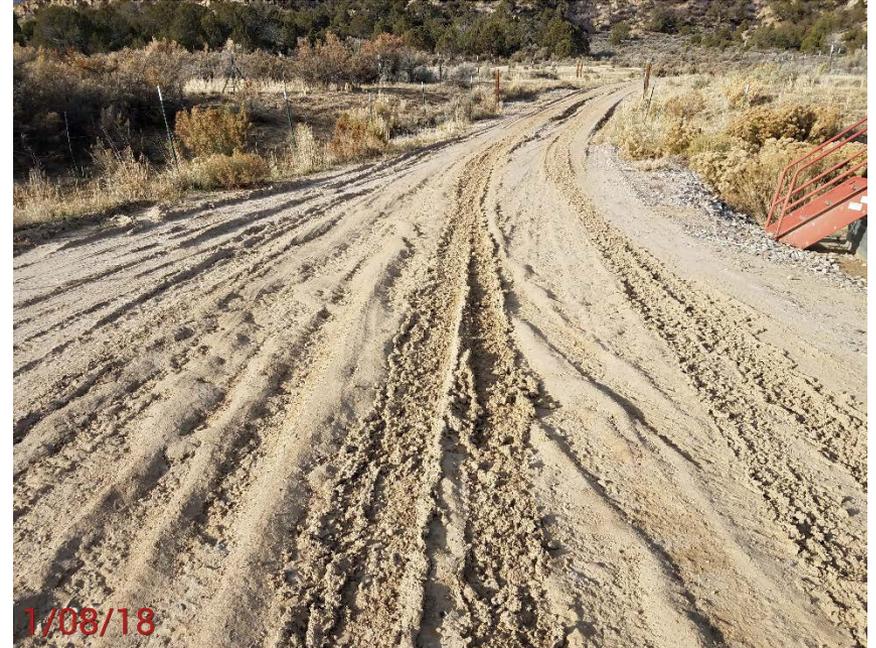
**Location Photo #6, Sediment being moved onto location.**

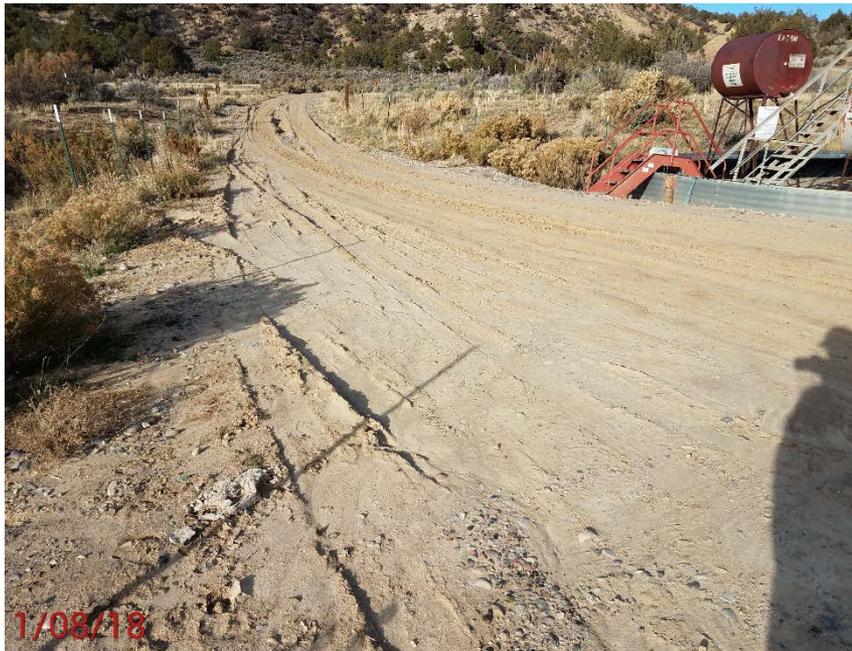
**Location Photo #7, Sediment being moved onto location.**

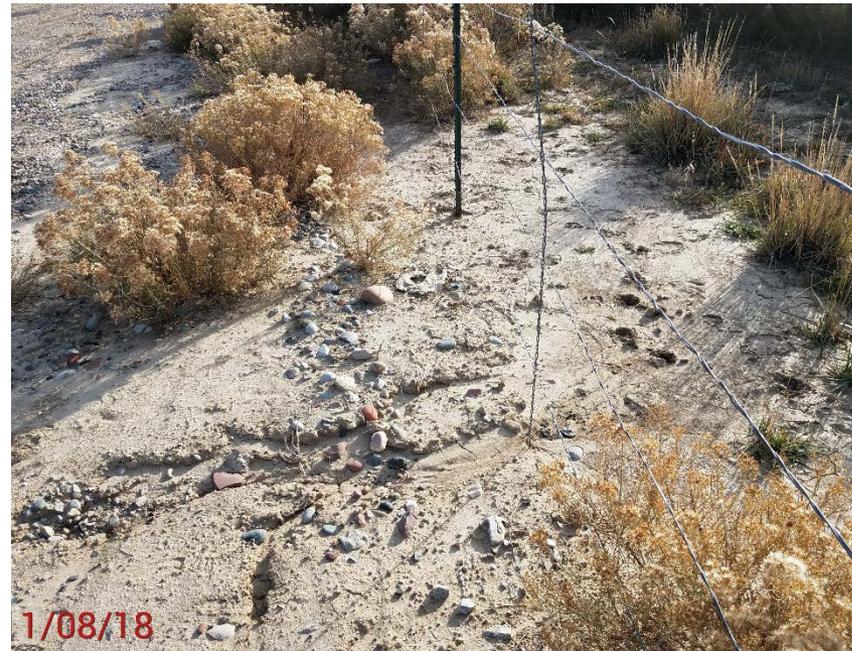
**Location Photo #8, Sediment being moved off location.**

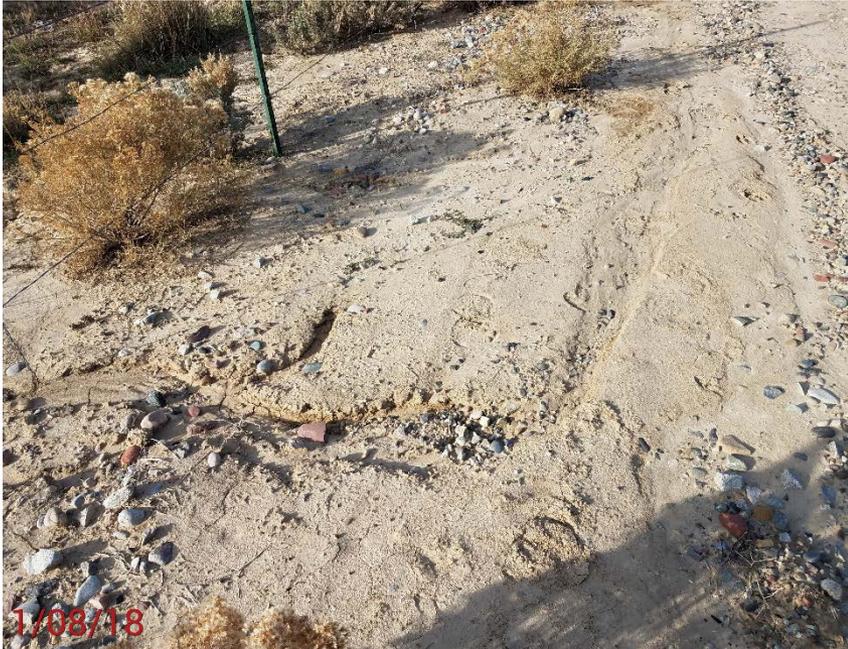
**Location Photo #9, Sediment being moved off location.**
