Inspection Photos 9-20-18
JA Farms 1, Location ID 313873
API: 05-087-07380
Operator Smith Oil Properties, Inc - #79905

COLORADO
Oil & Gas Conservation
Commission
Department of Natural Resources

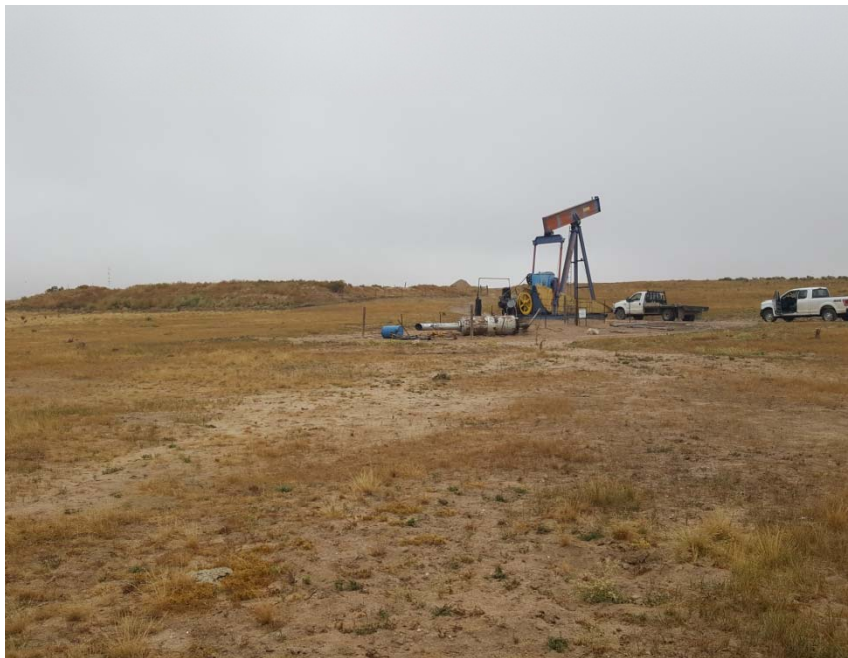
Photo #1
Former Spill area (Doc #2230022) Looking Northeast

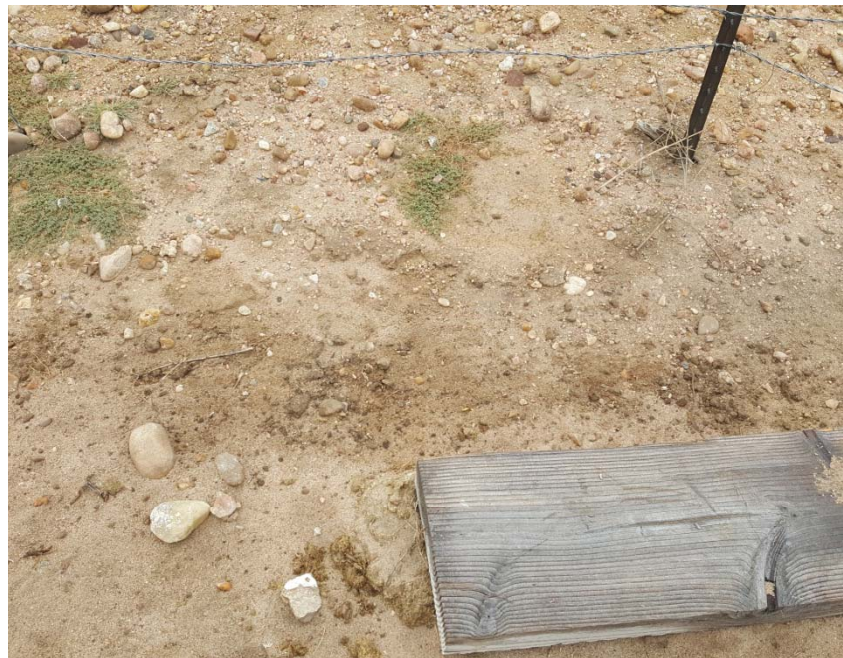
Photo #2
Localized oil stained soil at pumping unit.

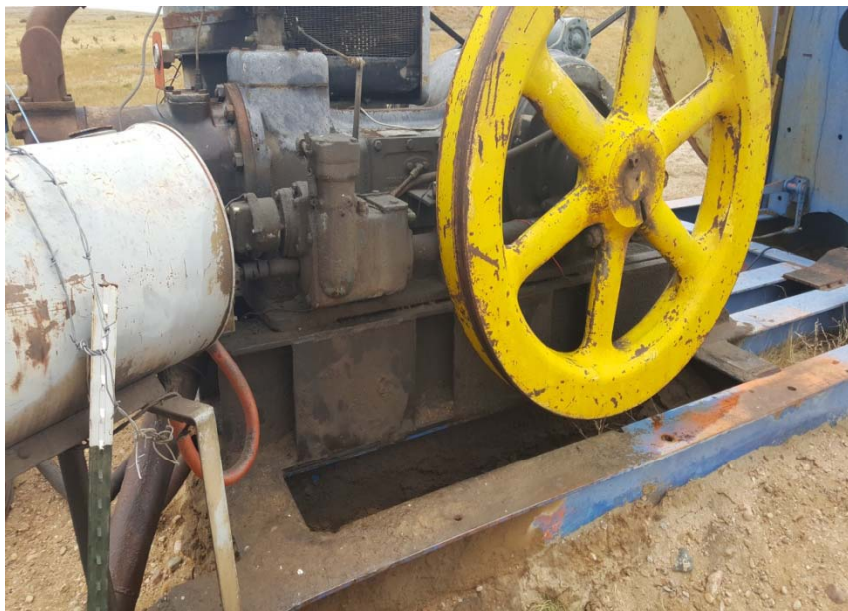
Photo #3
Accumulations of lube oil at base of pumping unit

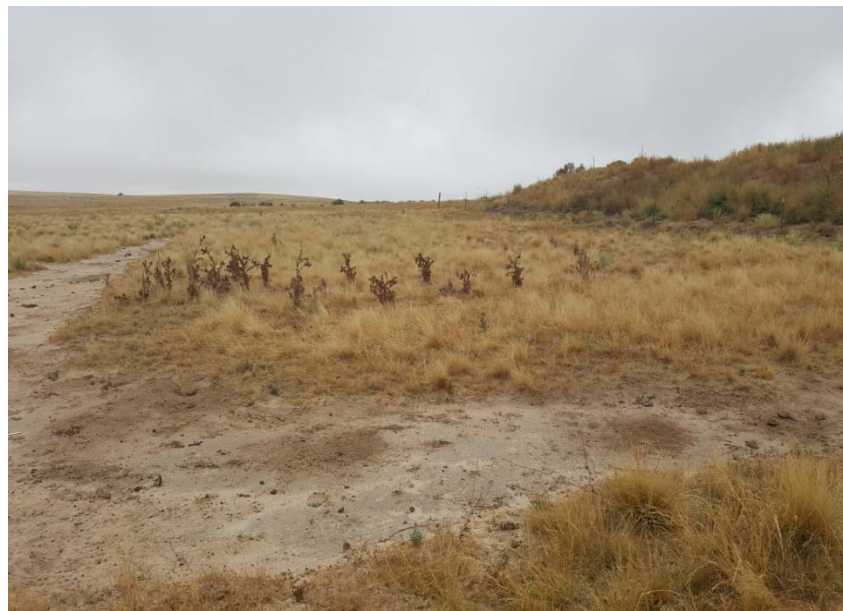
Photo #4
Looking north, areas of surface impact along former south and west berms of pit facility #109709.

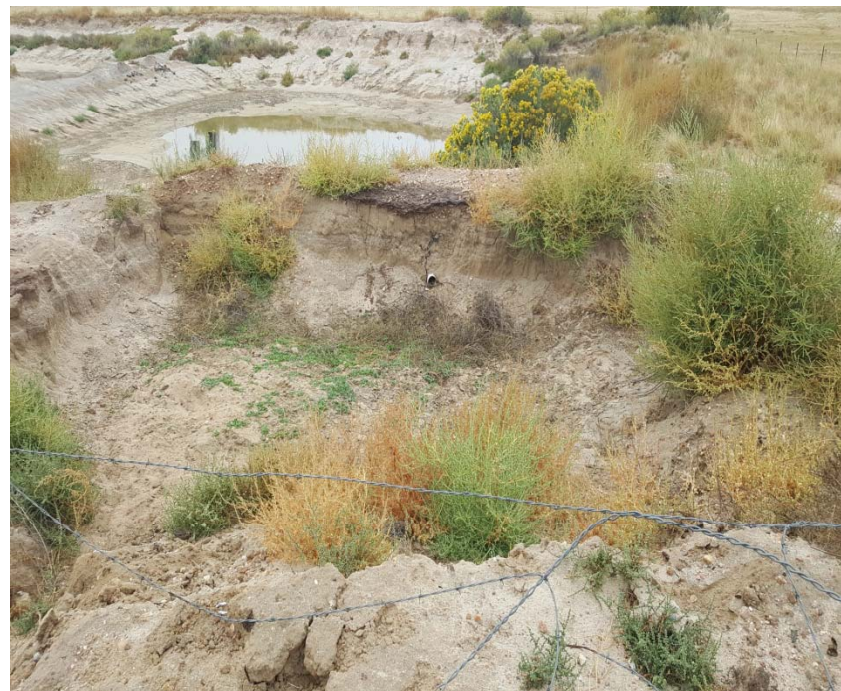
Photo #6
Former skim pit (Fac ID #109707) excavation looking west. Oily waste along top of west wall.

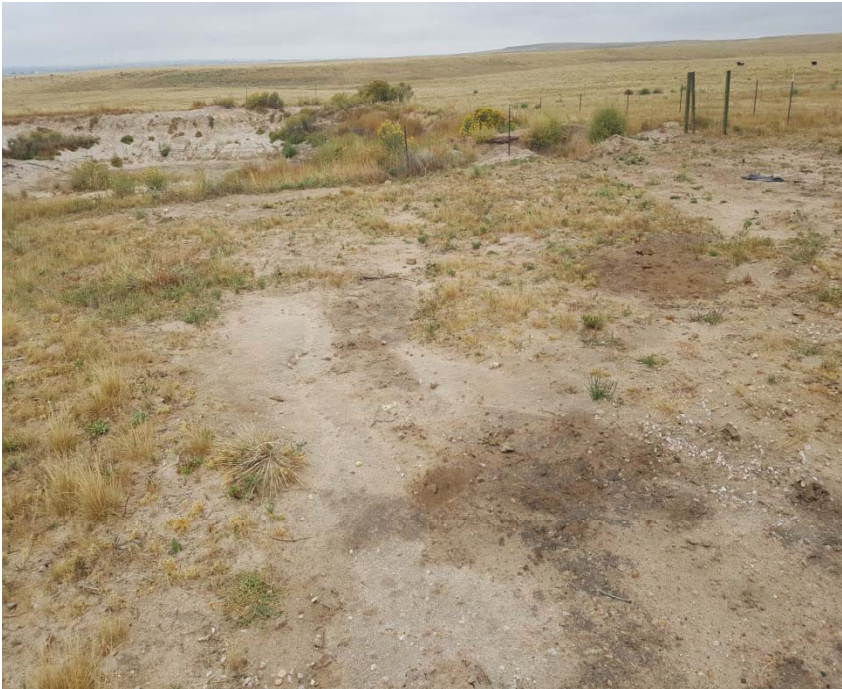
Photo #7
Localized oily waste and buried plastic liner east of pit complex looking west.

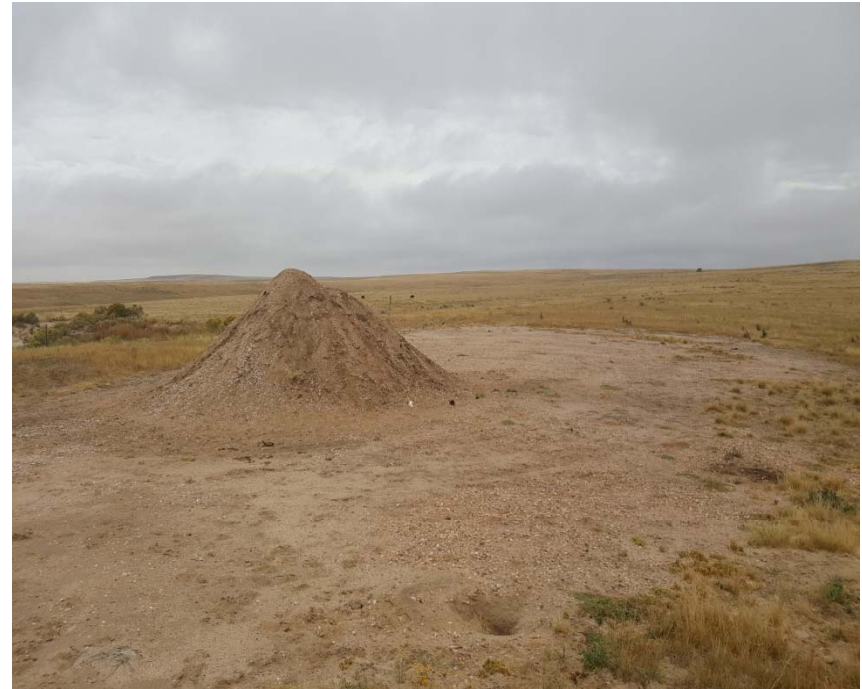
Photo #8
Stockpile of dirt mixed with gravel on former battery location. Some small localized areas of oil staining in disturbed areas.
