Inspection Photos  
Location Name: Mutual 01-17H  
Location ID: 324757

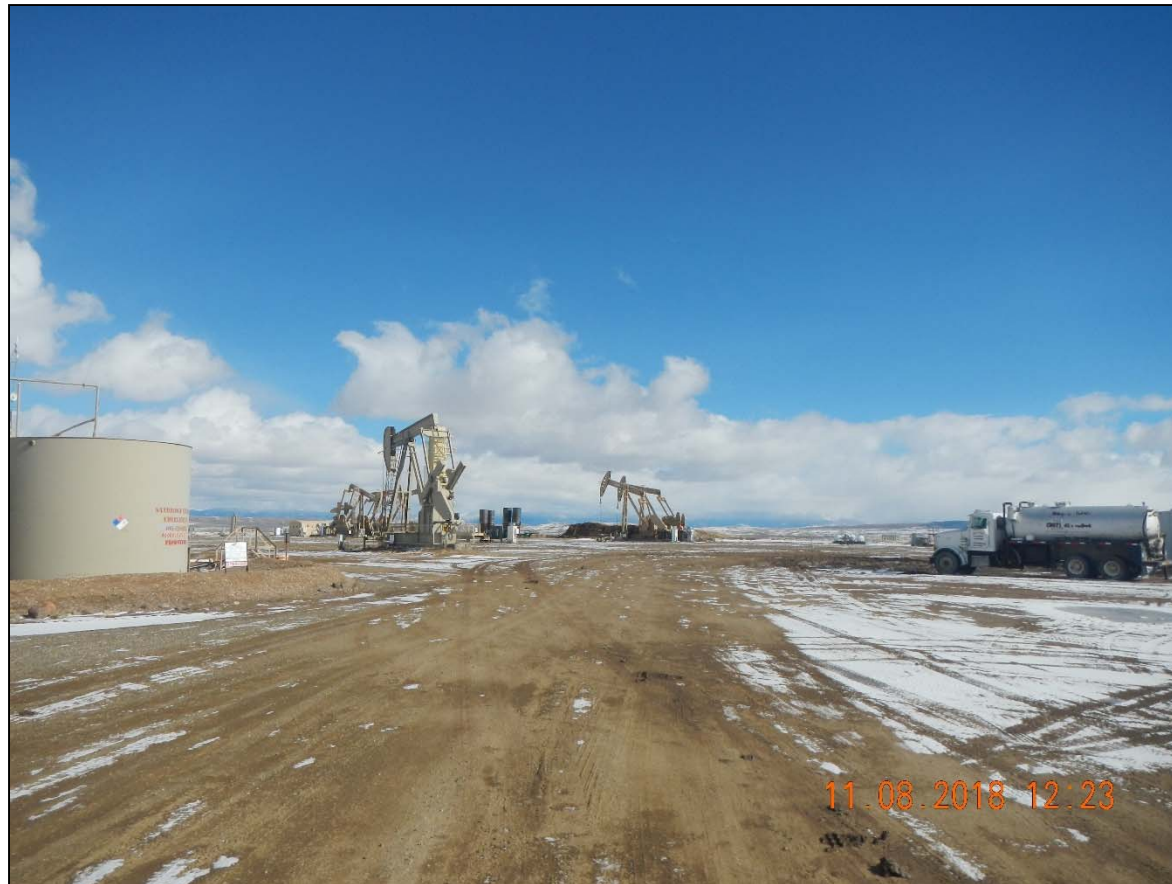
**Photo 1. Overview of location taken at entrance facing northeast.**

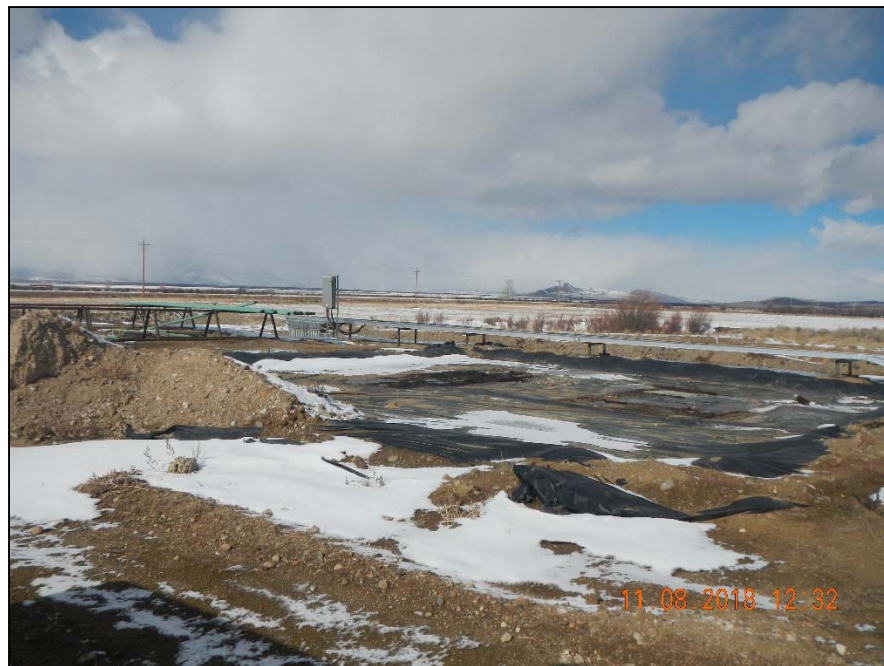
**Photo 2. Stained soil inside former equipment berm.  
Stored piping in background of photo.**

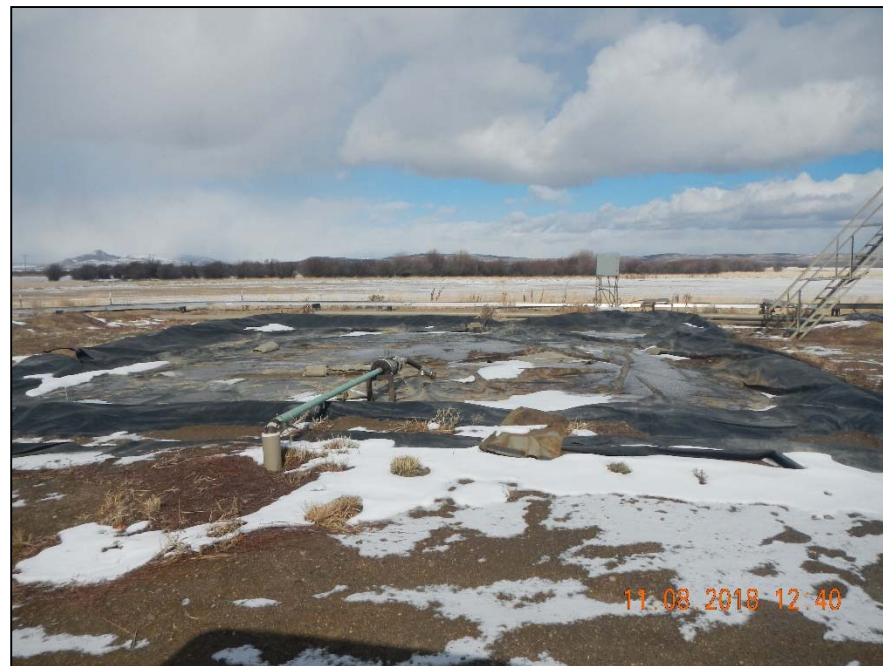
**Photo 3. Debris on location.**

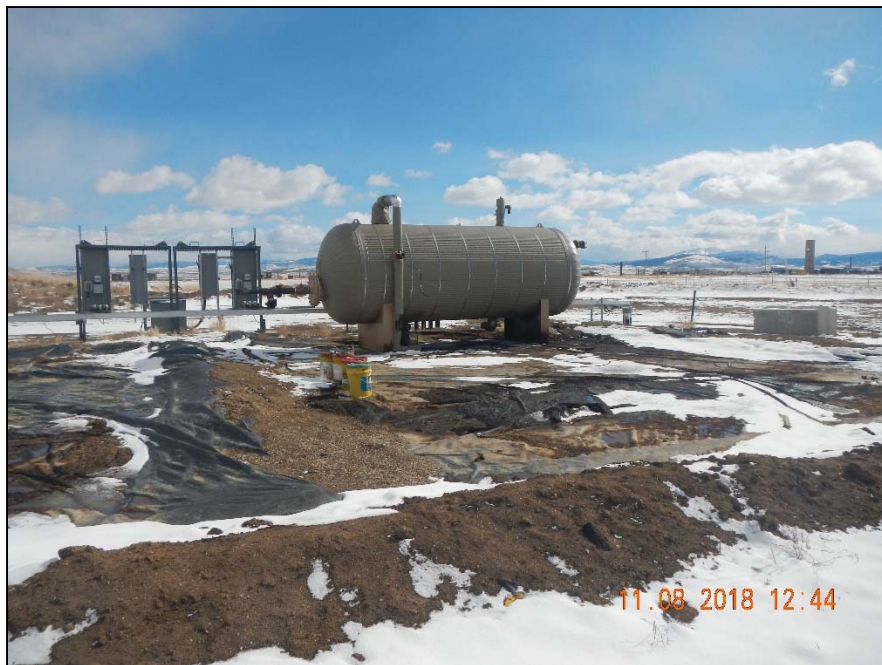
**Photo 4. Stained soil inside equipment berm.**

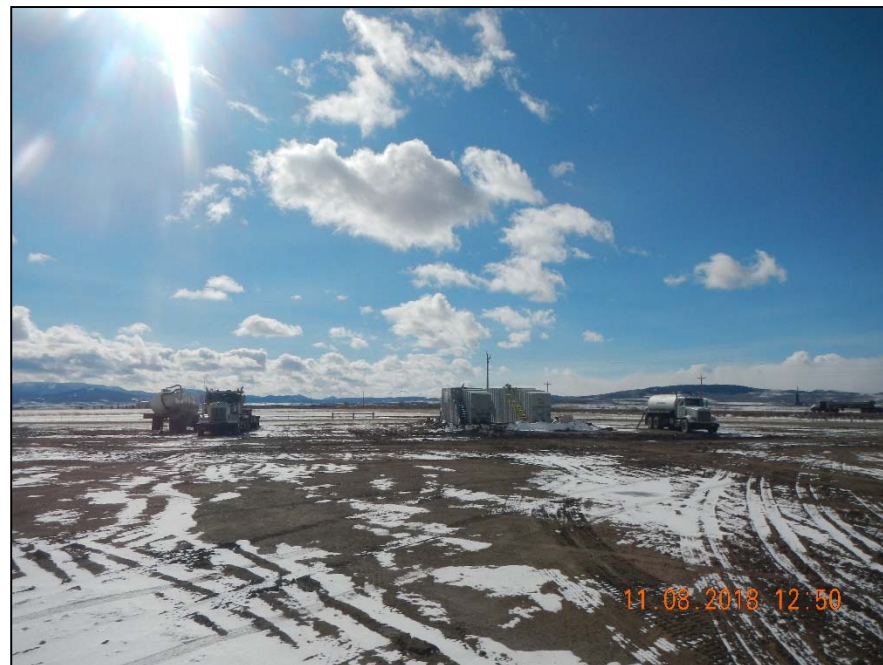
**Photo 5. Equipment stored on location.**

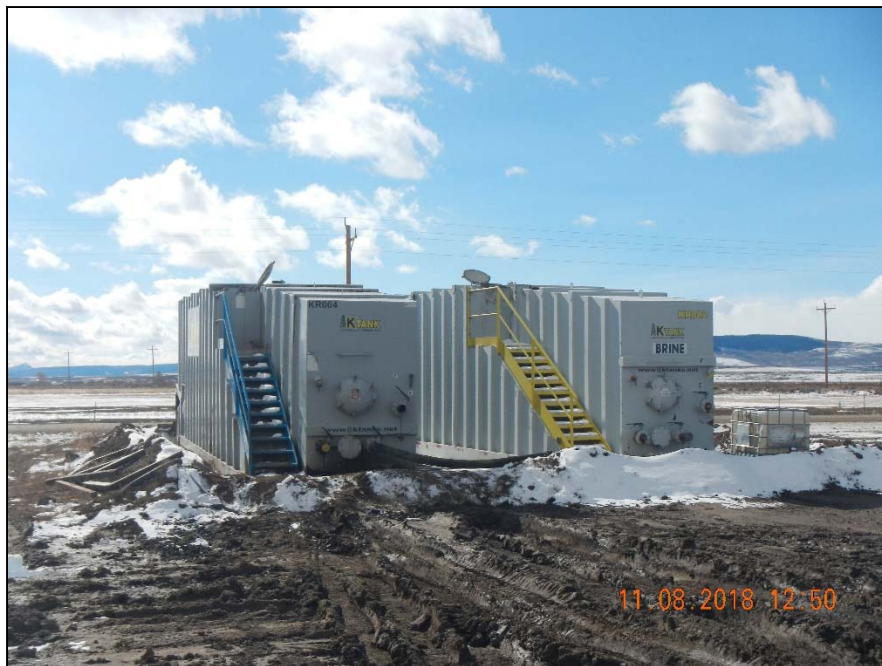
Photo 6. Tanks with open hatches and no labels.

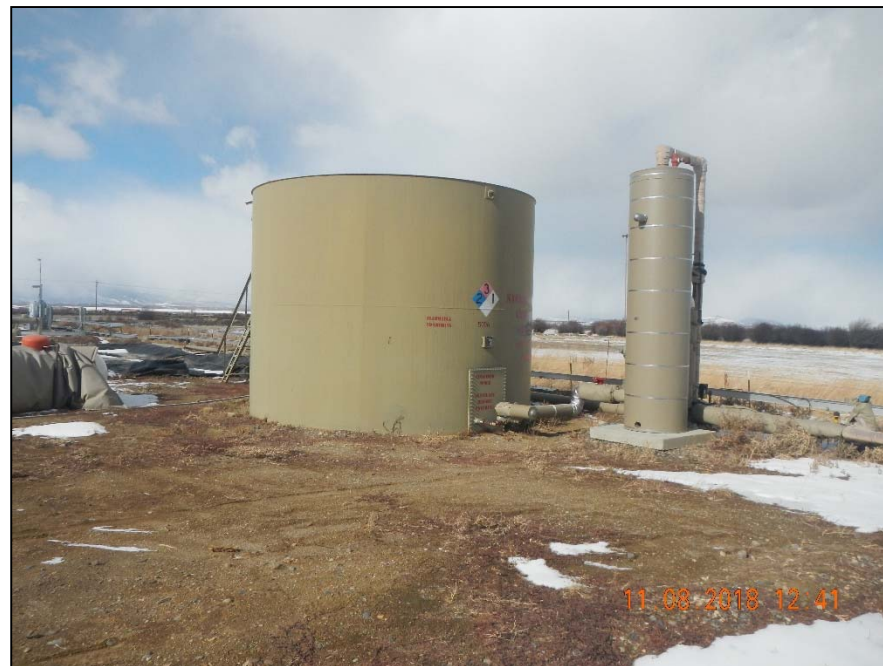
Photo 7. No berm.

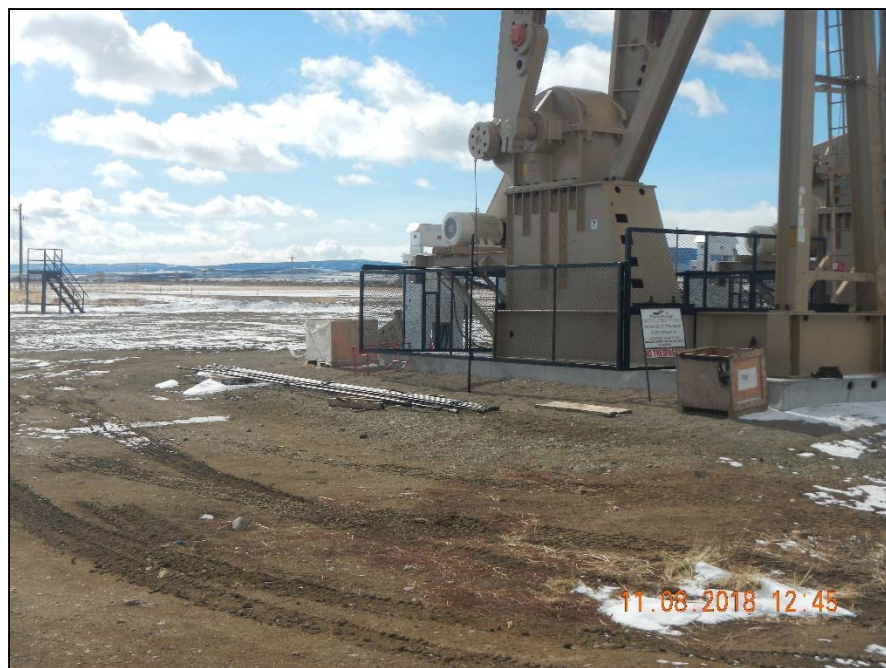
Photo 8. Example of trash and debris on location.

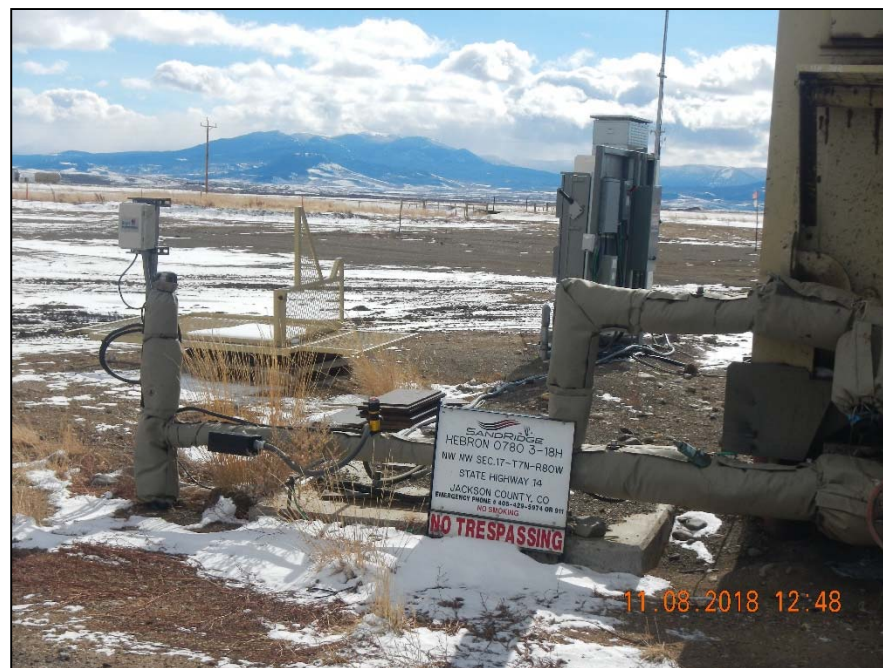
Photo 9. Example of trash and debris on location in left background of photo.

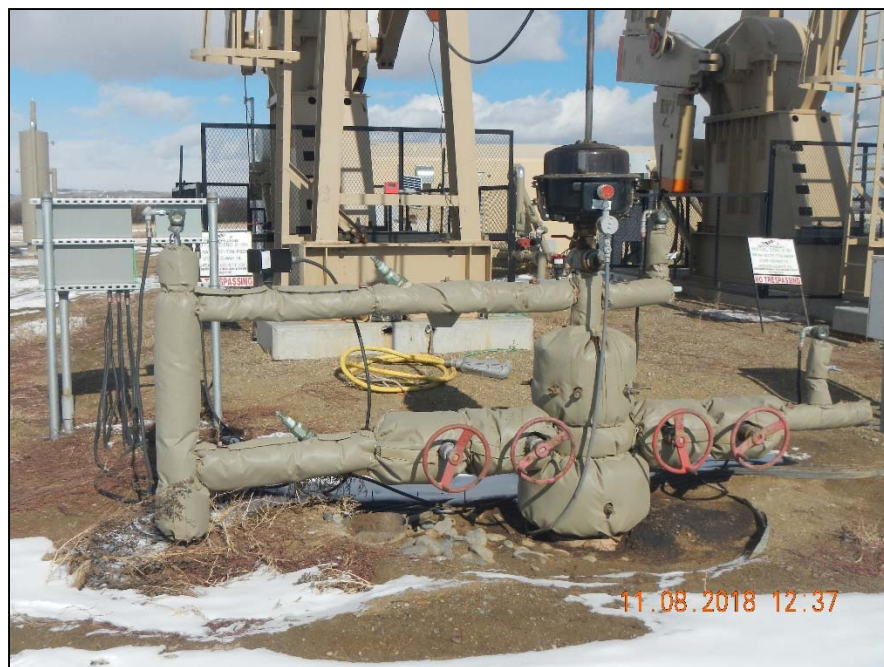
Photo 10. Stained soil and open rat hole at wellhead.

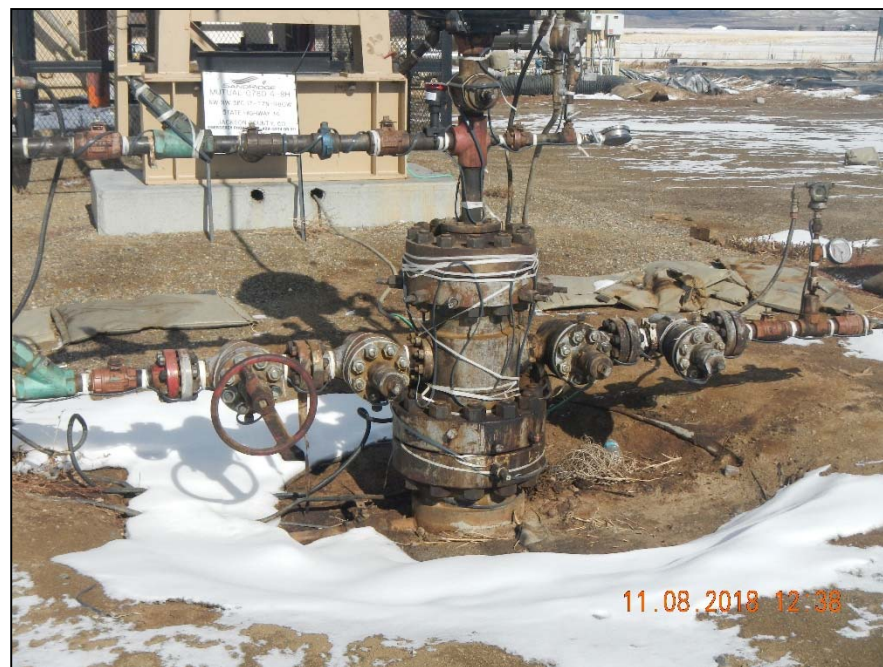
Photo 11. Stained soil and trash/debris.
