# Inspection Photos

11/8/2018

Operator: WESTERN OPERATING COMPANY -  
95620

Inspection Doc. Number: 682504107

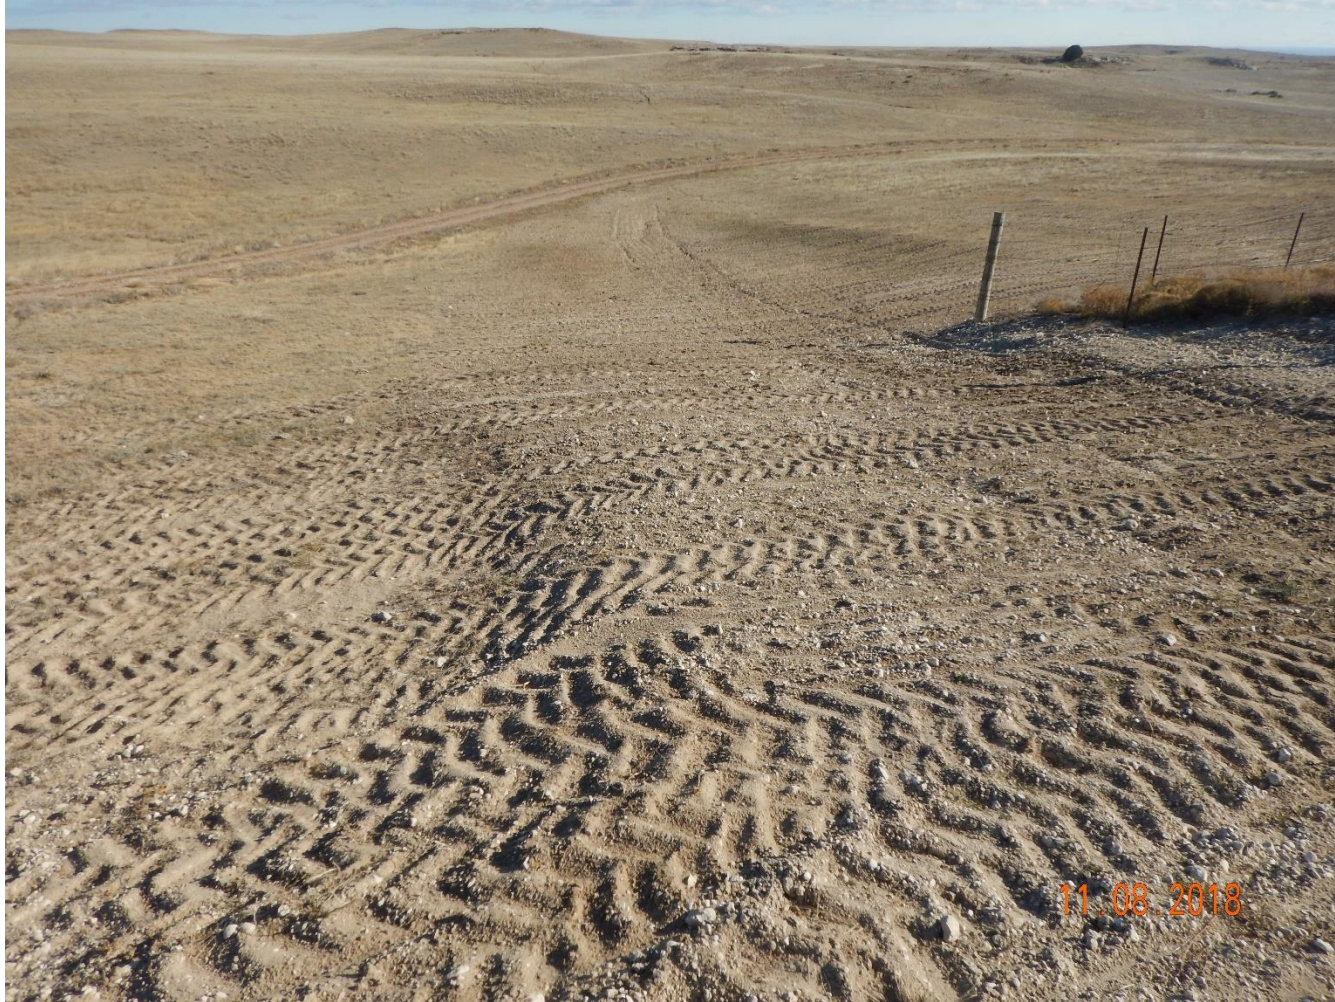
**Photo 1:** Photo taken from the east end of the pad, facing east. Photo shows additional reclamation activities appear to have been conducted on the spill areas to the south of the pit. Photo also shows that no sediment, erosion or stabilization controls have been installed.

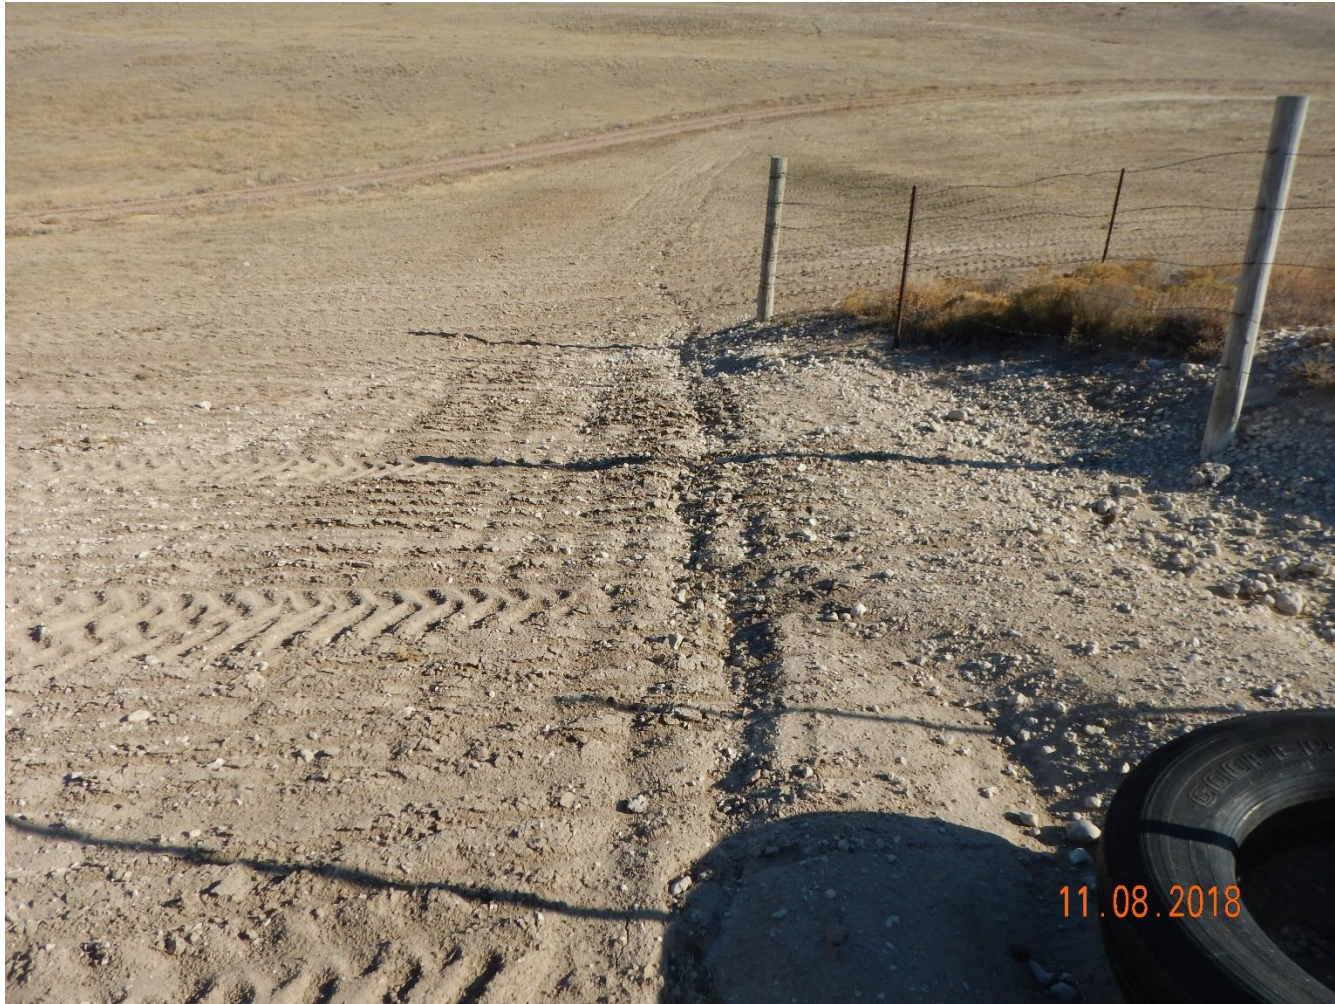
**Photo 2:** Photo taken from the east end of the pad, facing east. Though additional reclamation activities appear to have been conducted, no sediment, erosion or stabilization controls have been installed, allowing for stormwater erosion degradation to recur.

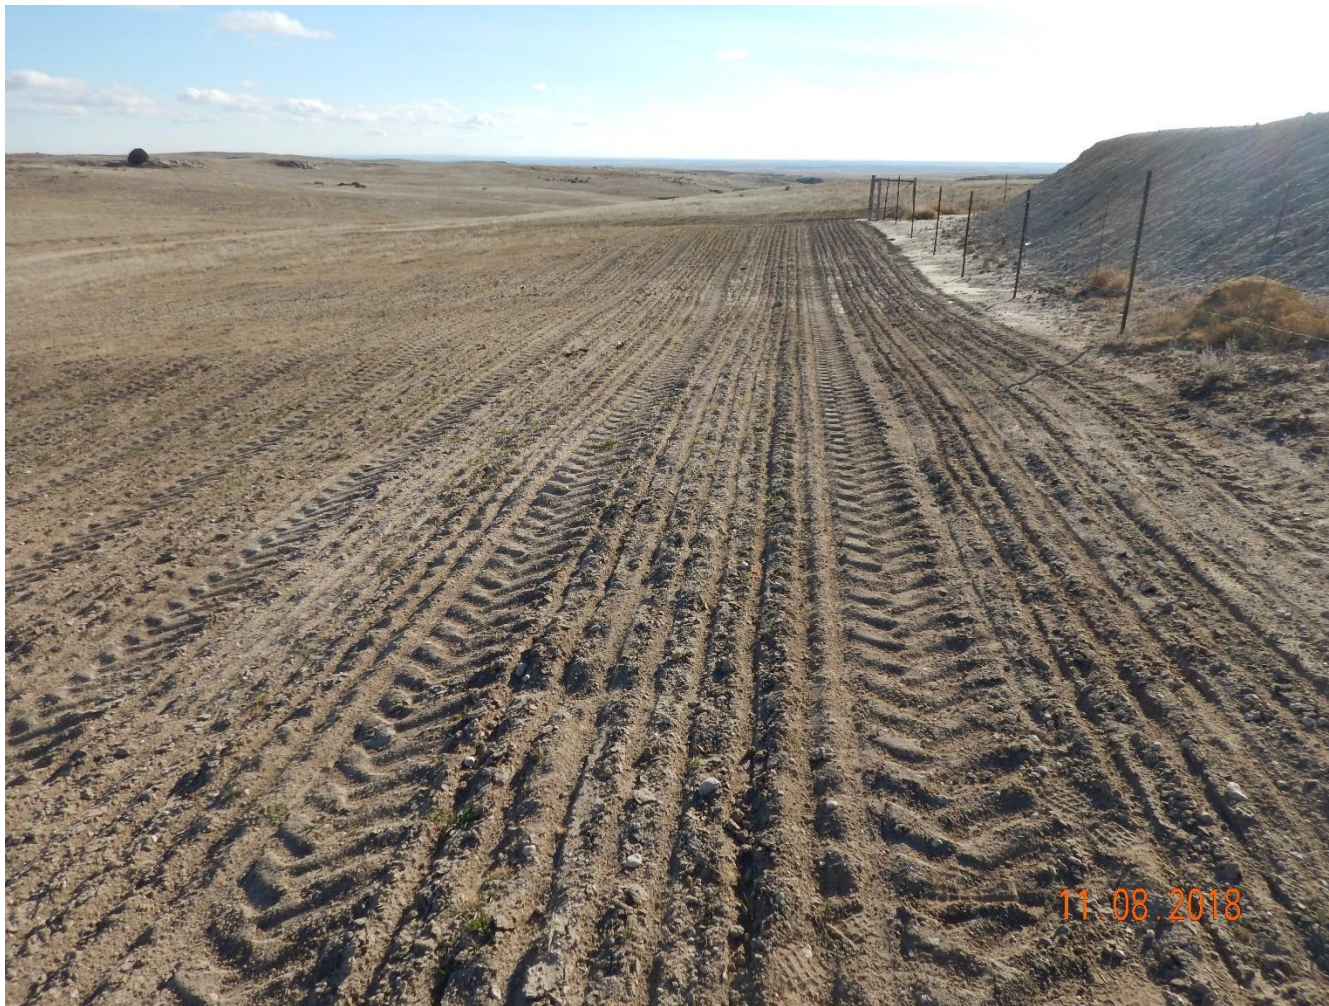
**Photo 3:** Photo taken from the east end of the pit, facing south. Photo shows additional reclamation activities appear to have been conducted on the spill areas to the south of the pit. Photo also shows that no sediment, erosion or stabilization controls have been installed.

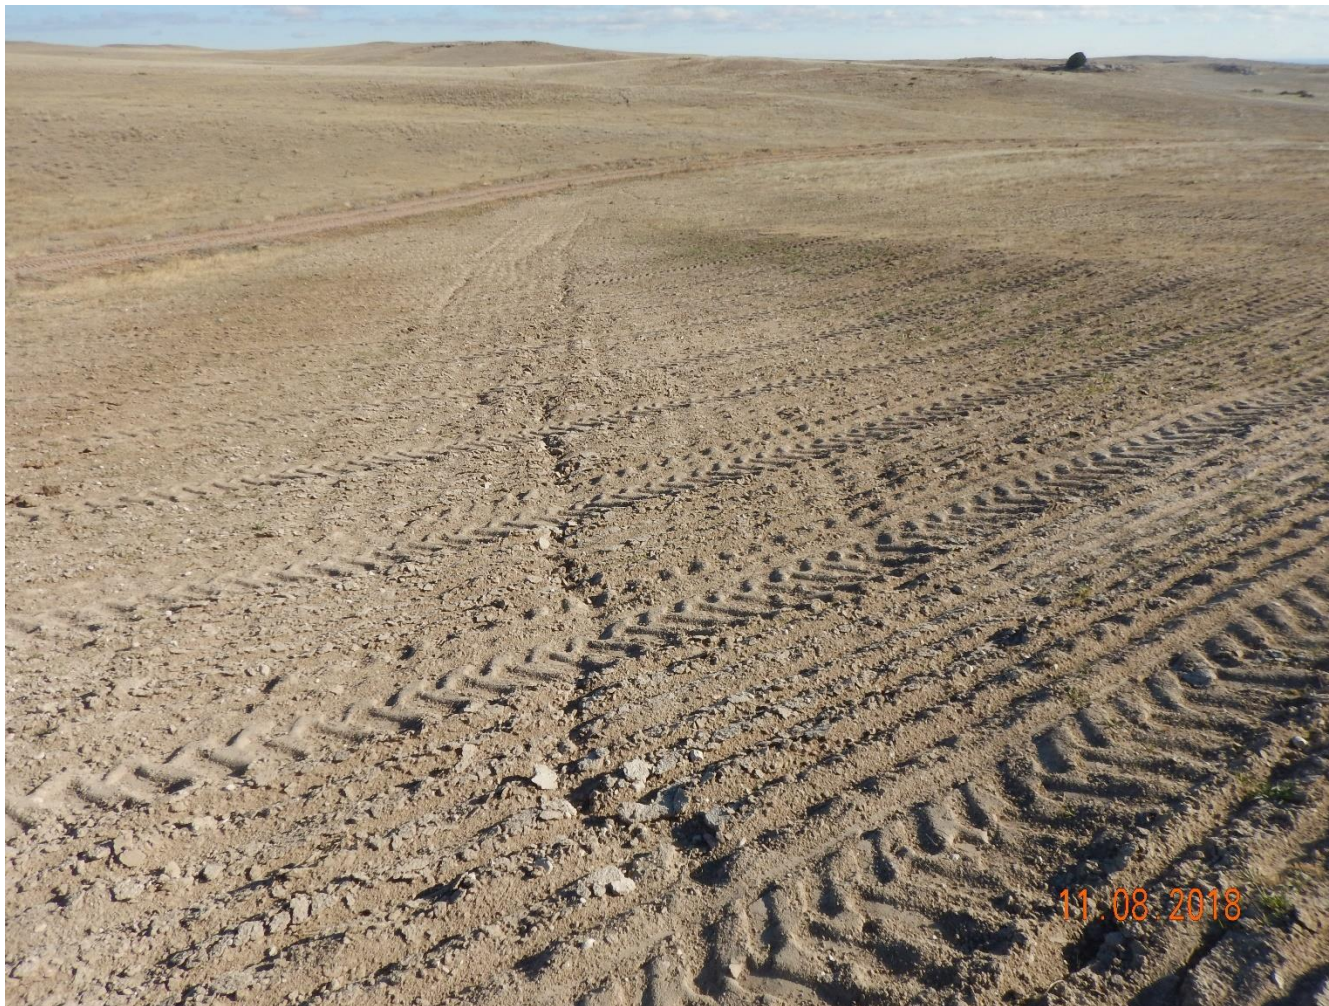
**Photo 4:** Photo taken from the east end of the pit, facing east. Though additional reclamation activities appear to have been conducted, no sediment, erosion or stabilization controls have been installed, allowing for stormwater erosion degradation to recur.

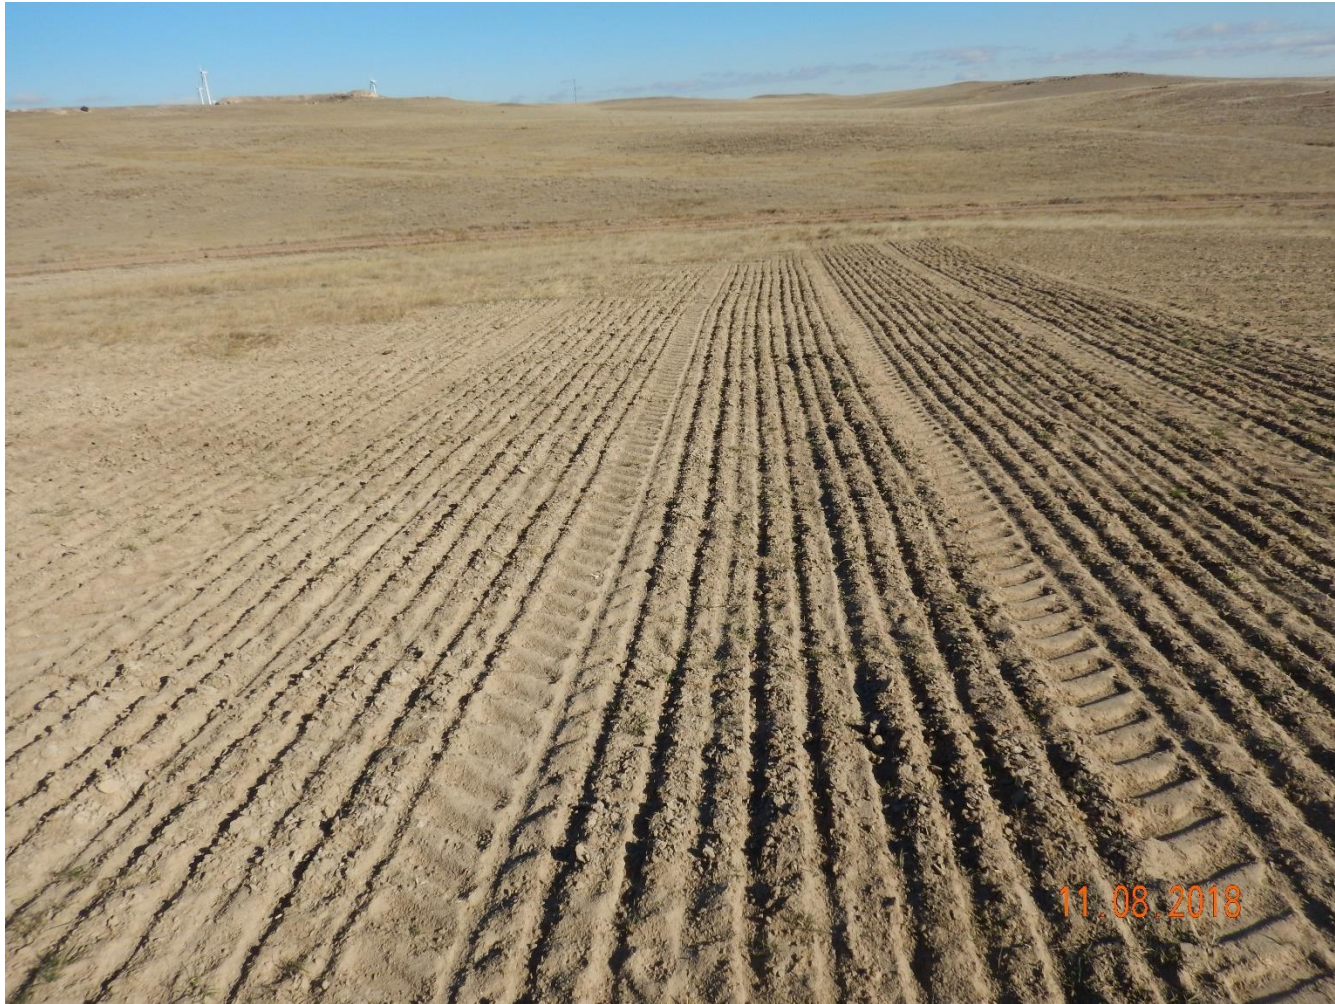
**Photo 5:** Photo taken from the southeast end of the pit, facing east. Photo shows additional reclamation activities appear to have been conducted on the spill areas to the south of the pit. However, areas appear to have been seeded up/down the slope rather than parallel to the contour. This may likely contribute to future erosion concerns as the furrows have created a straight path that will allow stormwater to concentrate and accelerate downslope. Photo also shows that no sediment, erosion or stabilization controls have been installed.

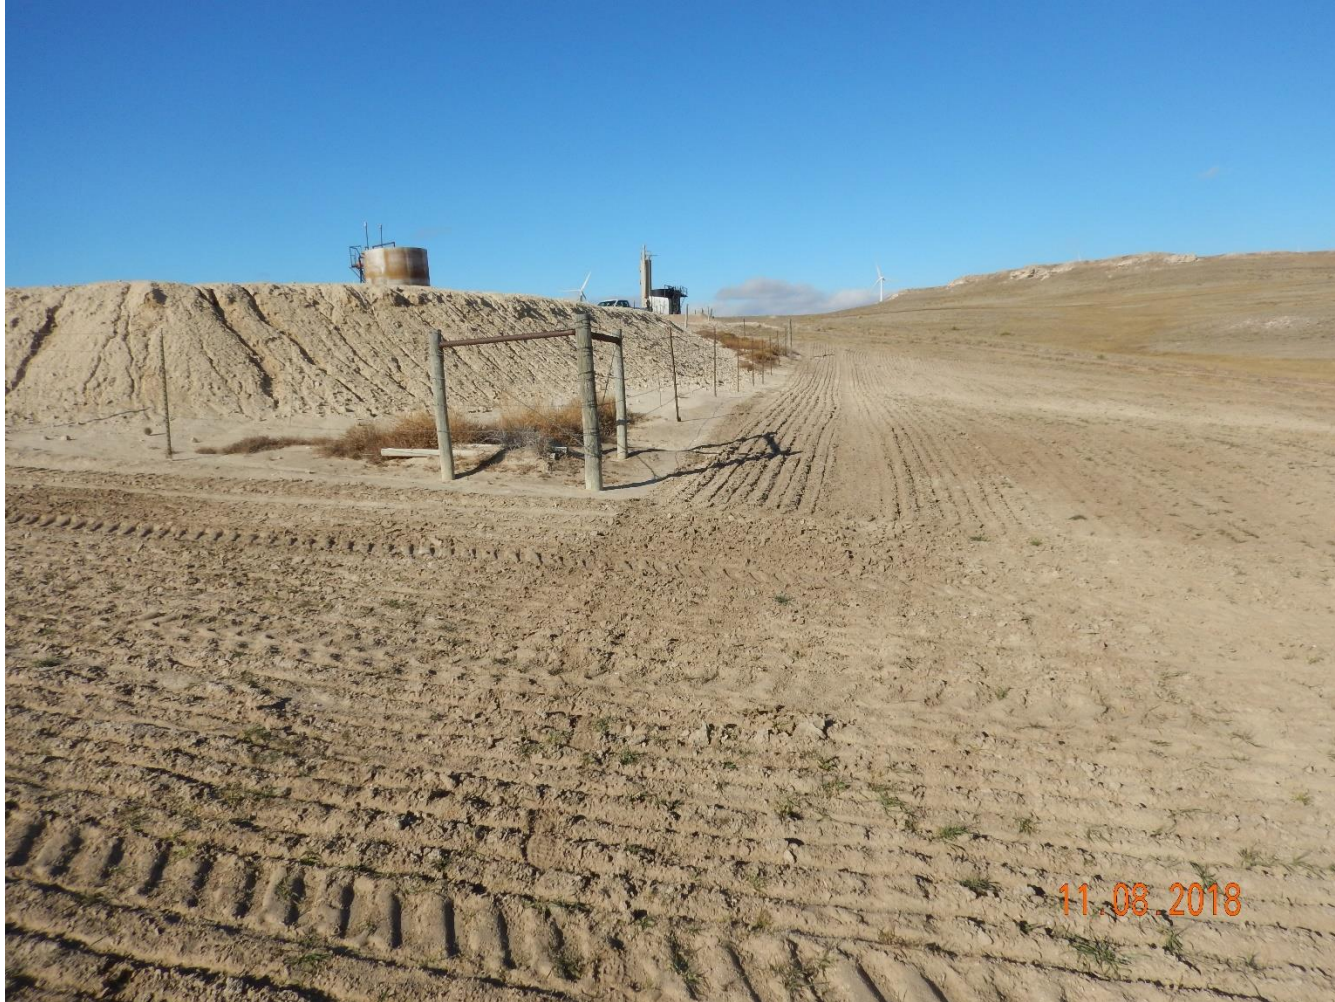
**Photo 6:** Photo taken from the southeast end of the pit, facing north. Photo shows additional reclamation activities appear to have been conducted on the spill areas to the south of the pit. Photo also shows that no sediment, erosion or stabilization controls have been installed.

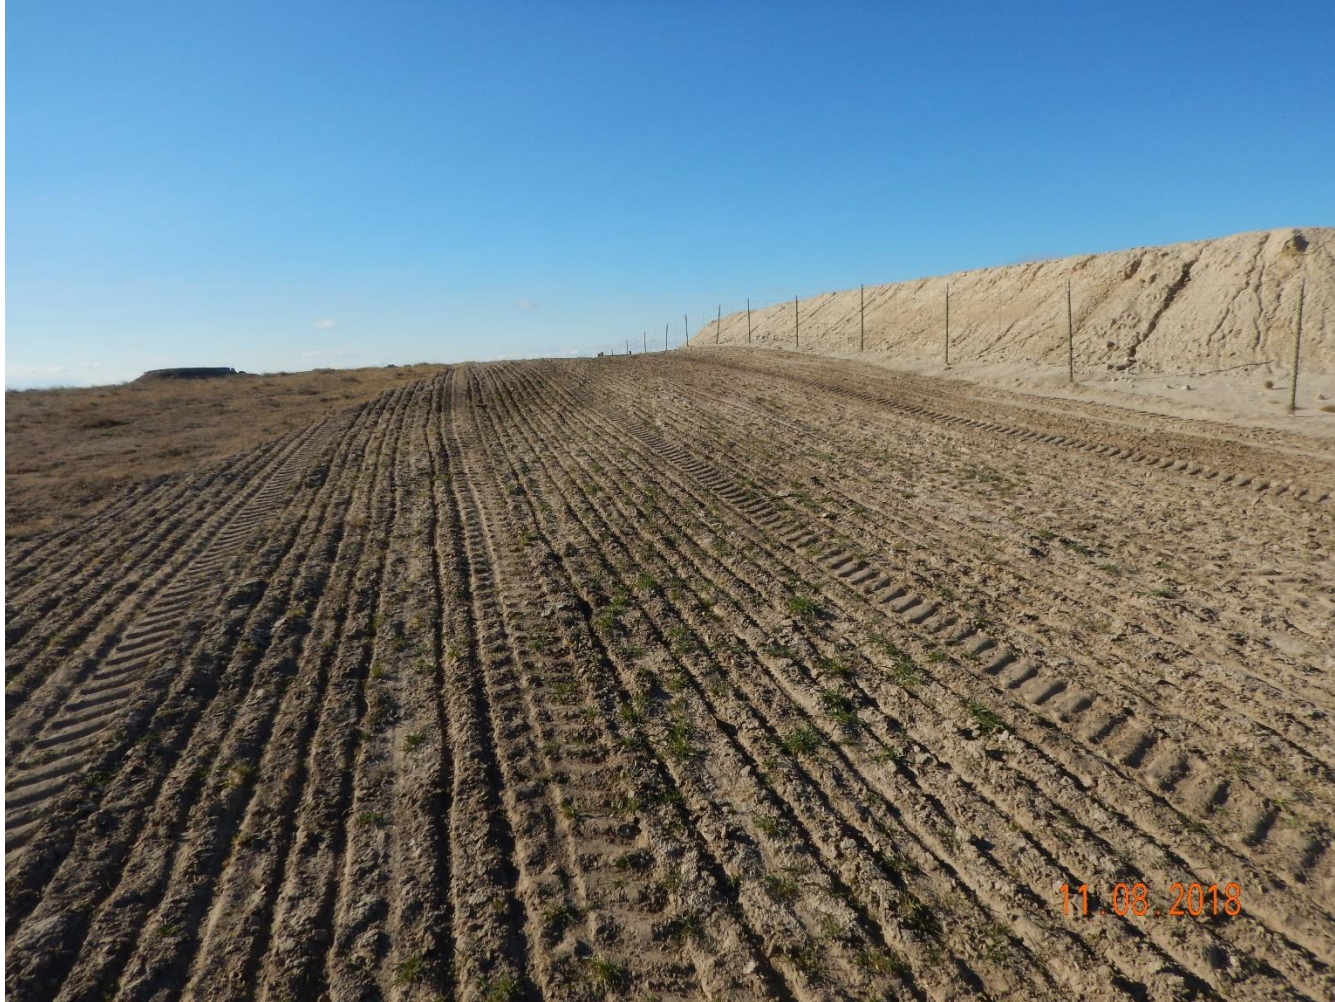
**Photo 7:** Photo taken from the southeast end of the pit, facing west. See comments under photo 5.

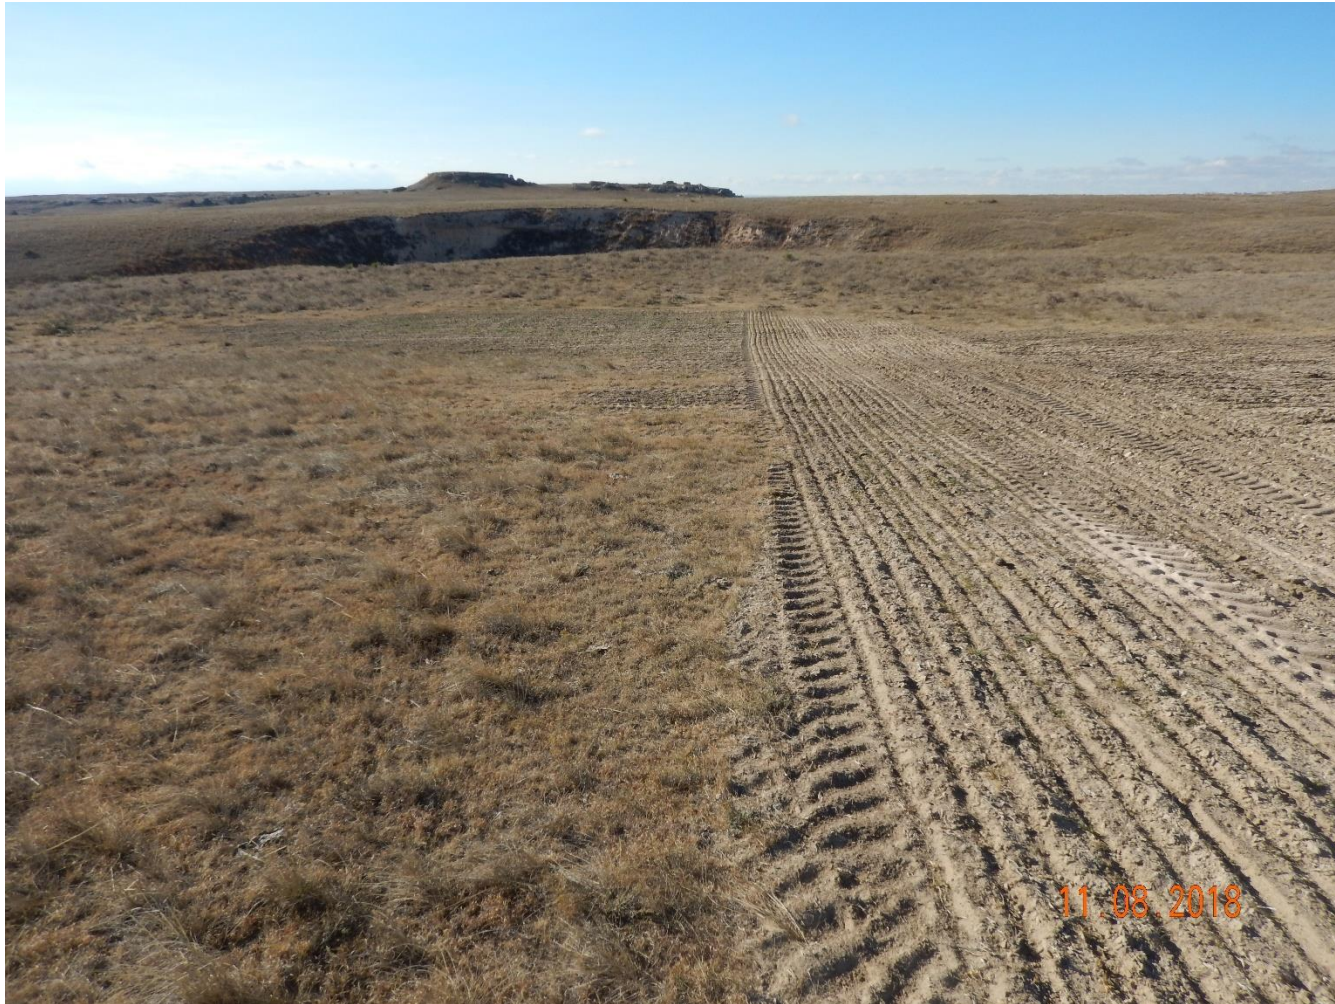
**Photo 8:** Photo taken from the southwest end of the pit, facing west. See comments under photo 5.

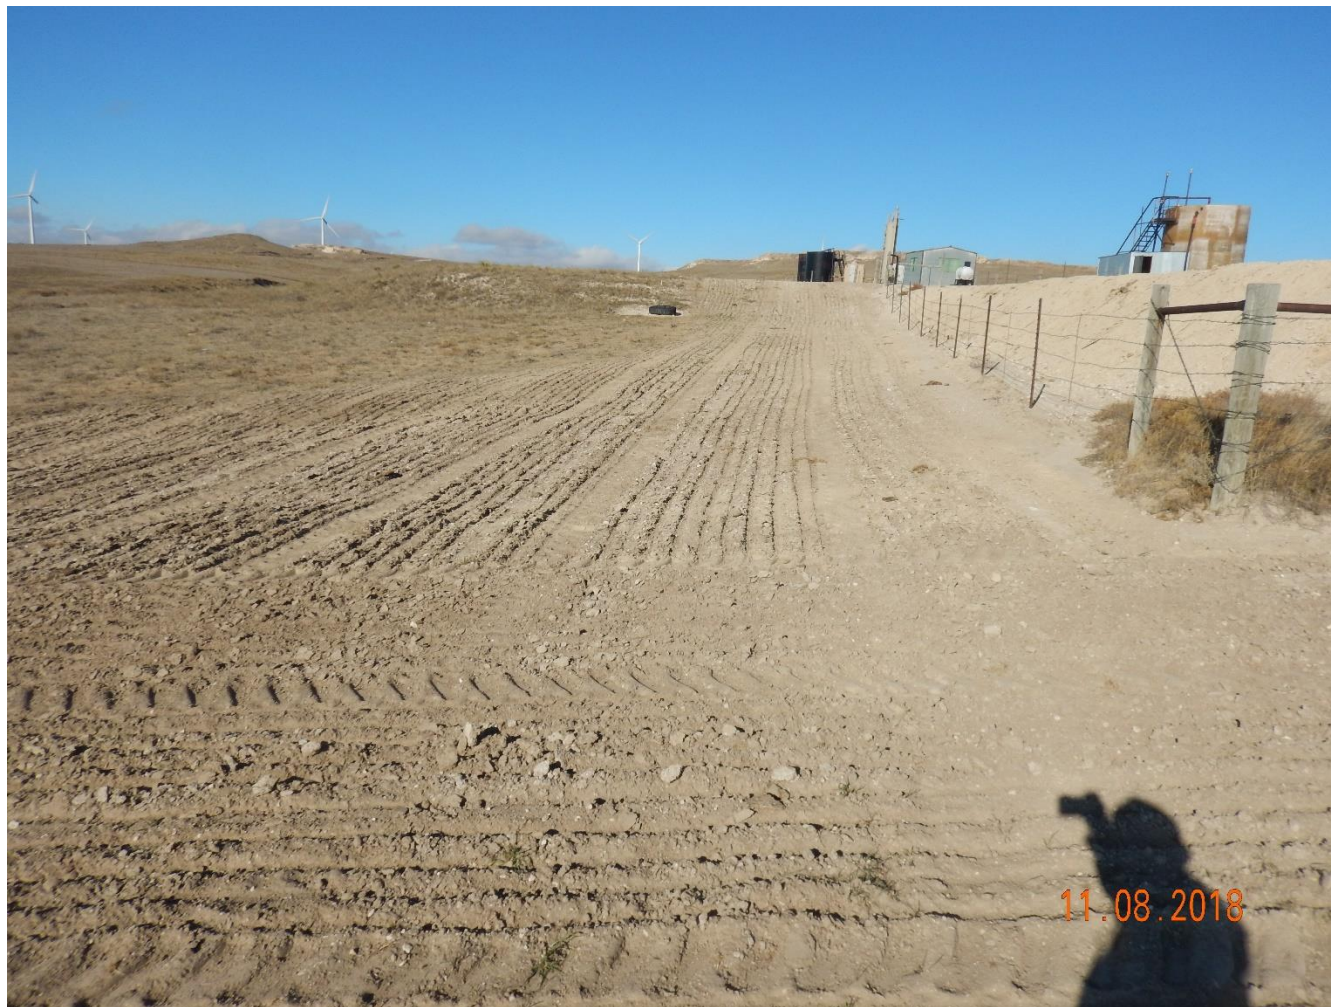
**Photo 9:** Photo taken from the southwest end of the pit, facing north. Photo shows additional reclamation activities appear to have been conducted on the spill areas to the south of the pit. Photo also shows that no sediment, erosion or stabilization controls have been installed.

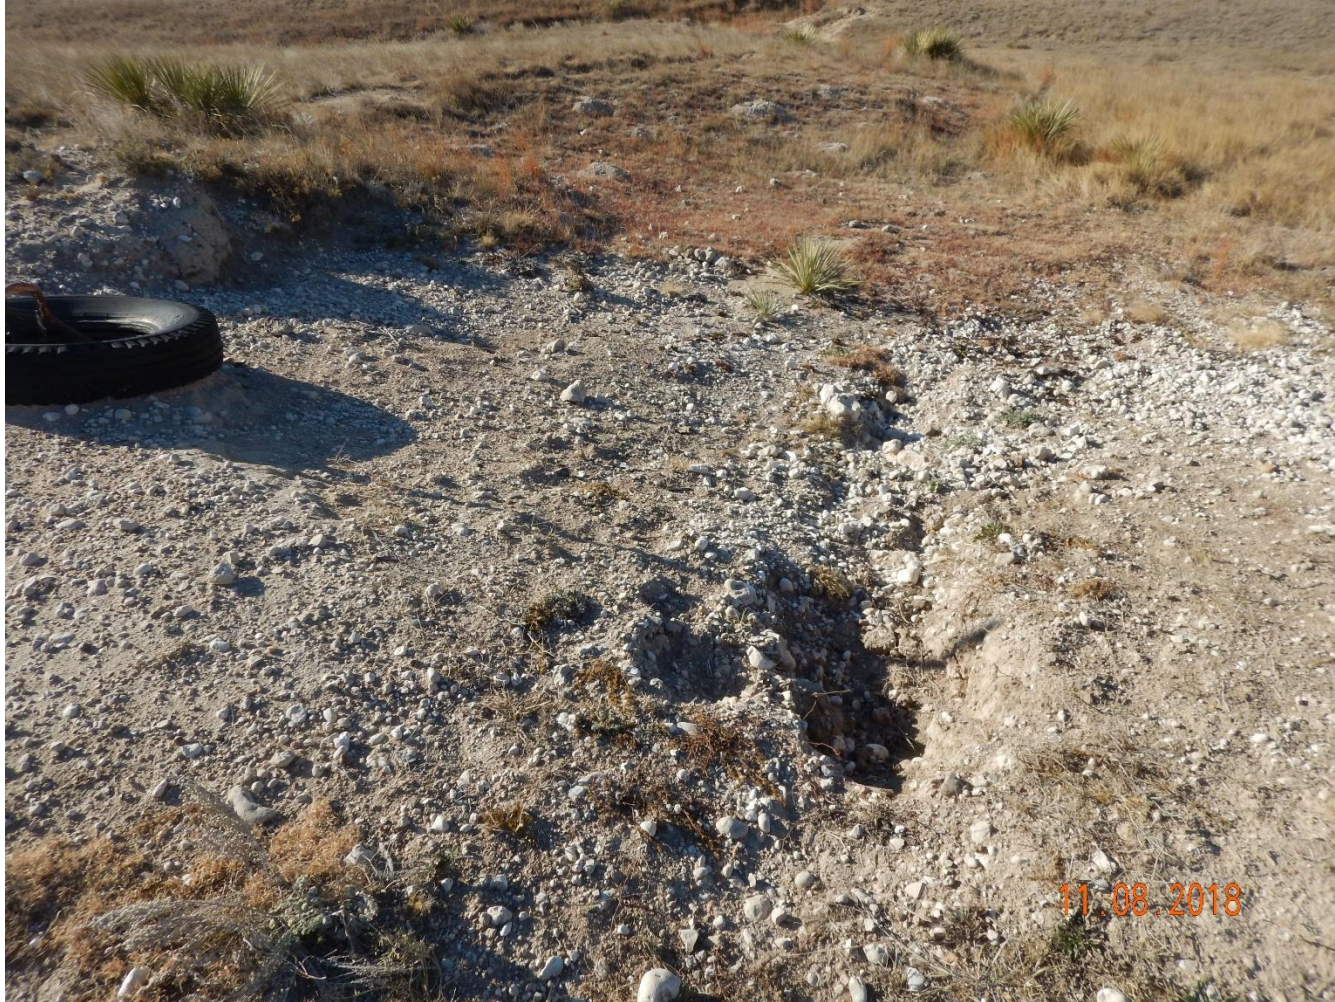
**Photo 10:** Photo taken from the west end of the location, facing west. Photo shows gully erosion due to stormwater runoff from the pad. Photo shows erosion has not been repaired and no BMPs have been installed to mitigate degradation.

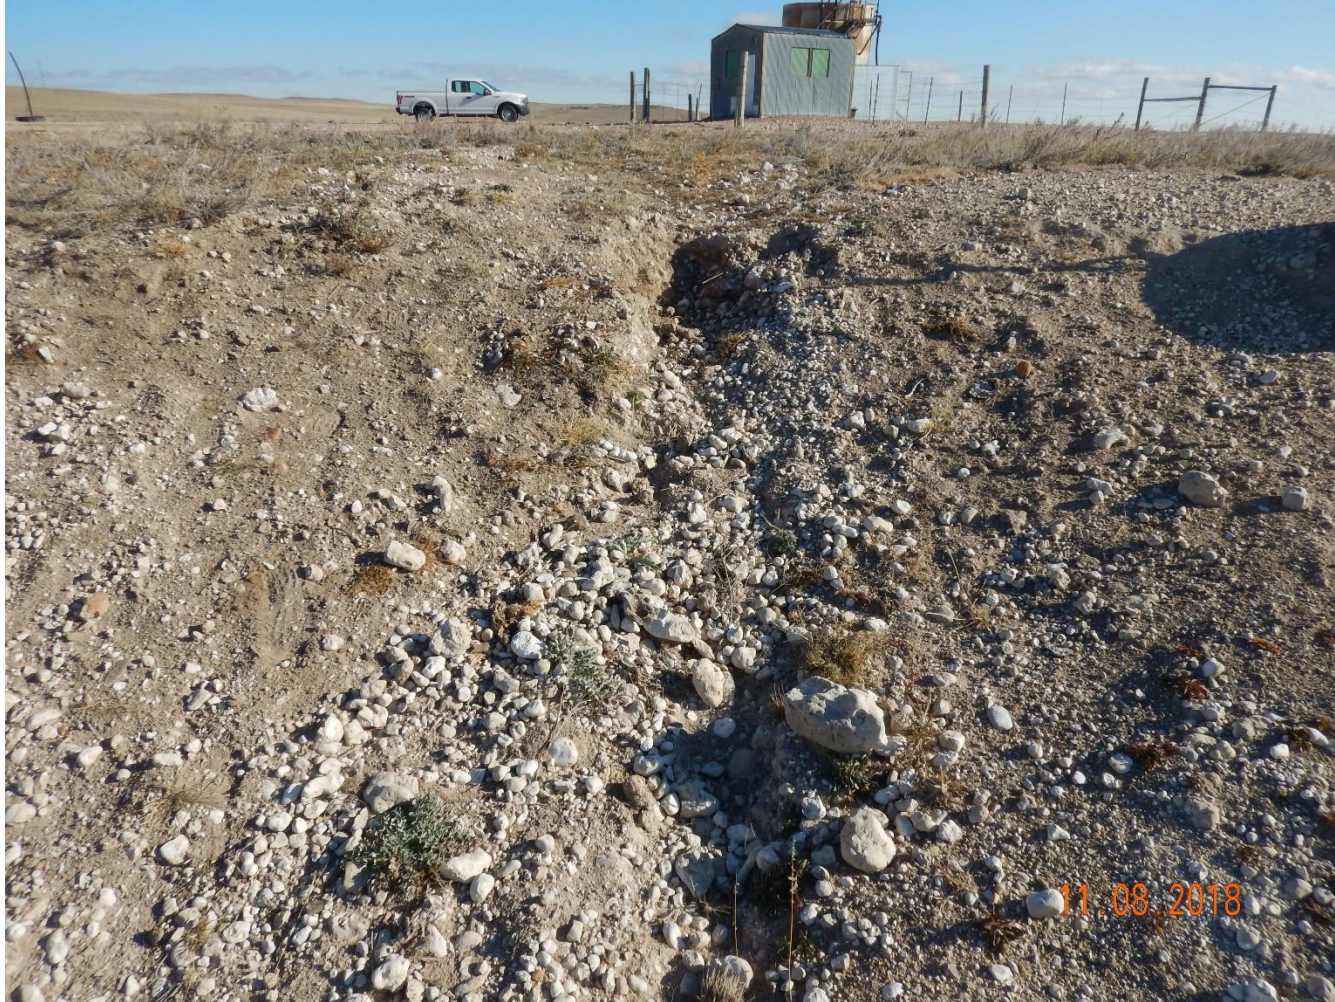
**Photo 11:** Photo taken from the west end of the location, facing east. Photo shows gully erosion due to stormwater runoff from the pad. Photo shows erosion has not been repaired and no BMPs have been installed to mitigate degradation.

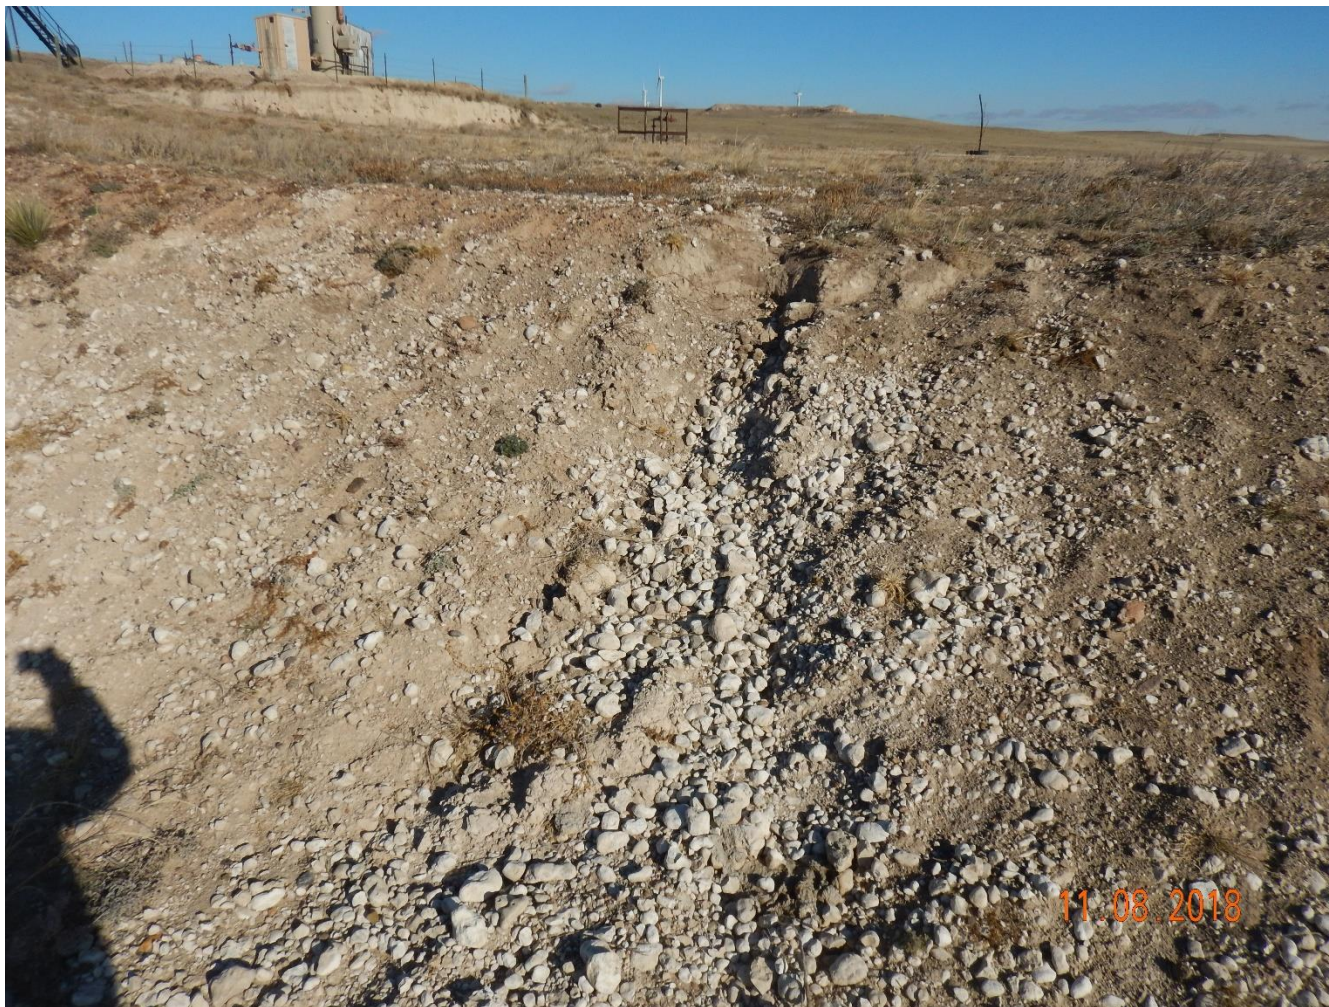
**Photo 12:** Photo taken from the west end of the location, facing east. Photo shows gully erosion due to stormwater runoff from the pad. Photo shows erosion has not been repaired and no BMPs have been installed to mitigate degradation.
