# Construction and Stormwater Inspection

Operator: PDC ENERGY INC - #69175

Location ID: 453057

Inspection Photos  
Location Name: Challenger /4N64W08  
1-9  
Location ID: 453057

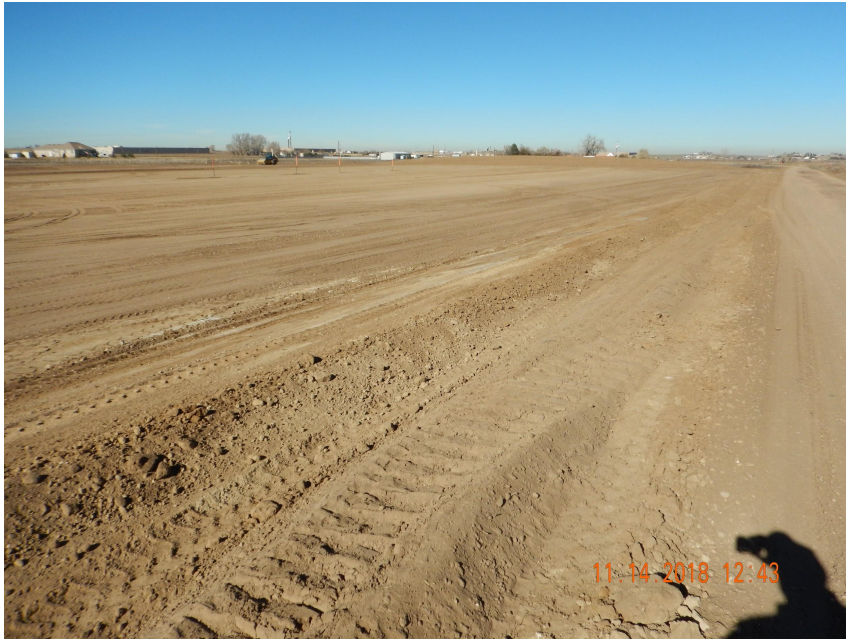
**Photo 1.** Photo taken from the southeastern perimeter of the pad, facing Northeast. Photo illustrates a ditch and berm BMP that has been installed around the entire perimeter of the location. Berm has been left unconsolidated. An unconsolidated berm BMP is not a proper functioning BMP, as the unconsolidated material becomes a source of potential pollution itself. Operator shall ensure this BMP is properly stabilized as it could be susceptible to wind and water erosion.

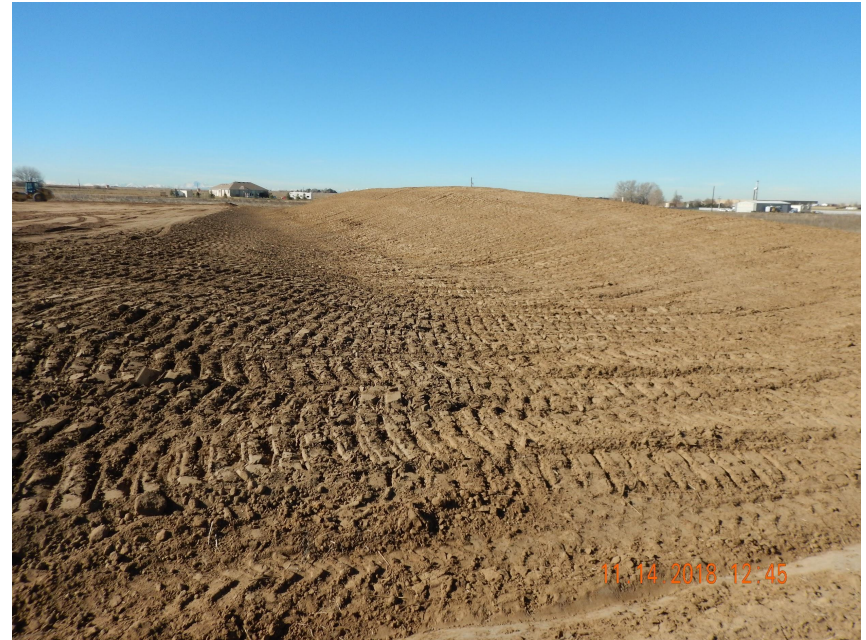
**Photo 2.** Photo taken from the northeastern perimeter of the locatoin, facing West. Photo illustrates the topsoil stockpile which has been temporarily stabilized with equipment tracking.

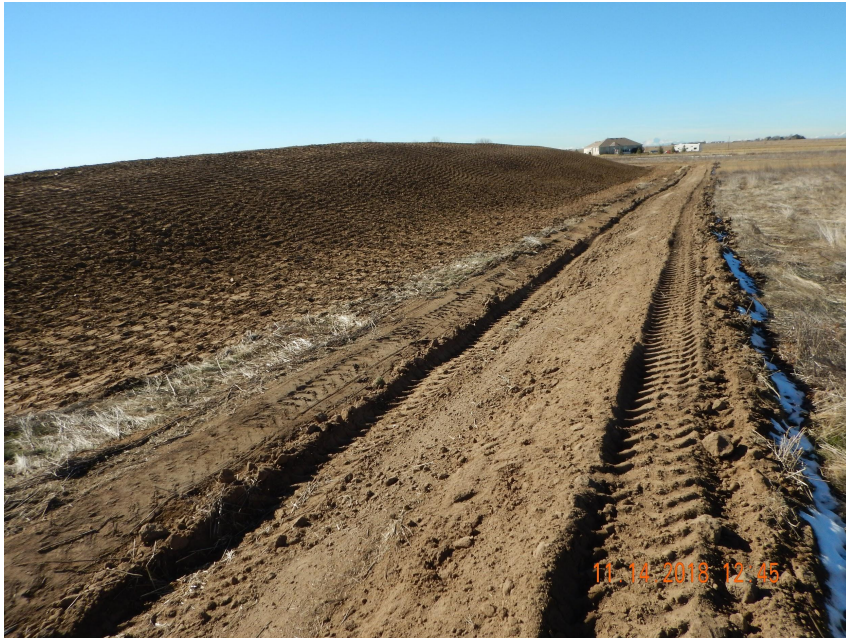
**Photo 3.** Photo taken from the northeastern perimeter of the location, facing West. See comments under Photo 1 5 2.

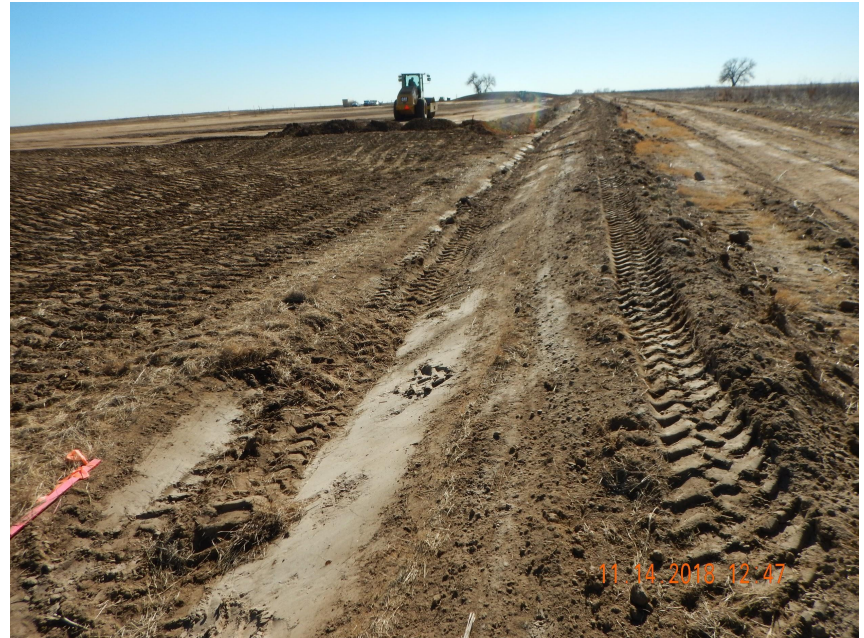
**Photo 4.** Photo taken from the northwestern perimeter of the location, facing South. See comments under Photo 1.

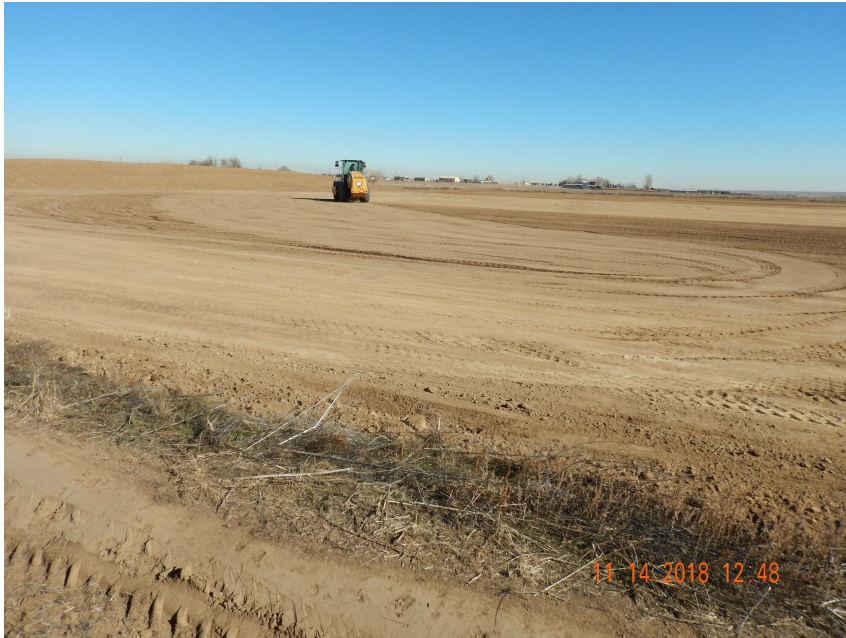
**Photo 5.** Photo taken from the western perimeter of the location, facing East. Operator in-process of stabilizing the pad with road base.

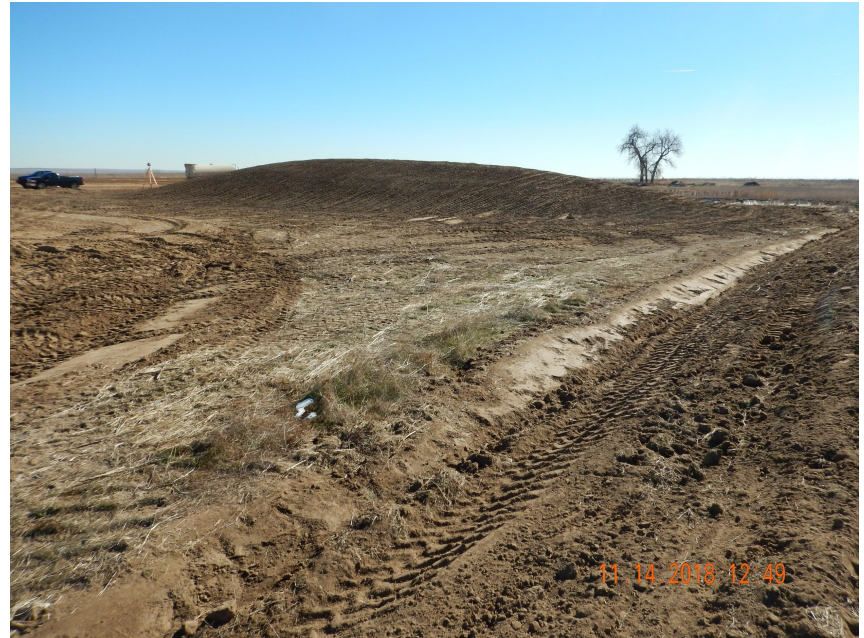
**Photo 6.** Photo taken from the southwestern perimeter of the pad, facing South. See comments under Photo 2.

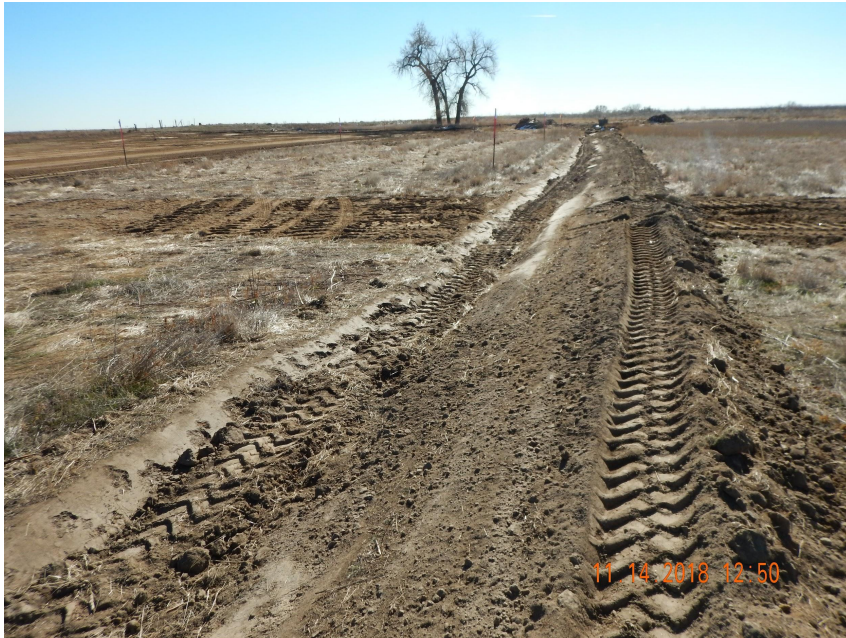
**Photo 7.** Photo taken from the southwestern perimeter of the production facility, facing South. See comments under Photo 1.

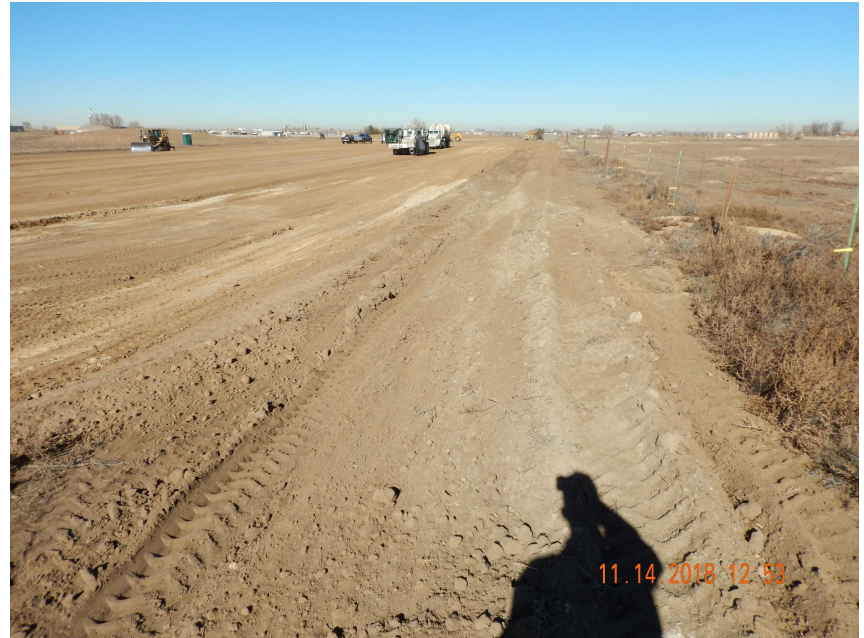
**Photo 8.** Photo taken from the southeastern perimeter of the production facility, facing North. See comments under Photo 1.
