Inspection Photos

11/26/2018

Operator: H & M PETROLEUM CORPORATION #
10032

Location ID: 458288

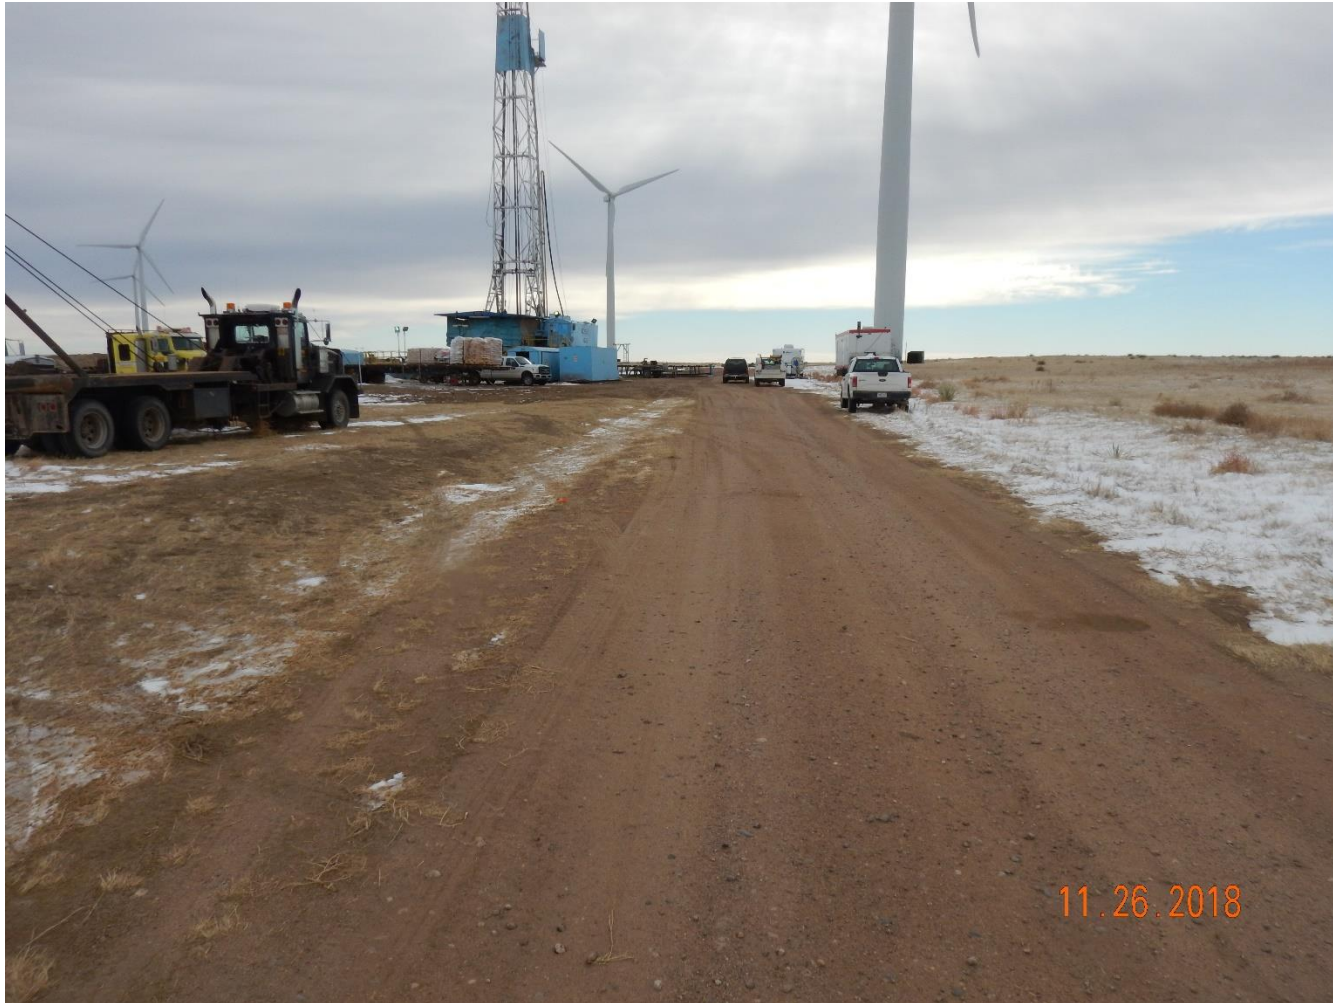
Photo 1: Photo taken from the access road north of the location, facing south. Photos 1-3 provide overview of the location from south, southeast to east.

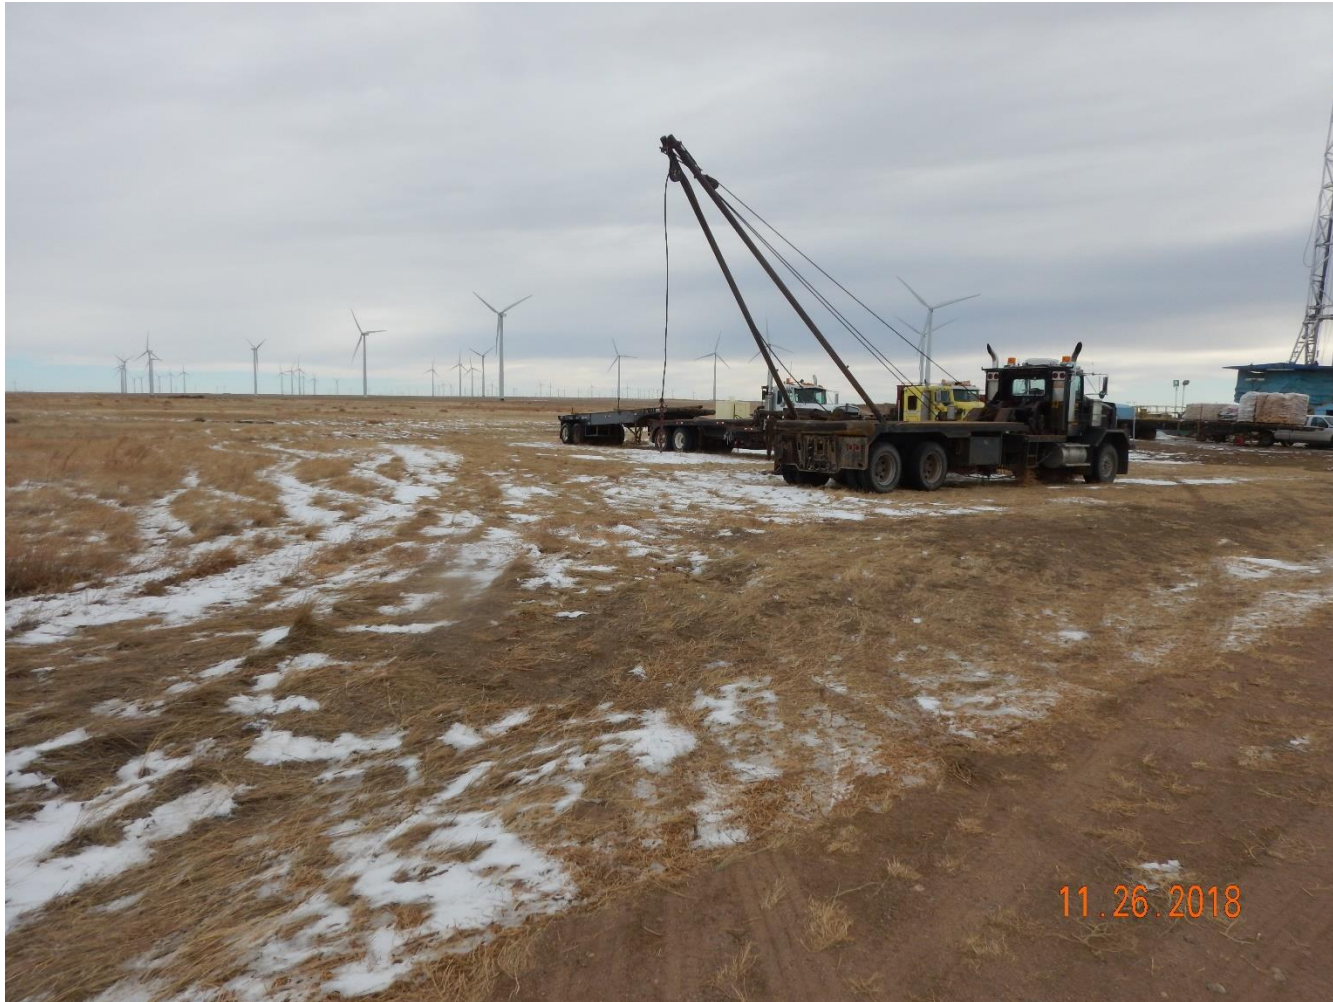
Photo 2: See comments under photo 1. Photo also shows operator appears to be storing vehicles/equipment on an area north of the pad that has not been constructed. 1002.e requires that “well sites/access roads shall be adequately sized, constructed and maintained so as to reasonably...minimize erosion, alteration of natural features, removal of surface materials and degradation due to contamination”. Location does not appear to have been constructed in such a manner to be appropriate in size to store all vehicles/equipment.

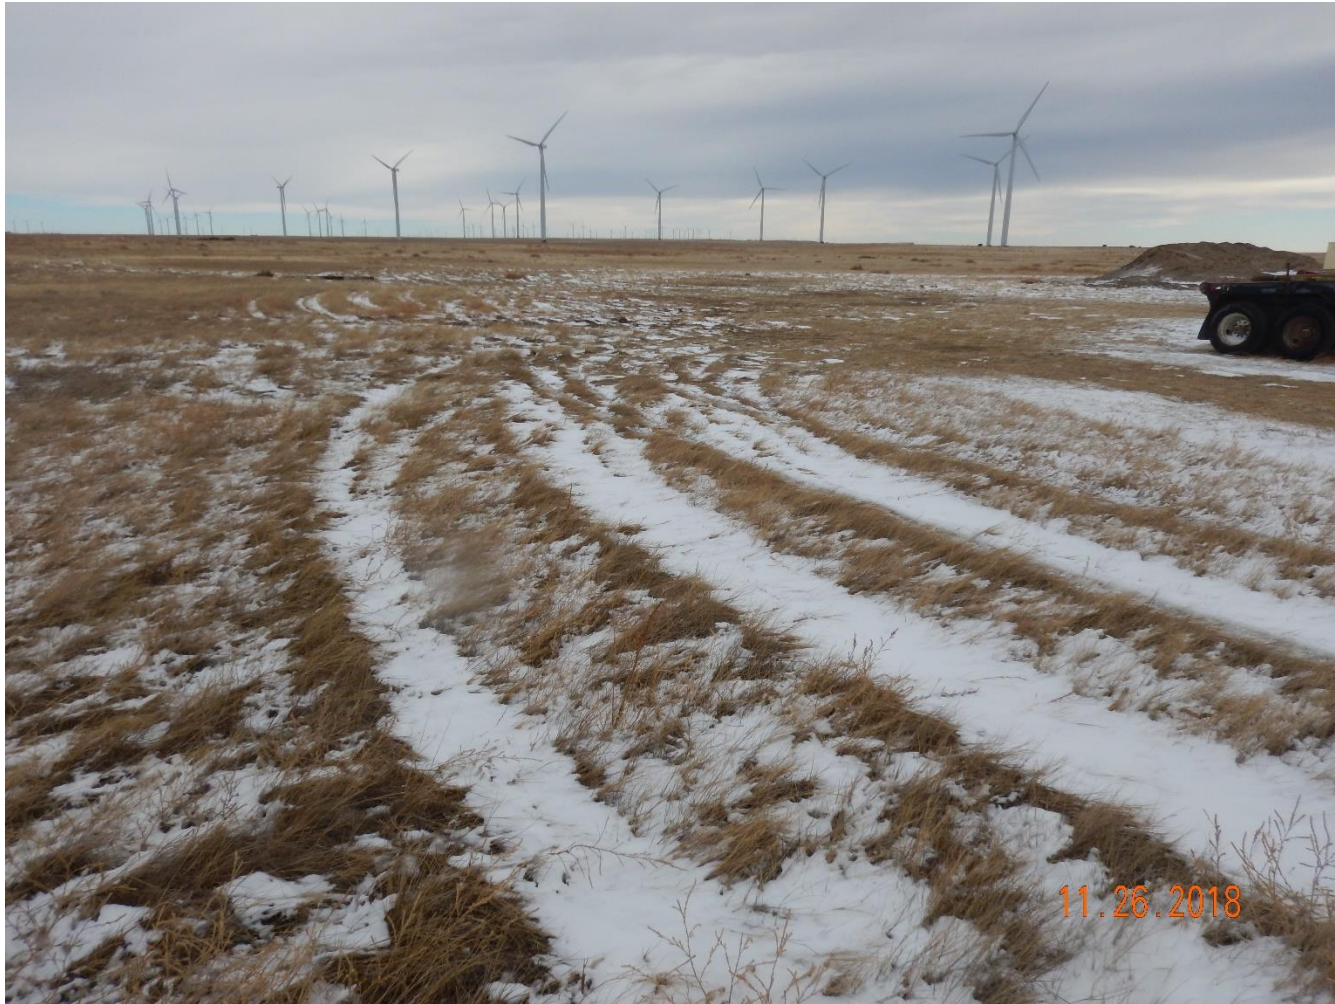
Photo 3: See comments under photo 1 and photo 2. Photo shows vehicle traffic on adjacent lands.

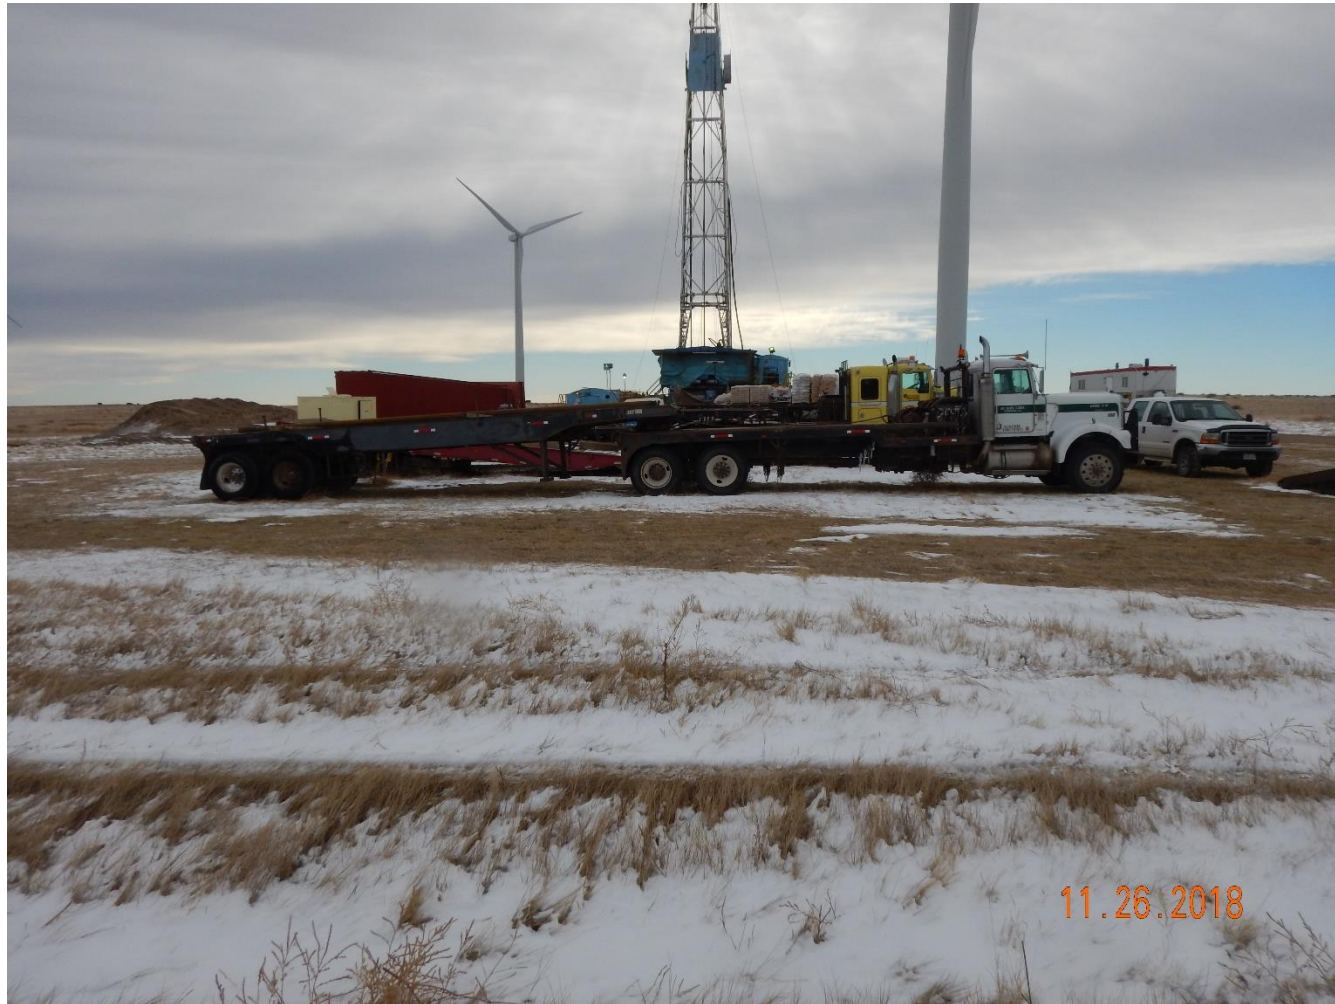
Photo 4: Photo taken from the north end of the location, facing south. See comments under photo 2.

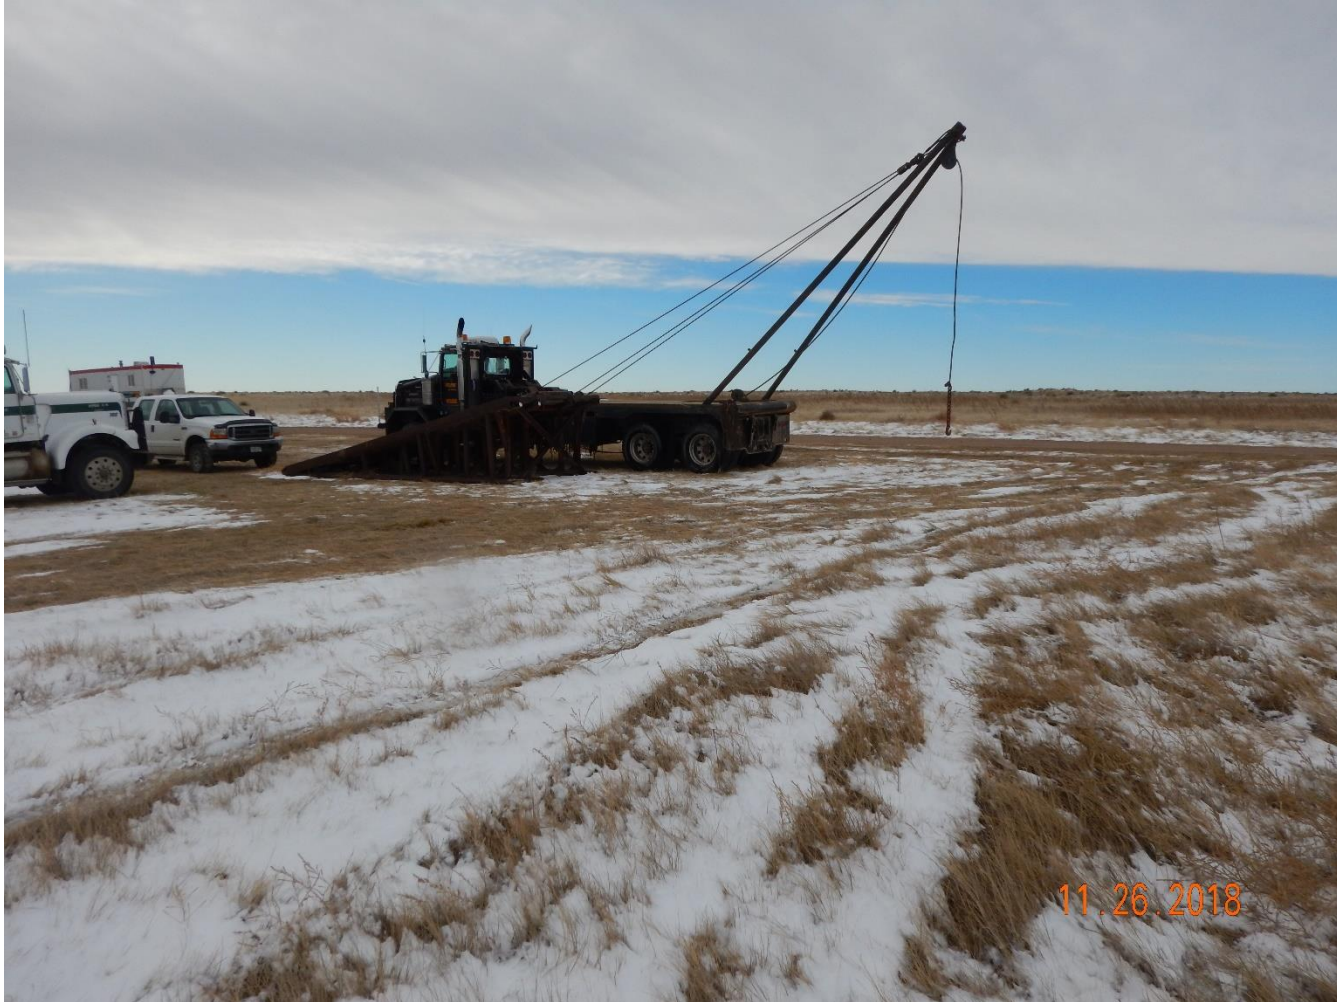
Photo 5: Photo taken from the north end of the location, facing west. See comments under photo 2.

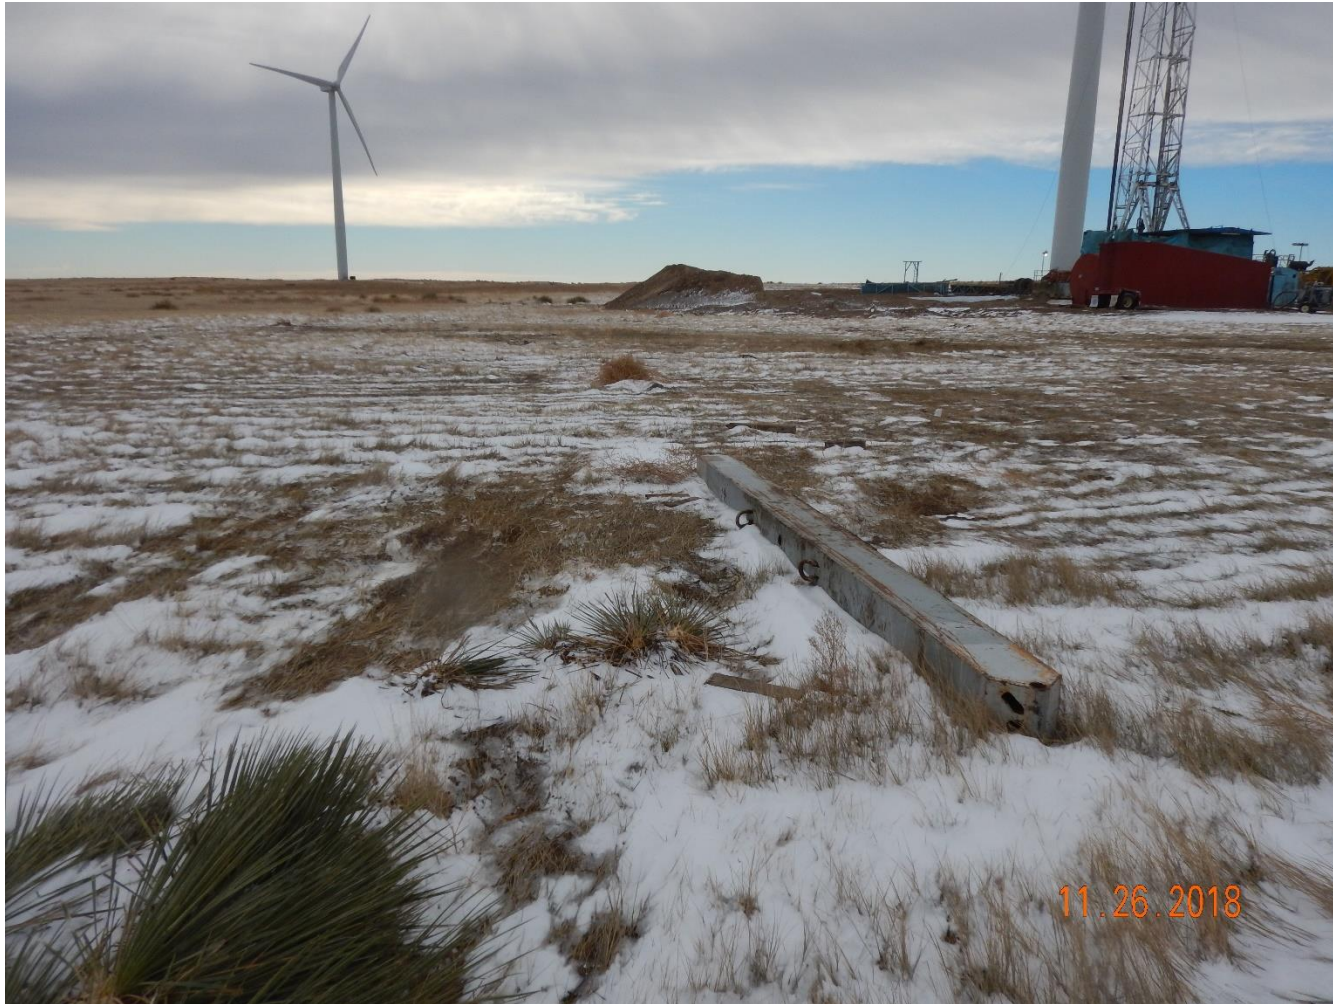
Photo 6: Photo taken from the northeast of the location, facing southwest. See comments under photo 2.

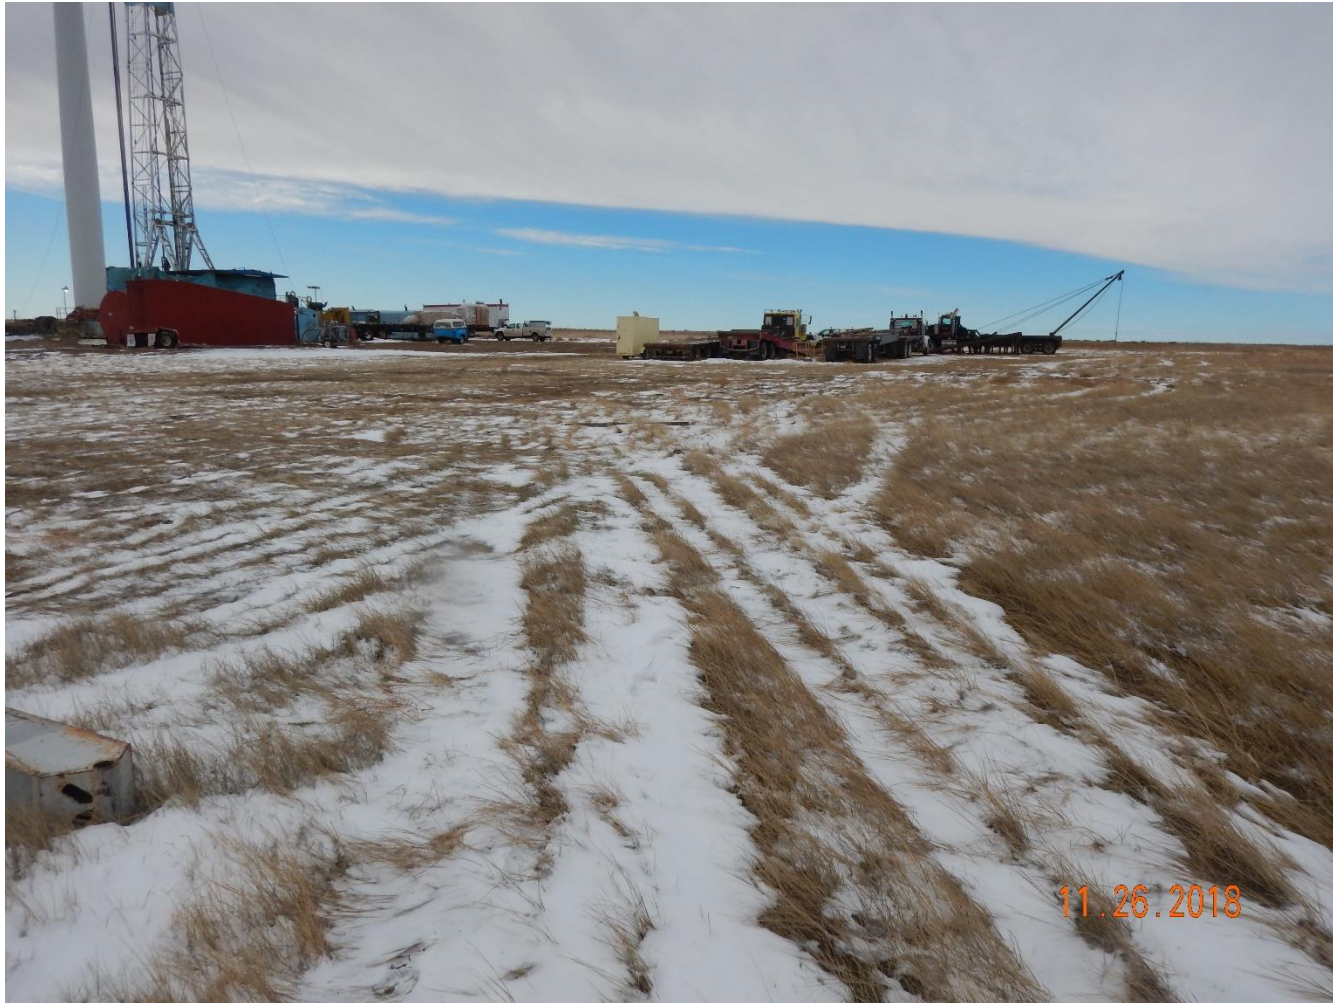
Photo 7: Photo taken from the northeast of the location, facing west. See comments under photo 2.

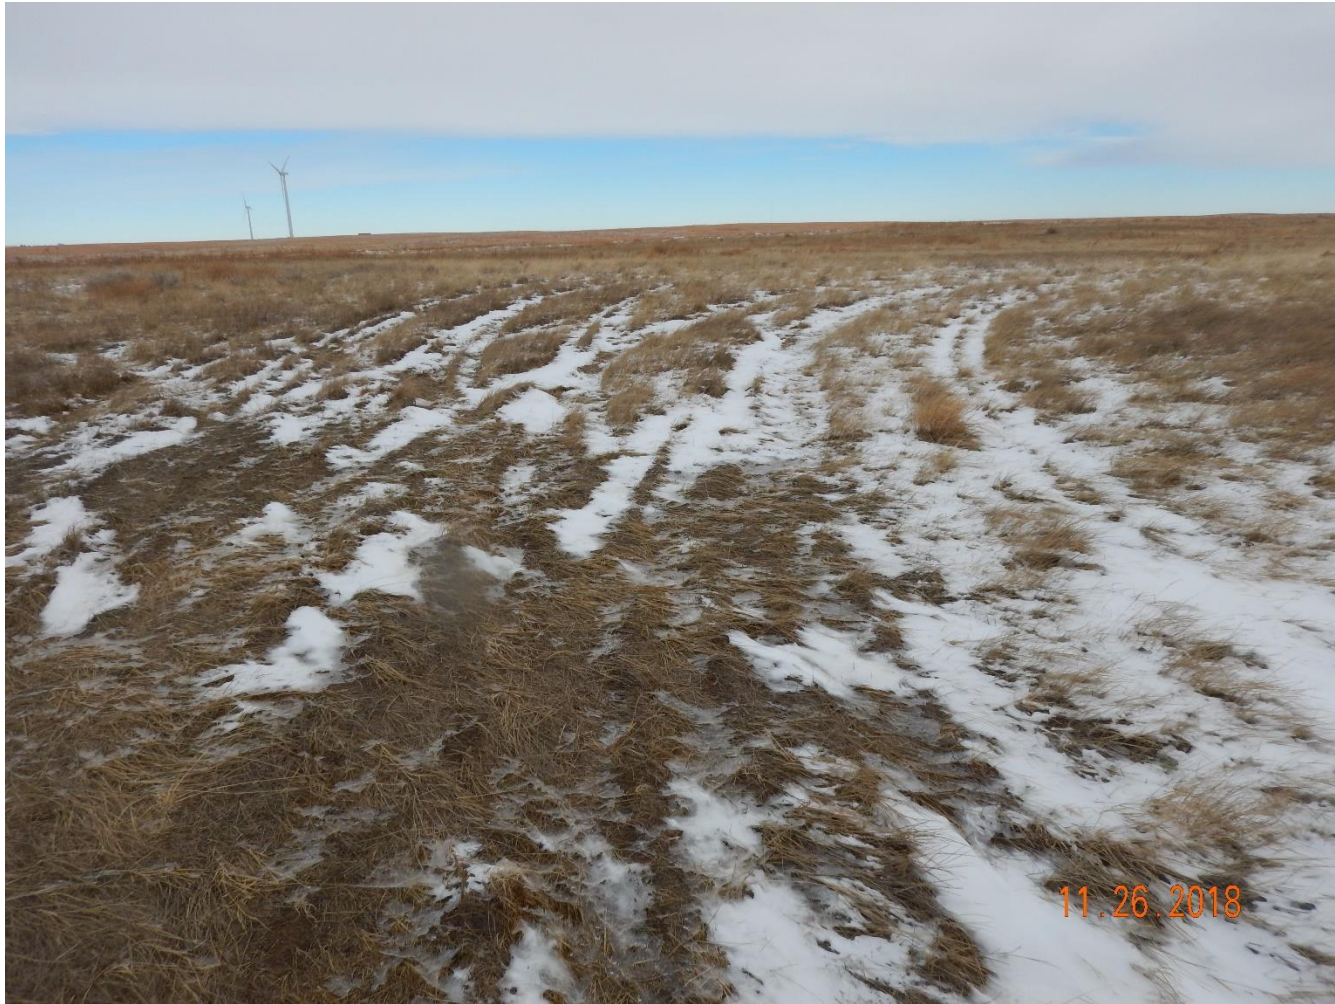
Photo 8: Photo taken from the northeast of the location, facing east. See comments under photo 2. Photo shows vehicle traffic on adjacent lands.

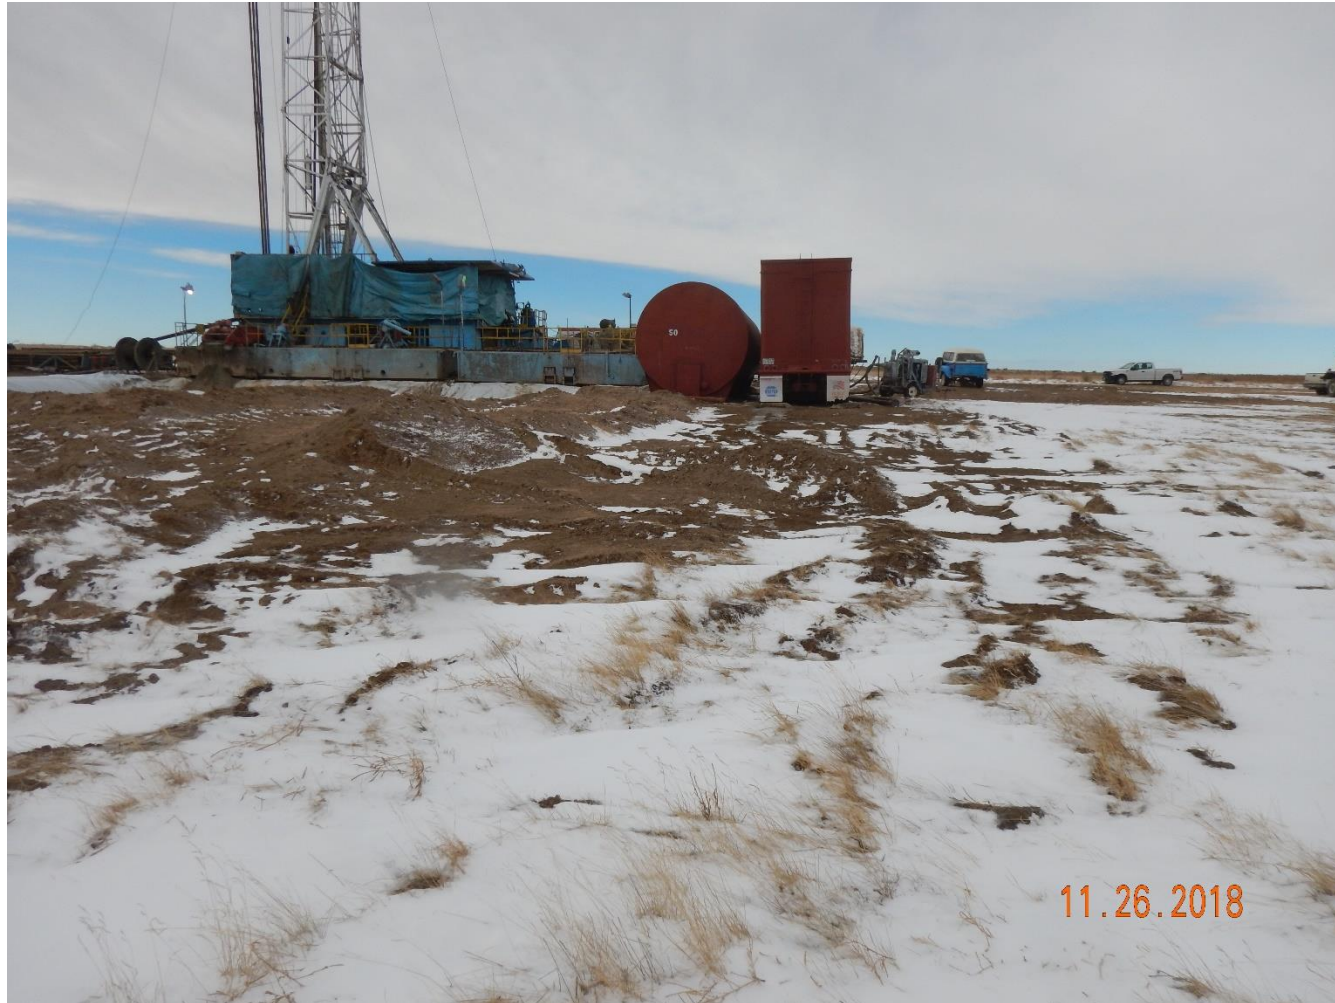
Photo 9: Photo taken from the northeast end of the pad, facing west. Operator indicated that ~3 feet of soil will be brought onto the location to build up the pad. It does not appear as though 3 feet of soils have been brought on site. Photo also shows no perimeter stormwater and erosion control BMPs have been installed on the location in accordance with 1002.f

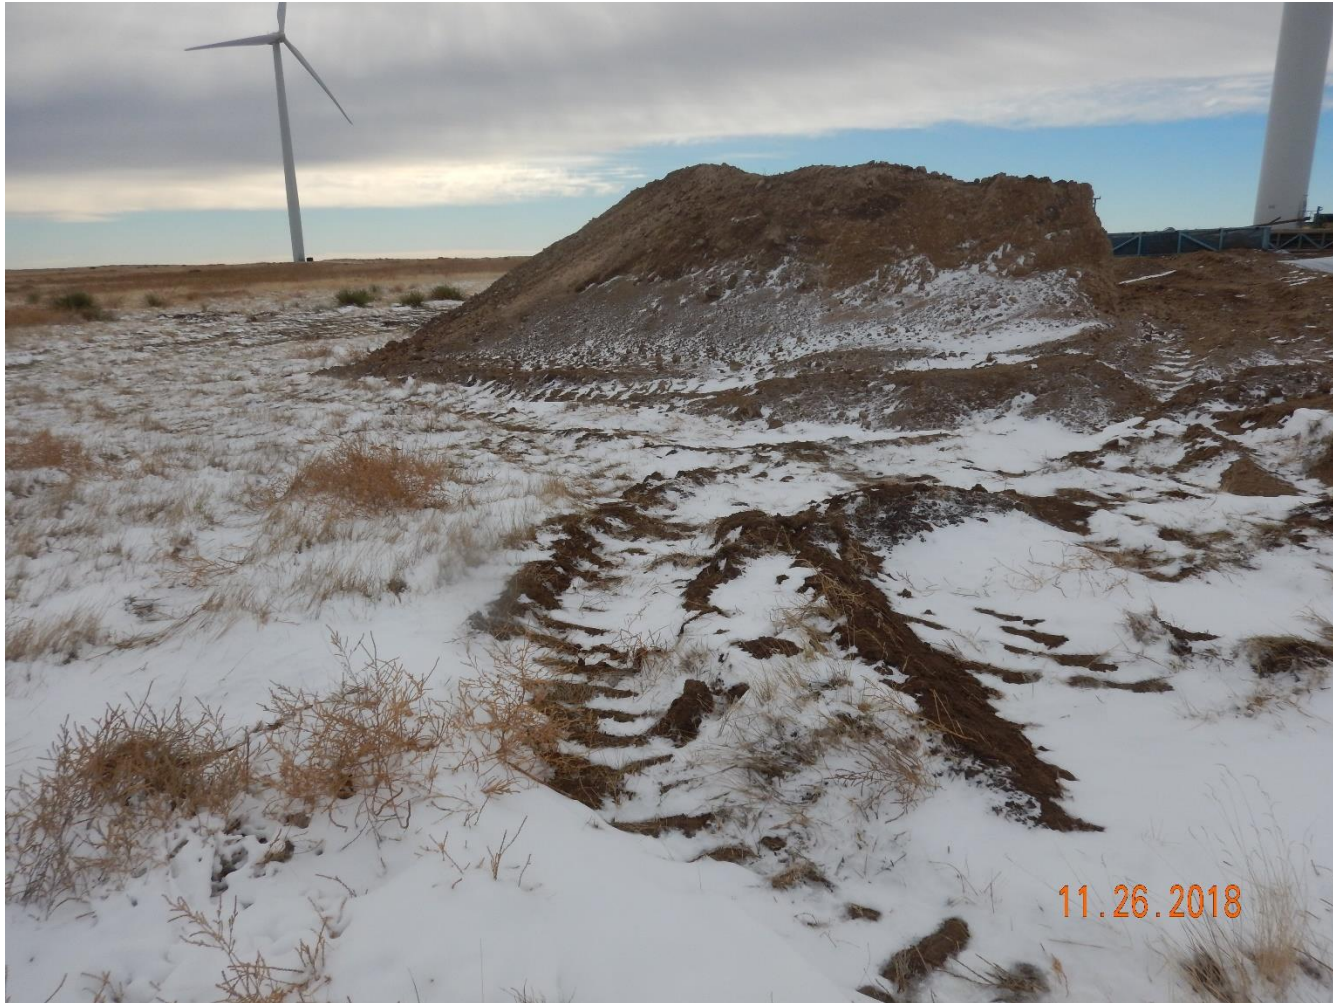
Photo 10: Photo taken from the northeast end of the pad, facing west. Photo shows soil excavated from the pit. 2A states pit to be 8 feet deep. Photo shows topsoil and subsoils do not appear to have been separated and stored or marked/documented. It appears that topsoil and subsoil horizons have all been placed into one soil stockpile. Photo also shows no perimeter stormwater and erosion control BMPs have been installed on the location in accordance with 1002.f

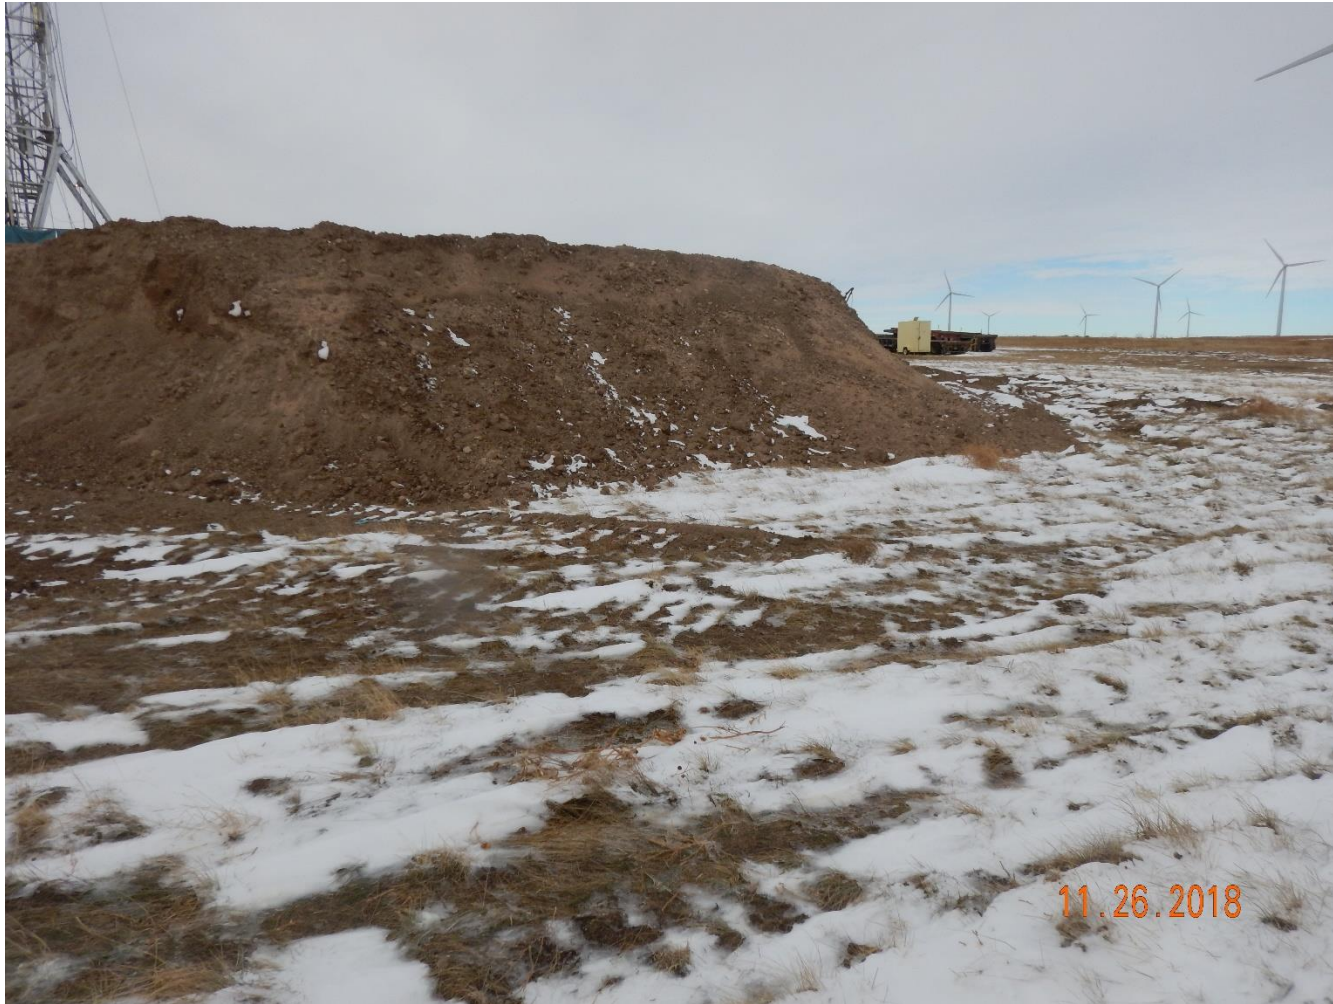
Photo 11: Photo taken from the east end of the location, facing northwest. See comments under photo 10.

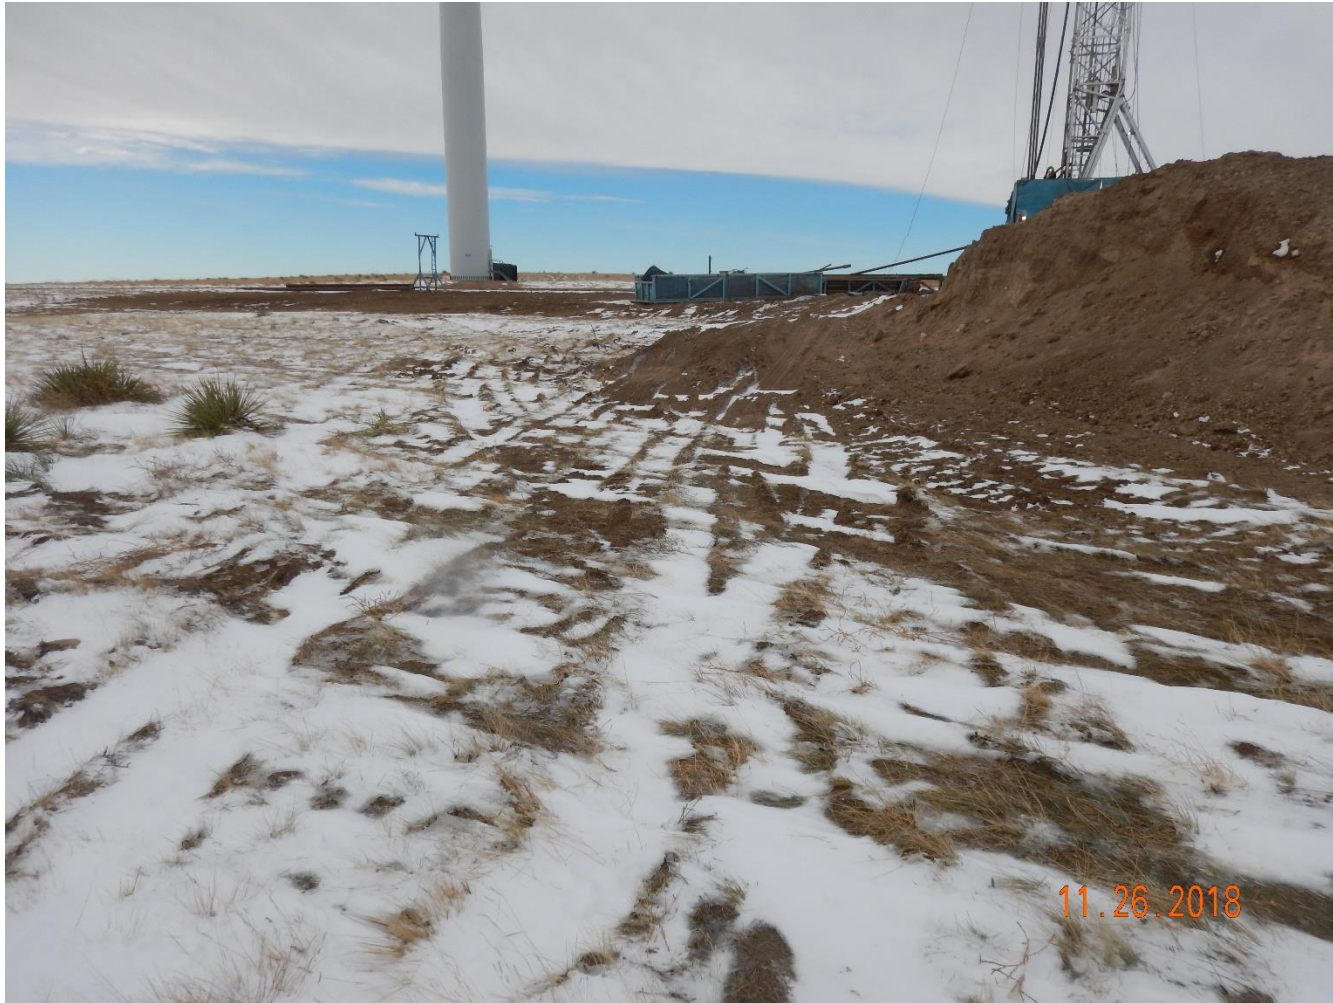
Photo 12: Photo taken from the east end of the location, facing southwest. See comments under photo 10.

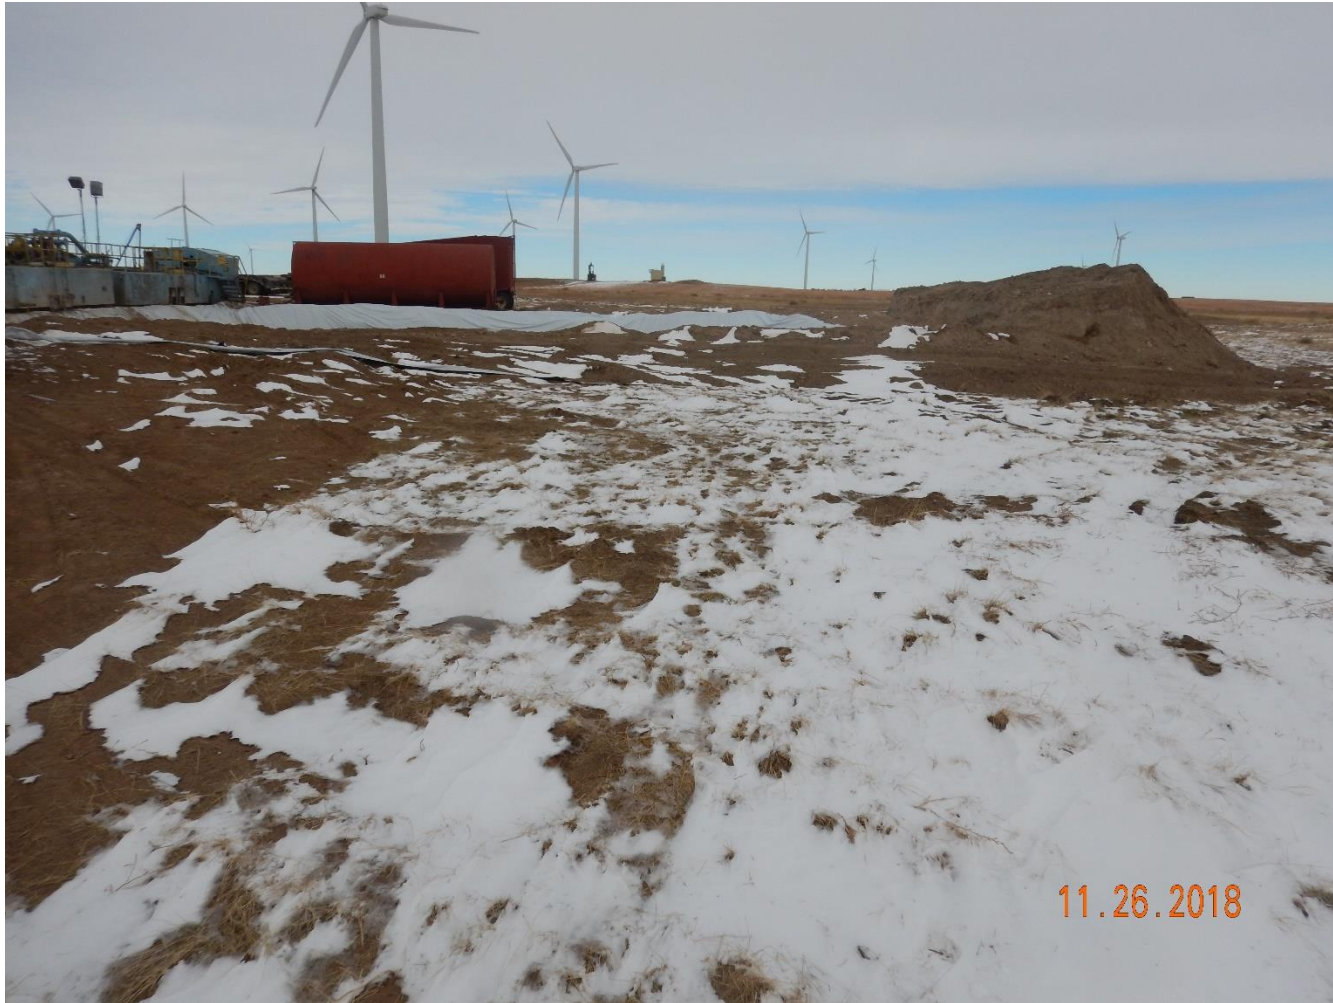
Photo 13: Photo taken from the southeast end of the location, facing north. See comments under photo 10.

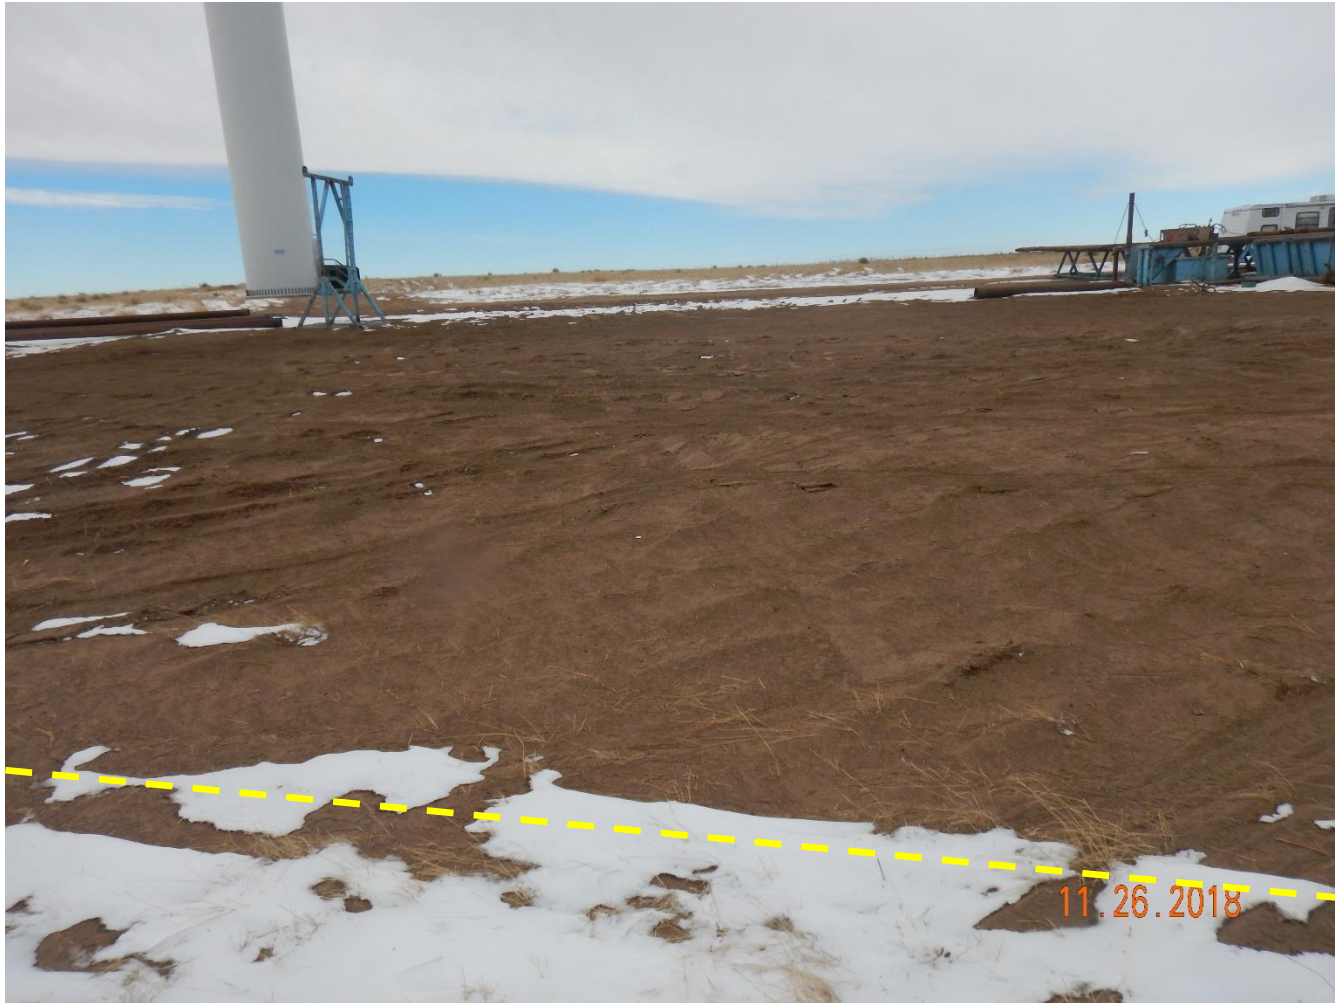
Photo 14: Photo taken from the south end of the location, facing west. Photo shows areas where soil has been brought onto the location. It does not appear as though location has been built up by 3 feet as indicated by operator. Photo shows perimeter of the pad and the adjacent lands. Photo also shows no perimeter stormwater and erosion control BMPs have been installed on the location in accordance with 1002.f

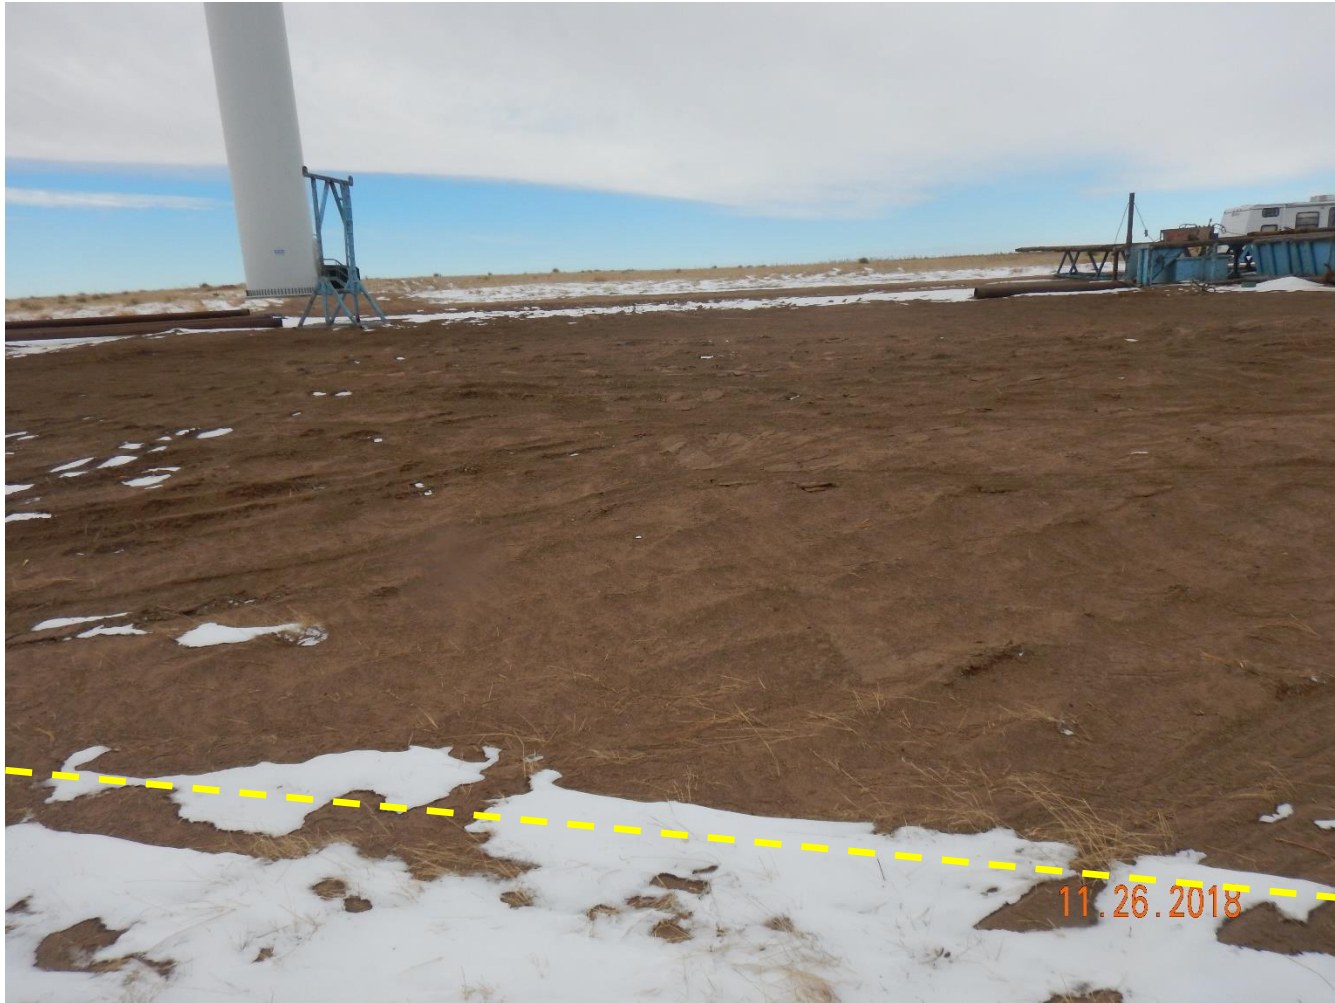
Photo 15: Photo taken from the south end of the location, facing west. Photo shows areas where soil has been brought onto the location. It does not appear as though location has been built up by 3 feet as indicated by operator. Photo shows perimeter of the pad and the adjacent lands. Photo also shows no perimeter stormwater and erosion control BMPs have been installed on the location in accordance with 1002.f

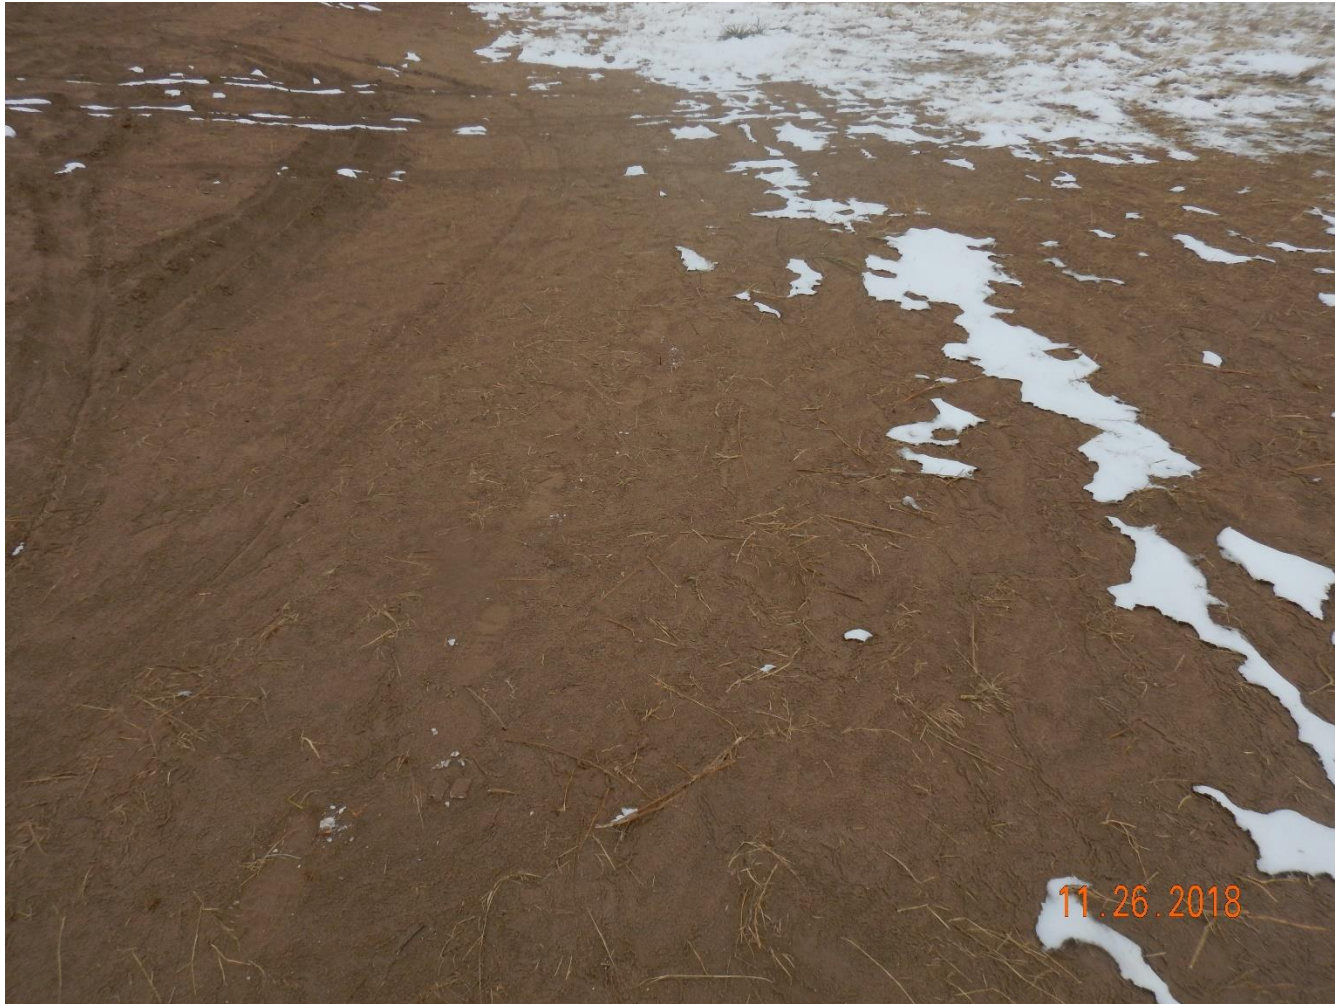
Photo 16: Photo taken from the east end of the location. Photo shows areas where soil was brought in. It does not appear as though location has been built up by 3 feet as indicated by operator. Vegetation from the soil surface appears to be evident.
