Inspection Photos

11/26/2018

Operator: H & M PETROLEUM CORPORATION #
10032

Location ID: 458288

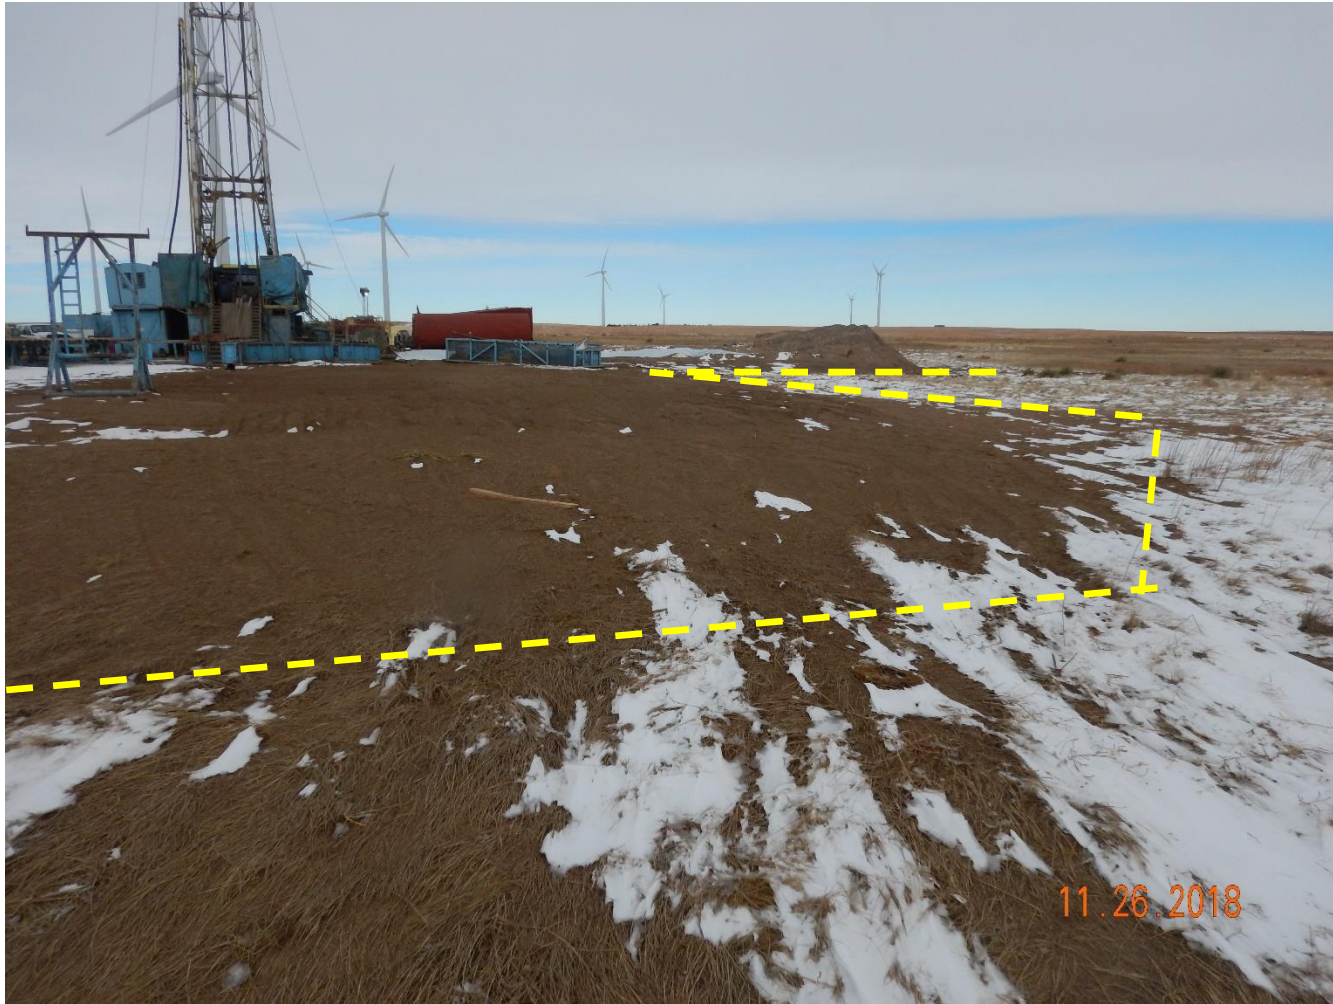
Photo 17: Photo taken from the south end of the location, facing north. See comments under photo 15.

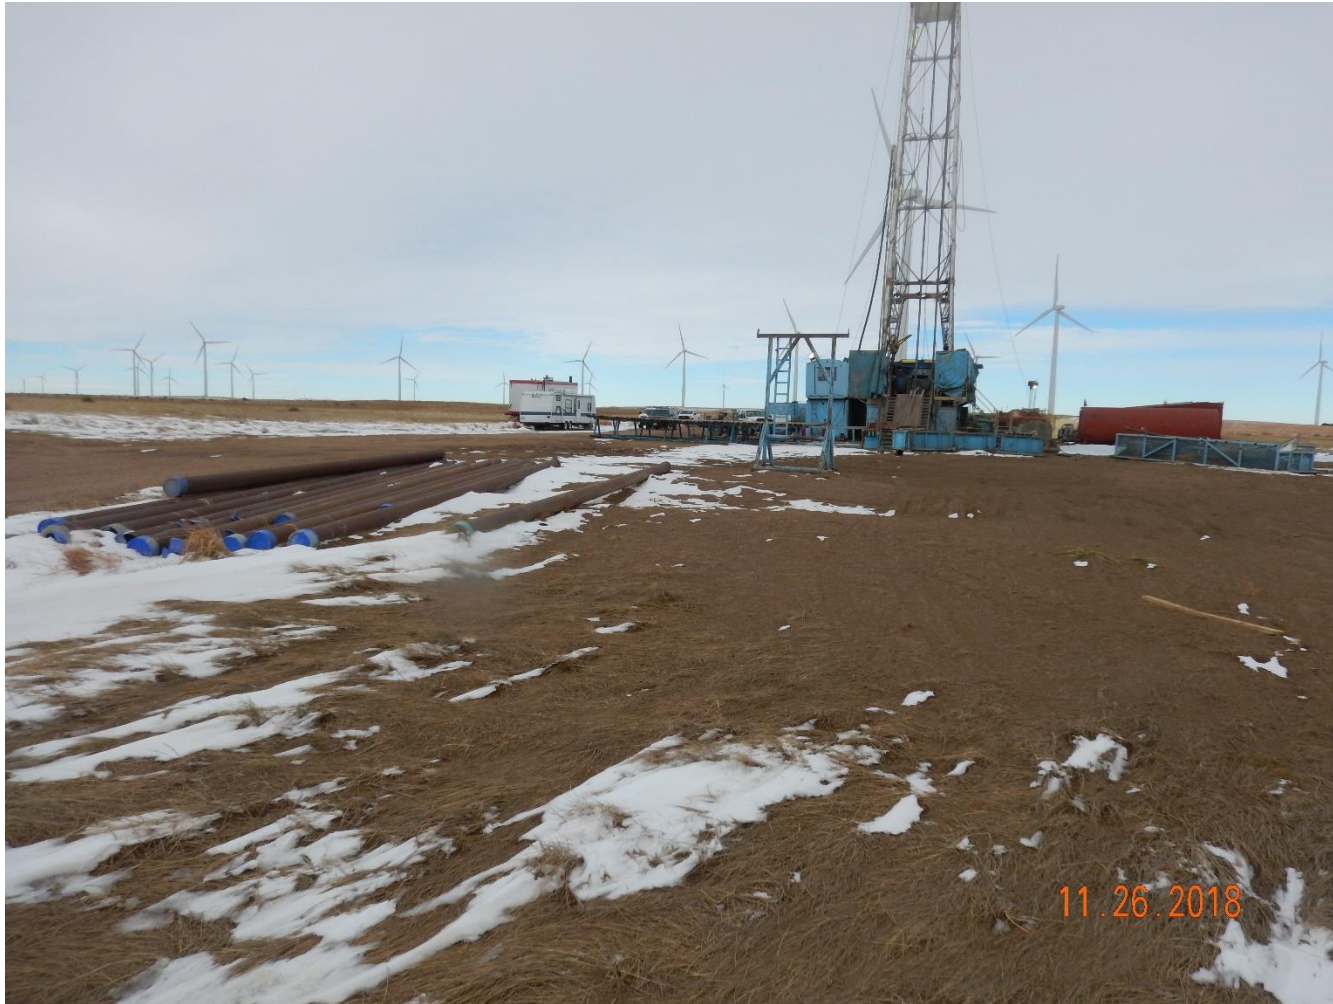
Photo 18: Photo taken from the south end of the location, facing northwest. See comments under photo 15.

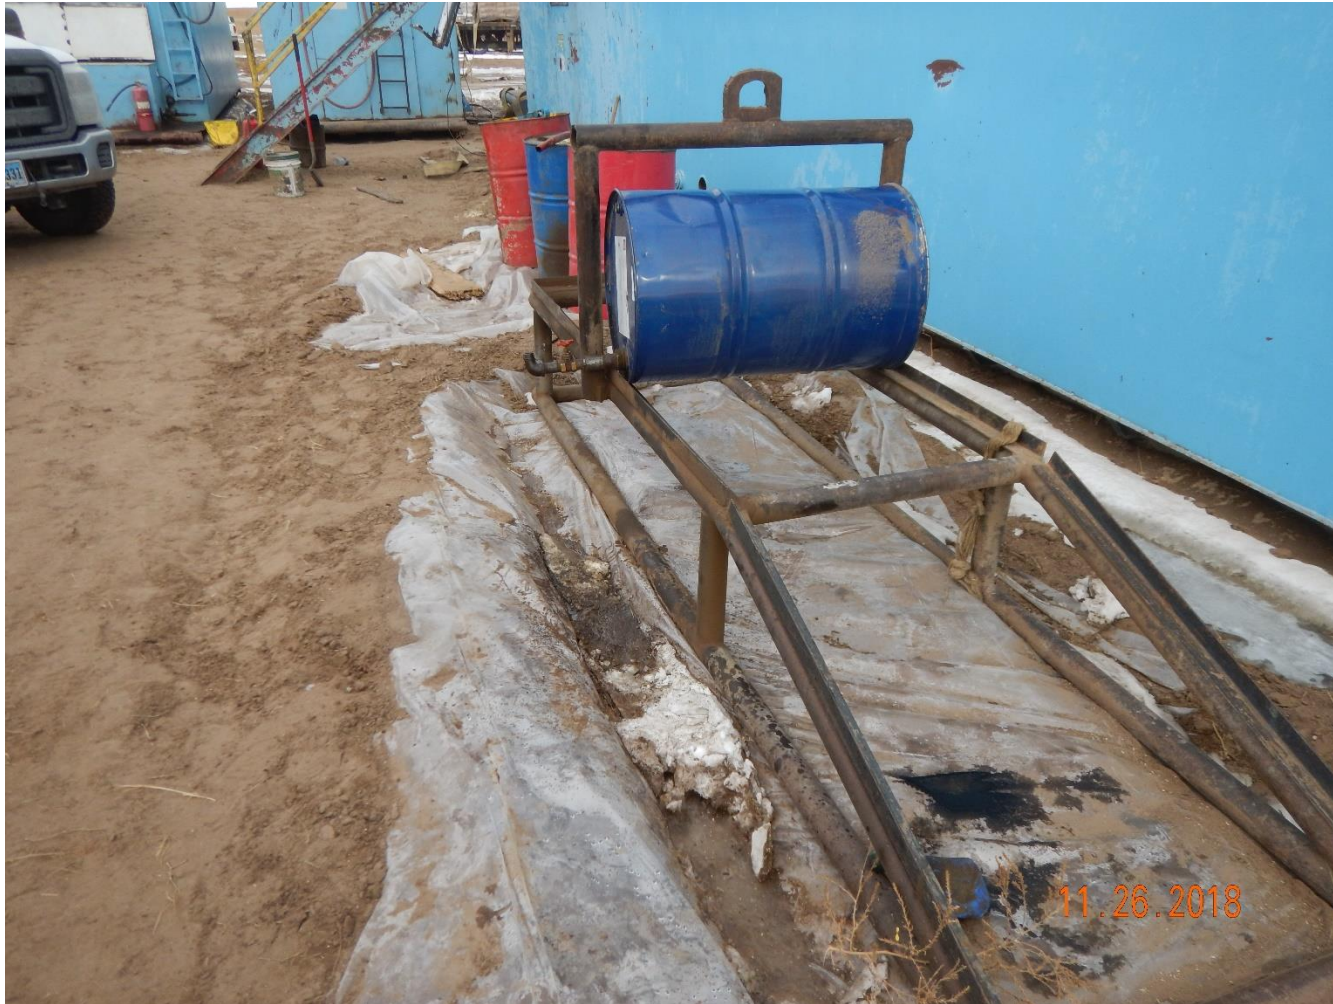
Photo 20: Photo taken from the west end of the drill rig. Photo shows various materials/barrels that do not appear to be within sufficient containment. Plastic material does not appear to be thick/sturdy enough to tolerate abrasions/tears/cuts/etc...

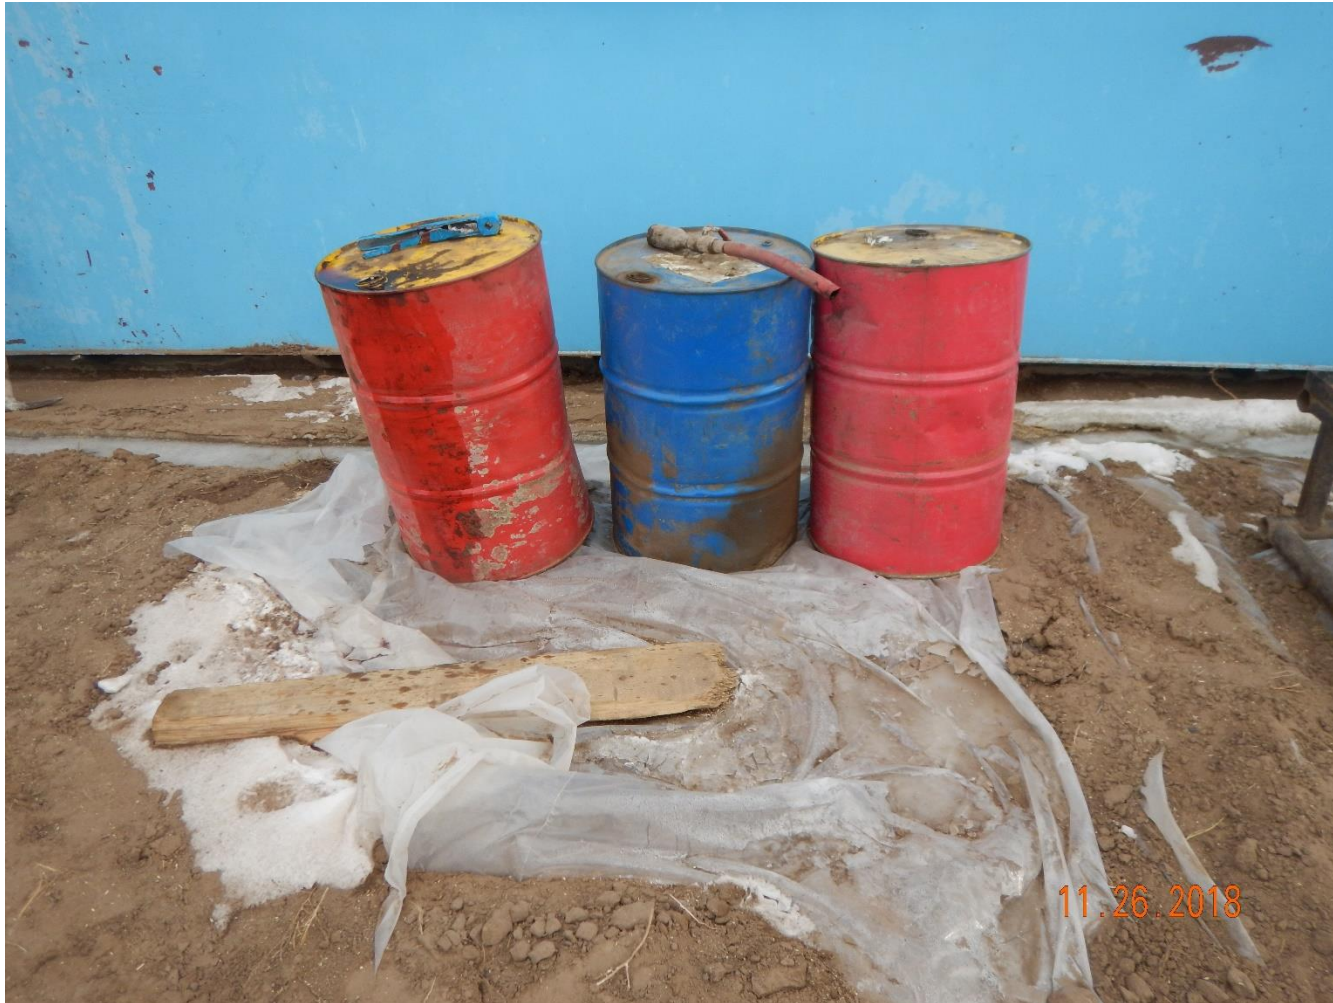
Photo 21: Continued from photo 20. Photos shows barrels with insufficient secondary containment. This is improper materials management.

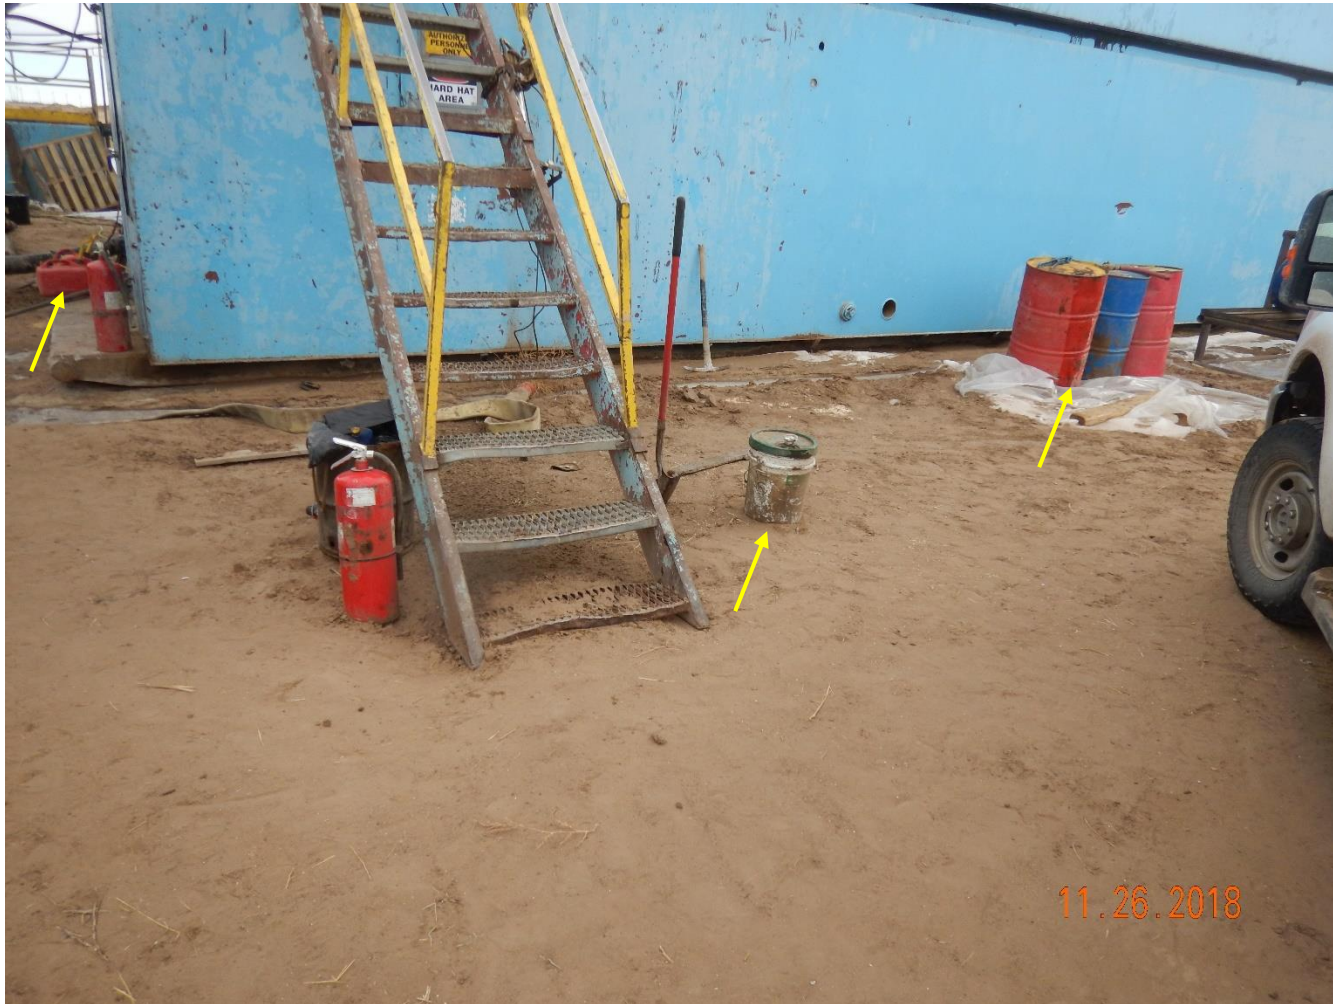
Photo 22: Photo taken from the southwest of the drill rig. Photo shows various buckets, barrels, gas cans without proper storage or secondary containment. This is improper materials management.

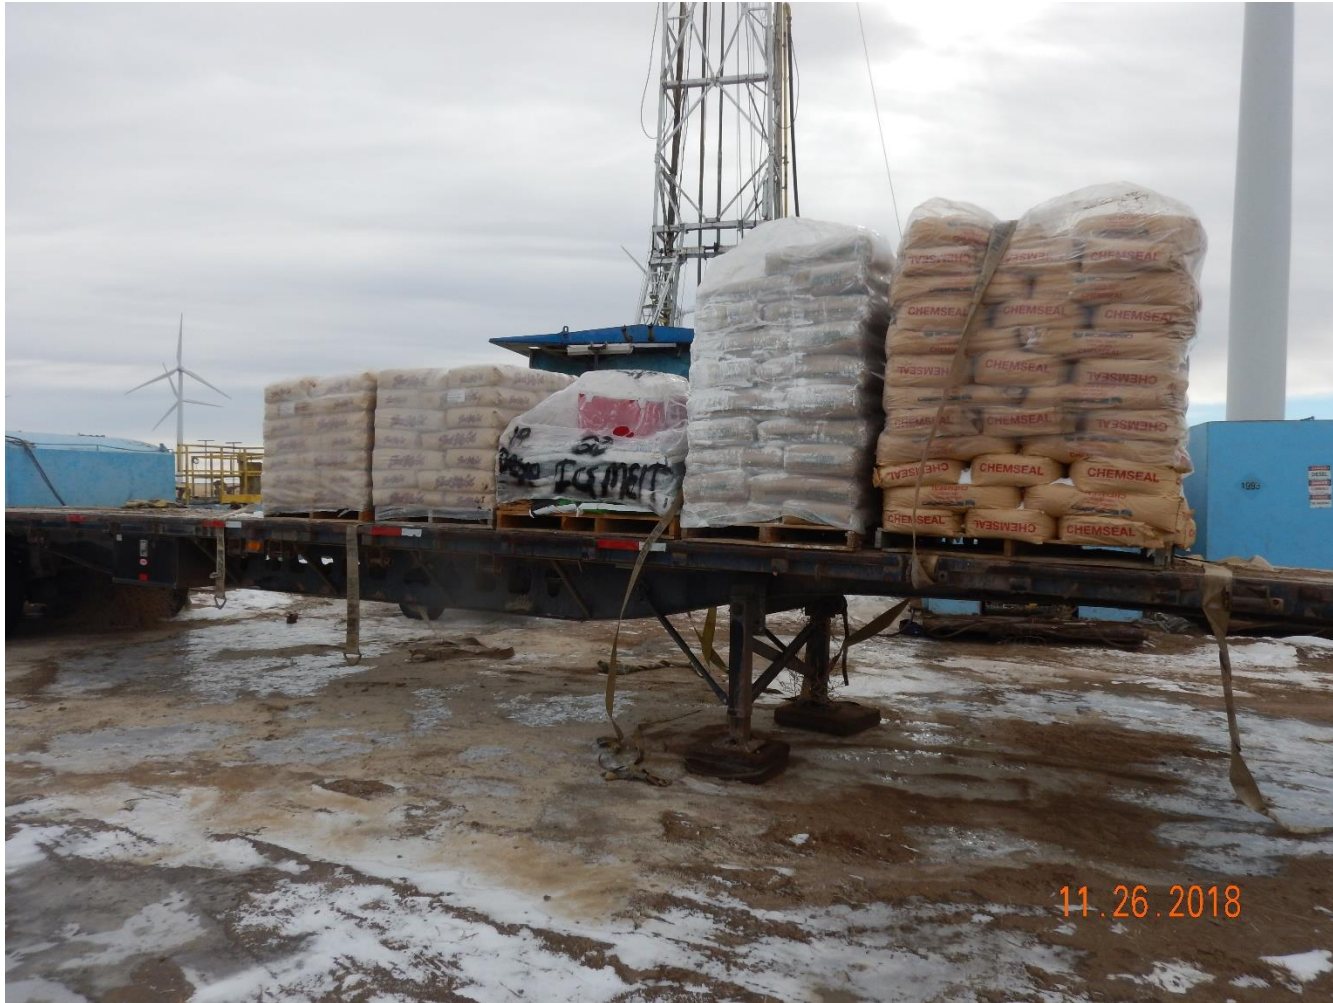
Photo 24: Photo taken from the north end of the drill rig, facing south. Photo shows materials that appear to be properly stored.

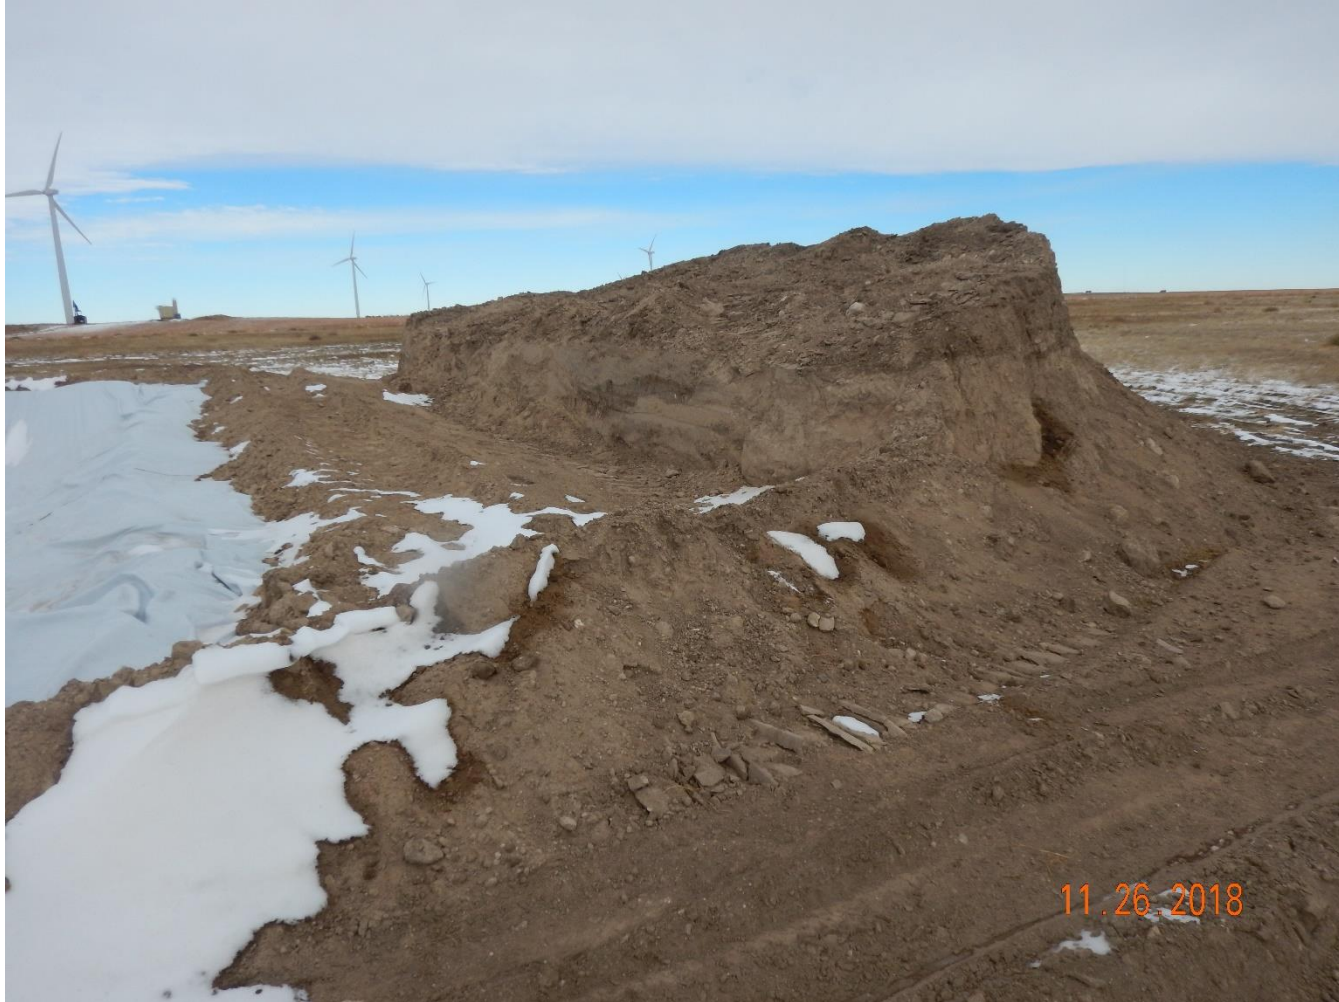
Photo 28: Photo taken from the southeast corner of the pit, facing north. See comments under photo 10

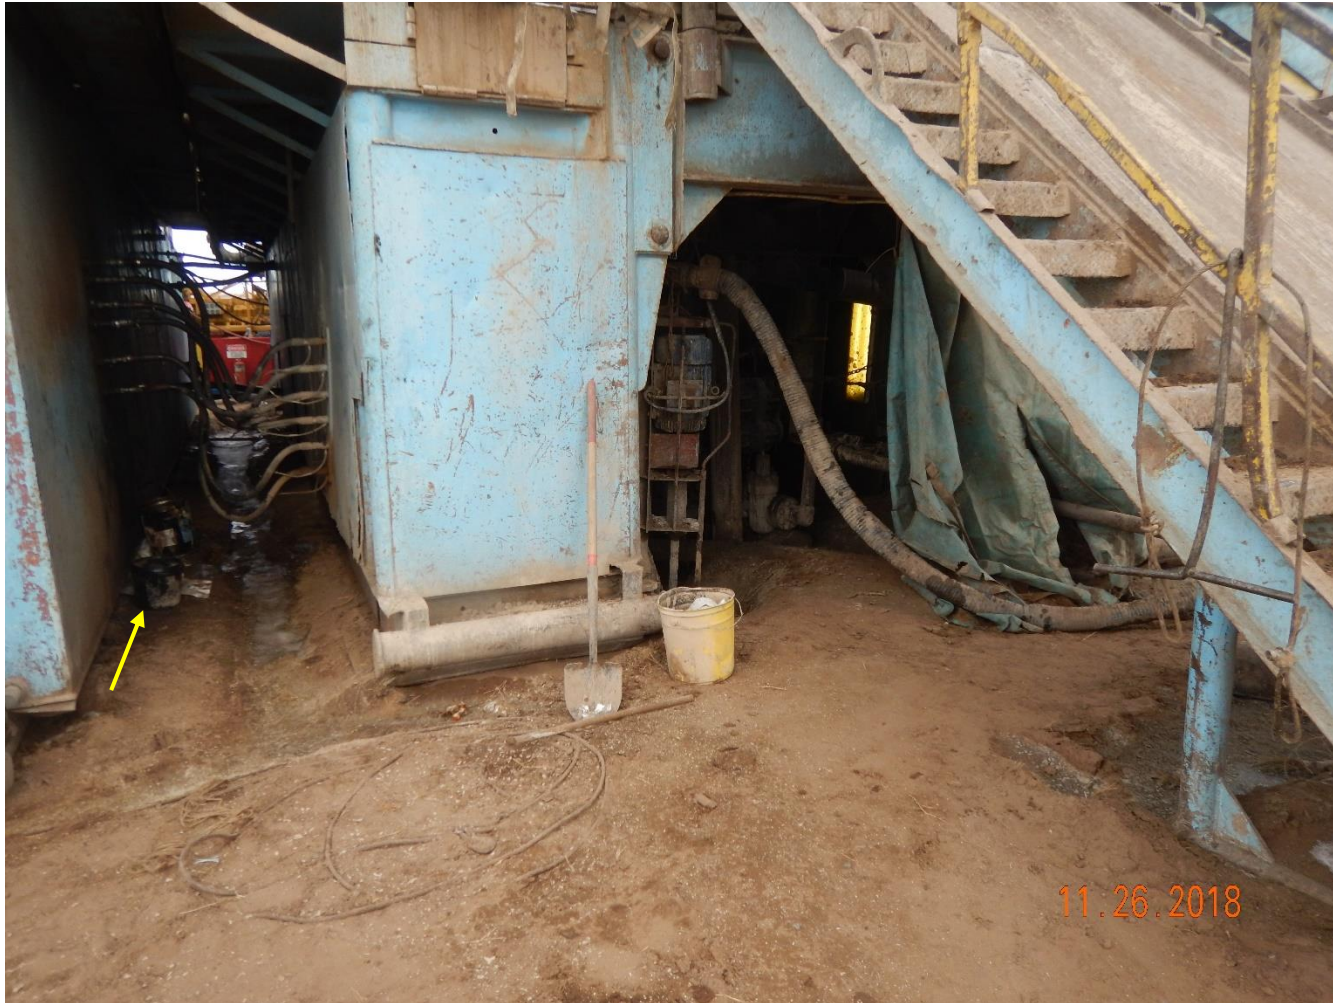
Photo 29: Photo taken from the south end of the drill rig facing north. See comments under photo 22

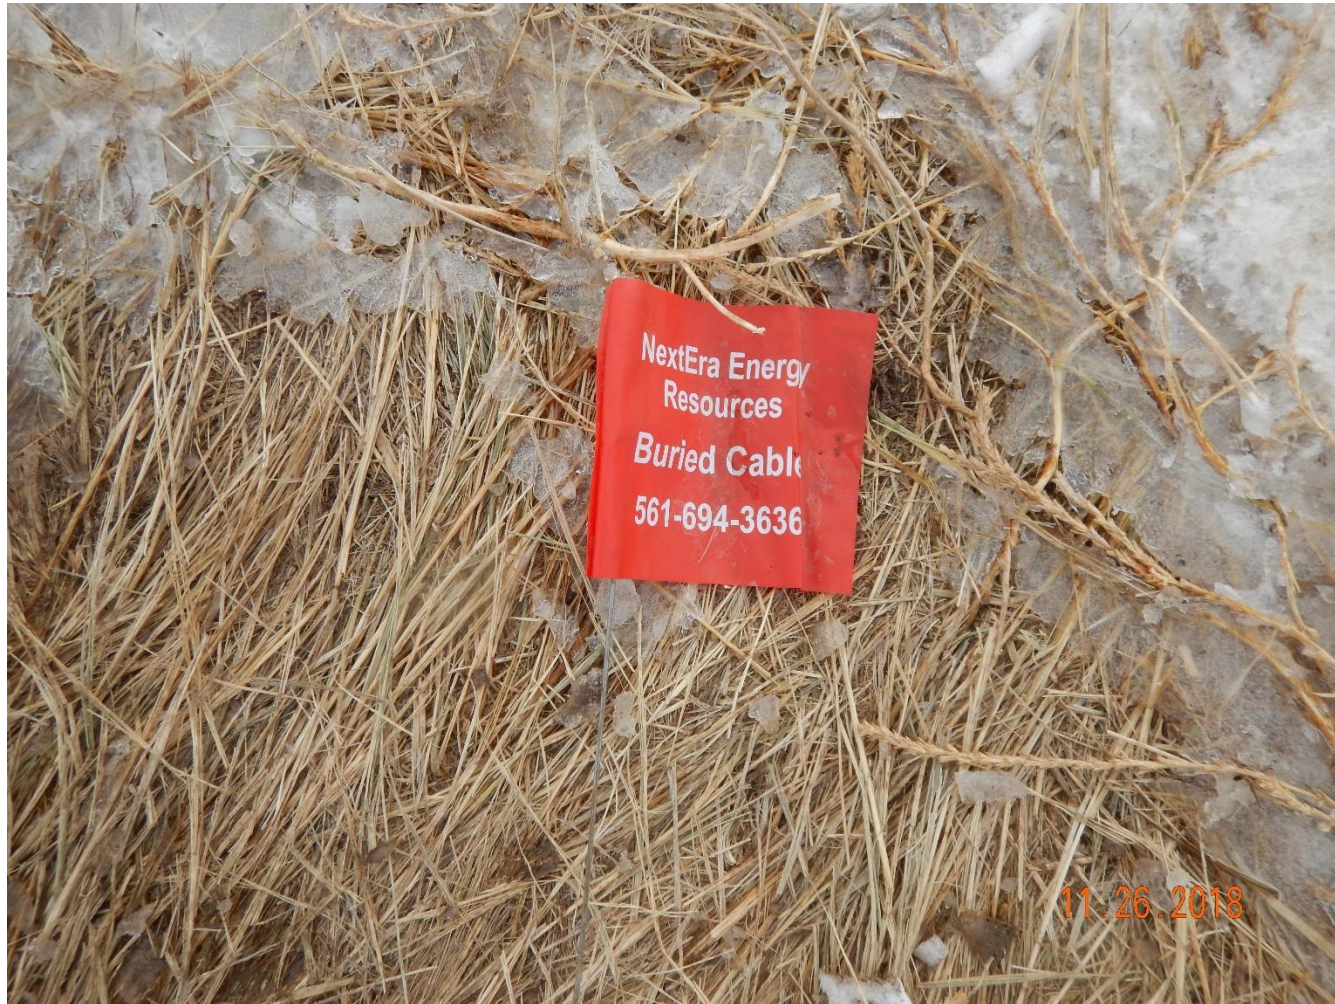
Photo 32: Photo taken from the north end of the location. Photo shows the flag identifying “Buried Cable”.

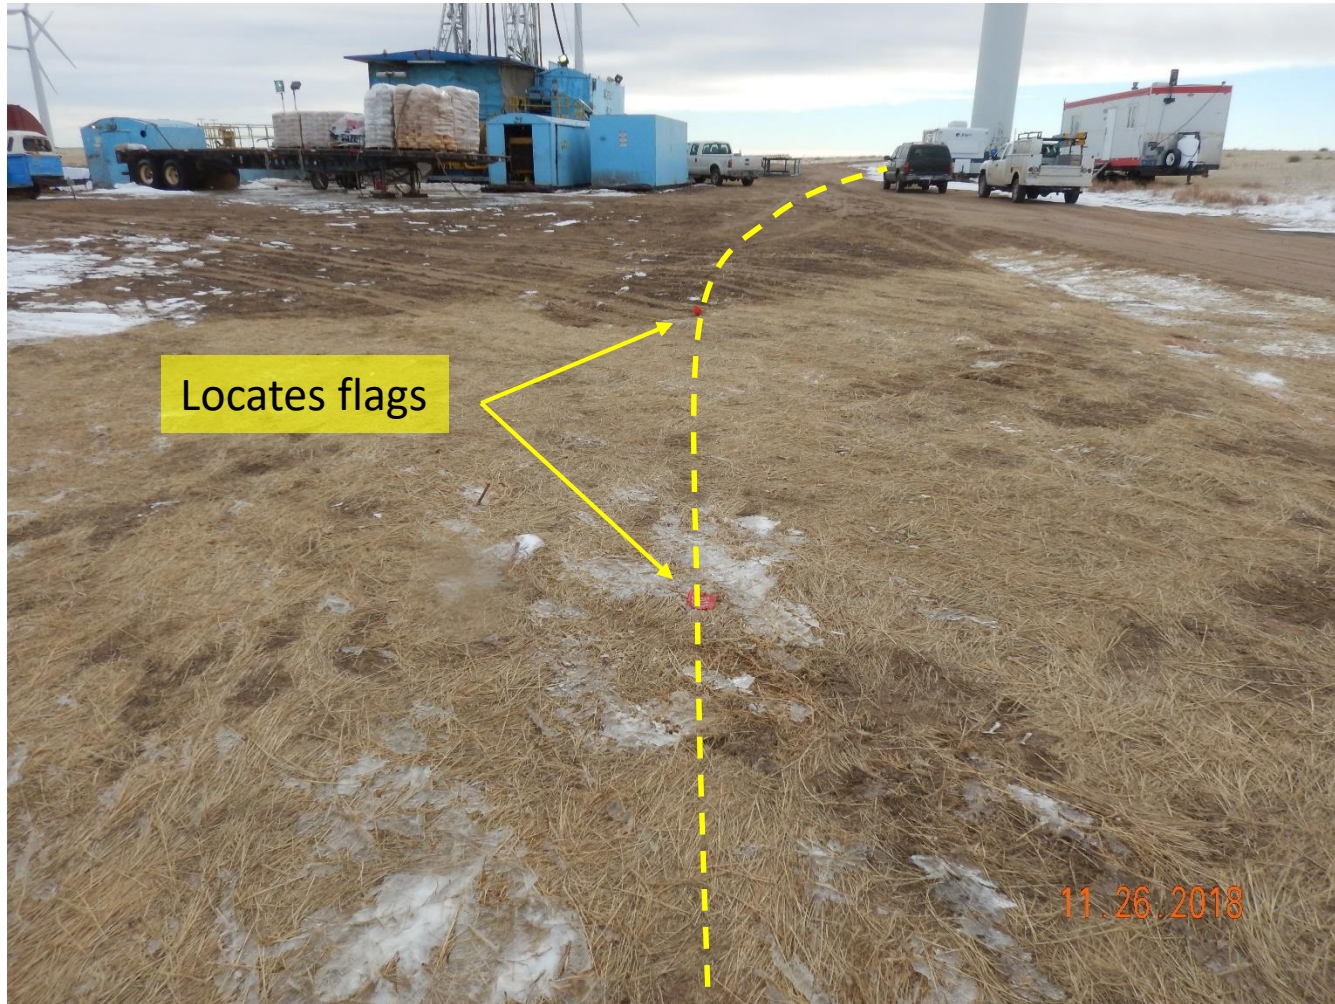
Photo 33: Photo taken from the north end of the location, facing south. Photo shows buried cable appears to travel south under the northwest corner of the pad, and then southwest under the access road towards the wind mill

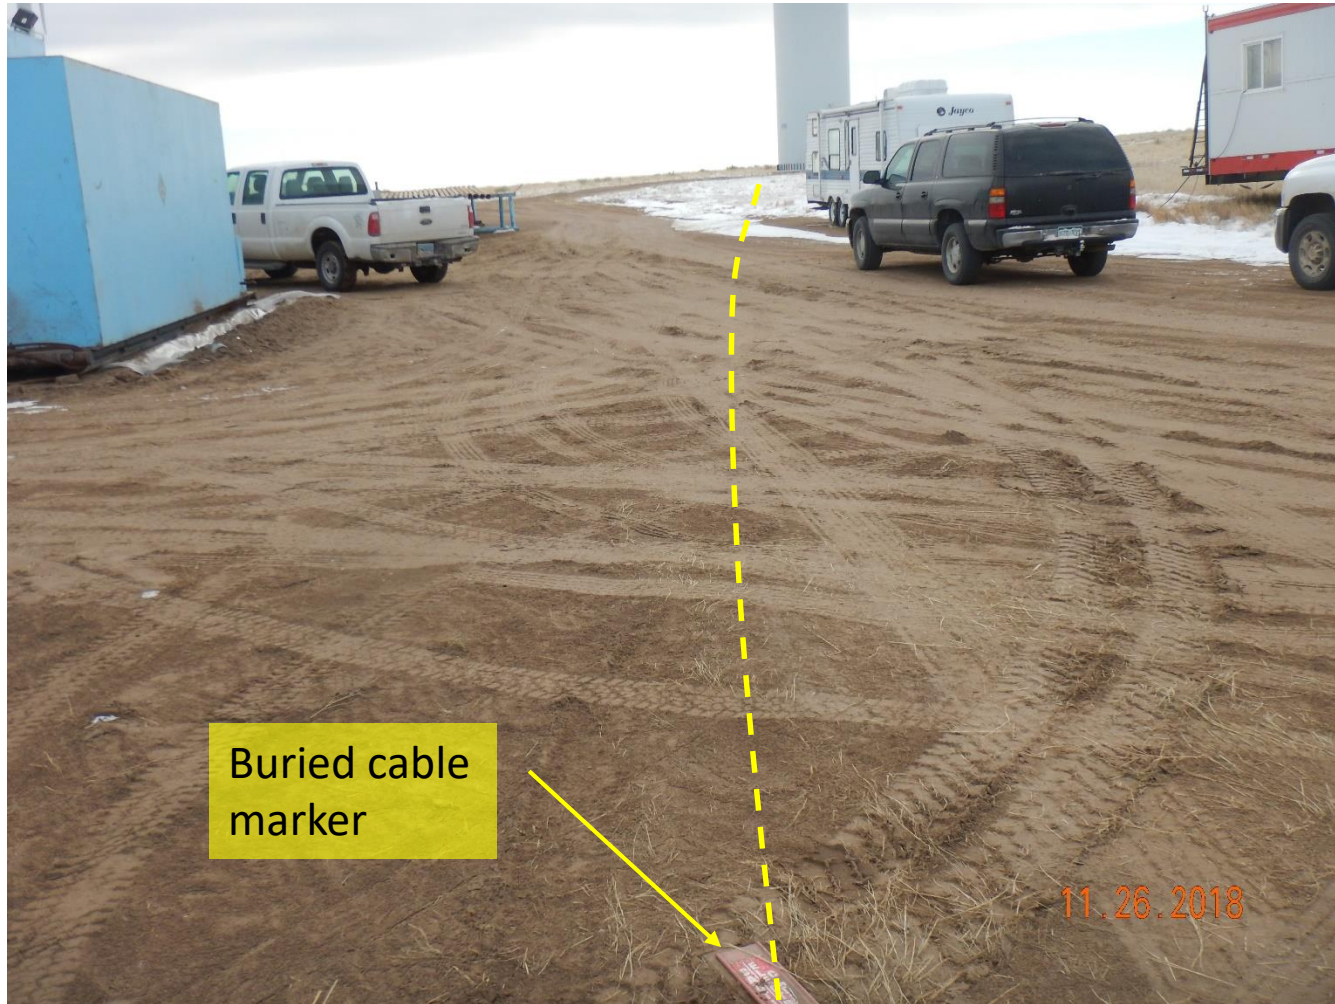
Photo 34: See comments under photo 33.

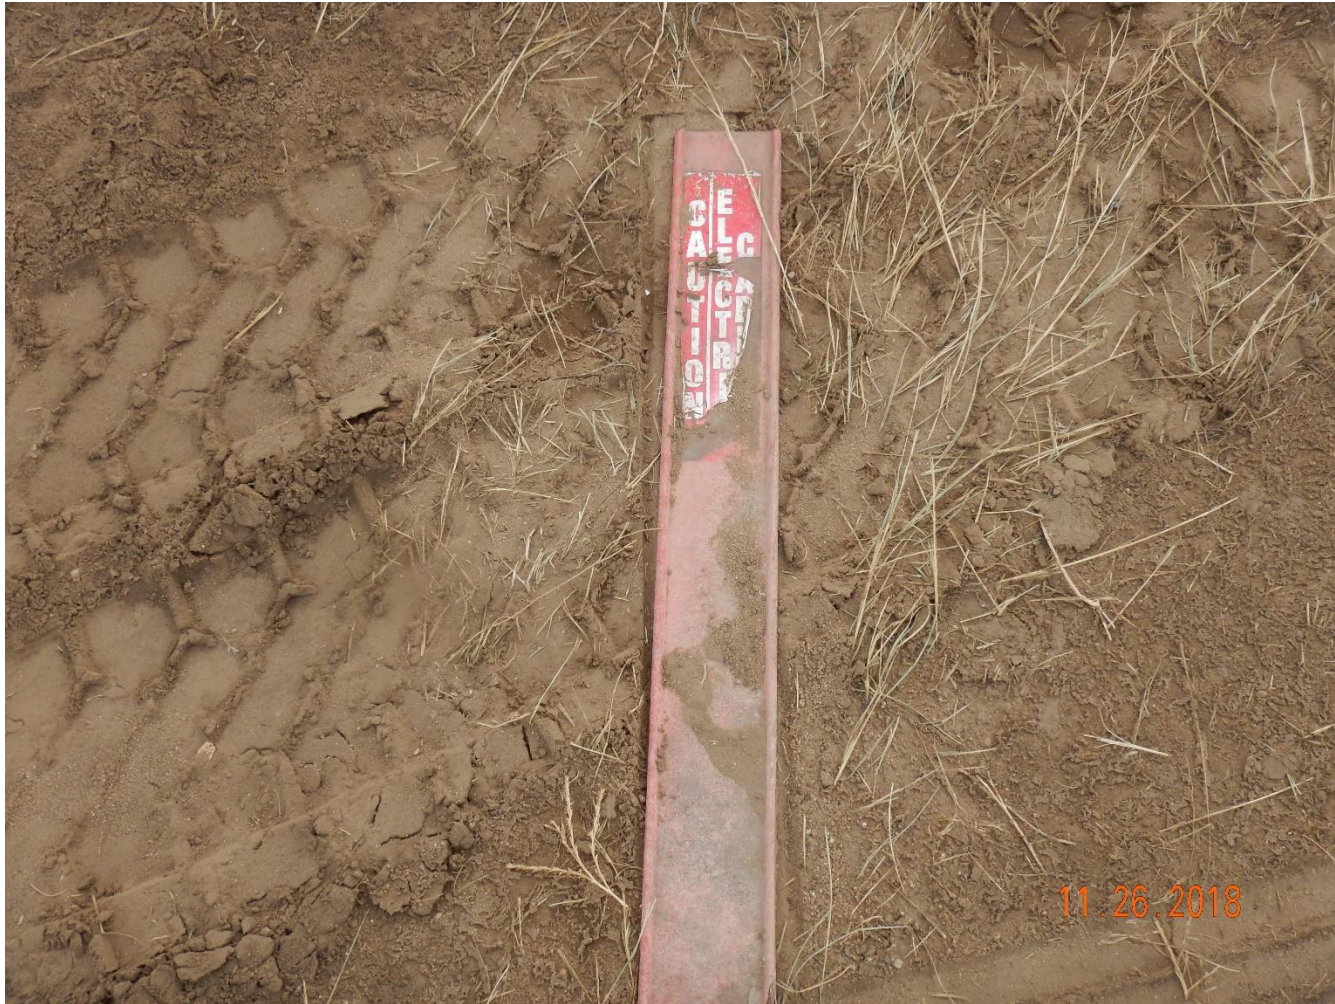
Photo 35: Buried cable sign seen at the bottom of photo 34.

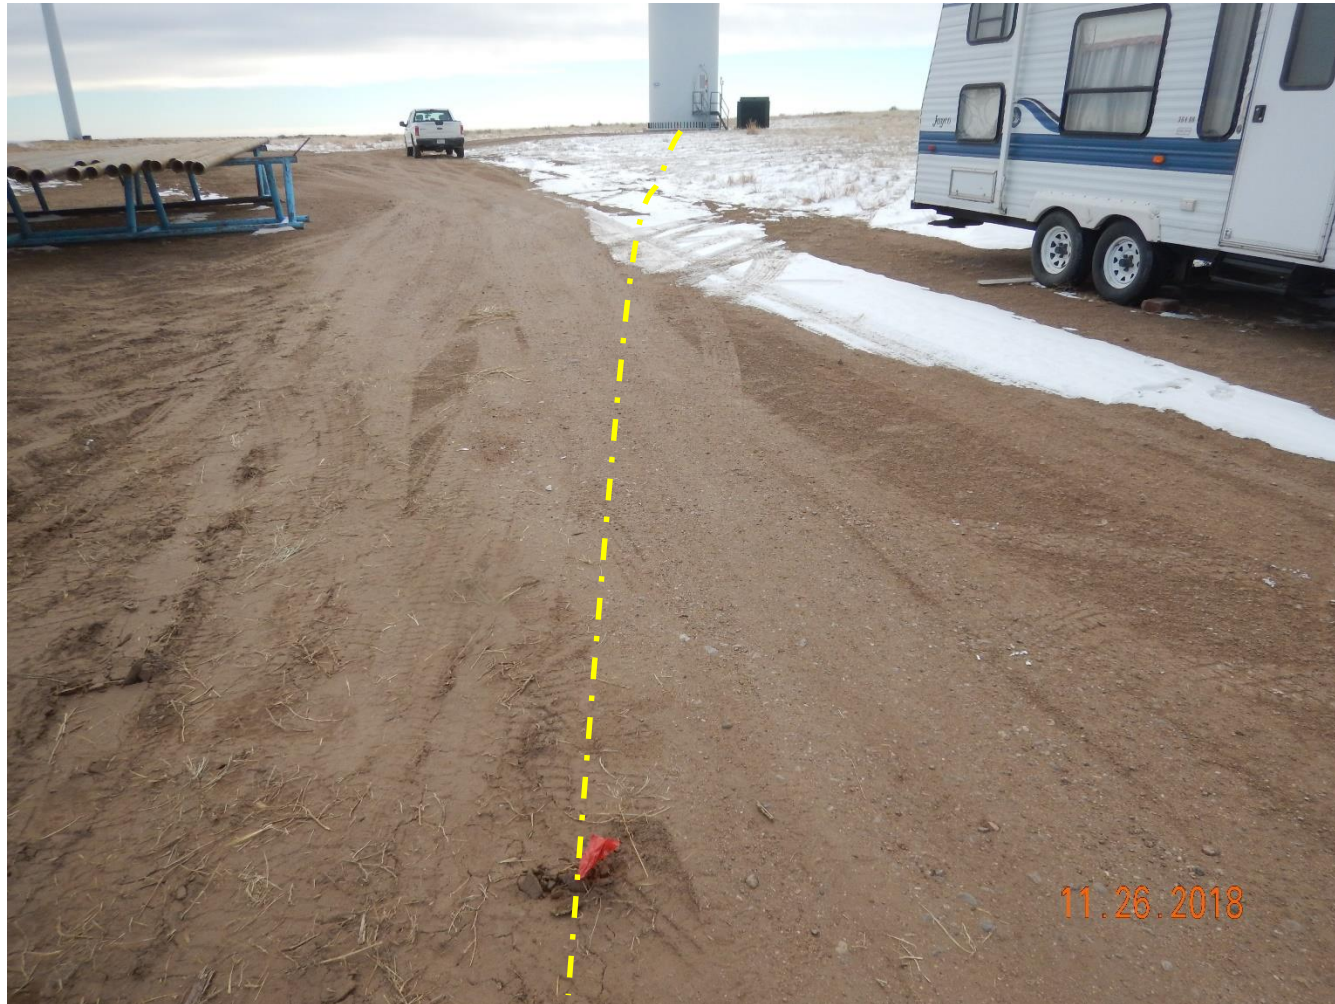
Photo 36: See comments under photo 33

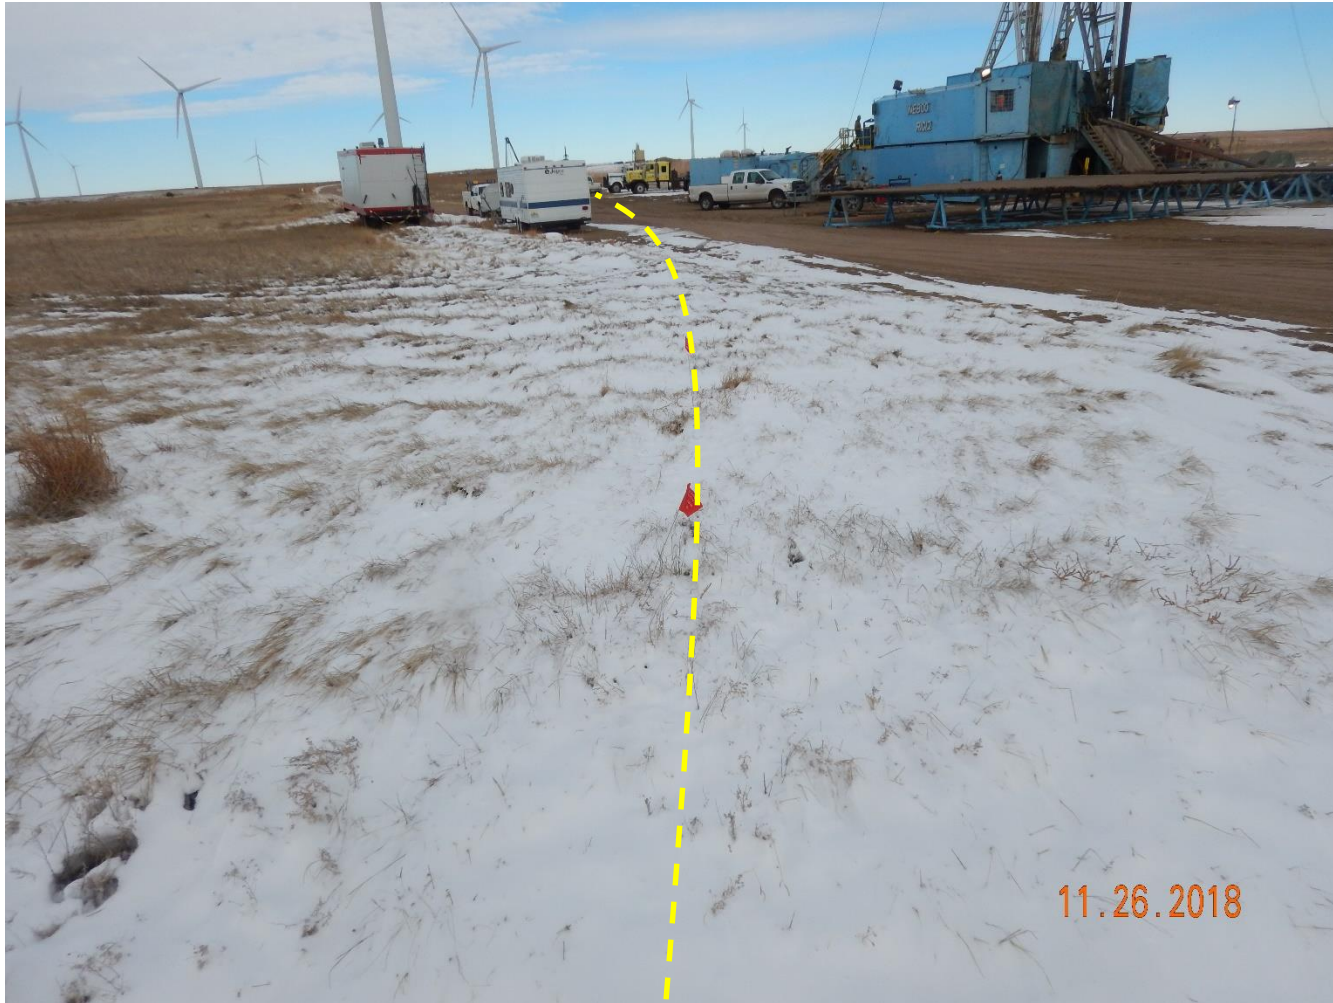
Photo 37: See comments under photo 33

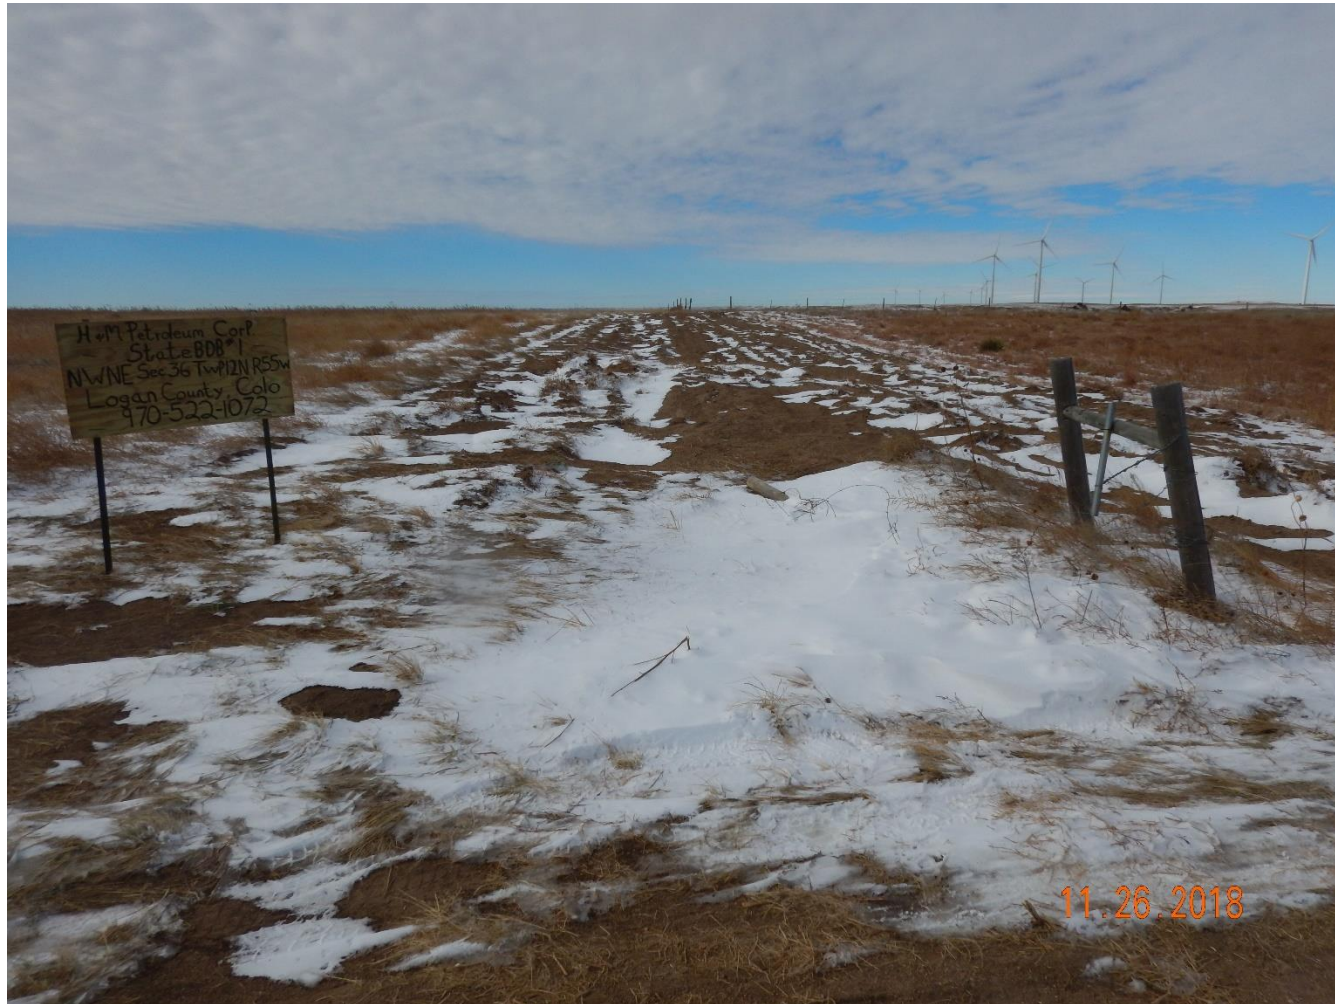
Photo 38: Photo taken from the access road, north of the location facing west. Photo shows areas where soil that was brought onto the pad was salvaged from.

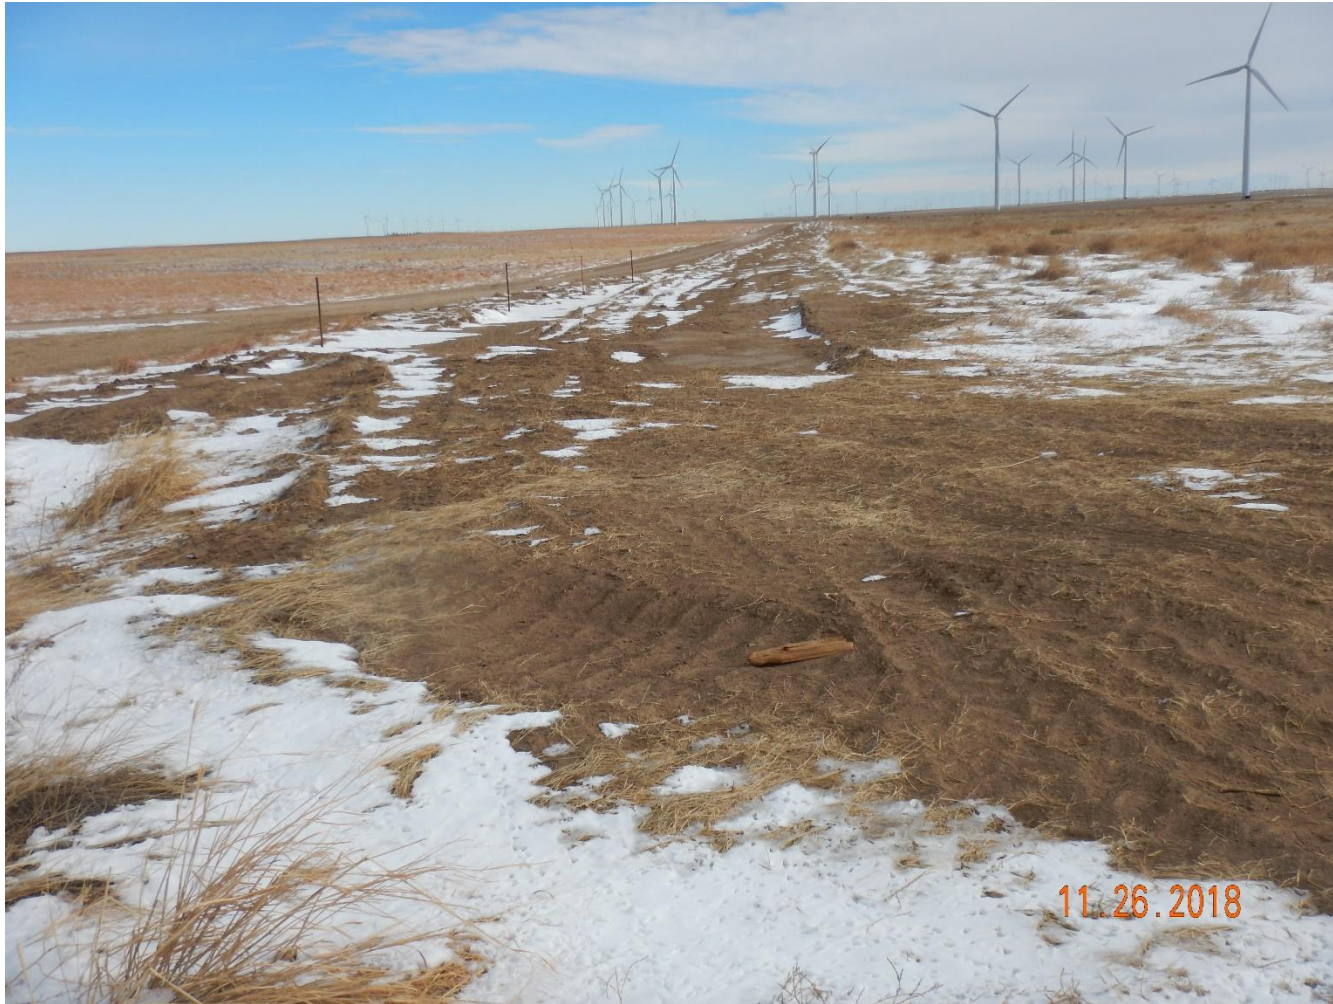
Photo 39: Photo taken from the access road, north of the location facing east. Photo shows areas where soil that was brought onto the pad was salvaged from.
