Inspection Photos

Operator: Petrox Resources

API: 05-007-06316

Date: 11/06/2018

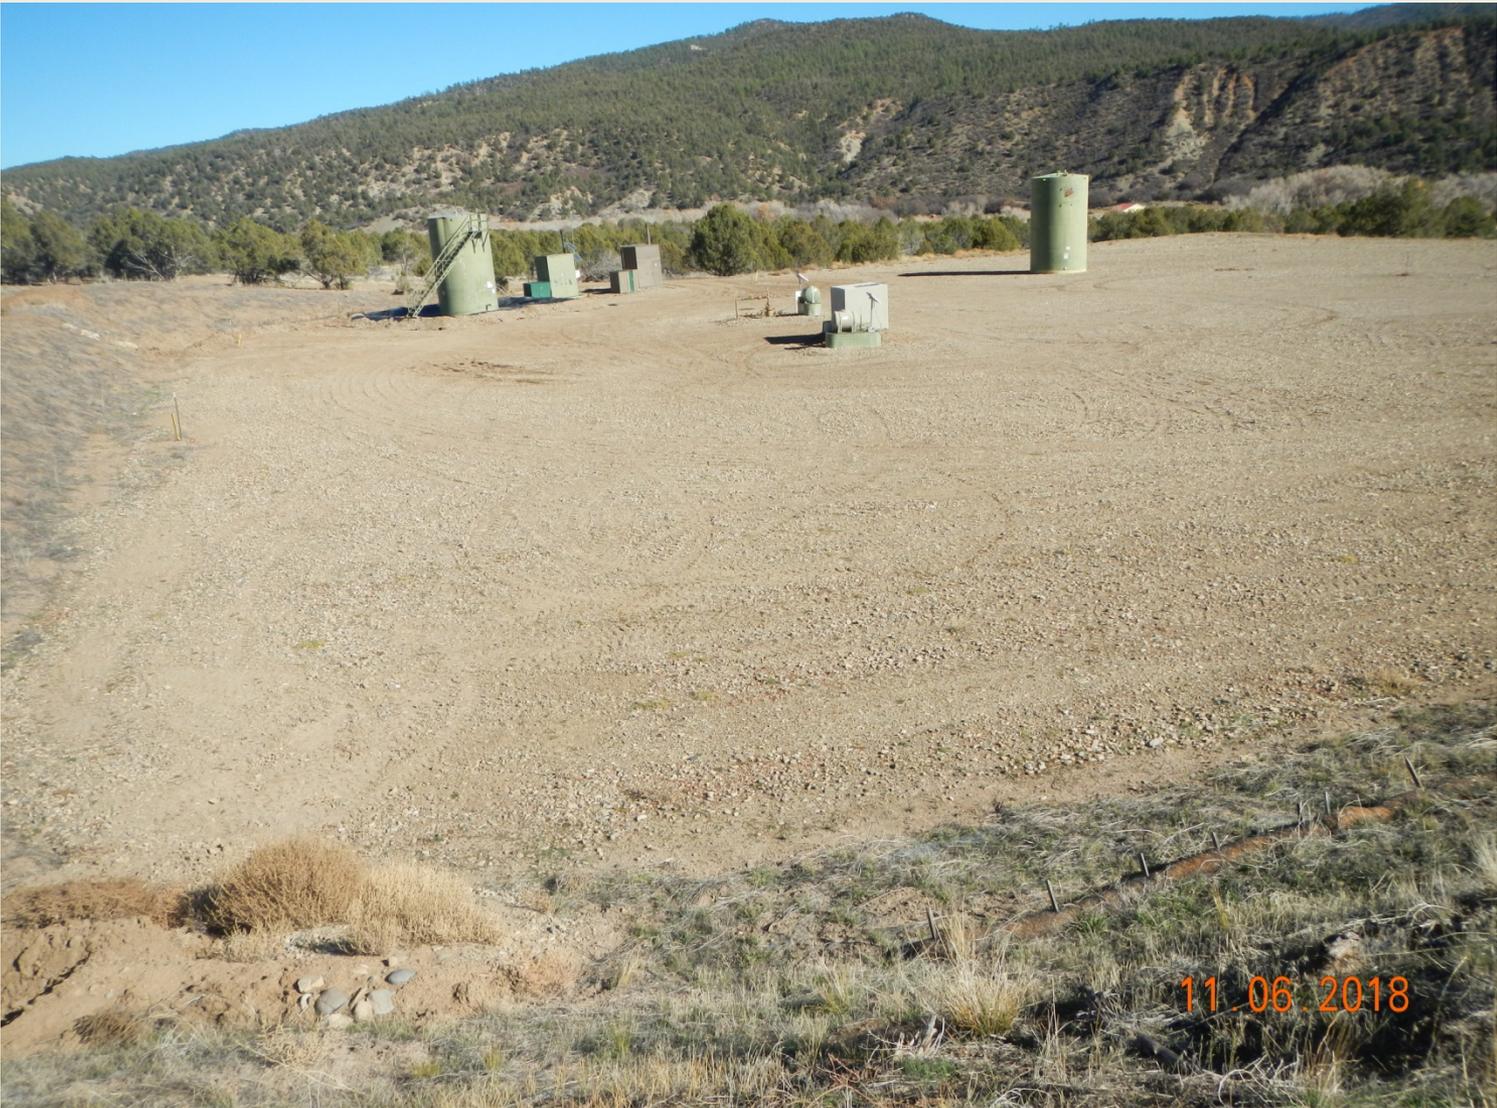
Photo 1. View of the project area from the western corner facing center.

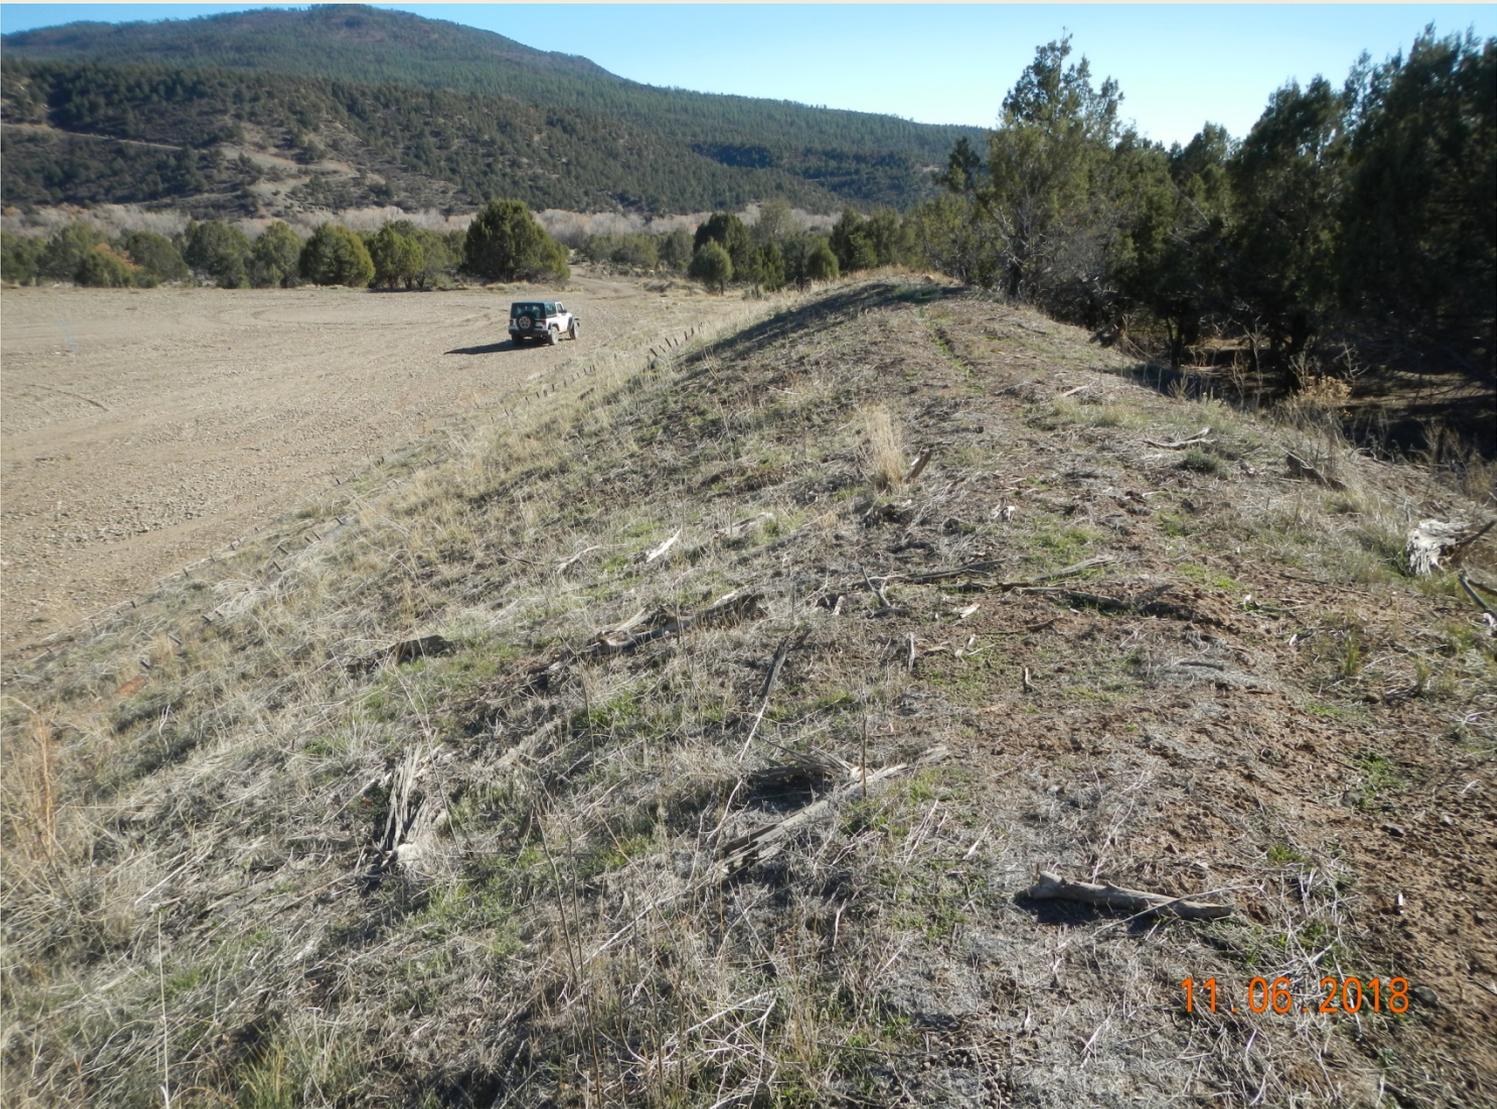
Photo 2. View of the western project area from the western corner facing southward. Some desirable vegetation is becoming established.

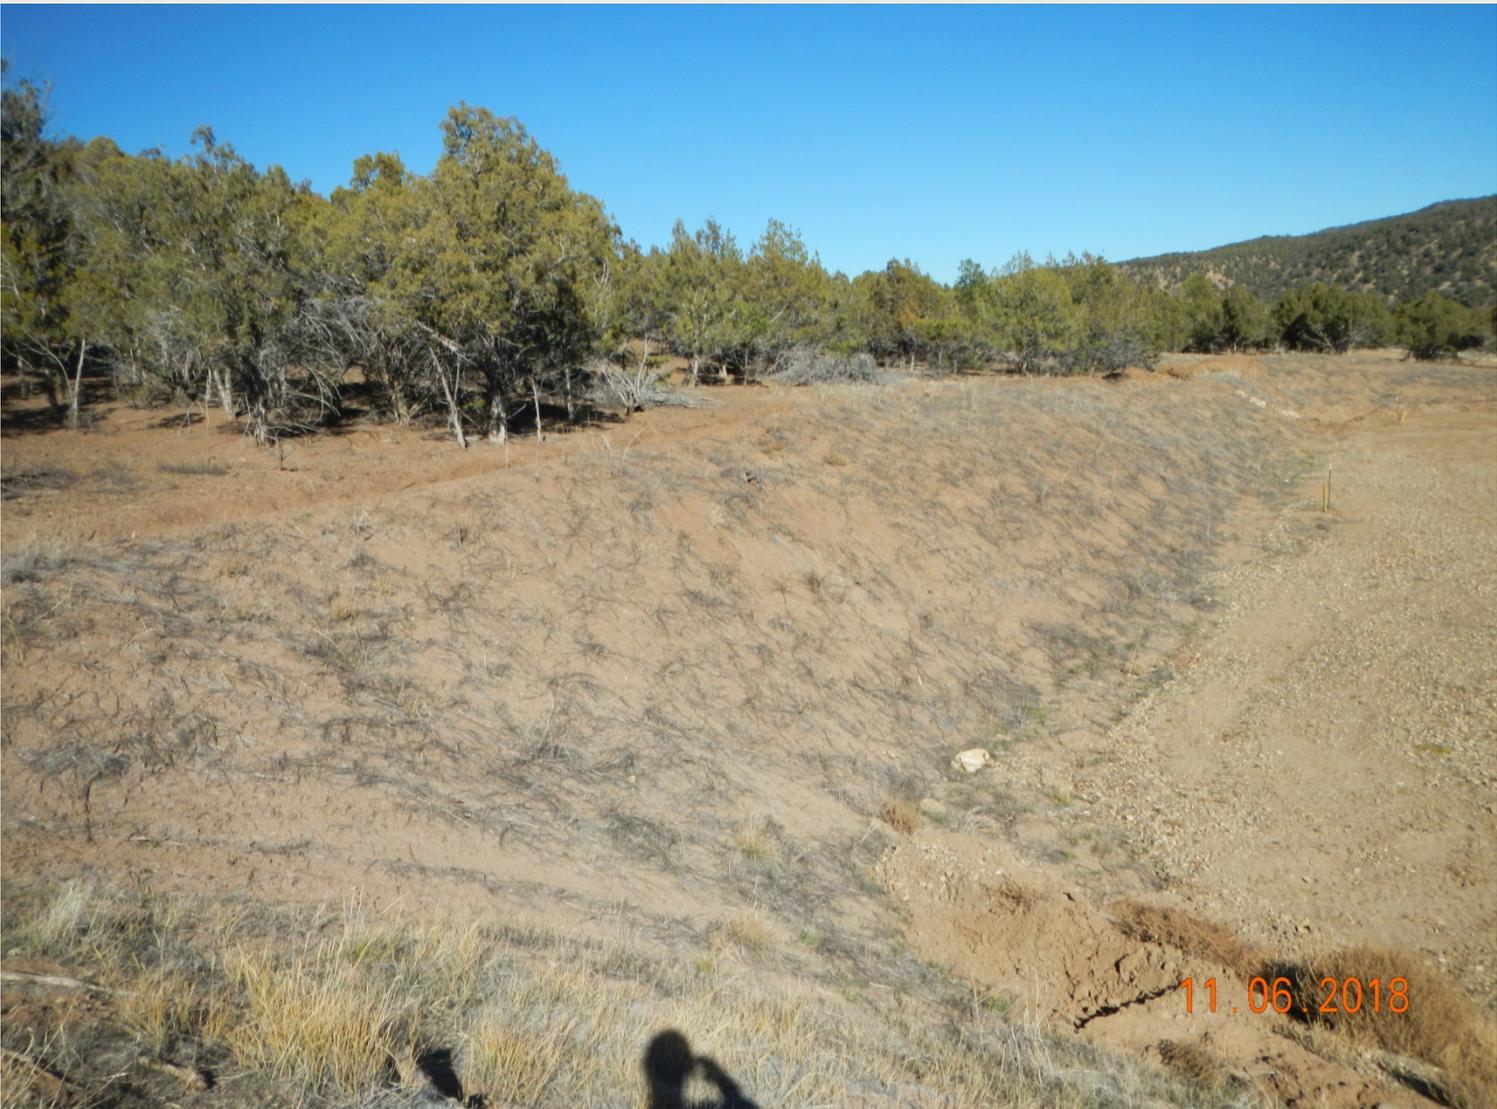
Photo 3. View of the northwestern project area from the western corner facing northeastward. Revegetation is sparse on this slope and needs to be monitored.

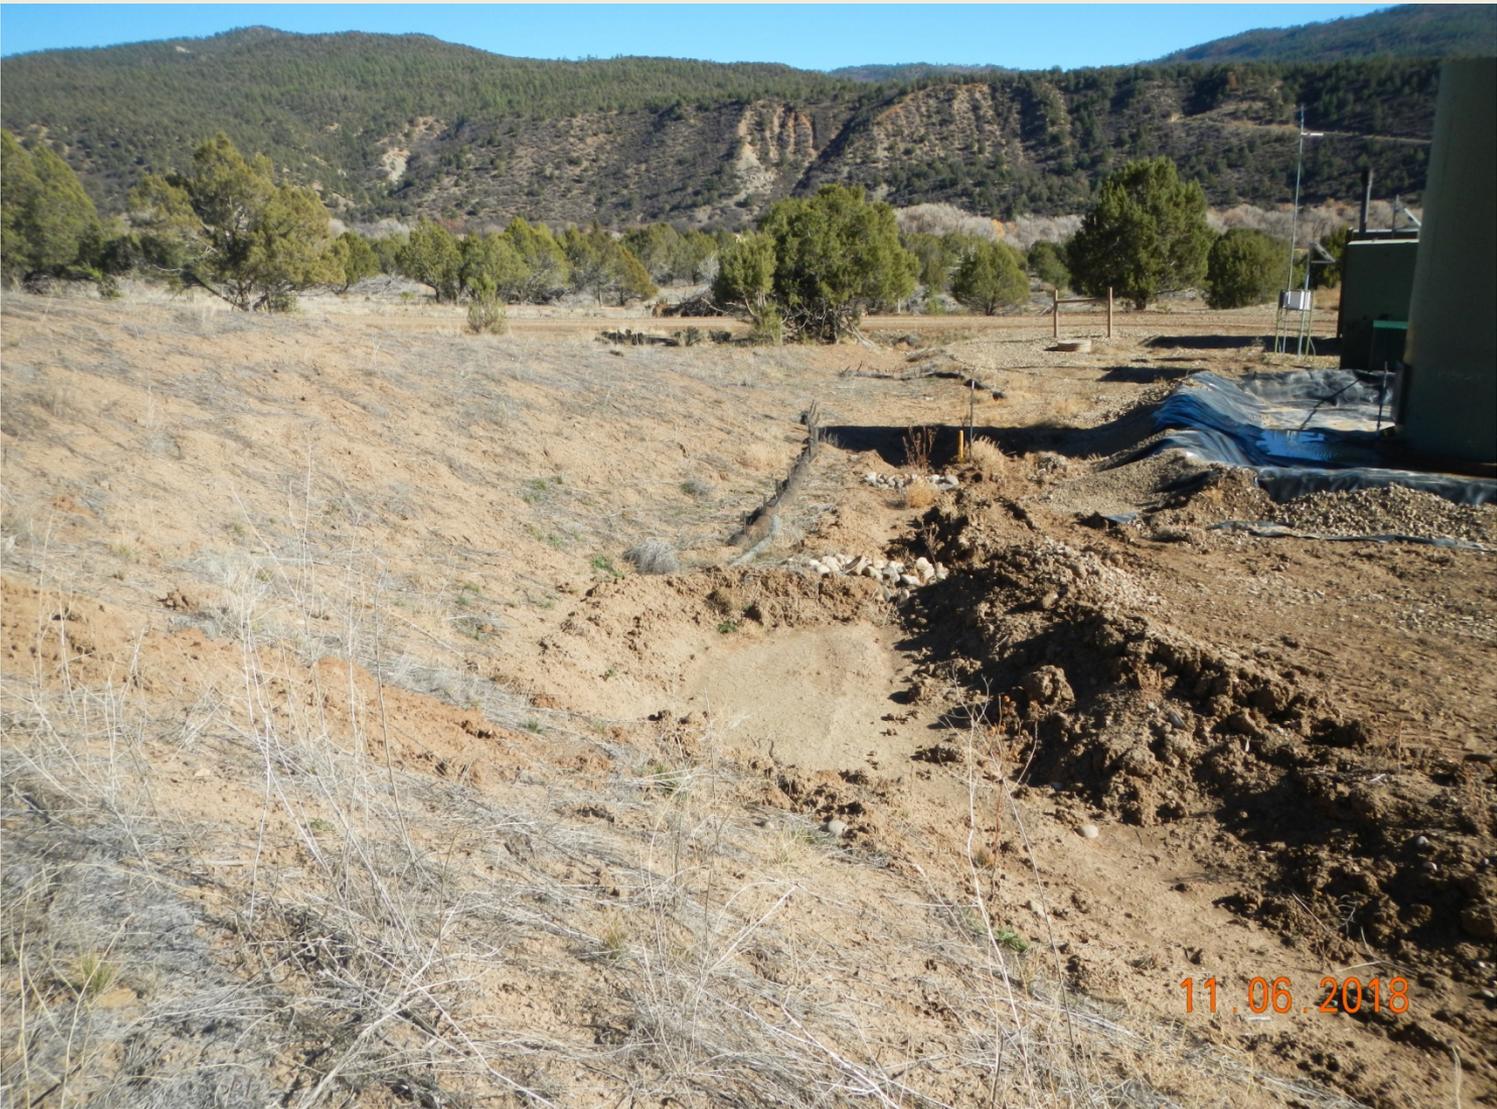
Photo 4. View of stormwater controls in the northeastern project area.

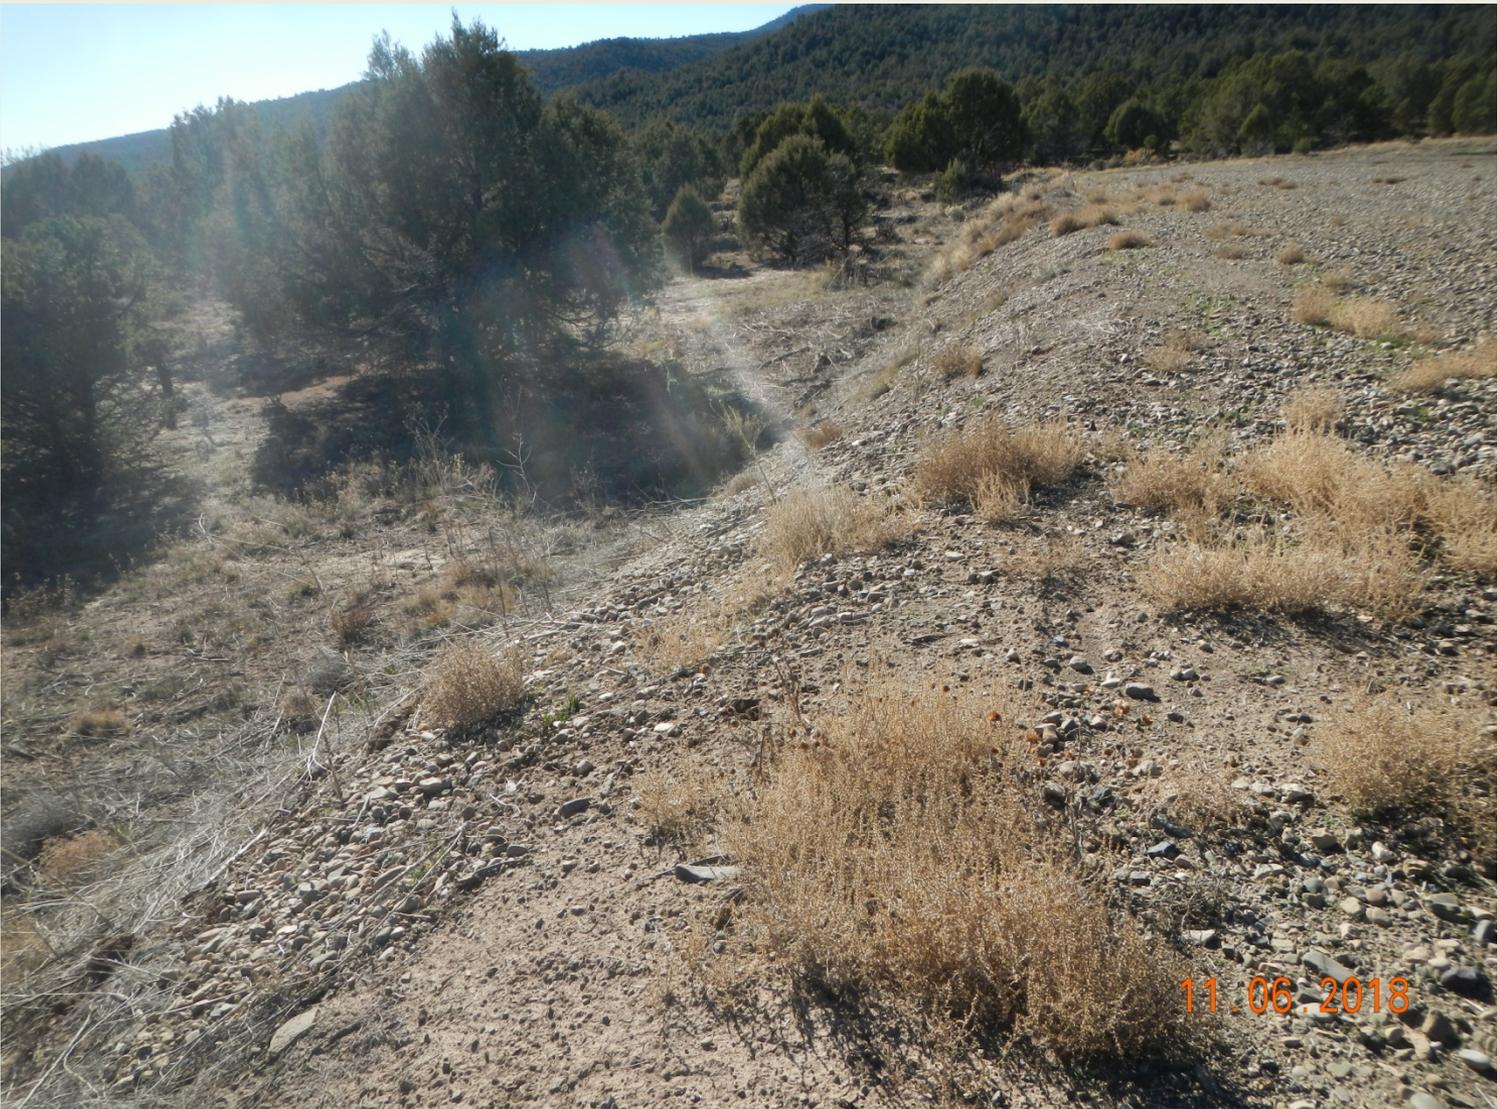
Photo 5. View of the southern project area from the southeastern corner facing southwestward.

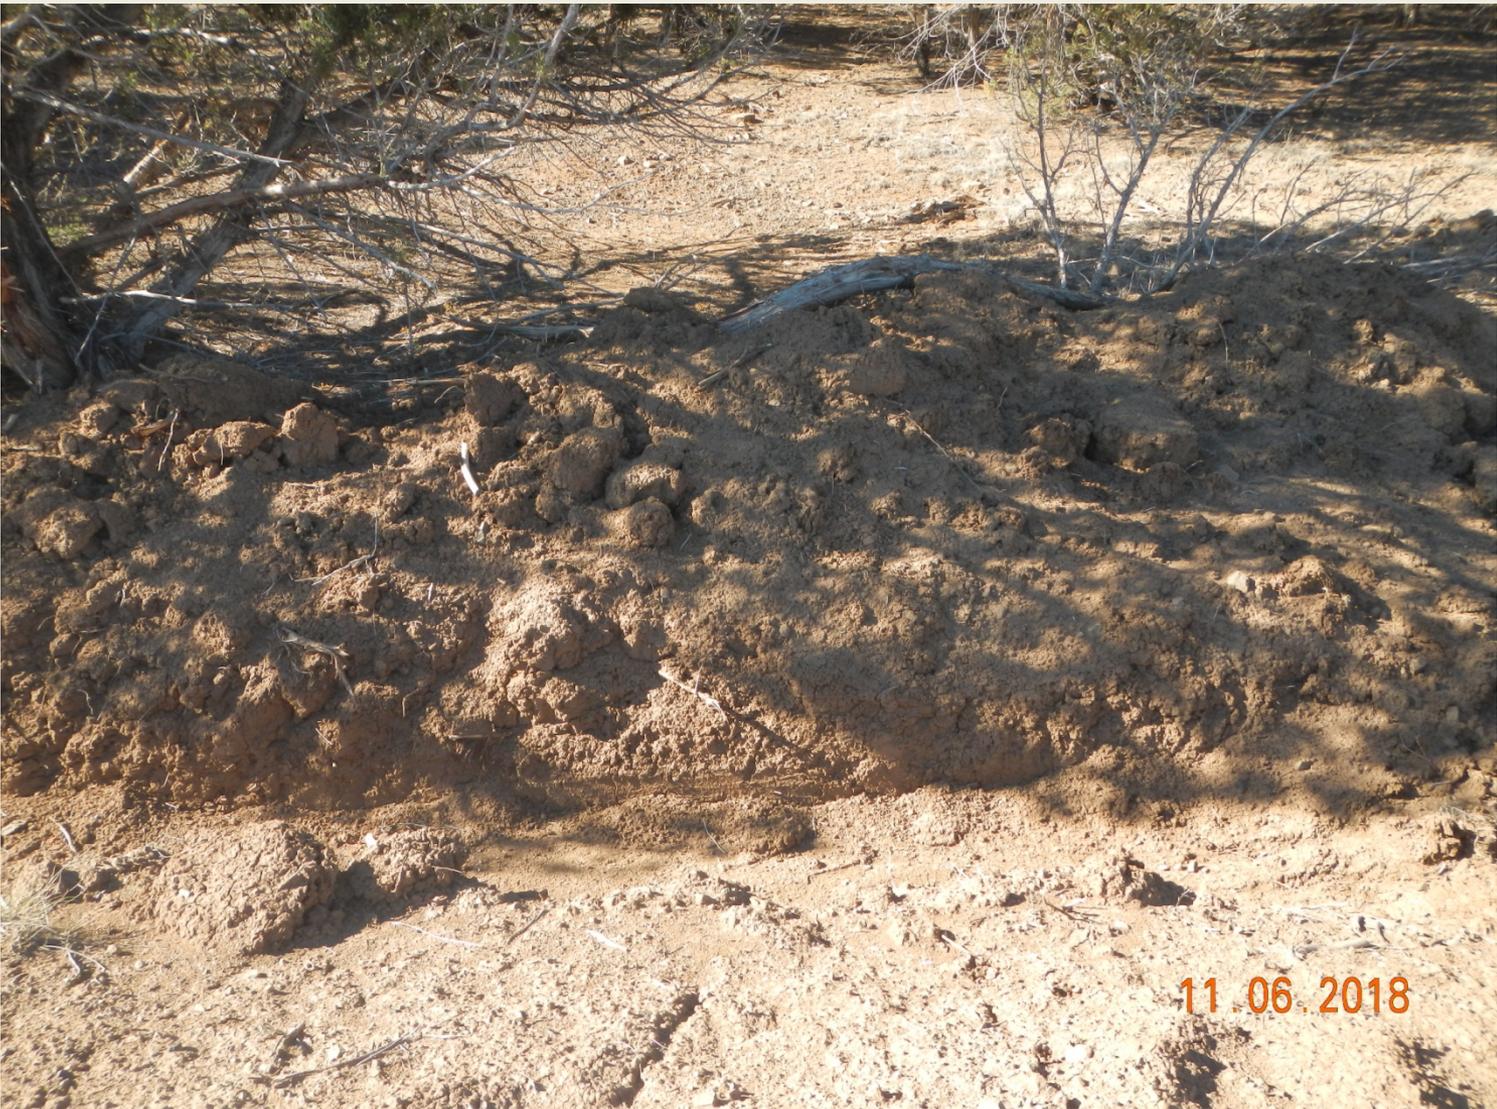
Photo 6. View of unstabilized soils in the northern project area diversion that appear to be discharged from ditch excavation. Erosion control measures such as revegetation need to applied to loose, disturbed soils.
