Inspection Photo (s)
Savage 41A-8
API # 05-045-18560
Inspection # 689302497

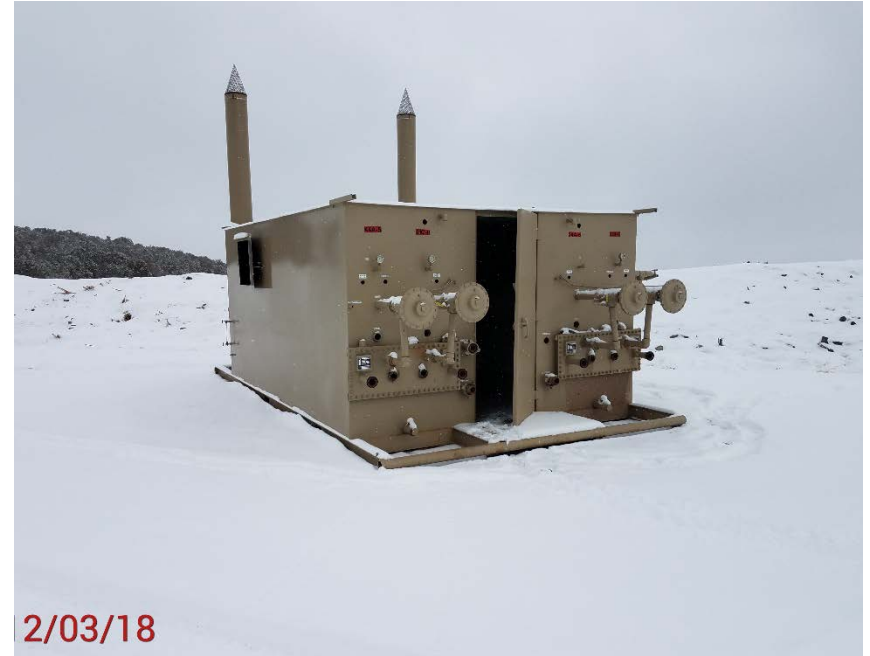
**Location Photo #4, unused equipment on
North side of location.**

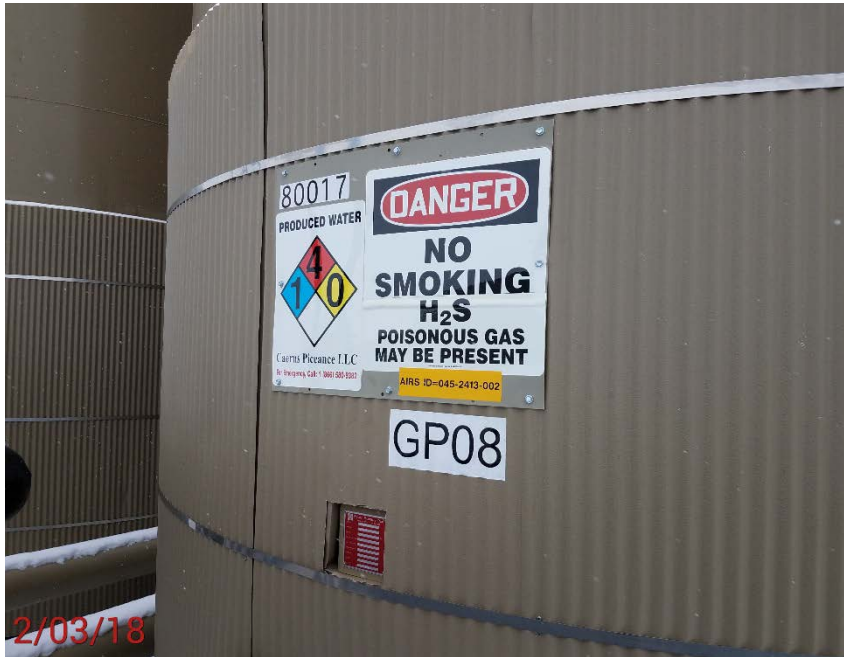
Location Photo #5, missing barrel capacity on all tanks within battery.

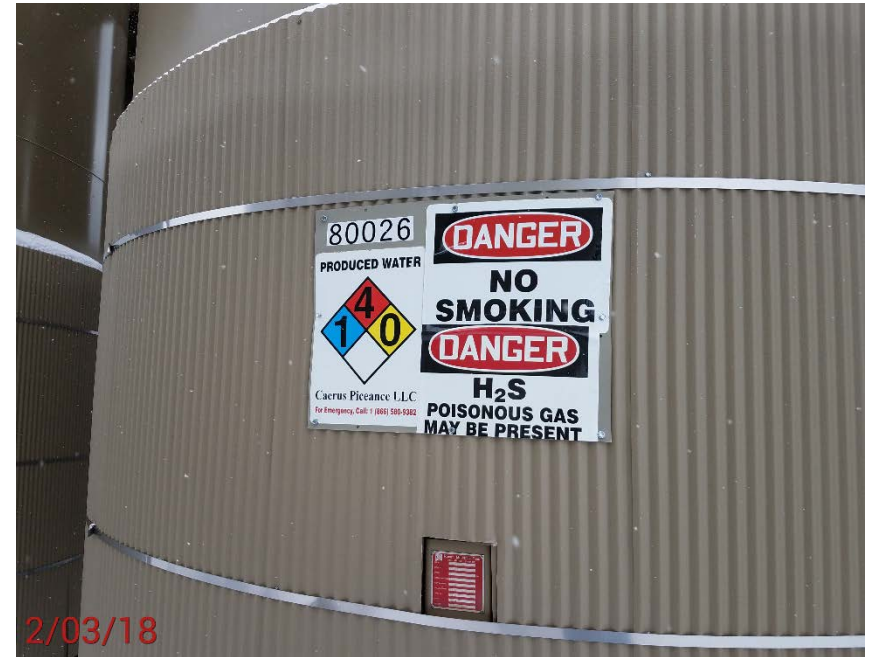
Location Photo #6, missing barrel capacity on all tanks within battery.

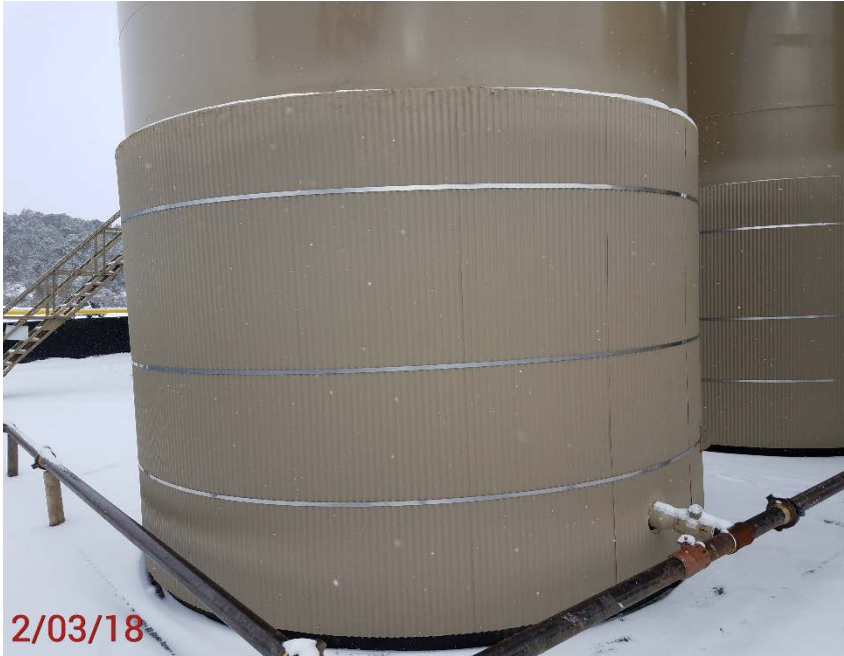
Location Photo #7, Missing information on 5 tanks in the battery.

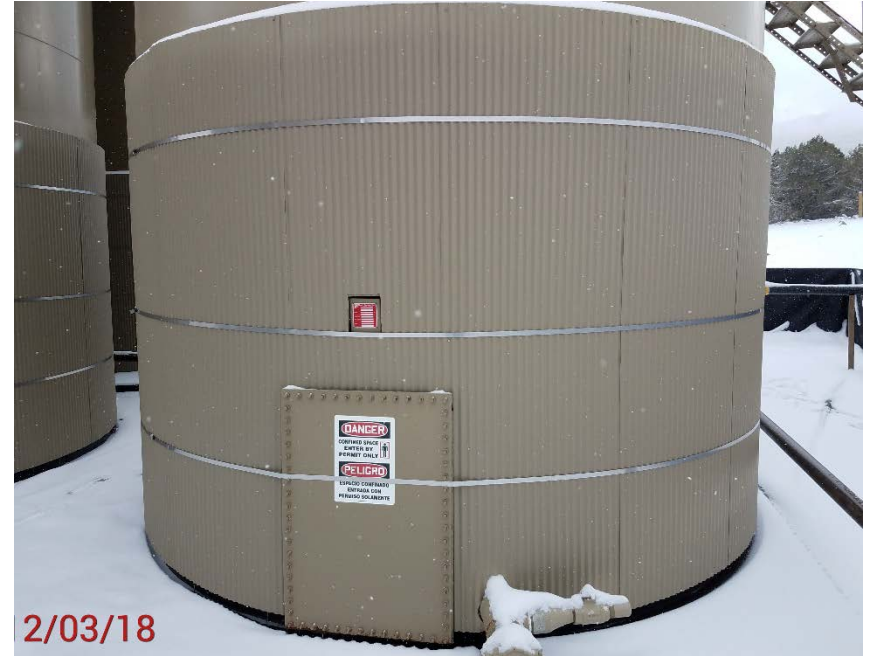
Location Photo #8, Missing information on 5 tanks in the battery.

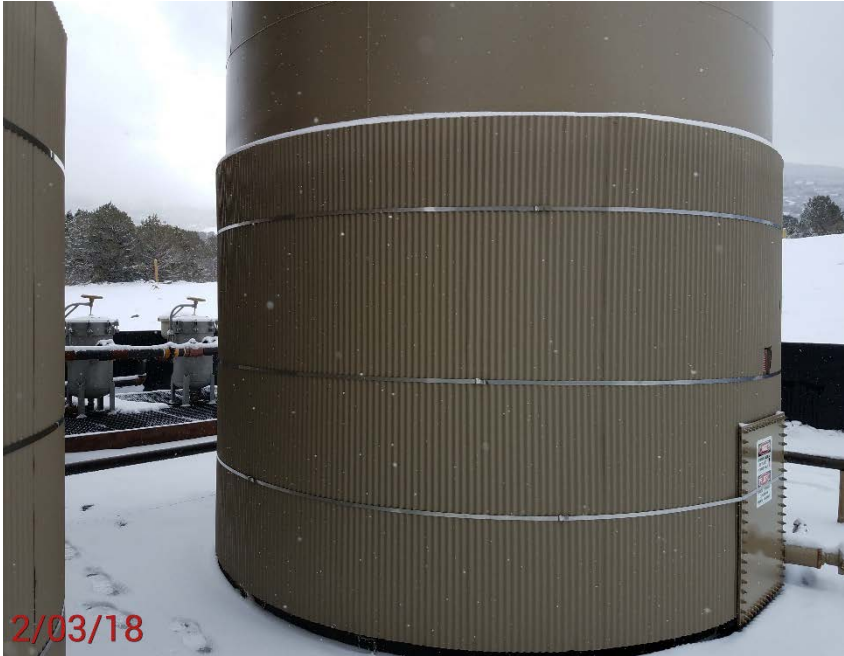
Location Photo #9, Missing information on 5 tanks in the battery.

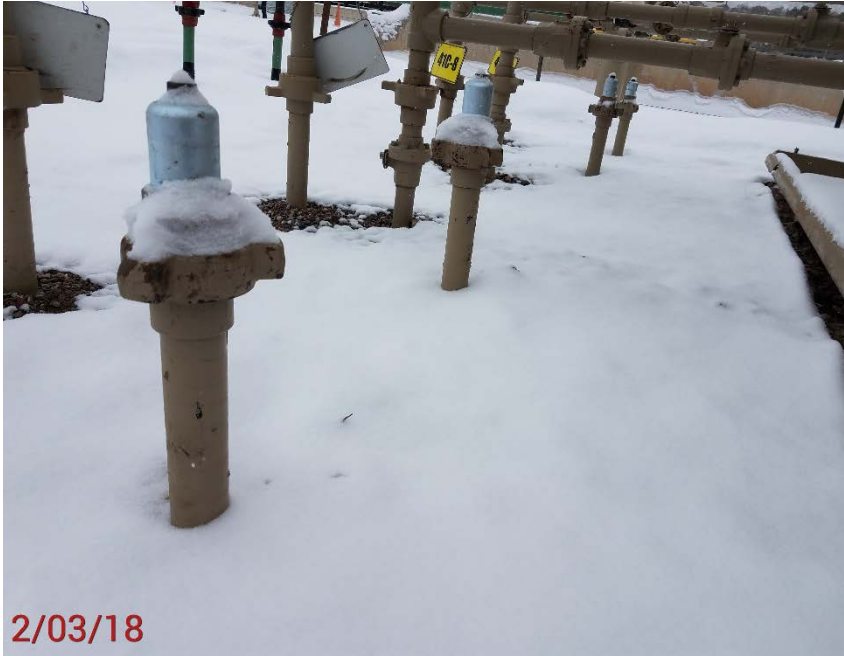
Location Photo #10, Unmarked flow lines

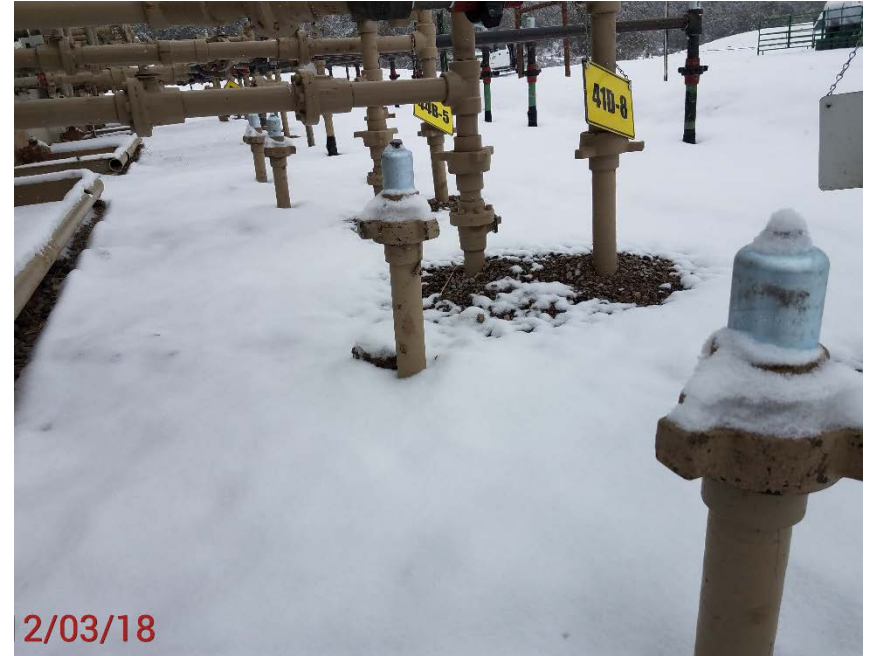
Location Photo #11, Unmarked flow lines

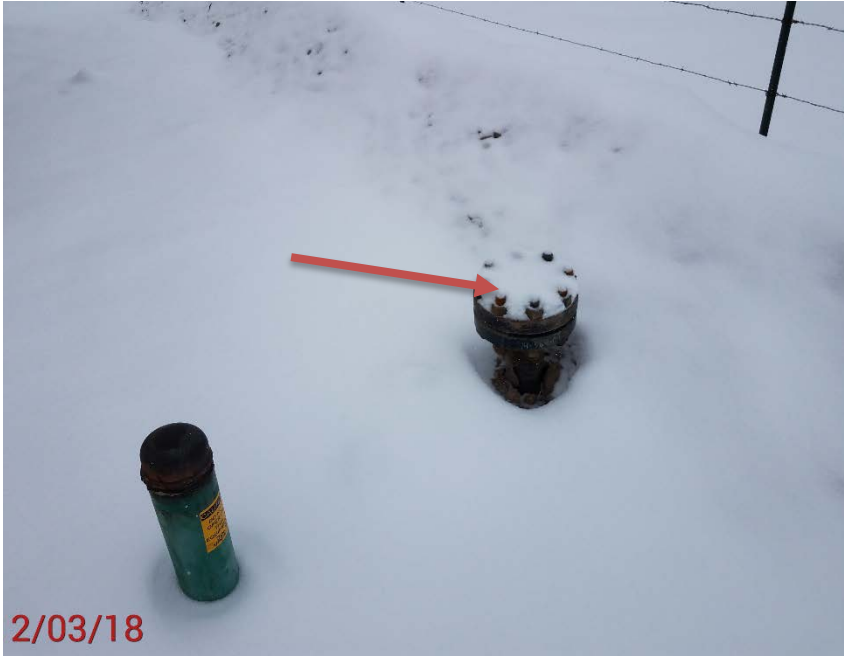
Location Photo #12, unmarked flow line.

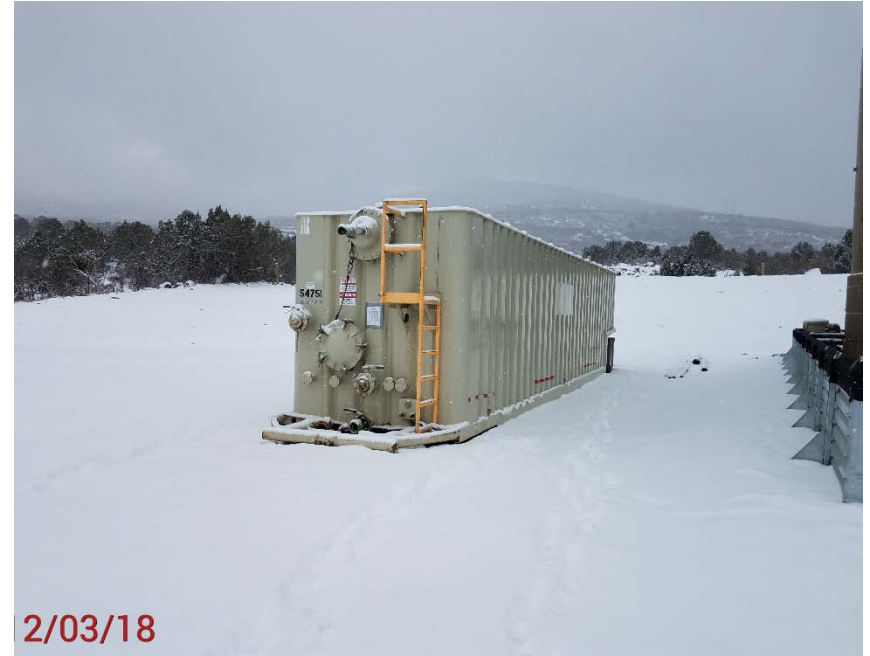
Location Photo #13, Unused 500 bbl frac tank.

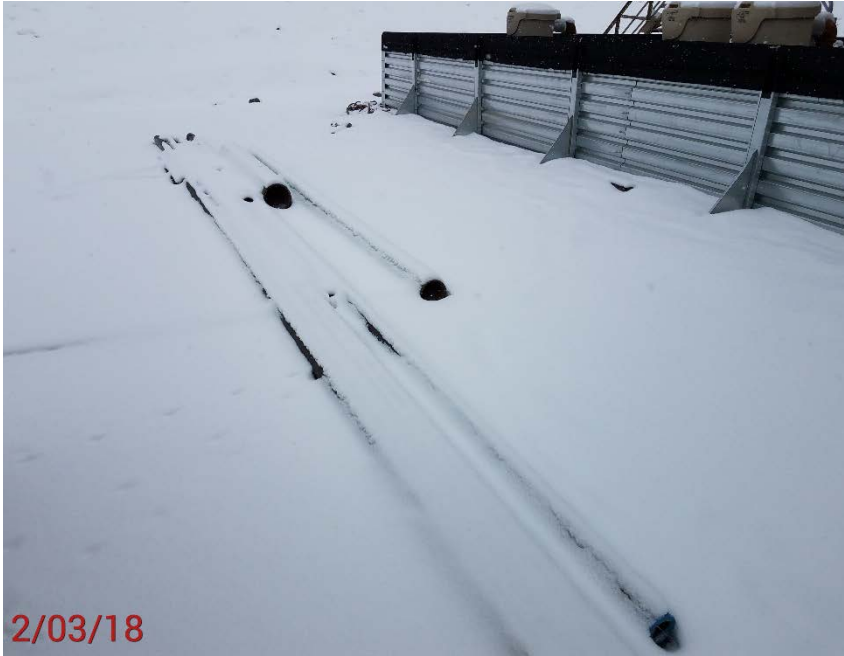
Location Photo #14, unused pipe on East side of battery containment.

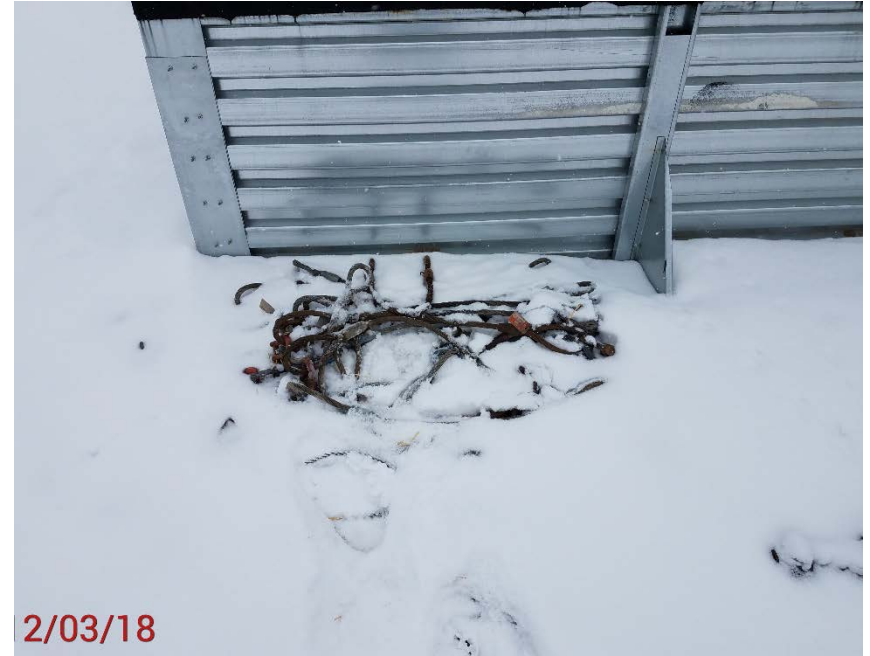
Location Photo #15, Cable restraints on East corner of battery containment.
