Inspection Photos

Operator: BP Production

API: 05-067-09267

Date: 11/9/2018

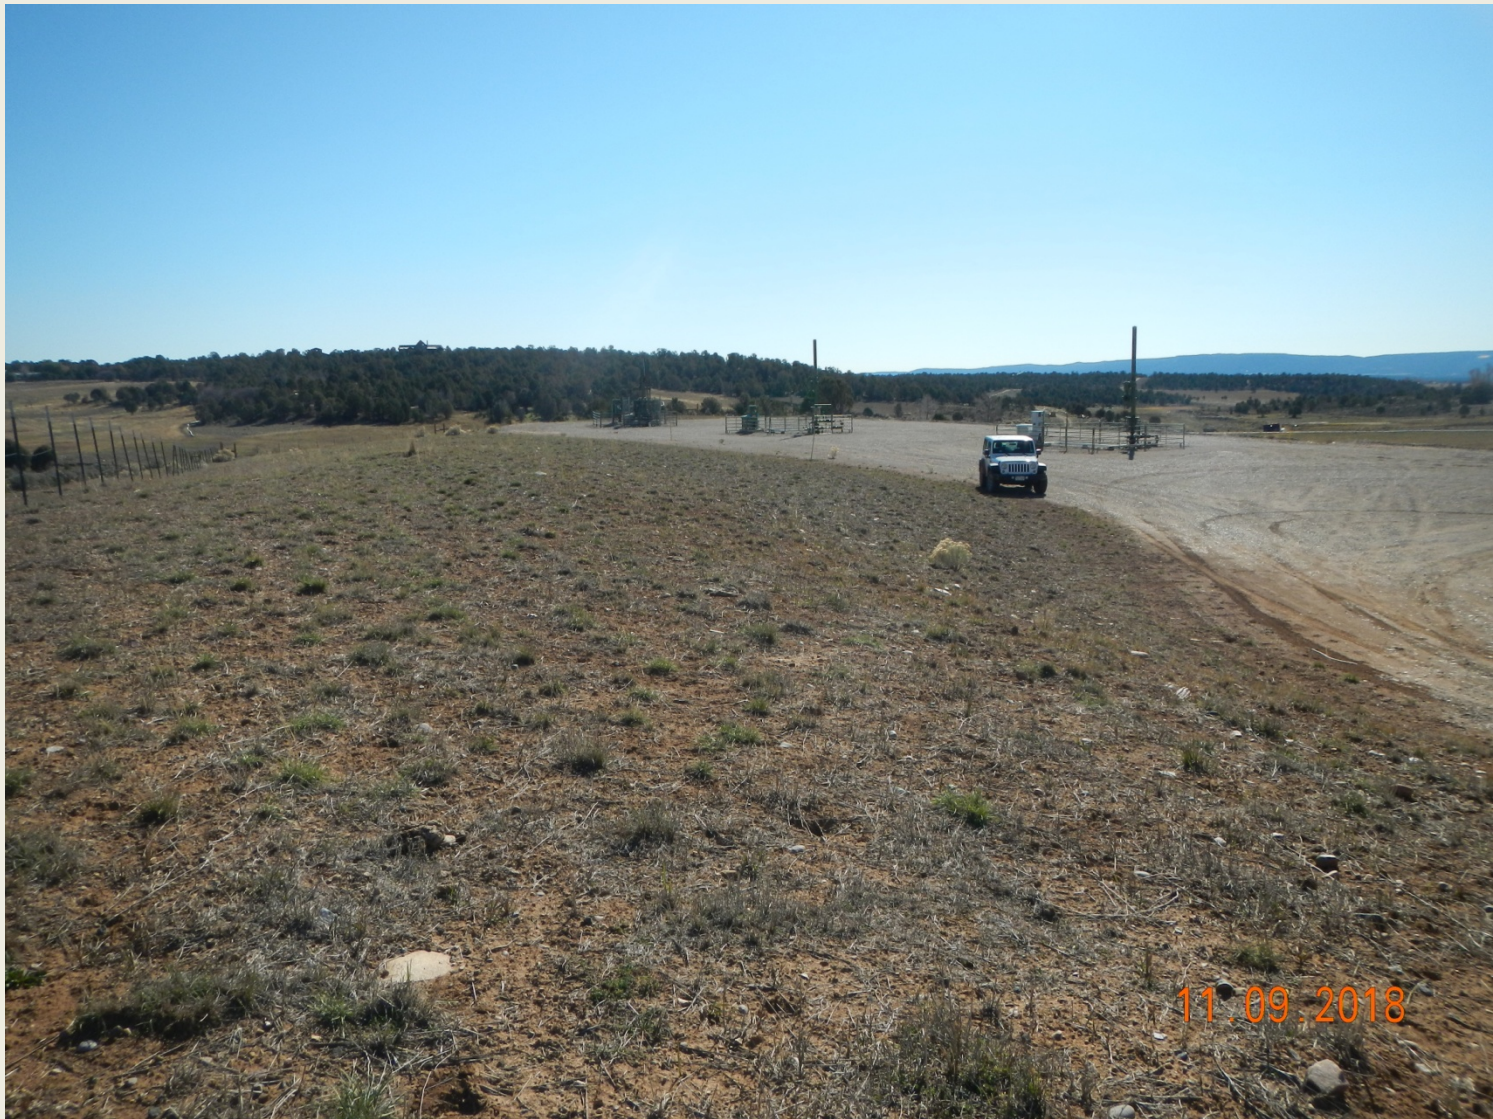
Photo 1. View of the project area from the northwestern edge facing center.

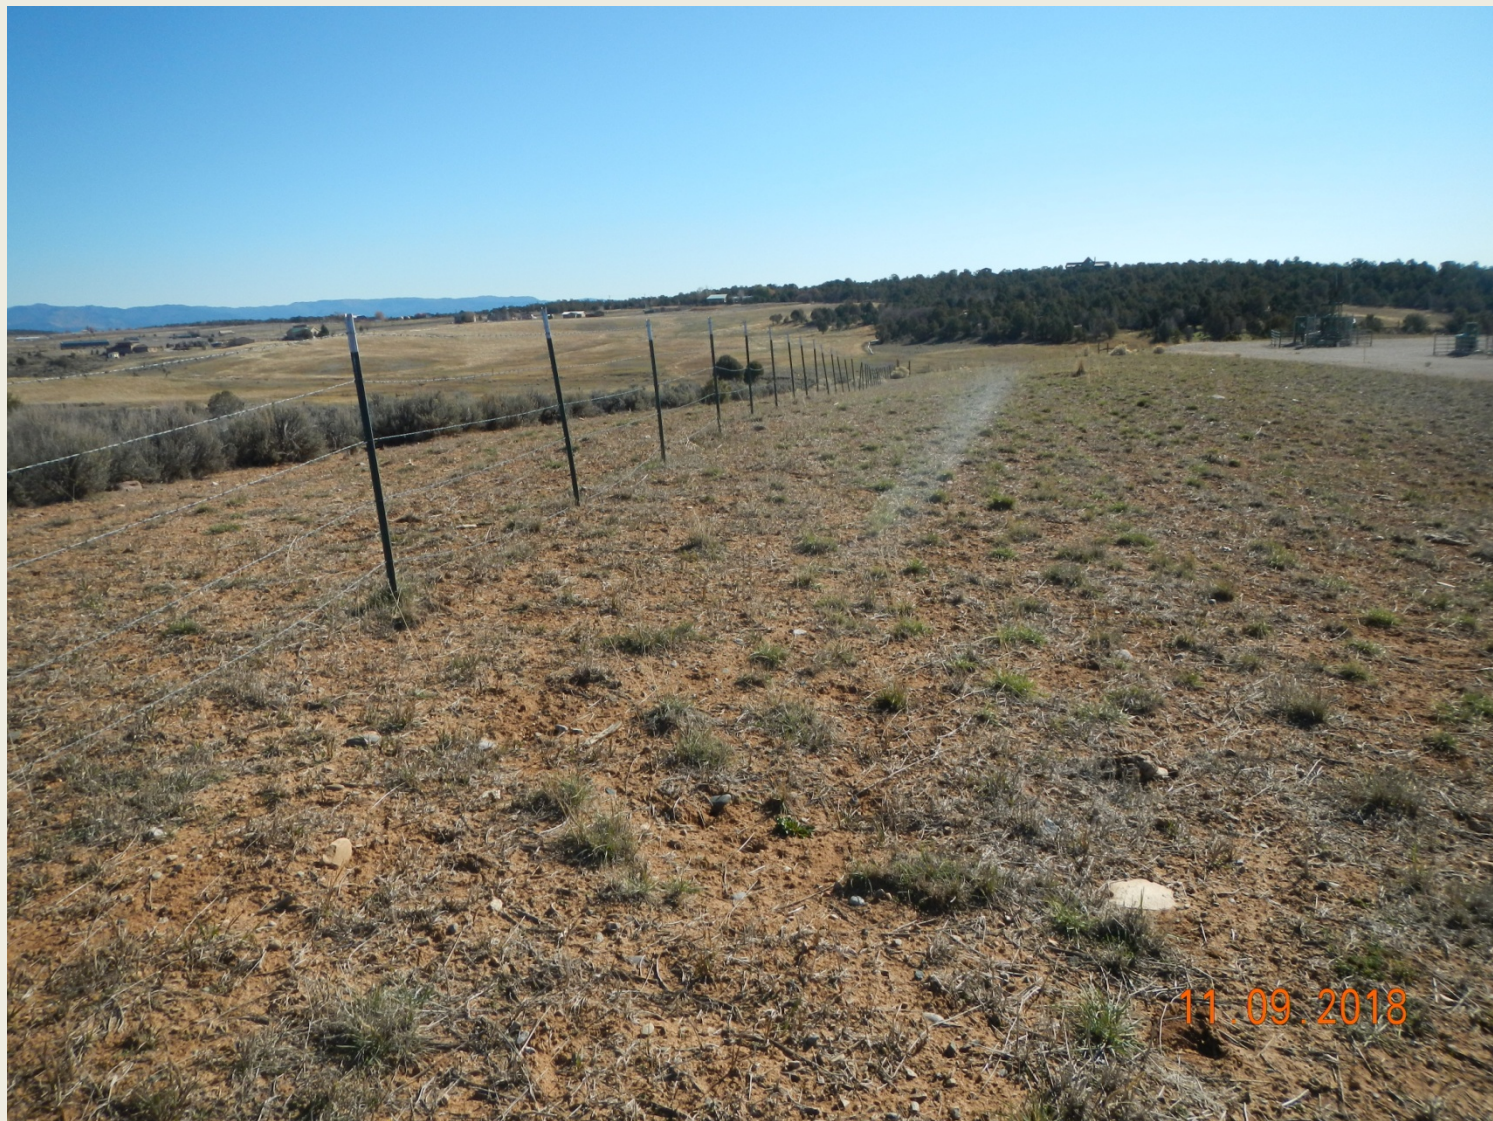
Photo 2. View of the northern project area from the northwestern corner facing southeastward. Revegetation is progressing with grasses such as intermediate wheatgrass (*Thinopyron intermedium*), and crested wheatgrass (*Agropyron cristatum*).

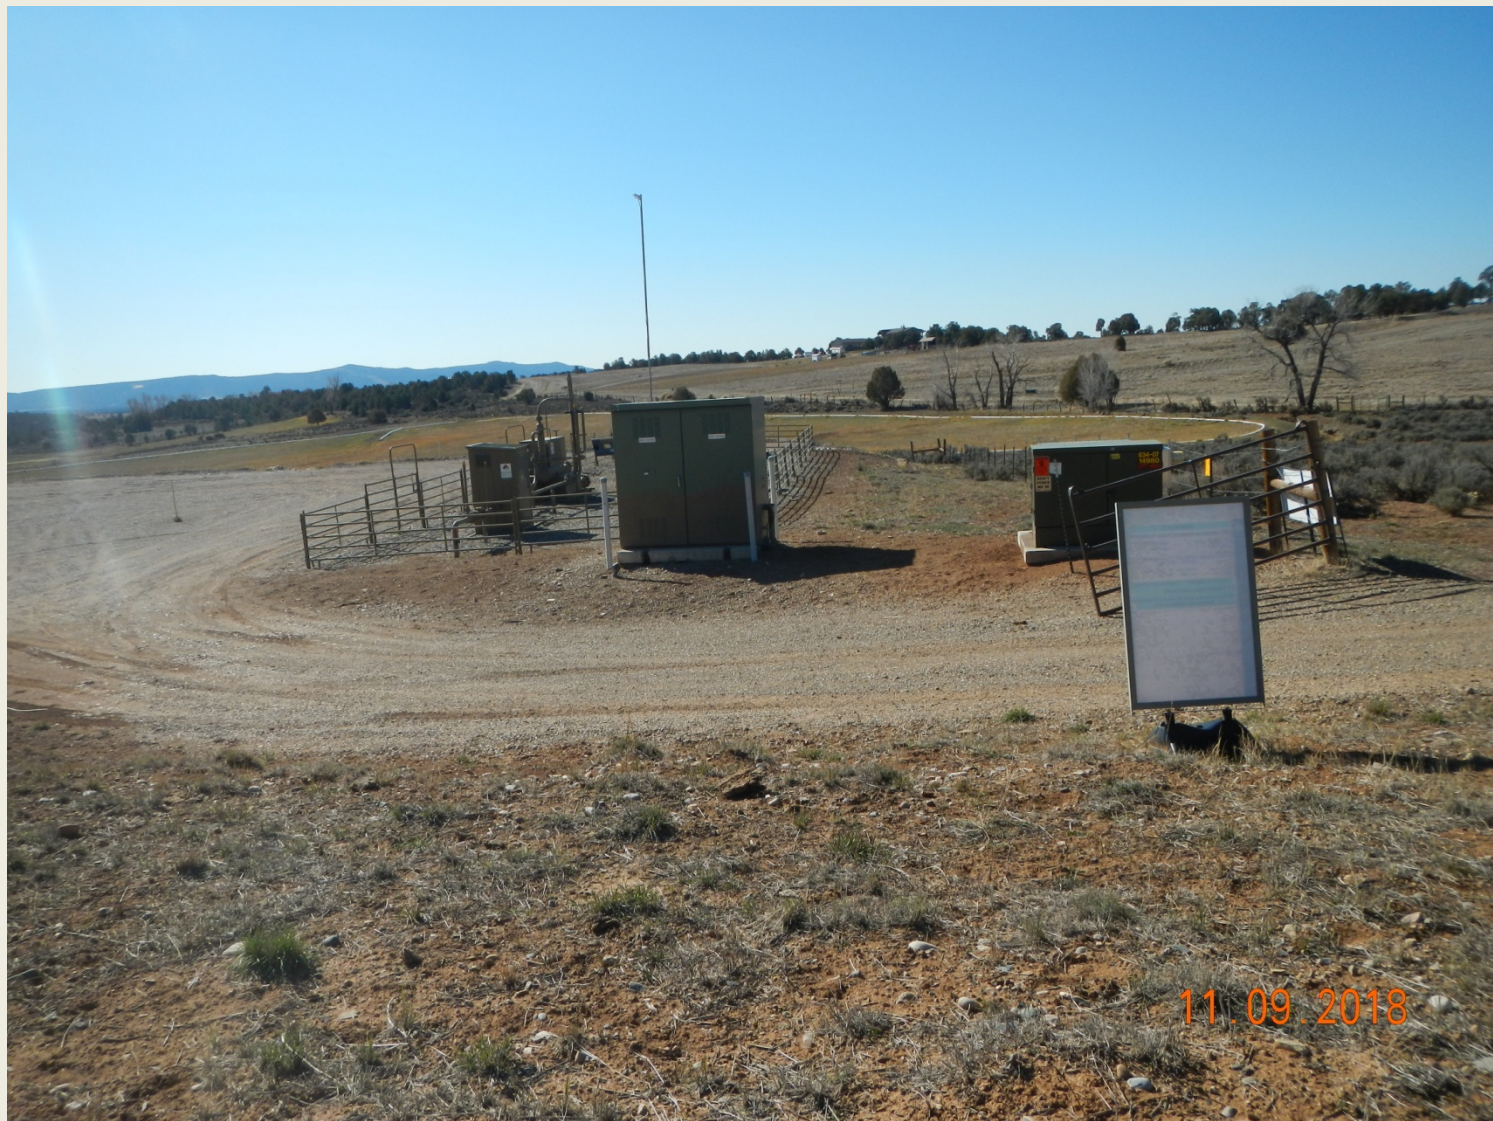
Photo 3. View of the western project area from the northwestern corner facing southwestward.

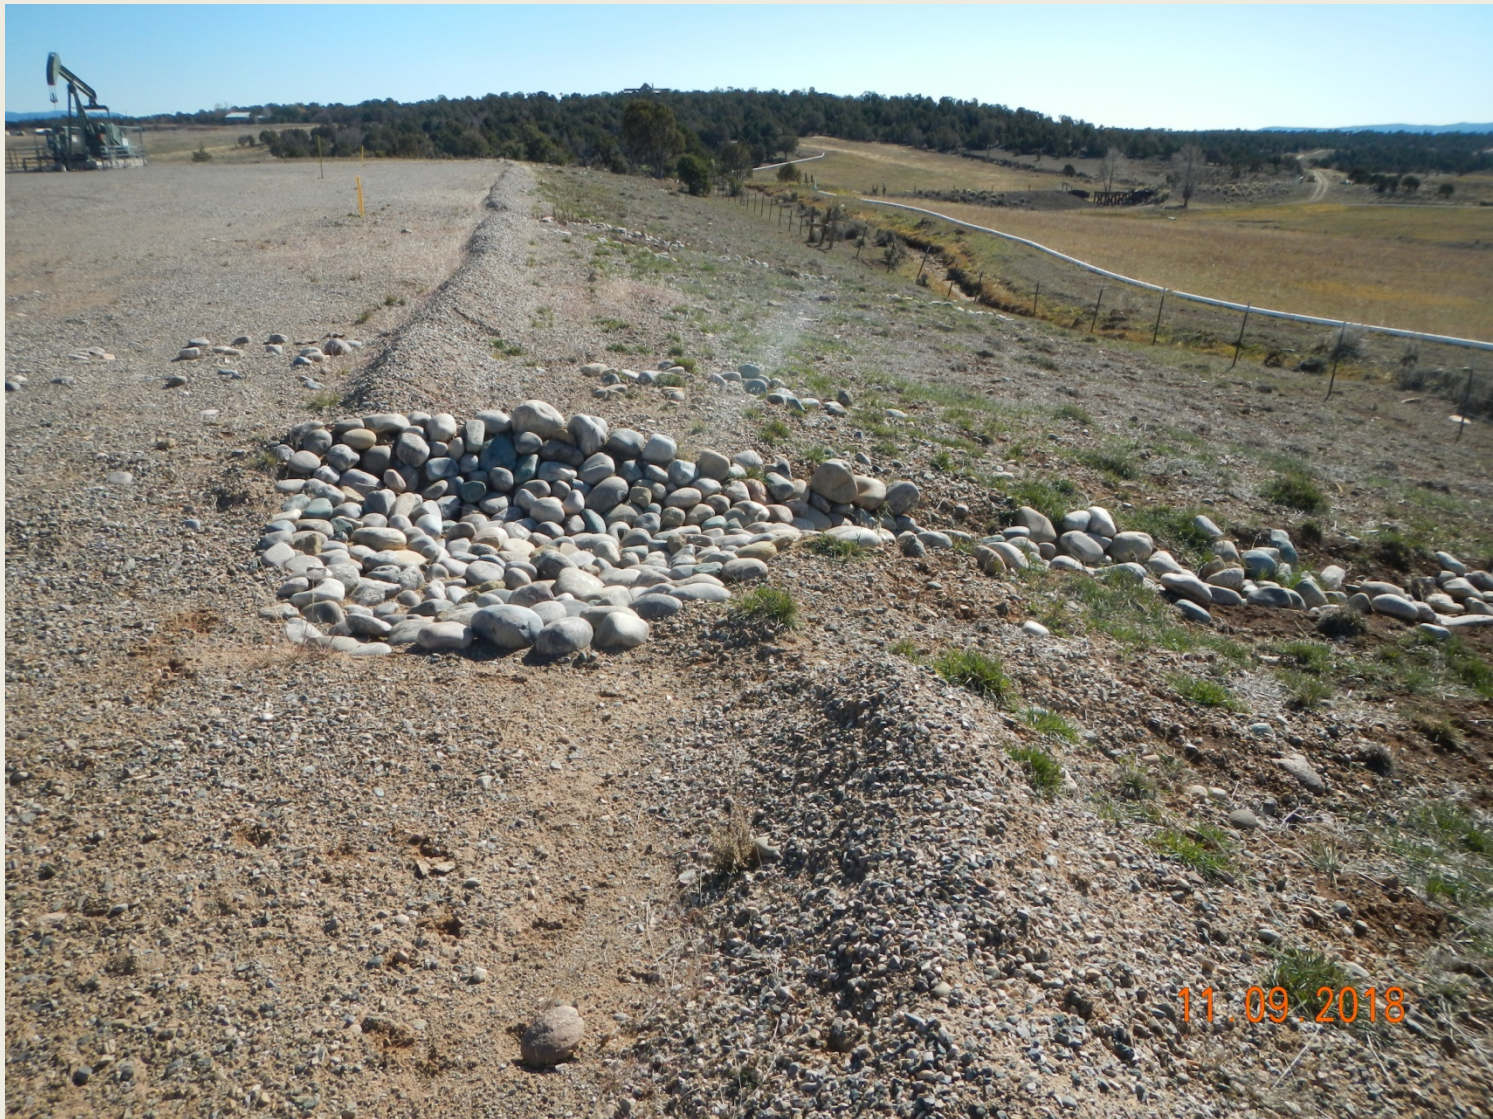
Photo 4. View of the southwestern project area from the southwestern corner facing southeastward. Irrigation ditch runs adjacent to southern and eastern edges of the project area.

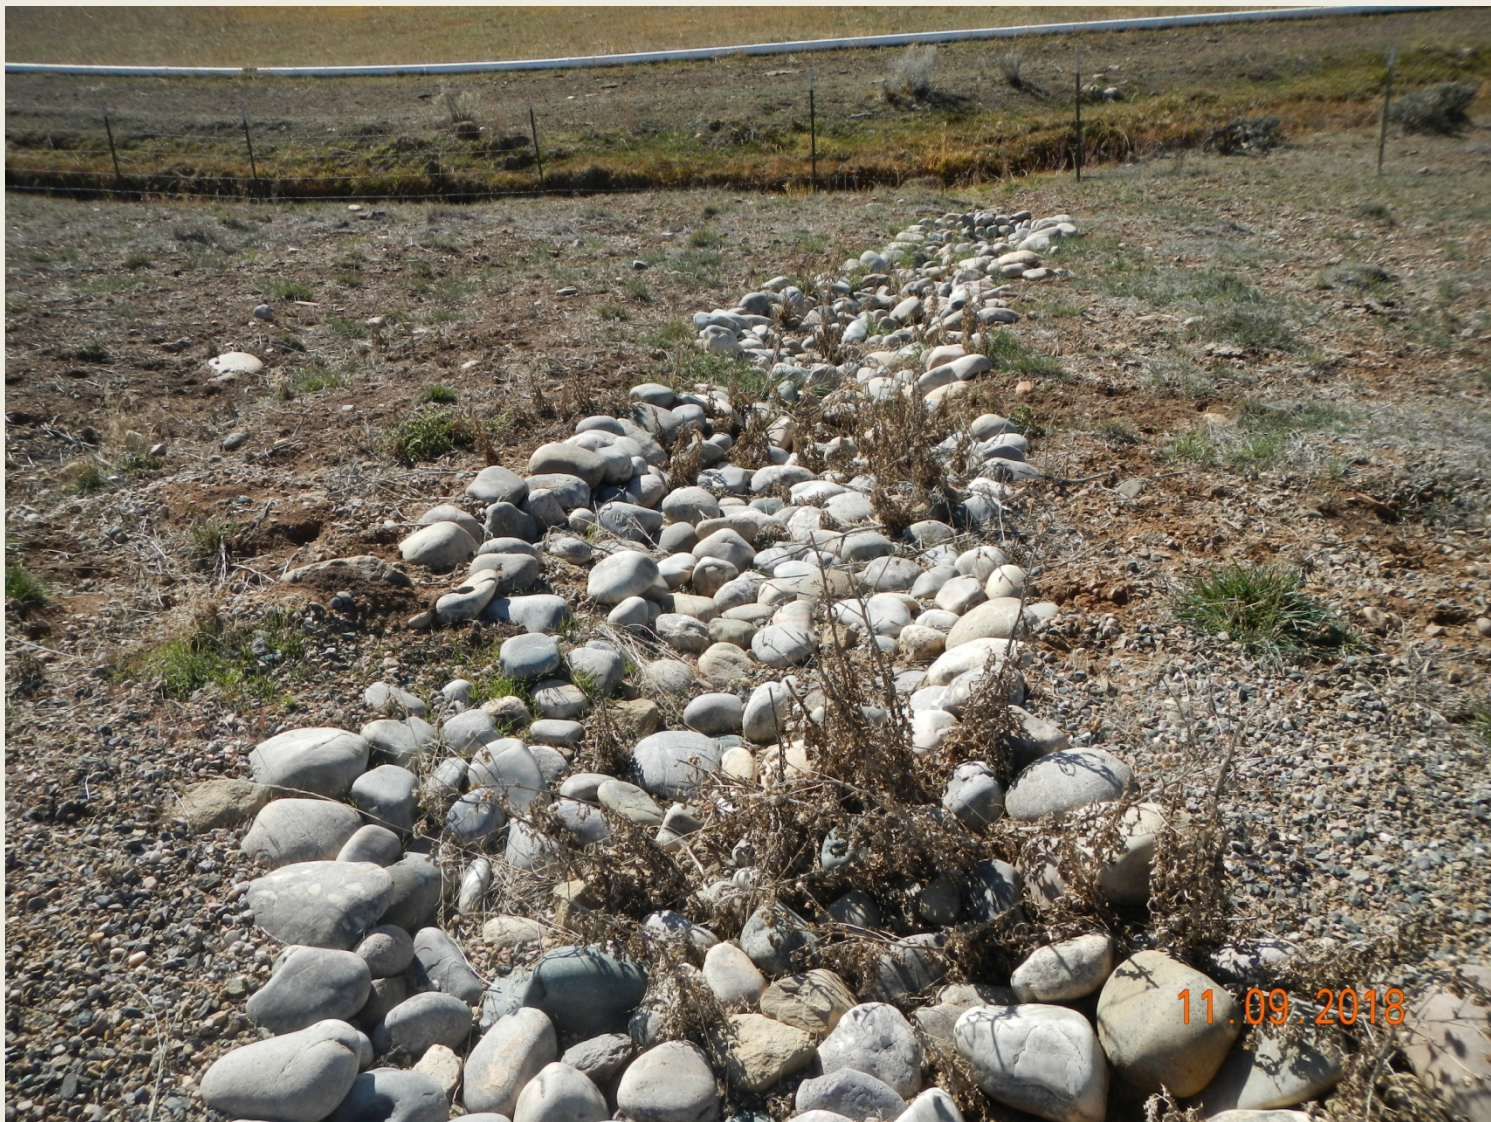
Photo 5. View of cobble rundown in the southwestern project area appears to be functioning at this time, but may soon require maintenance. Approximately 500 Canada thistles (visible in the cobble in the foreground) are growing within the southern interim reclamation areas.
