# Inspection Photos

Operator: BP Production

API: 05-067-06657

Date: 11/9/2018

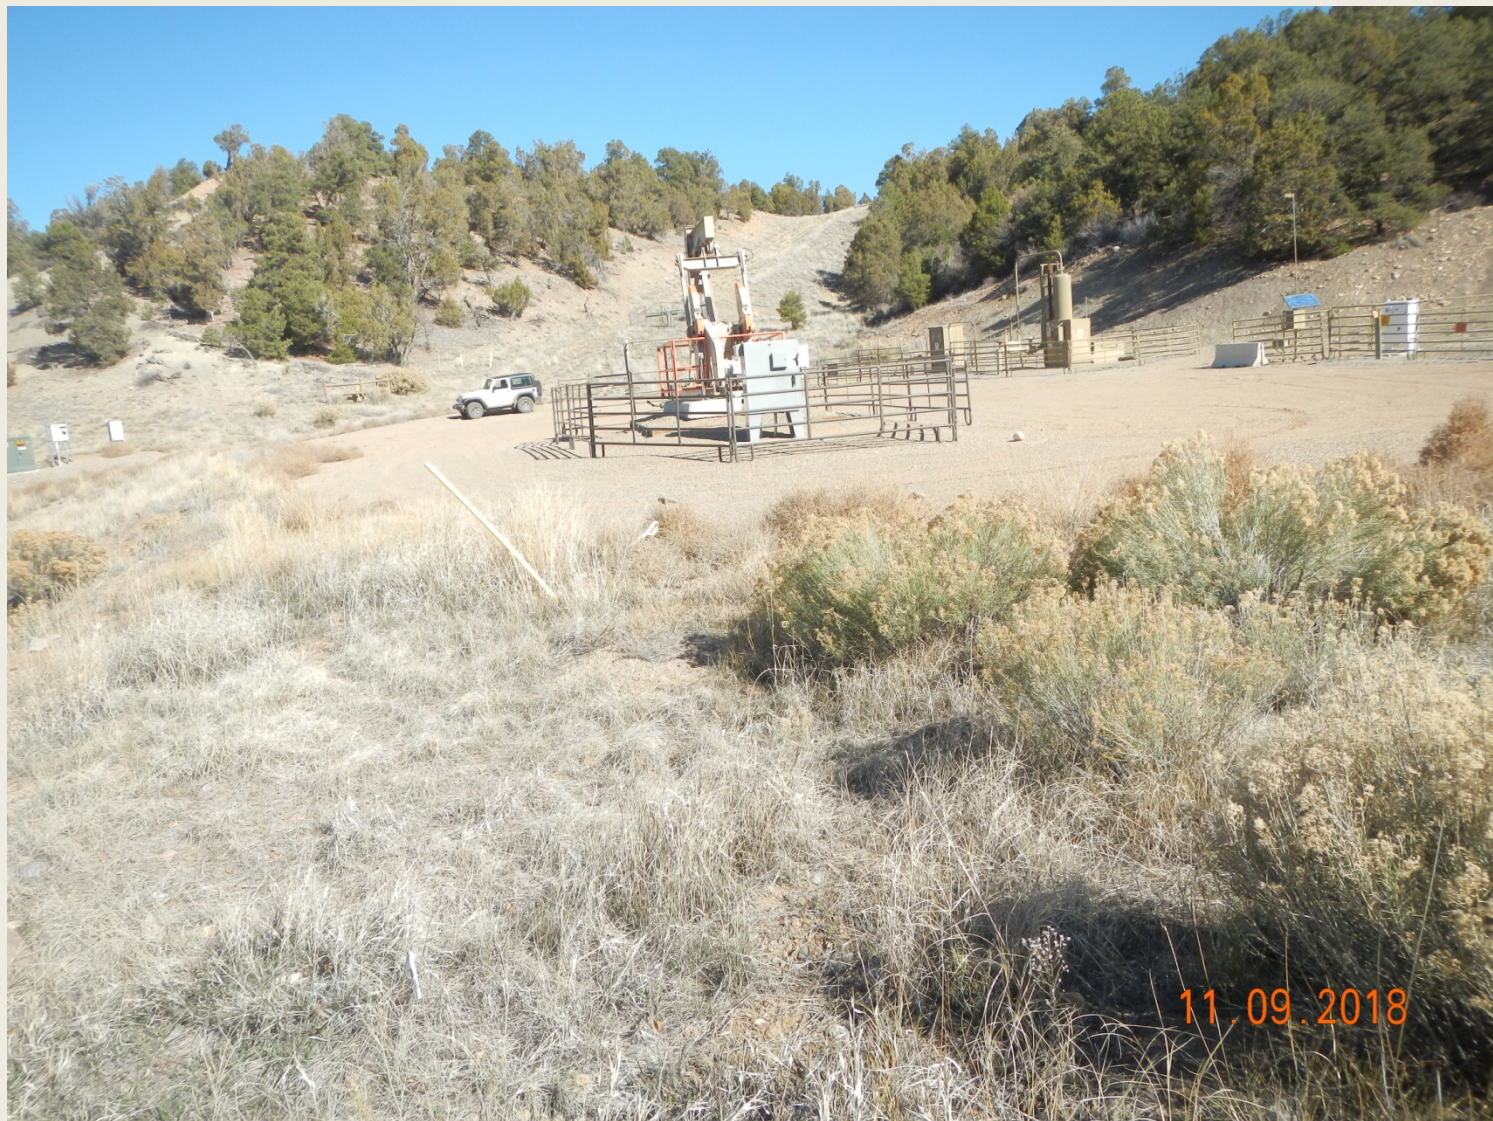
**Photo 1. View of the project area from the southwestern corner facing center.**

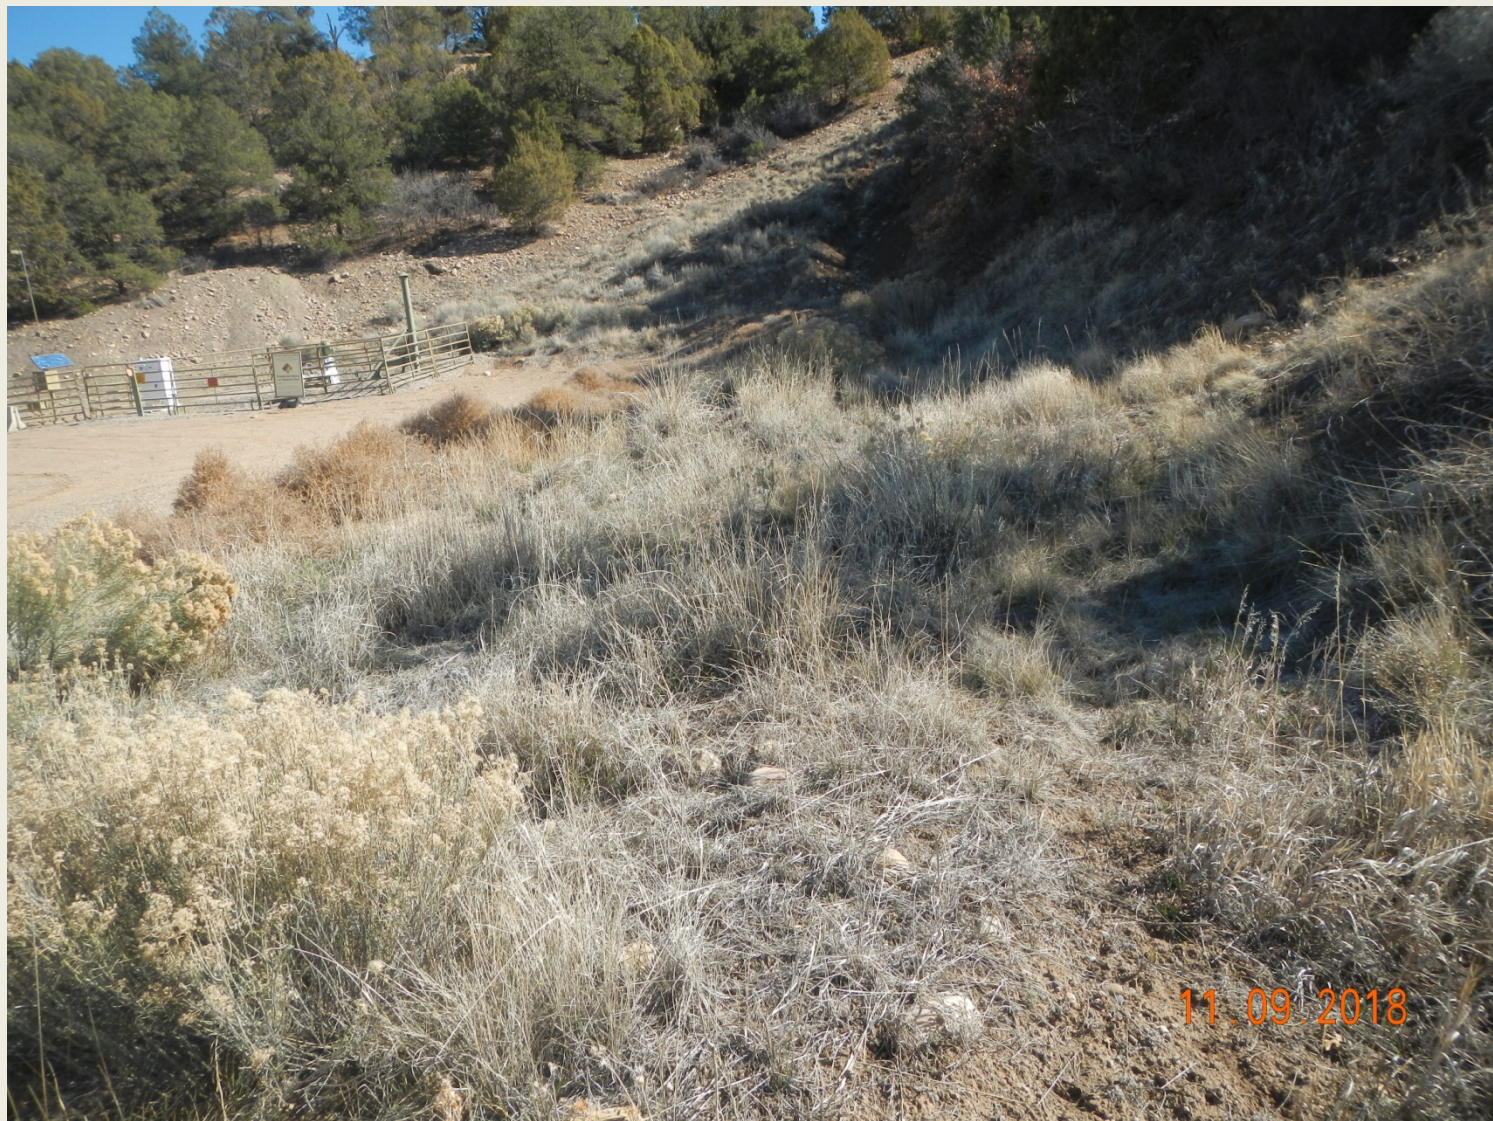
**Photo 2.** View of the southern project area from the southwestern corner facing eastward. Revegetation is progressing here with western wheatgrass (*Pascopyrum smithii*), sand dropseed (*Sporobolus cryptandrus*), and rubber rabbitbrush (*Chrysothamnus nauseosus*).

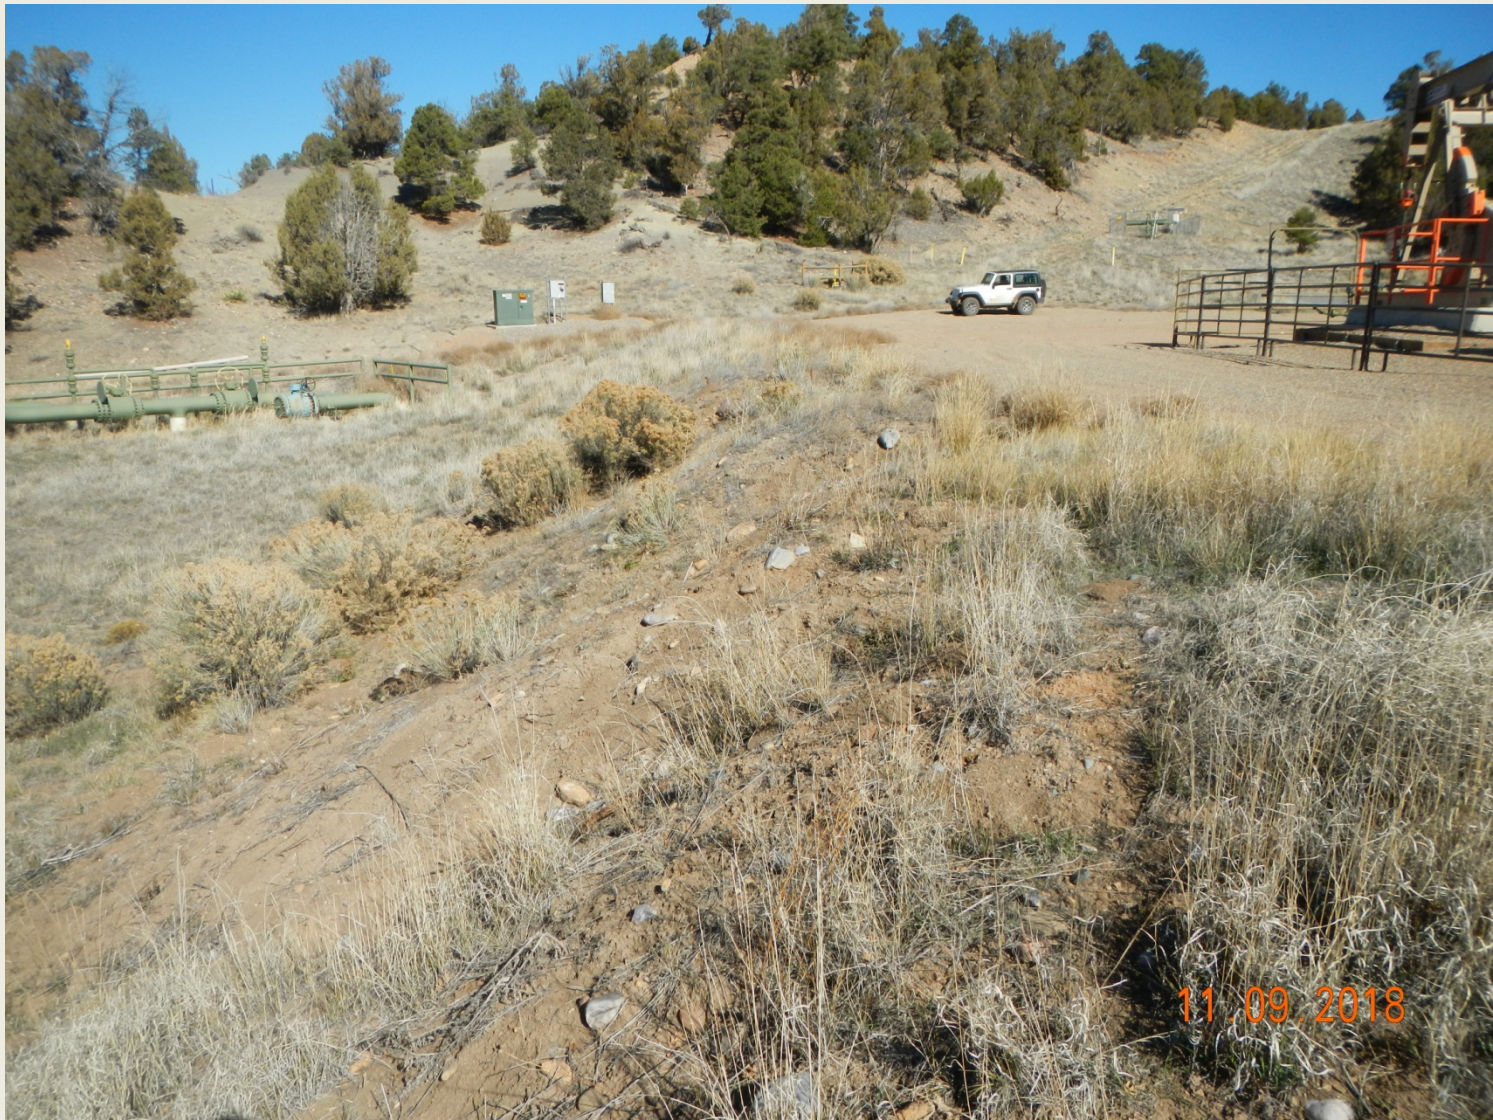
**Photo 3. View of the western project area from the southwestern corner facing westward.**

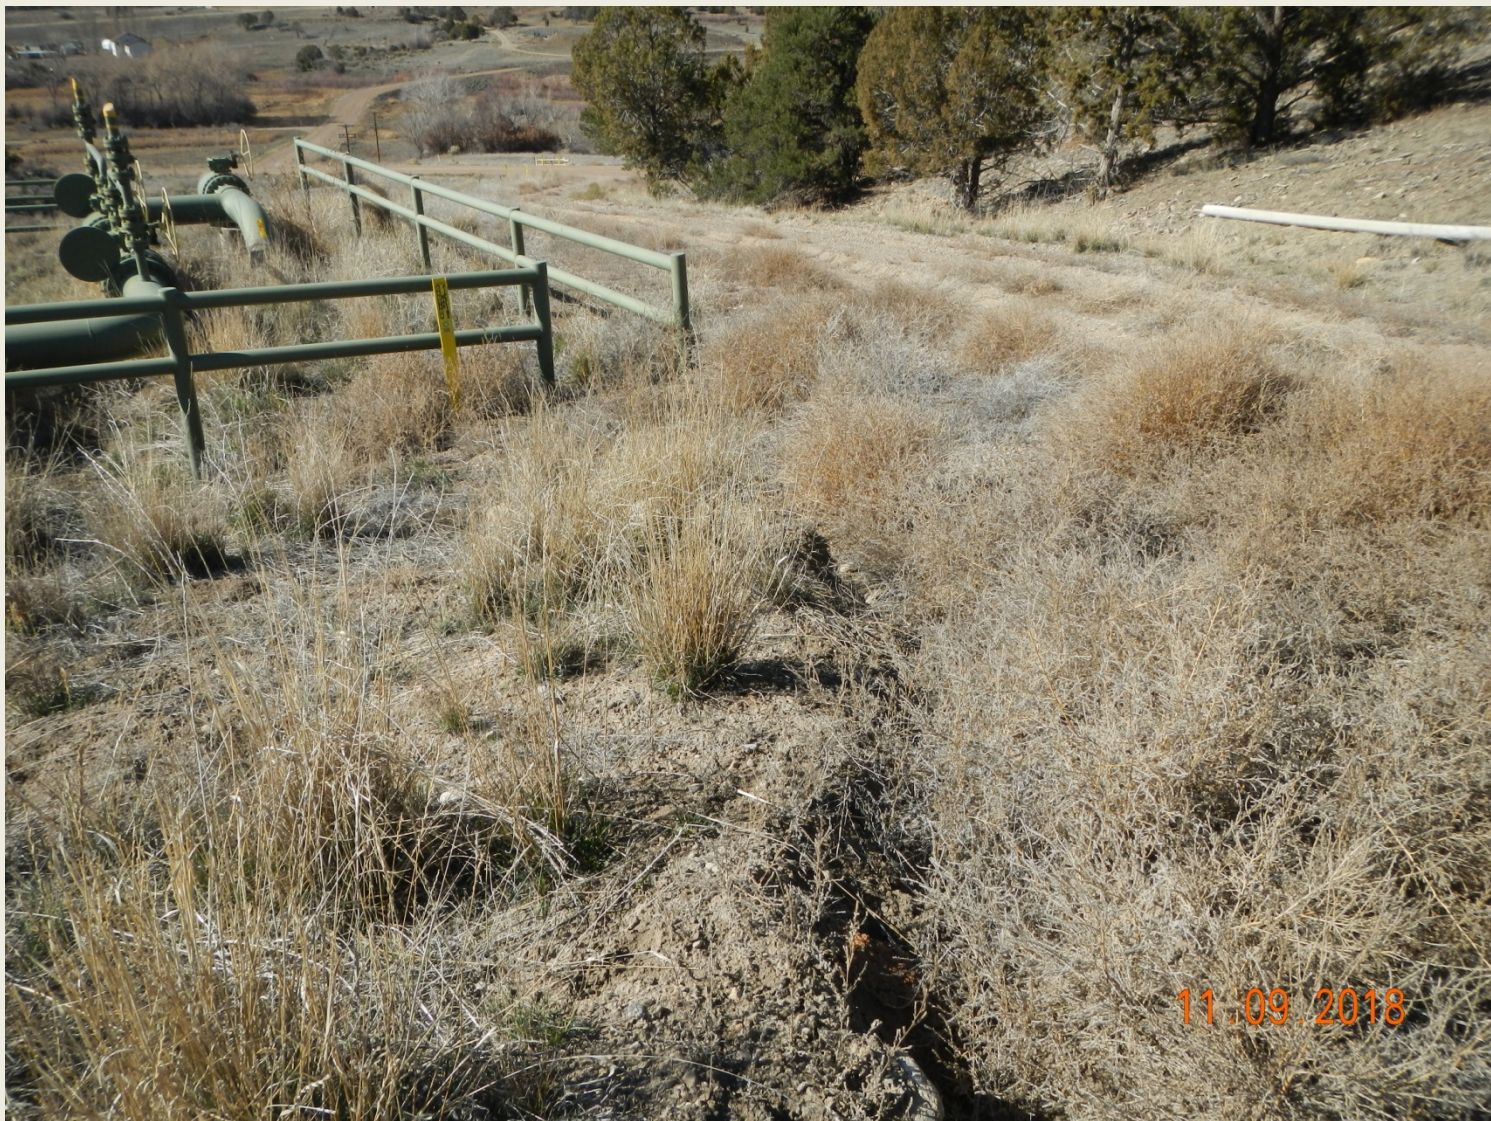
**Photo 5. View of erosional channeling occurring within the western project area.**

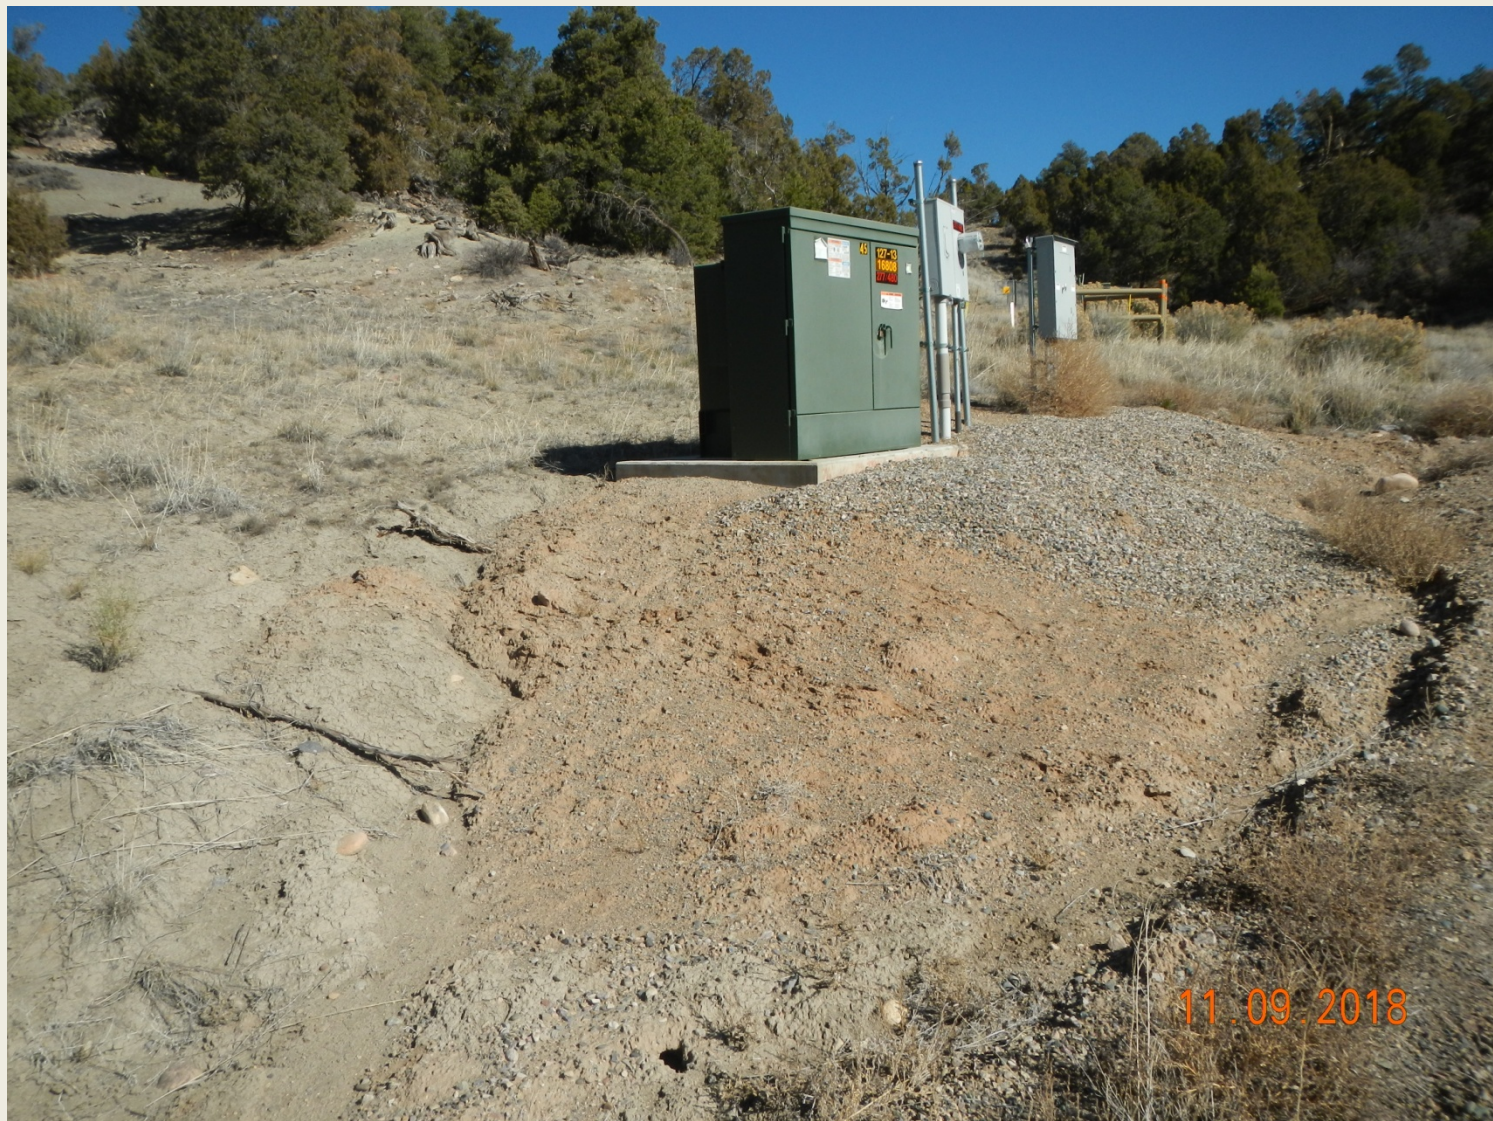
**Photo 5. View of erosional channel approximately 1.5 feet wide and 10 inches deep, forming within the northern project area around project facilities.**

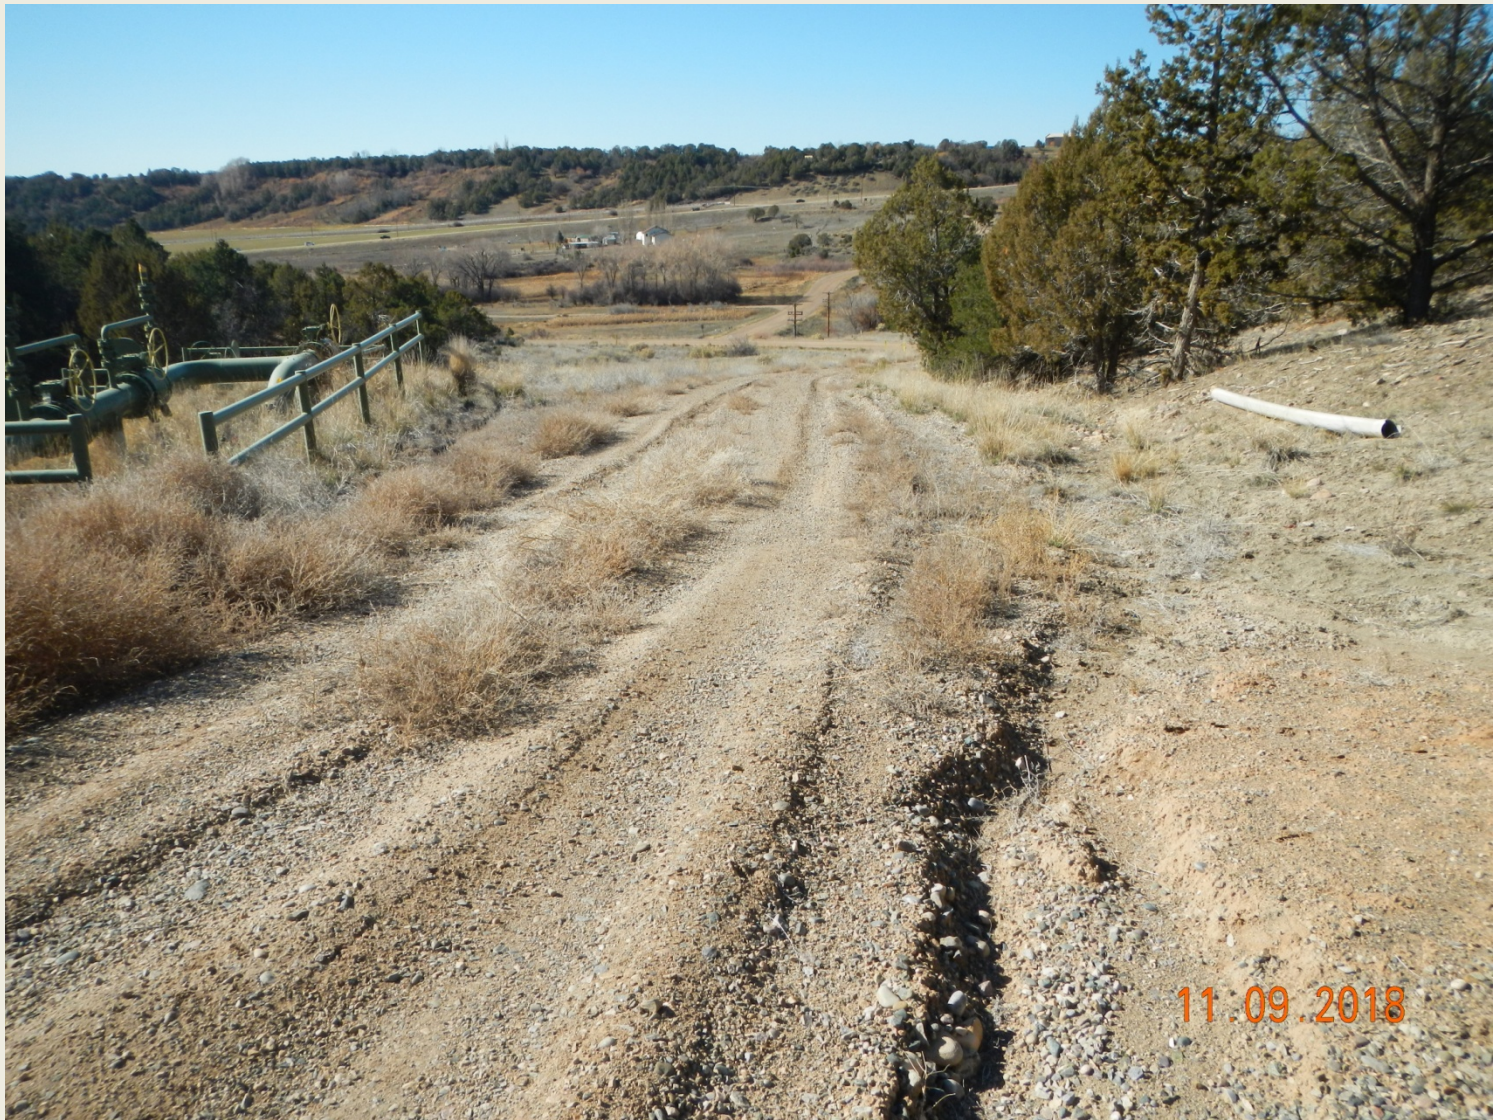
**Photo 5. View of erosional channel along the access road.**

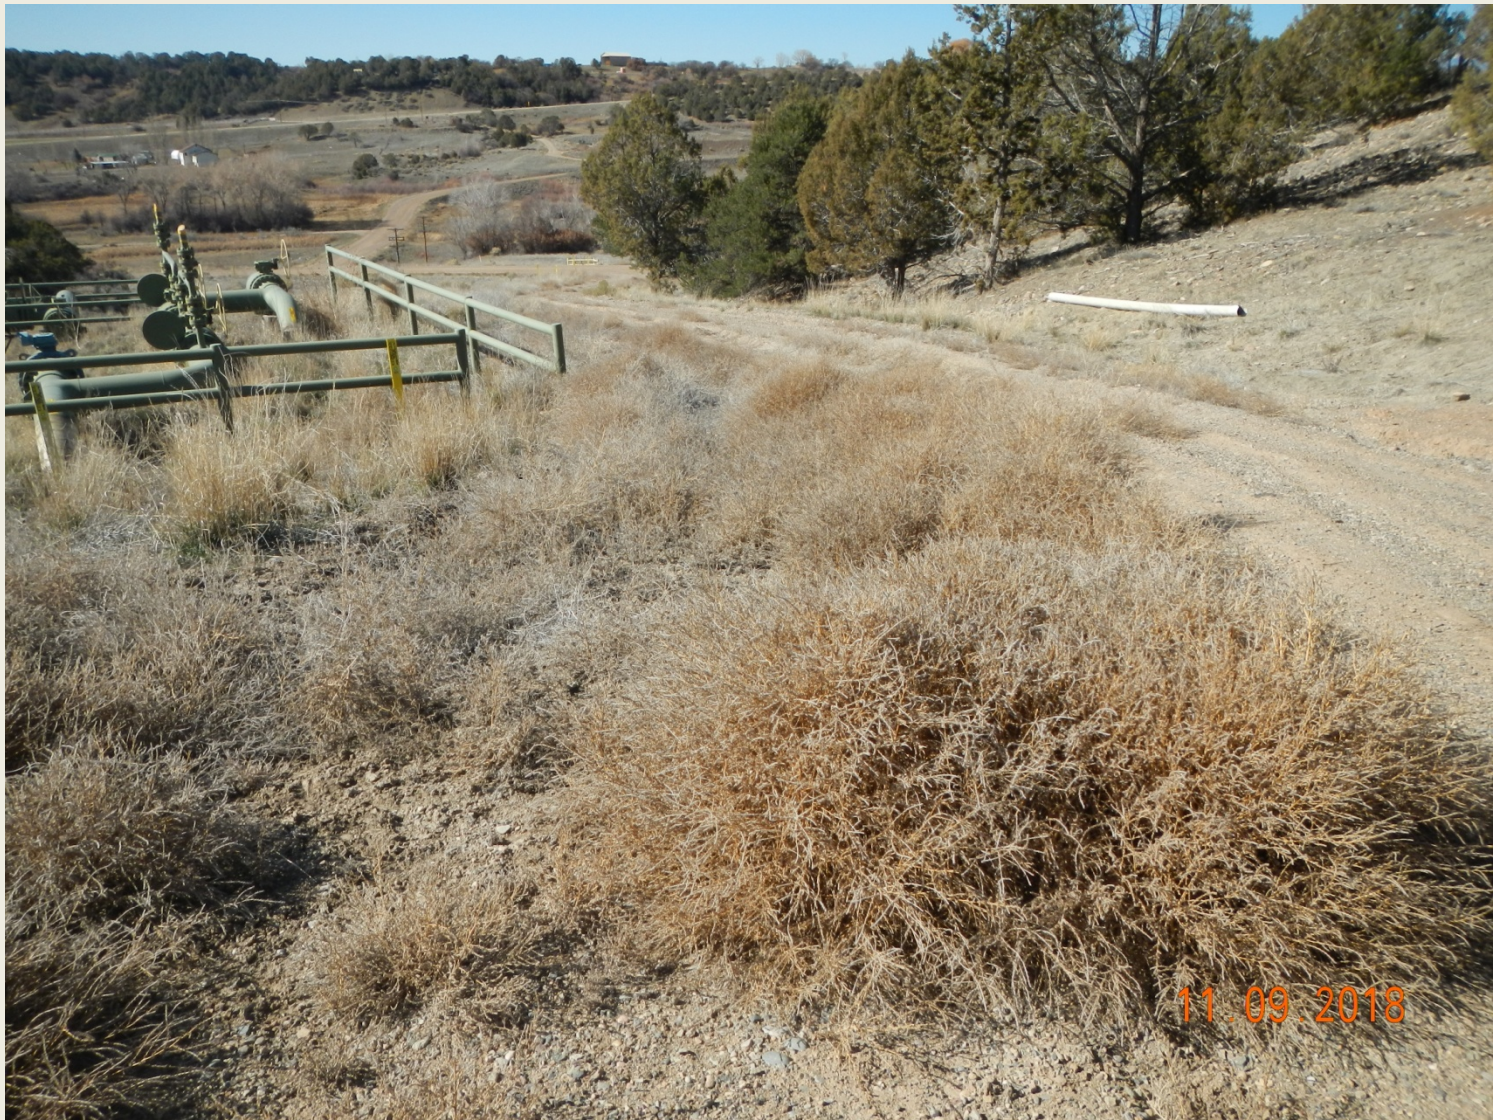
**Photo 5. View of kochia debris up to 2.5 feet high, at the well pad entrance and along the access road.**
