Inspection Photos

Operator: ST CROIX OPERATING INC - 81490

Location ID: 455607

Inspection Doc. Number: 682504213

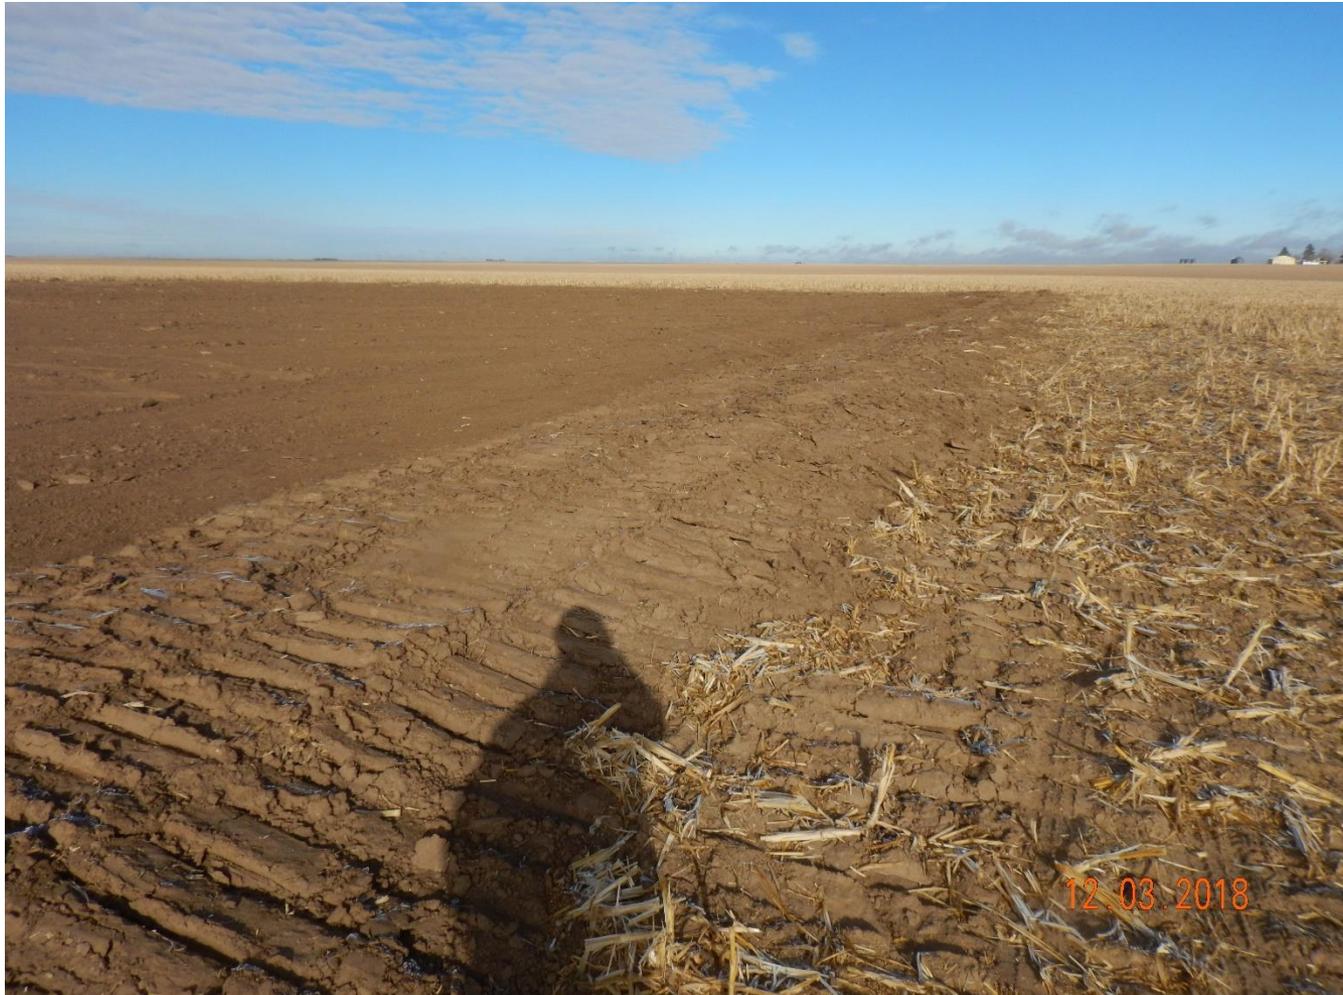
Photo 1: Photo taken from the east end of the location, facing north. Photos 1-4 provide an overview of the location from north, northwest, southwest, to south. Photos show constructed pad.

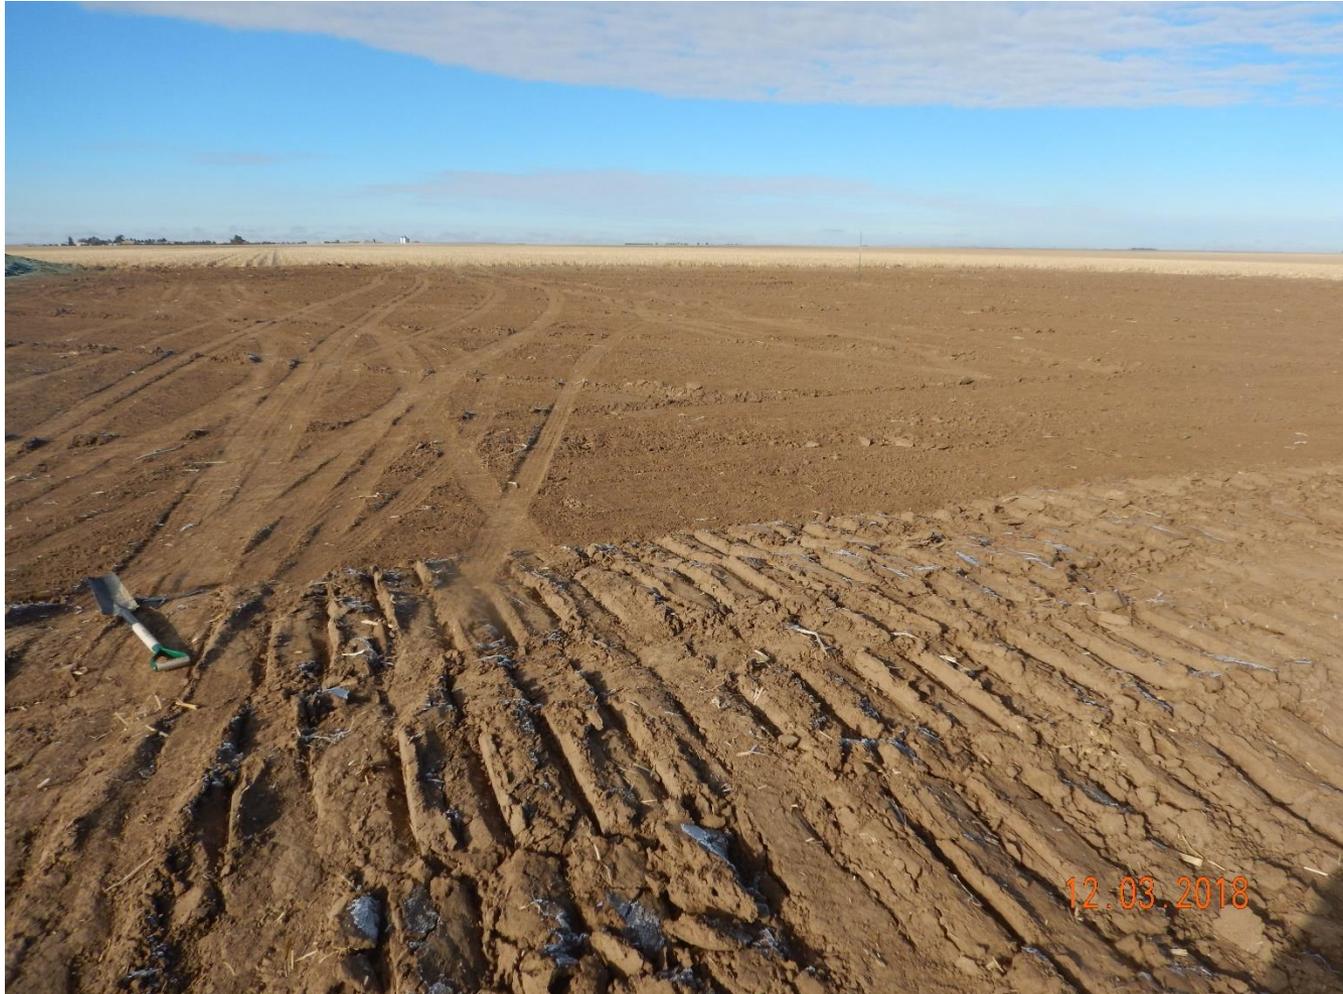
Photo 2: See comments under photo 1.

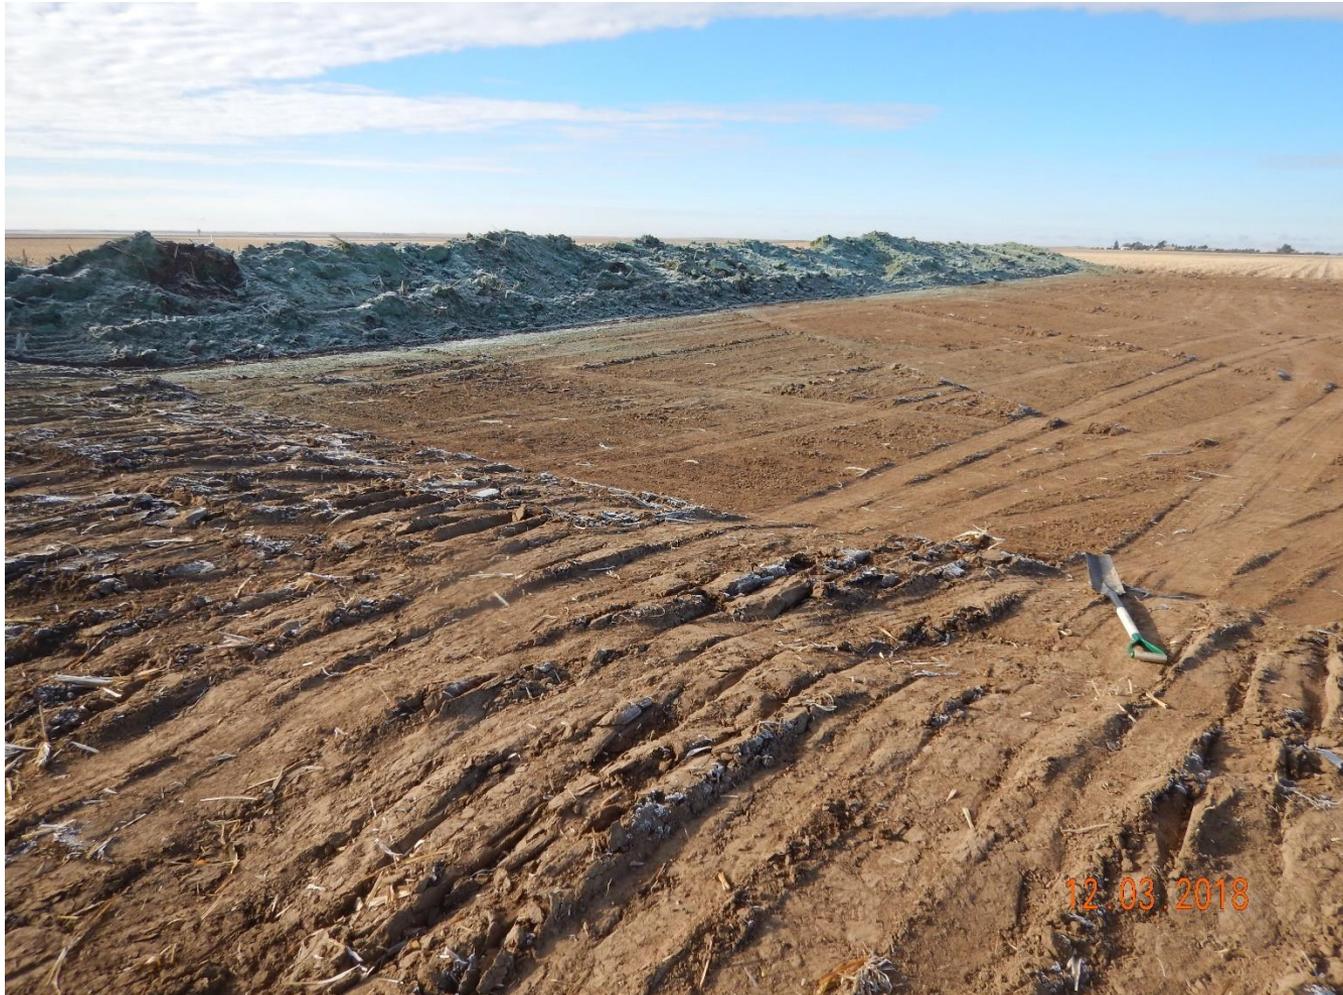
Photo 3: See comments under photo 1.

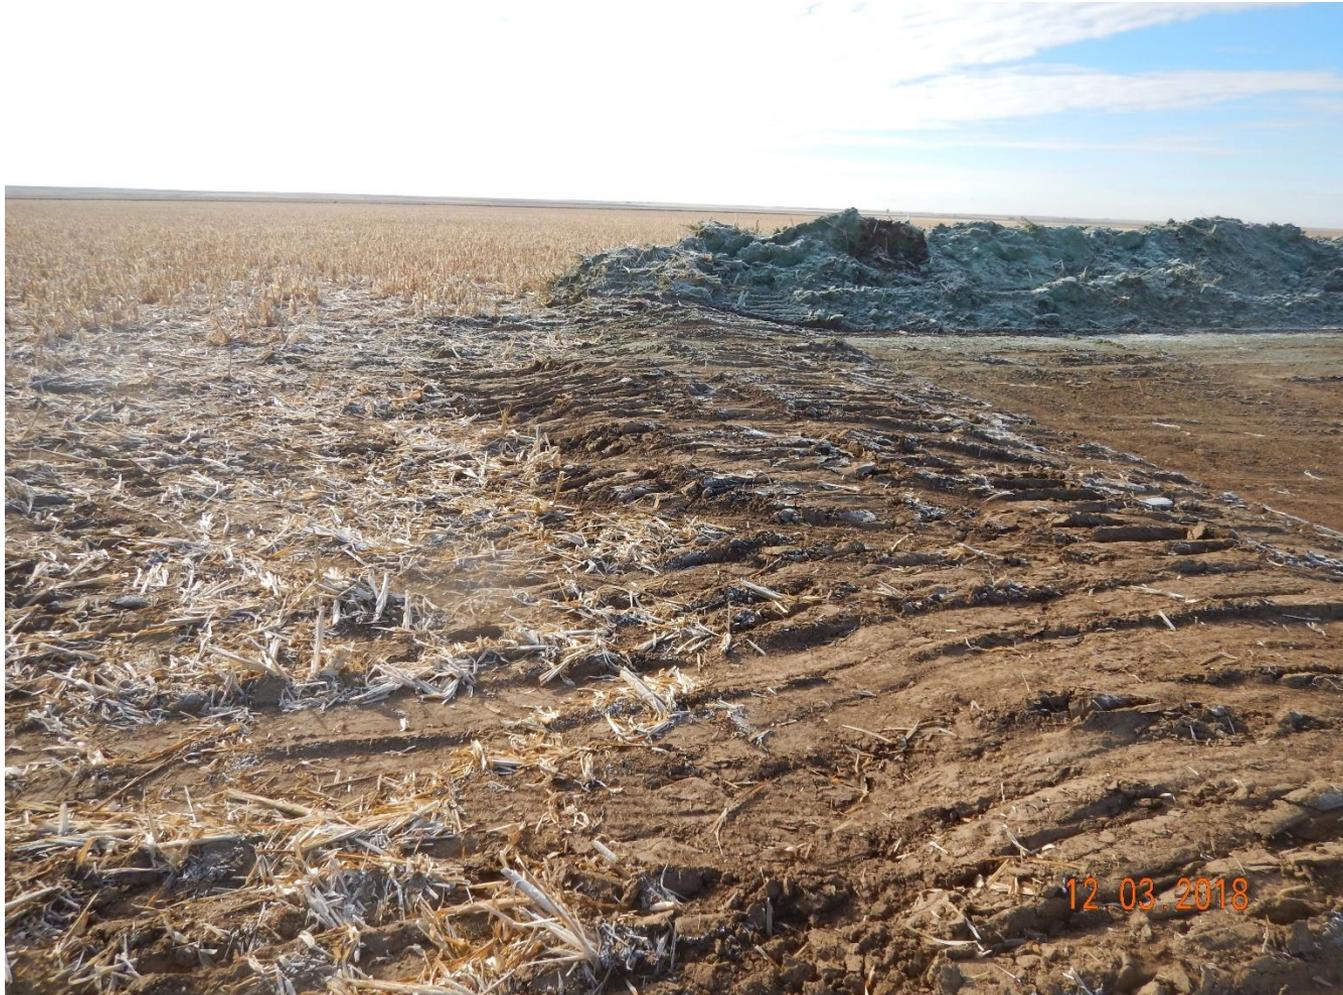
Photo 4: See comments under photo 1.

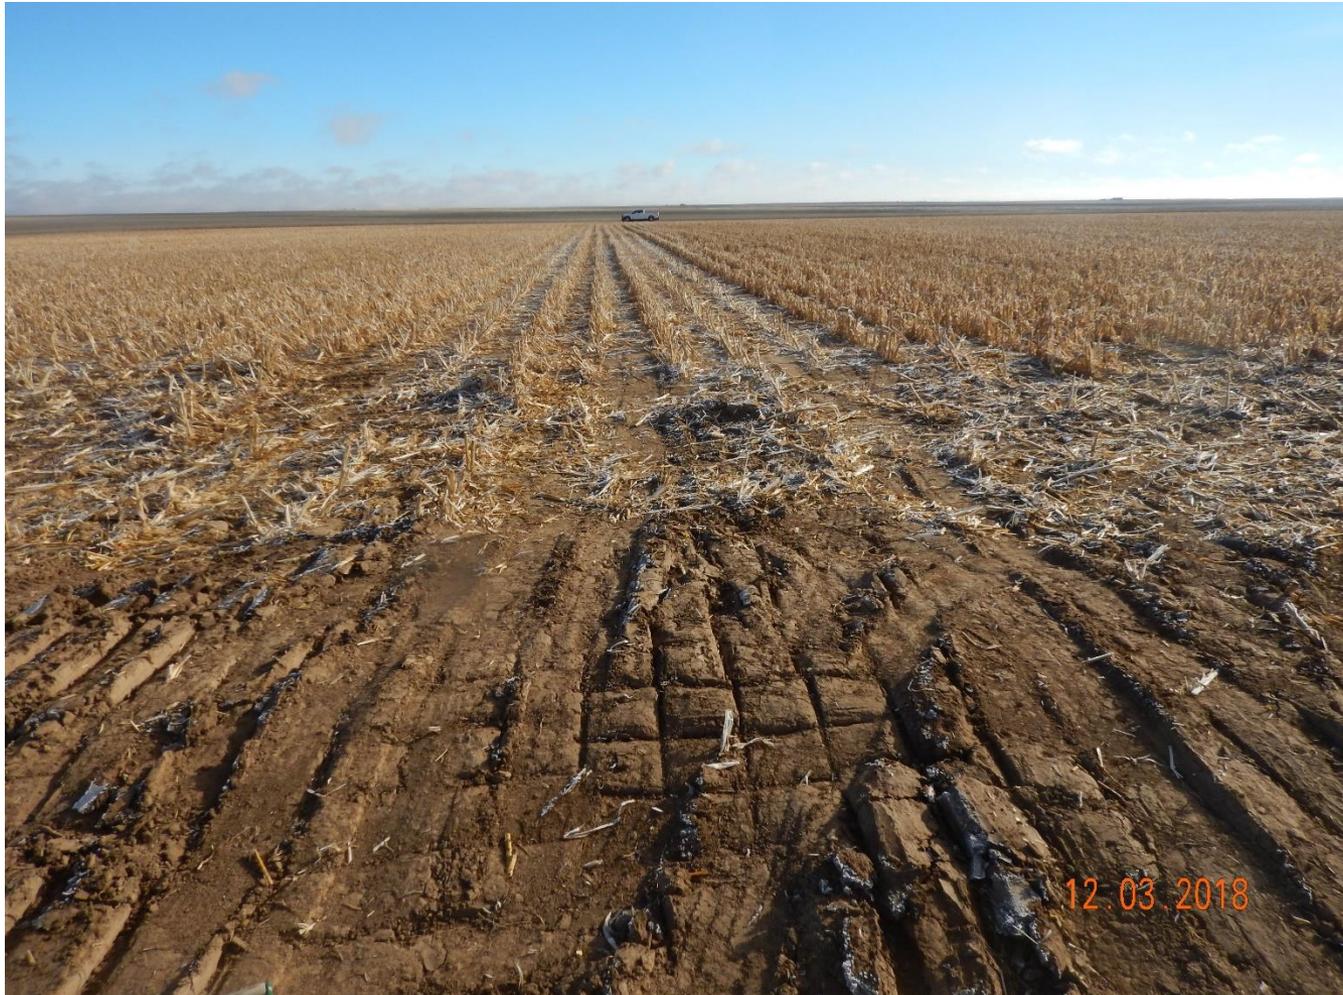
Photo 5: Photo taken from the east end of the location, facing east. Photo shows areas where vehicles appear to be traveling to access the site, however, no access road has been constructed.

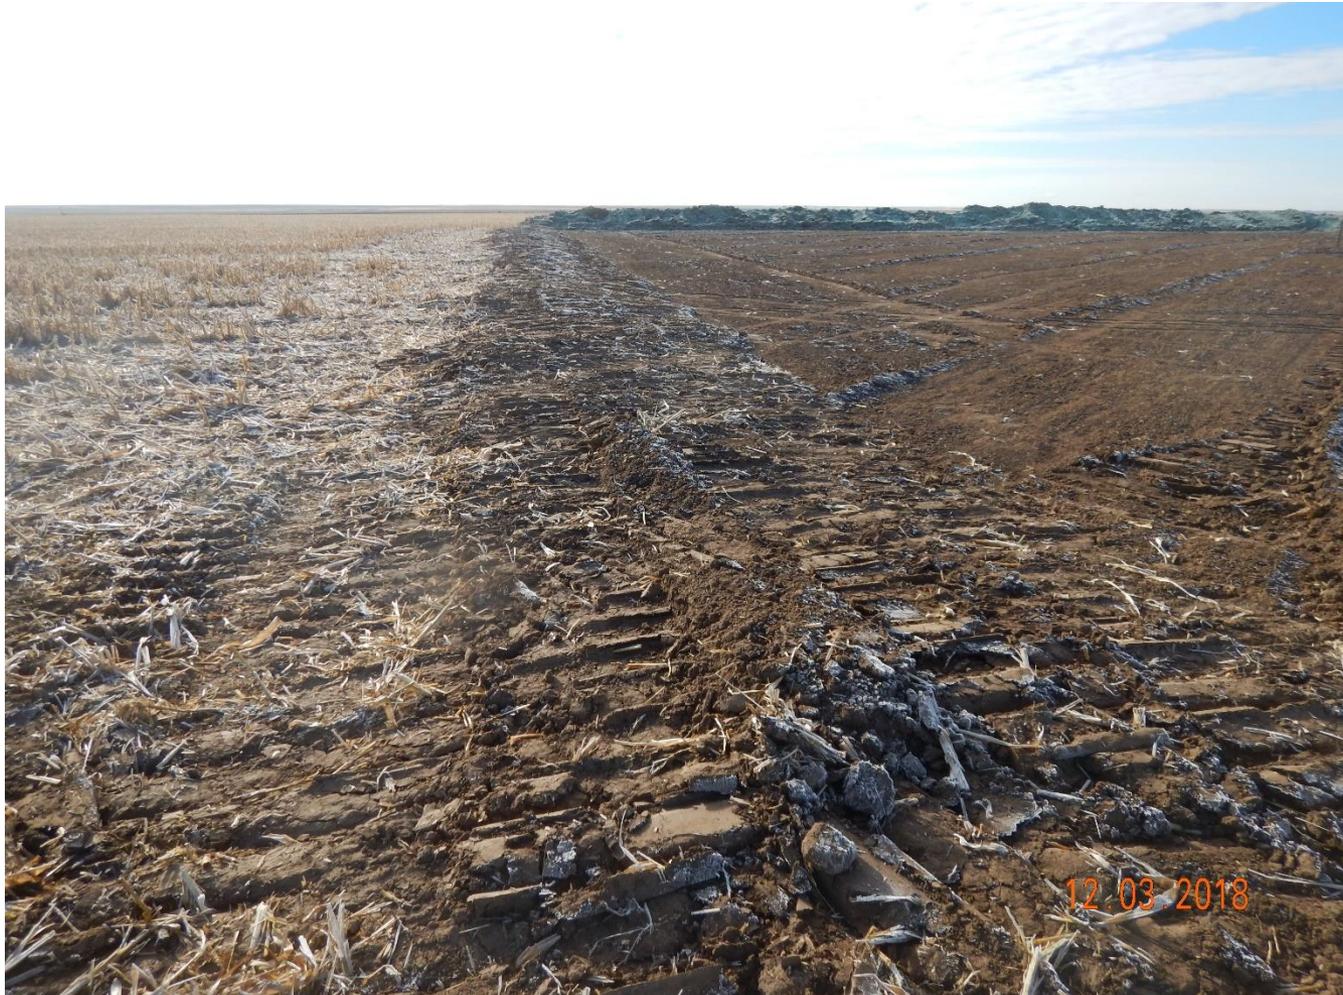
Photo 6: Photo taken from the northeast corner of the location, facing south. Photo shows what appears to be a shallow berm has been constructed on the east end of the location.

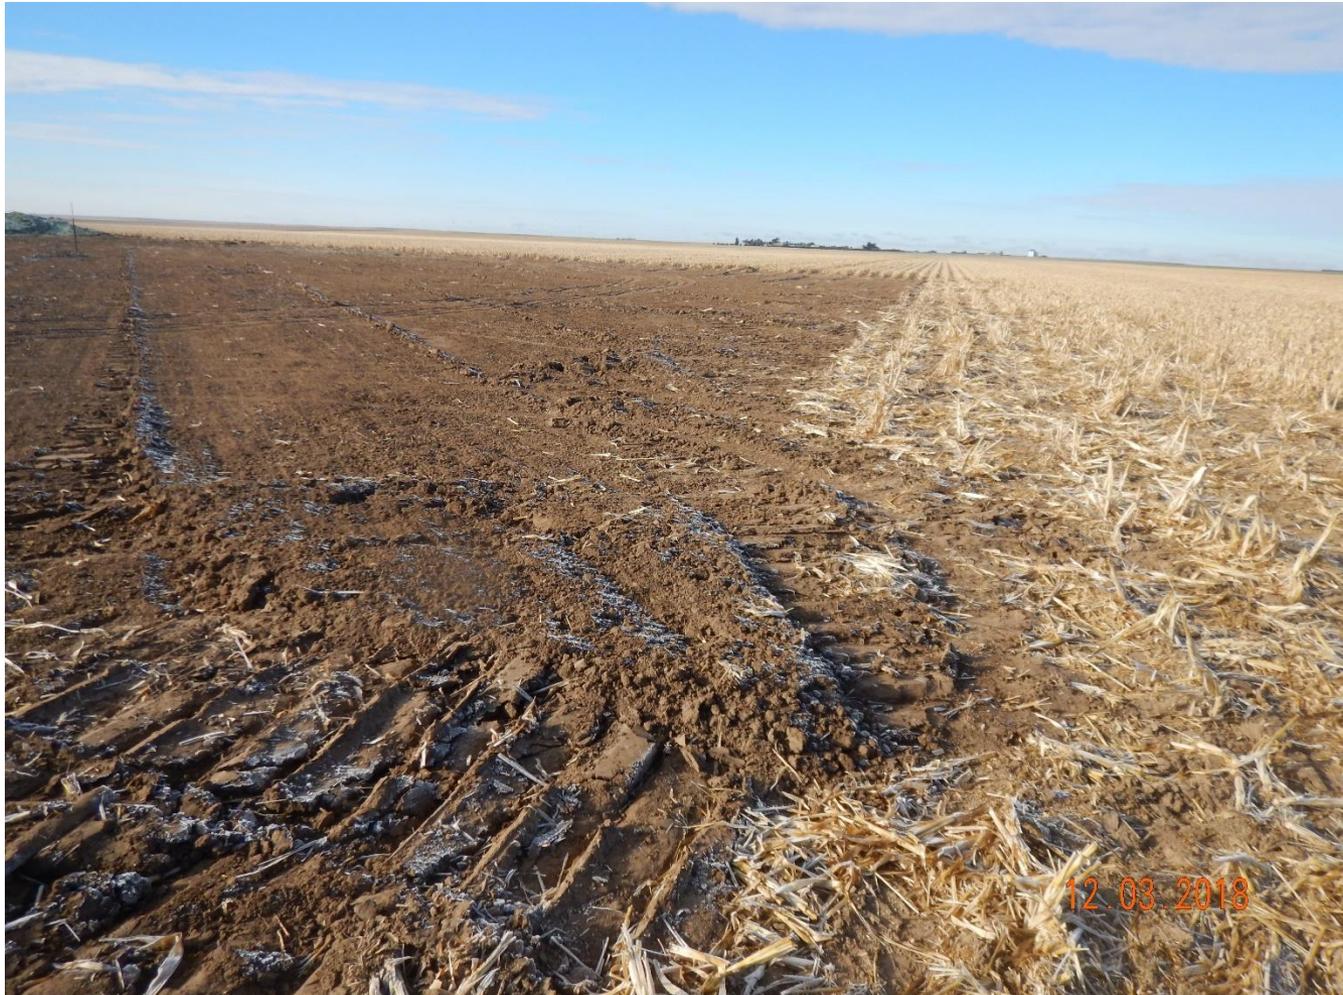
Photo 7: Photo taken from the northeast corner of the location, facing south. No perimeter stormwater controls appear to have been implemented on the north end of the location.

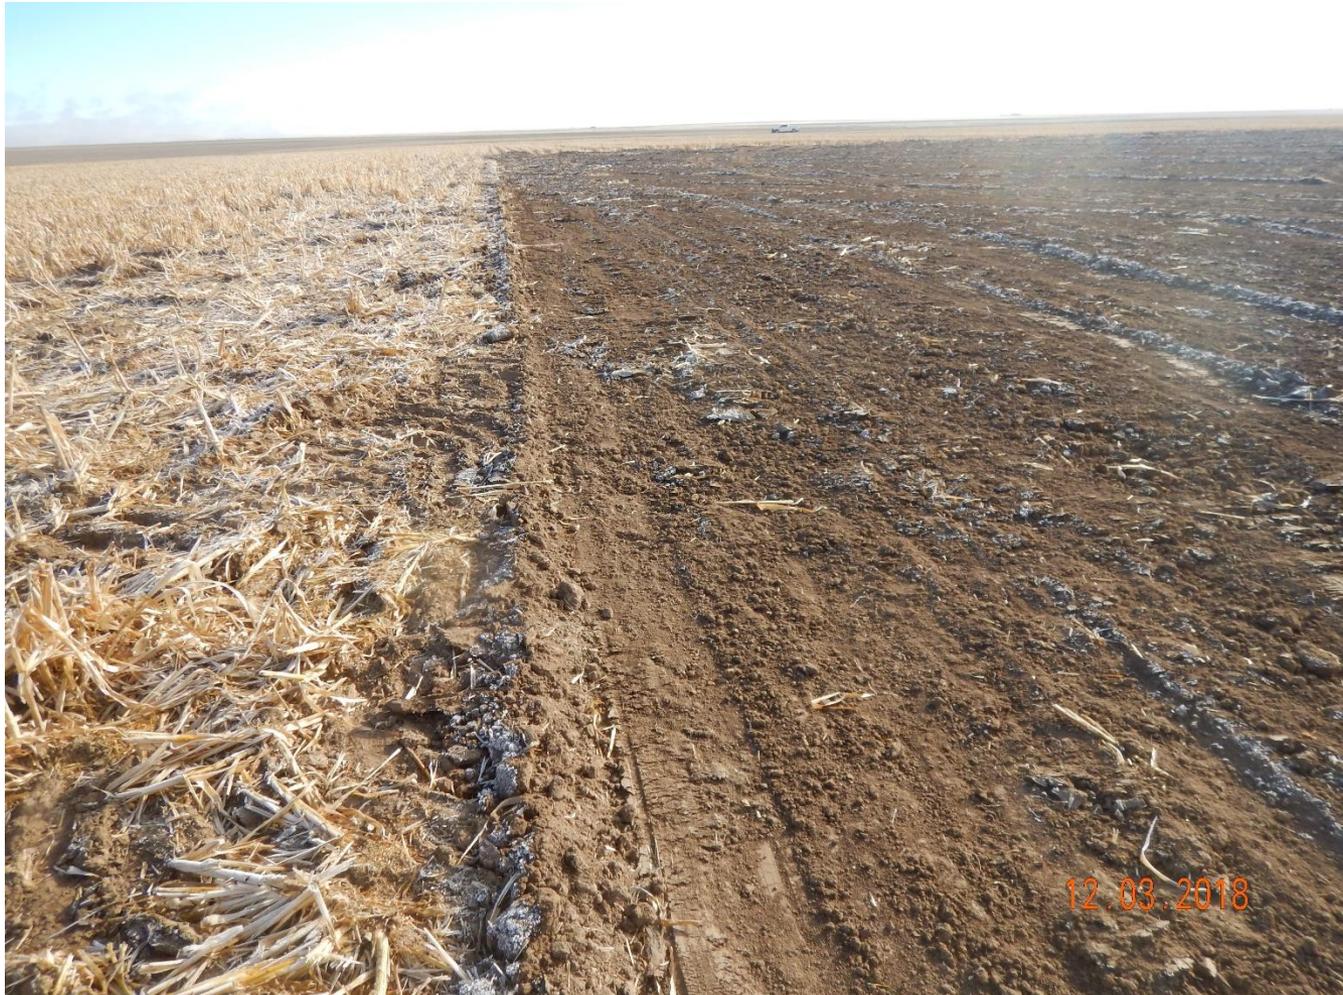
Photo 8: Photo taken from the northeast corner of the location, facing south. No perimeter stormwater controls appear to have been implemented on the north end of the location.

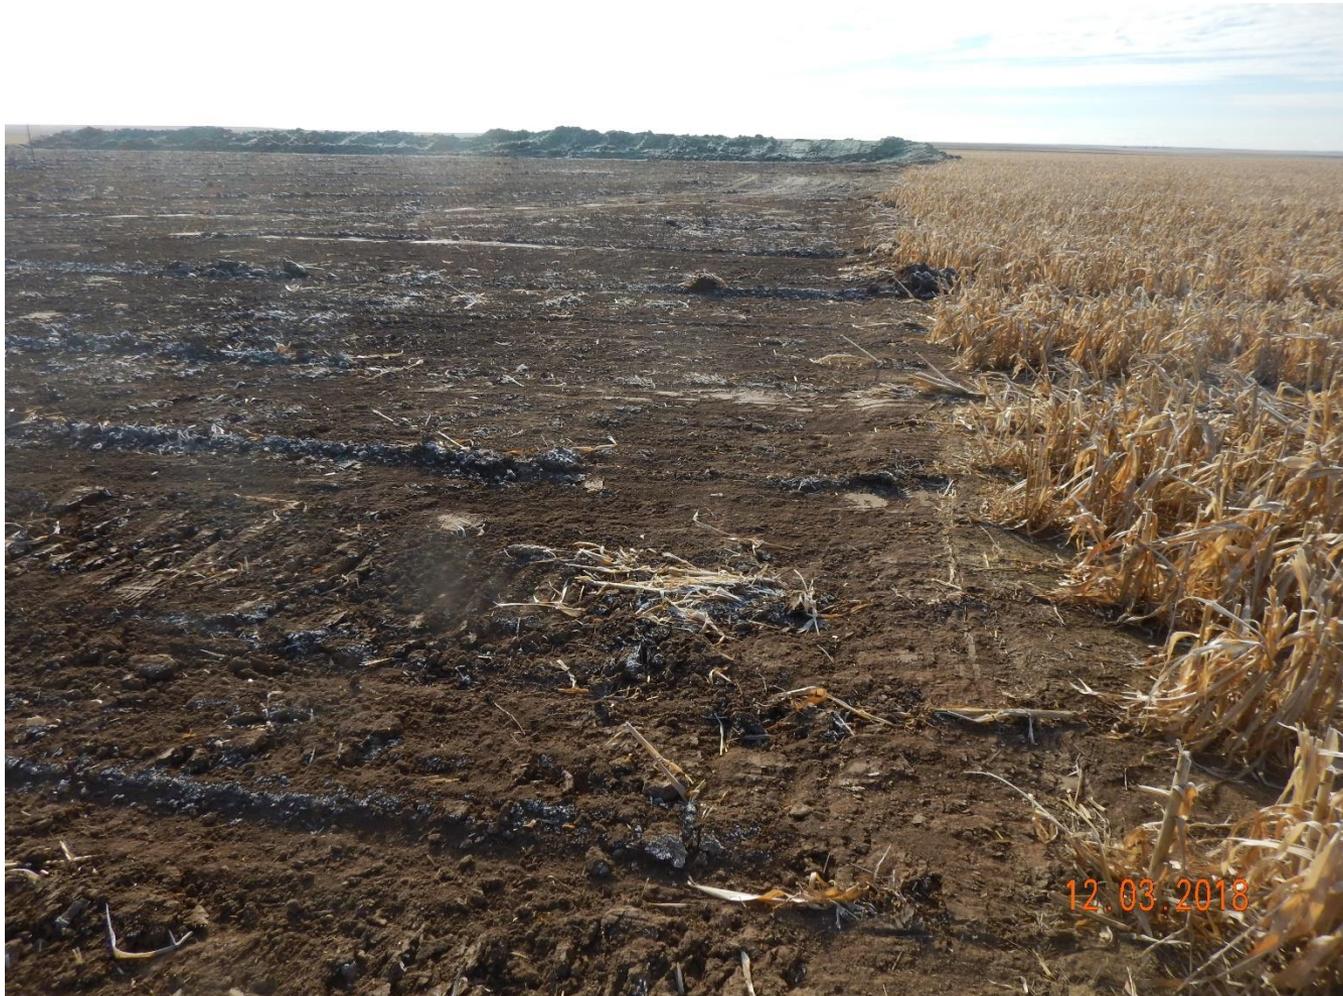
Photo 9: Photo taken from the northeast corner of the location, facing south. No perimeter stormwater controls appear to have been implemented on the west end of the location.

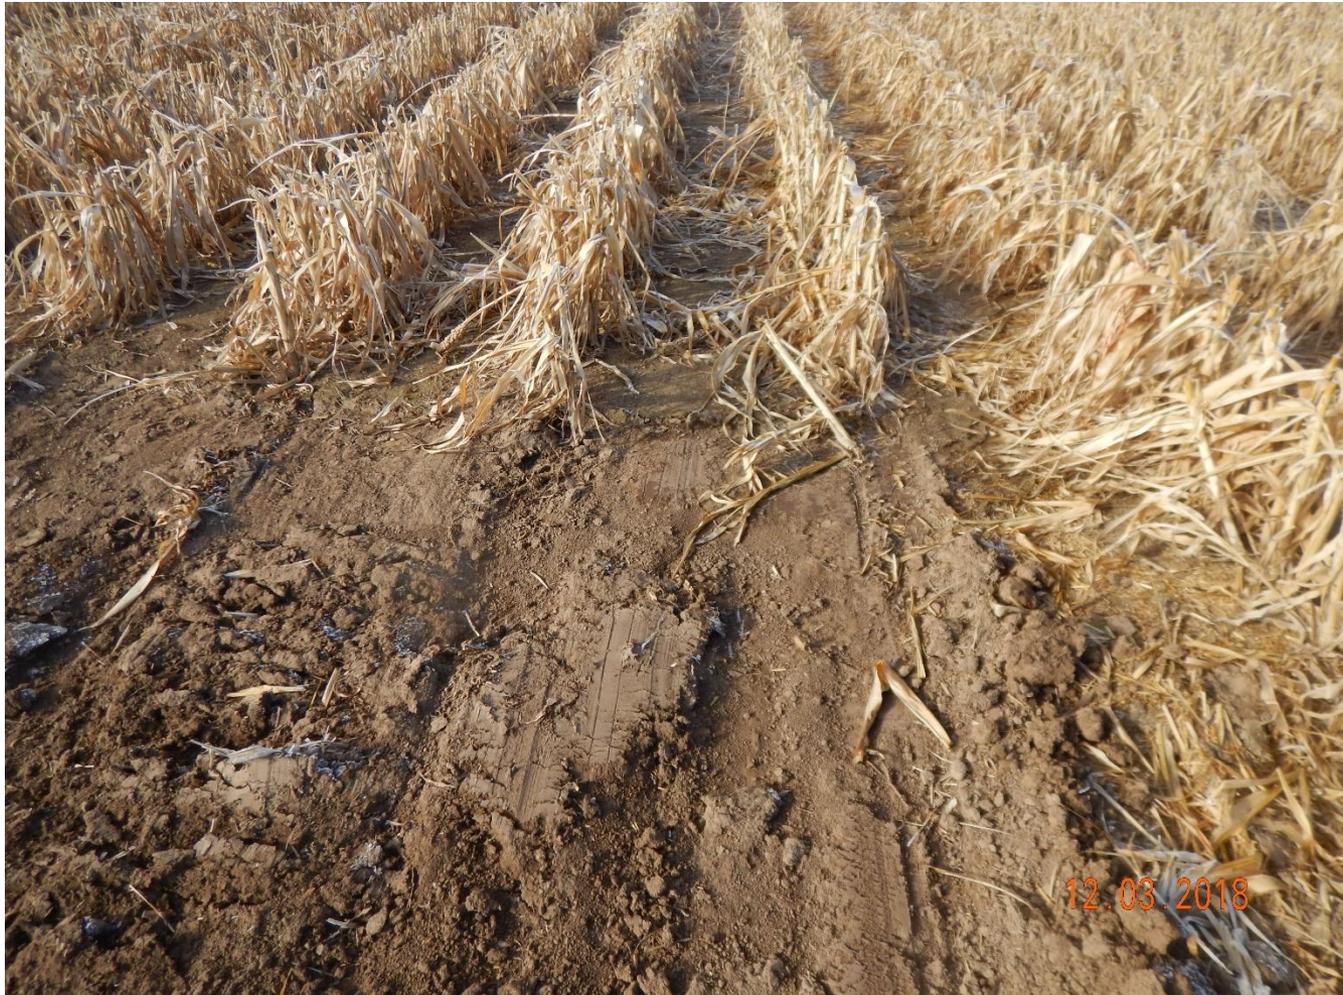
Photo 10: Photo taken from the northwest corner of the location. Photo shows operator appears to have conducted soil salvage operations, however, sufficient soil salvage does not appear to have been conducted on the entire location in accordance with 1002.b. Photo shows areas on the north end compared to the reference; it is unlikely that the entire topsoil horizon has been salvaged in these area.

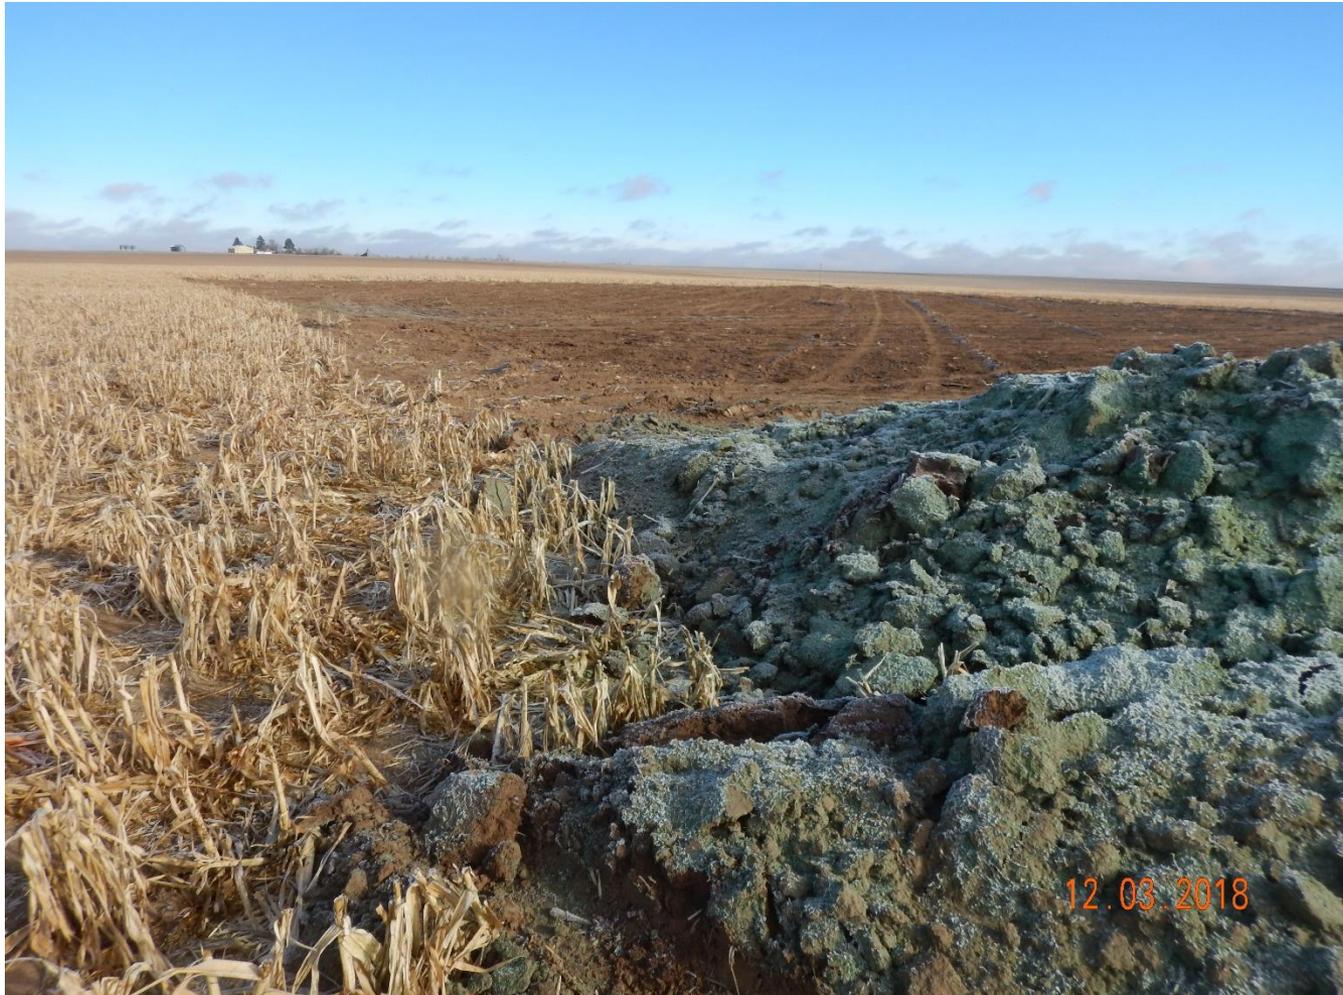
Photo 11: Photo taken from the southwest corner of the pad, facing northeast. Photo shows that no perimeter stormwater controls appear to have been implemented on the west end of the location.

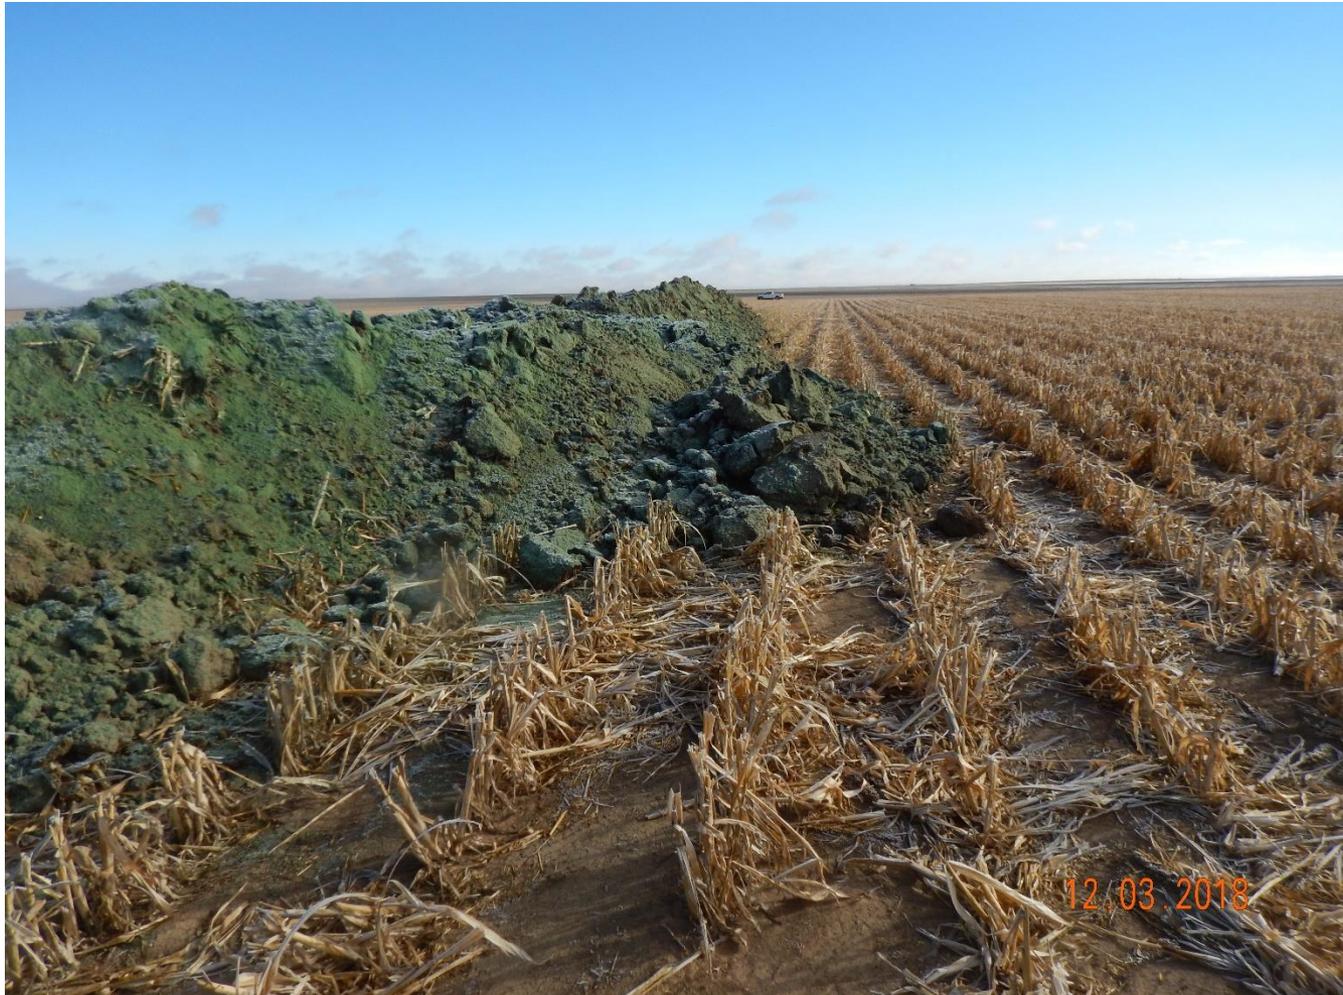
Photo 12: Photo taken from the southwest corner of the pad, facing northeast. Photo shows that hydromulch appears to have been applied to the soil stockpile. Additionally, it does not appear that perimeter stormwater controls were implemented, and/or existed prior to hydromulch, on the south end of the location.

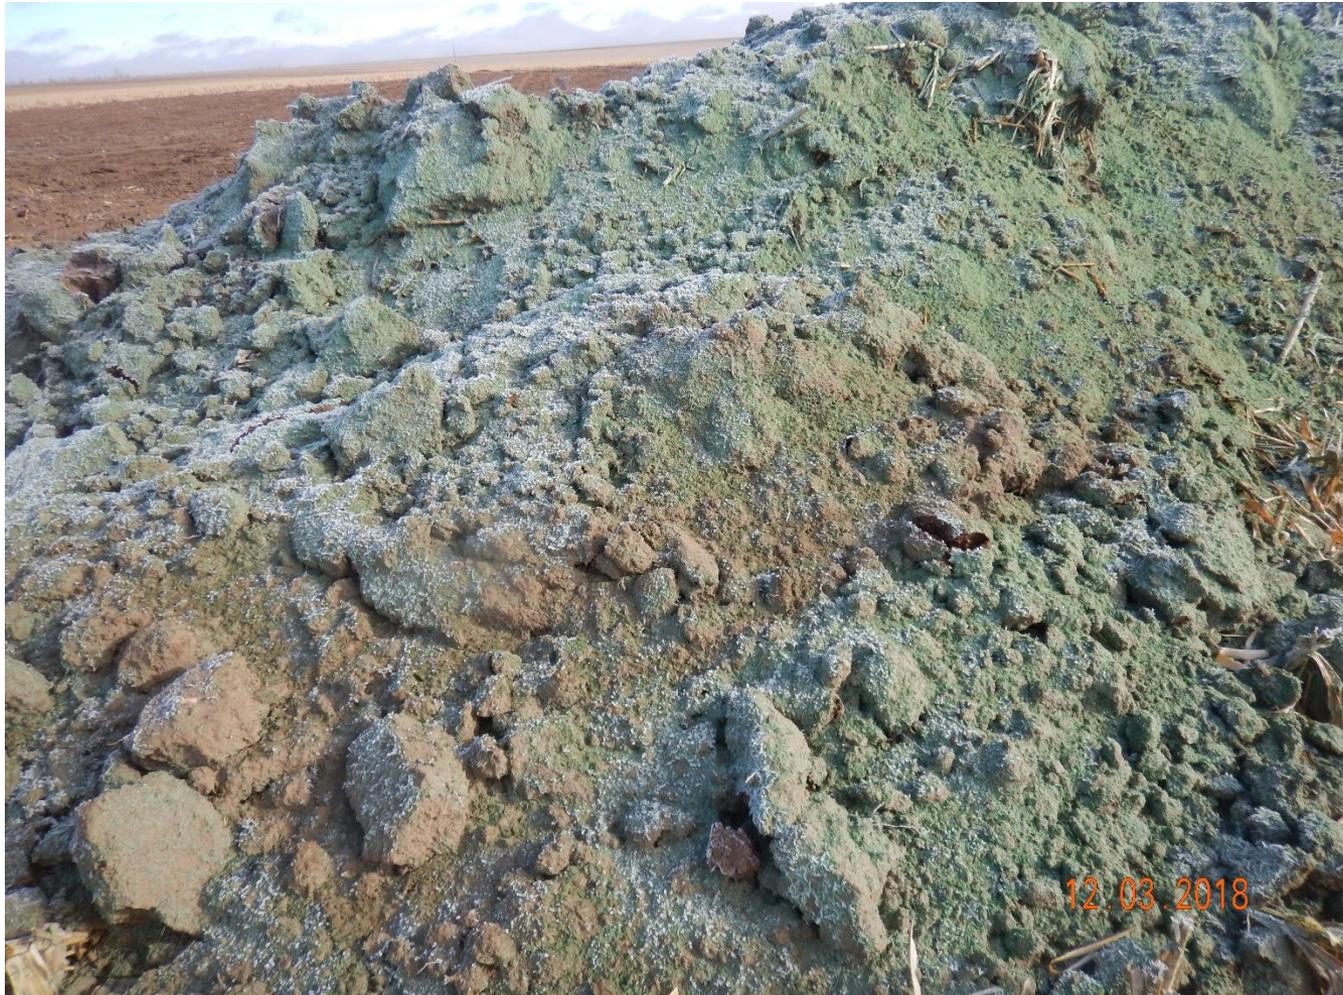
Photo 13: Photo of hydromulch applied to soil stockpile.

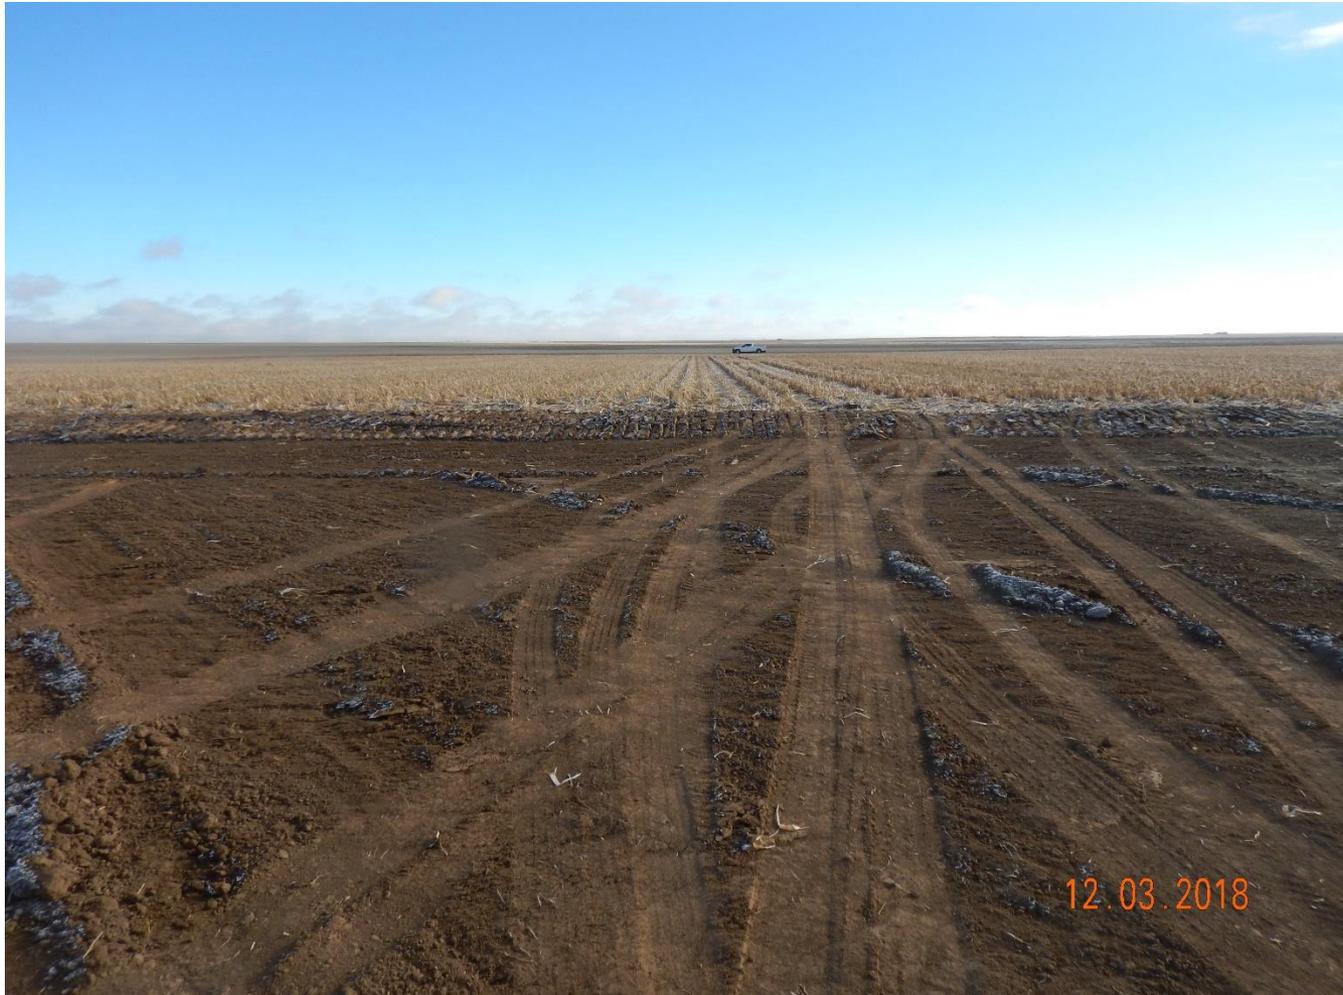
Photo 14: Photo taken from the center of the pad, facing east. Photo shows berm on east end of location.

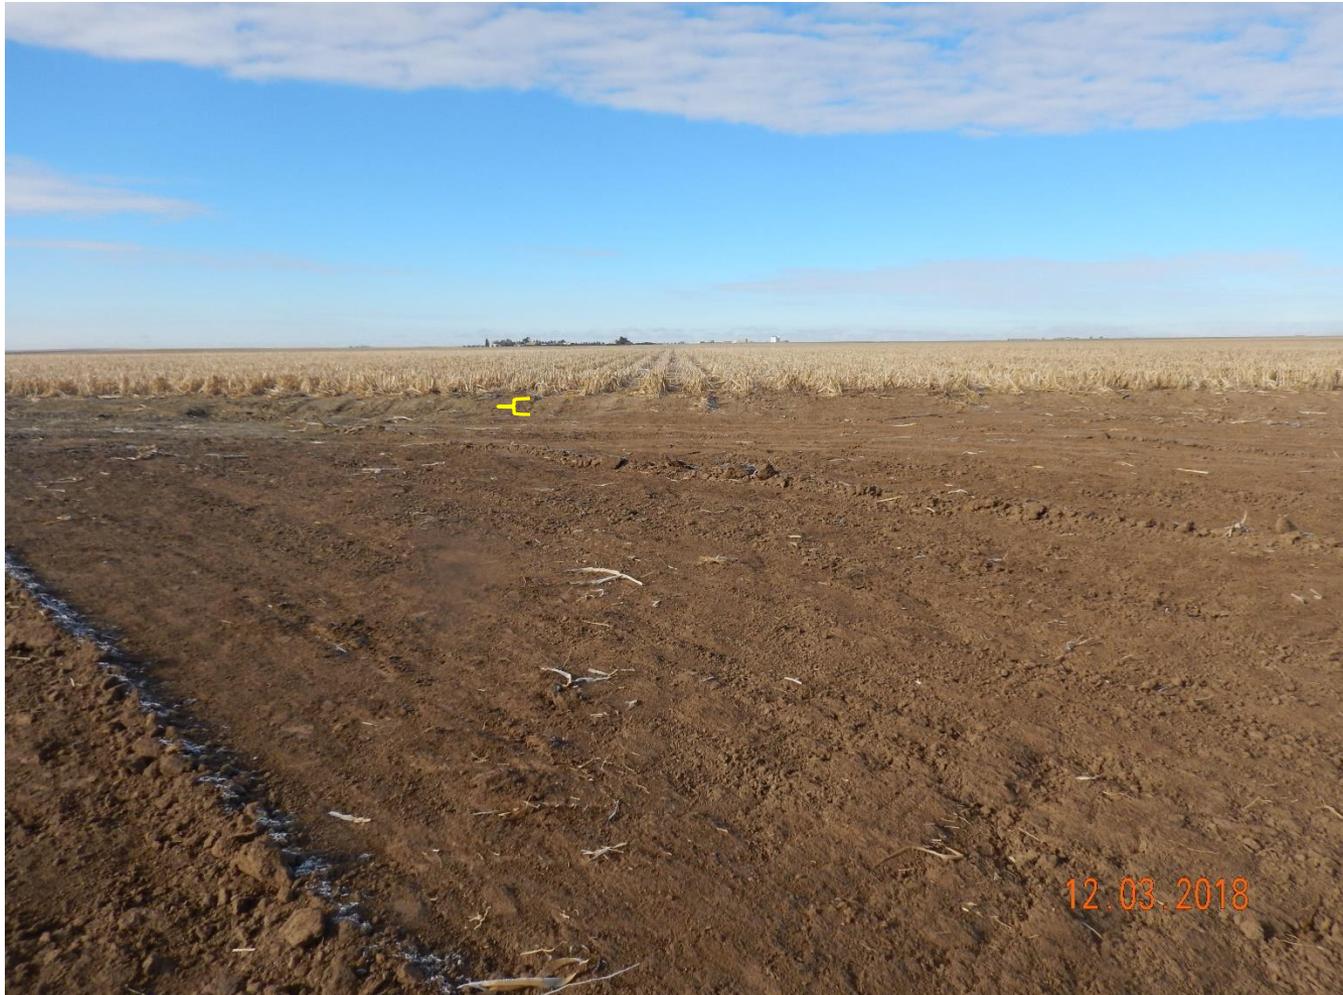
Photo 15: Photo taken from the center of the pad, facing west. Photo shows areas of the south and west end of the pad where ~6-8 inches of soil appears to have been salvaged when compared to the adjacent reference.

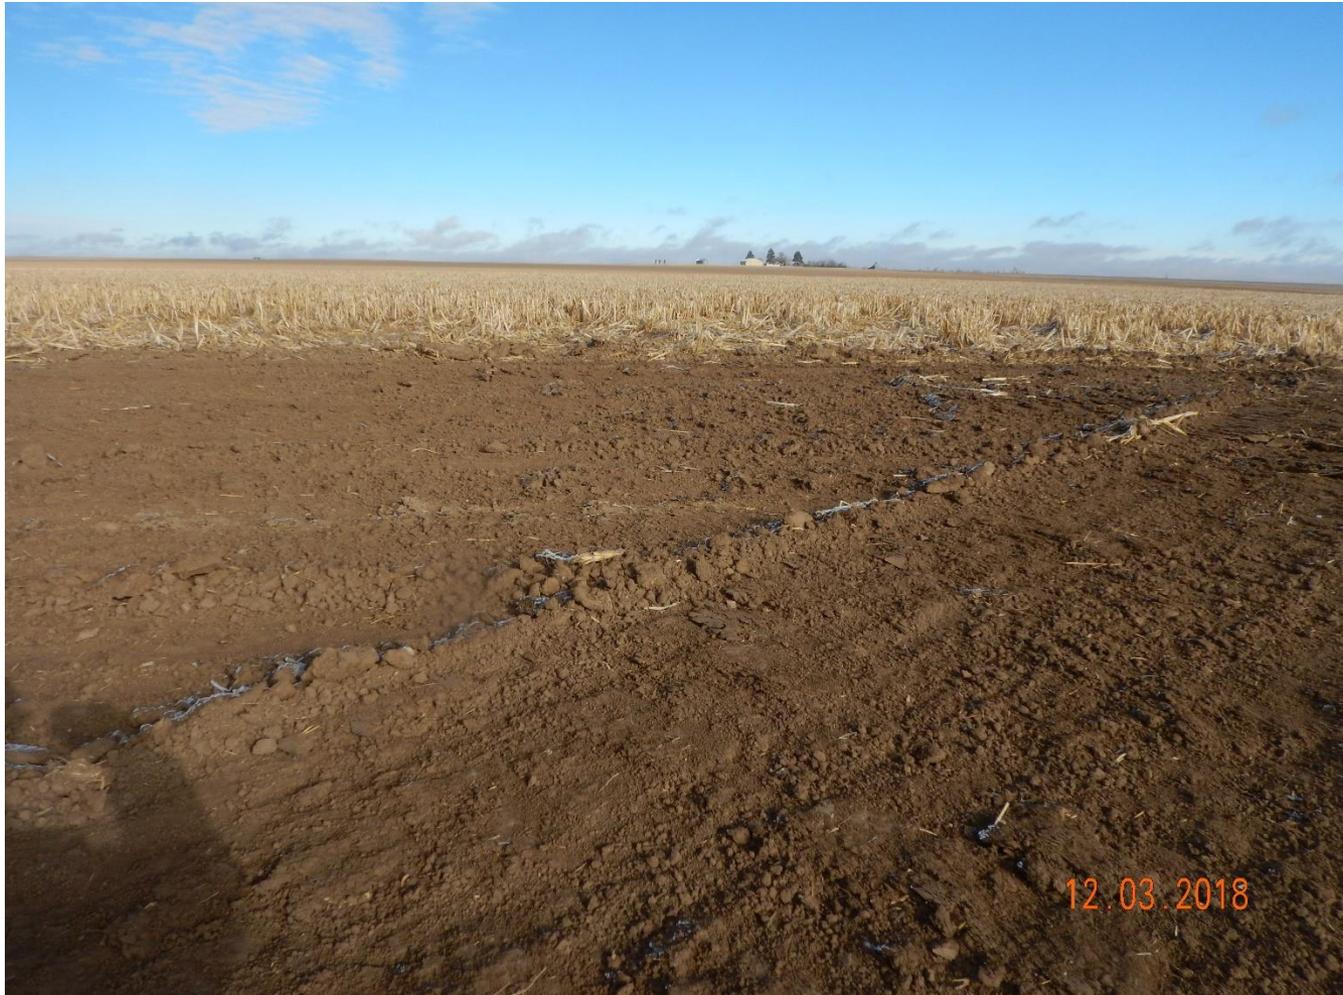
Photo 16: Photo taken from the center of the pad, facing North. Photo shows areas of the south and west end of the pad where ~1 inch of soil appears to have been salvaged when compared to the adjacent reference.
